SR 518 SeaTac Airport to I-5/I-405 Interchange Stream (Gilliam Creek) Mitigation Site

USACE # 200600651

2014 MONITORING REPORT

Issued March 2015

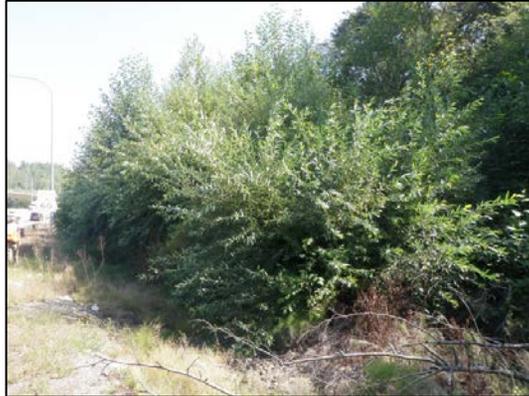
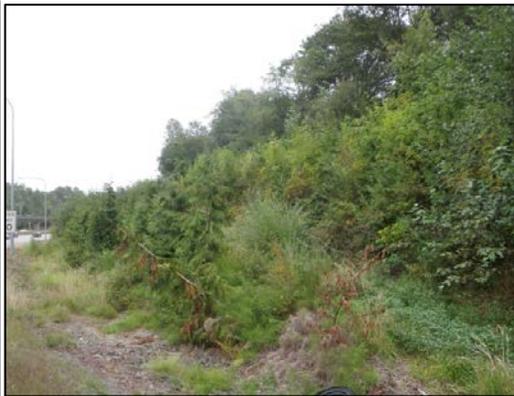
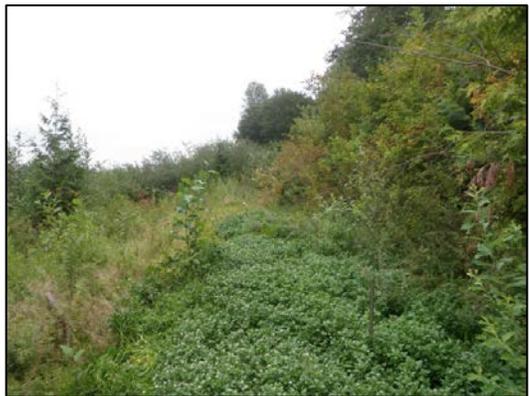
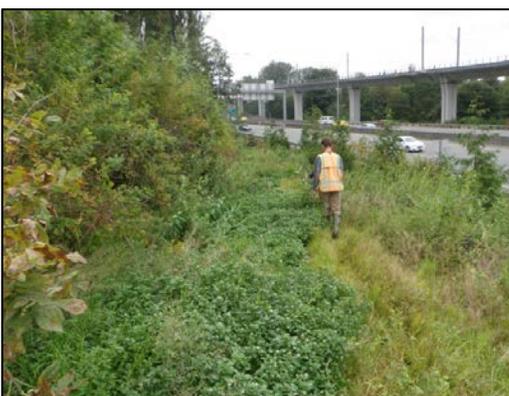
The willow plantings along the creek on the Tributary 1 site were inadvertently cut by Area Maintenance in April of 2014, but despite this overall native woody cover is still quite high across the site. Woody cover across the rest of the site is estimated at 95 percent, but along the creek channel it is now only about five percent.

Weed control will continue as needed and plans to restore Tributary 1 are currently in development.

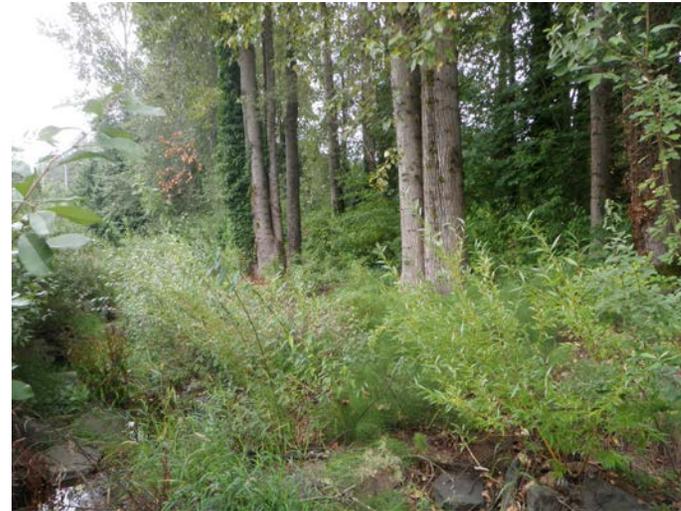
Native woody cover at the southwest tributary is estimated at 65% cover ($CI_{80\%} = 56-73\%$) (Photo 1), thus meeting the requirement. Native woody cover at unnamed tributary 1 (Photo 2) is estimated at 85 percent and at unnamed tributary 2 (Photo 3) cover is estimated at 85 percent.

Photo 1
Woody cover at the southwest tributary (September 2014)

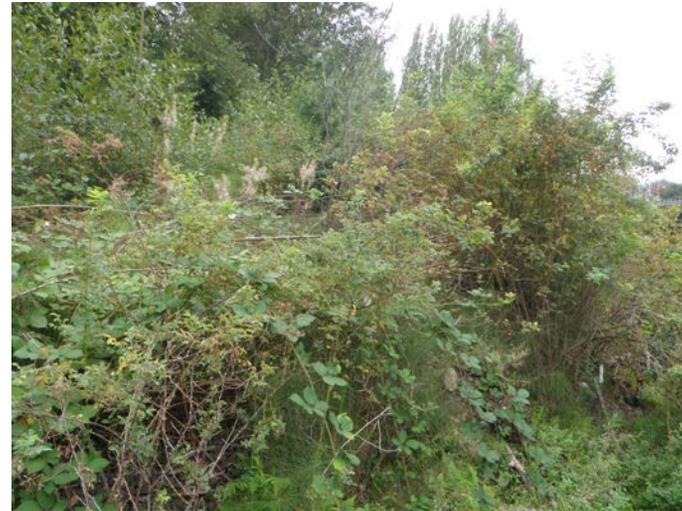
Photo 2
Woody cover at unnamed tributary 1 (September 2014)

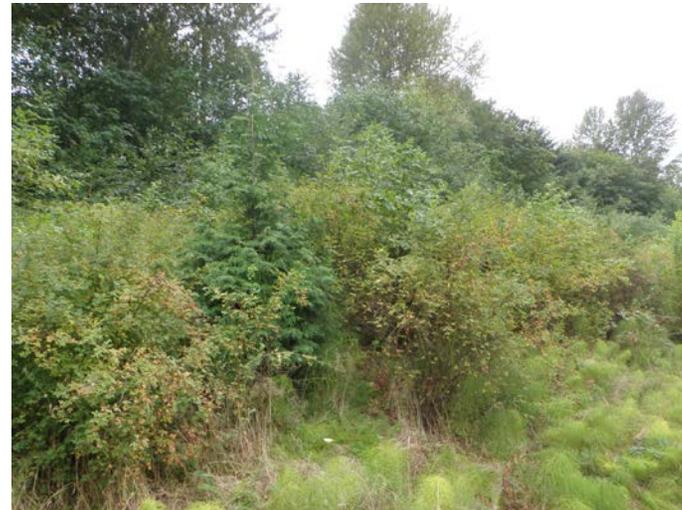
Photo 3
Woody cover at unnamed tributary 2 (September 2014)

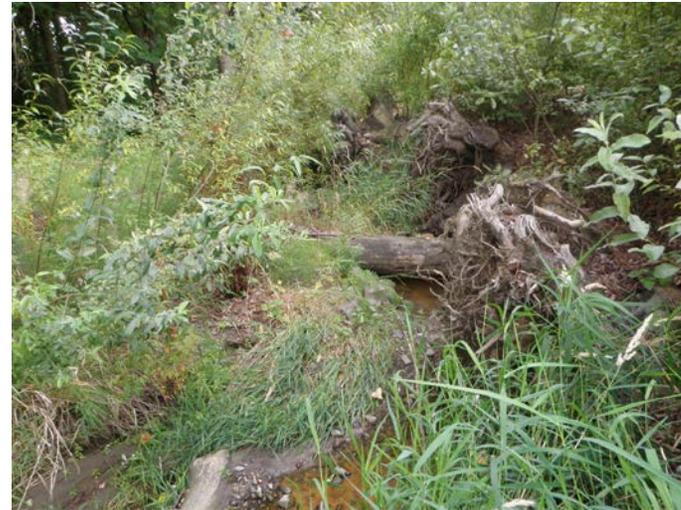
An inspection of the stream determined that that there has been no movement of root wads or in-stream woody debris (Photo 4).

Photo 4
Root wad in-stream placement (September 2014)
