Washington State
Department of Transportation
Paula J. Hammond, P.E.
Secretary of Transportation

May 12, 2008

RE: Structural Examination of Woodland State Airport

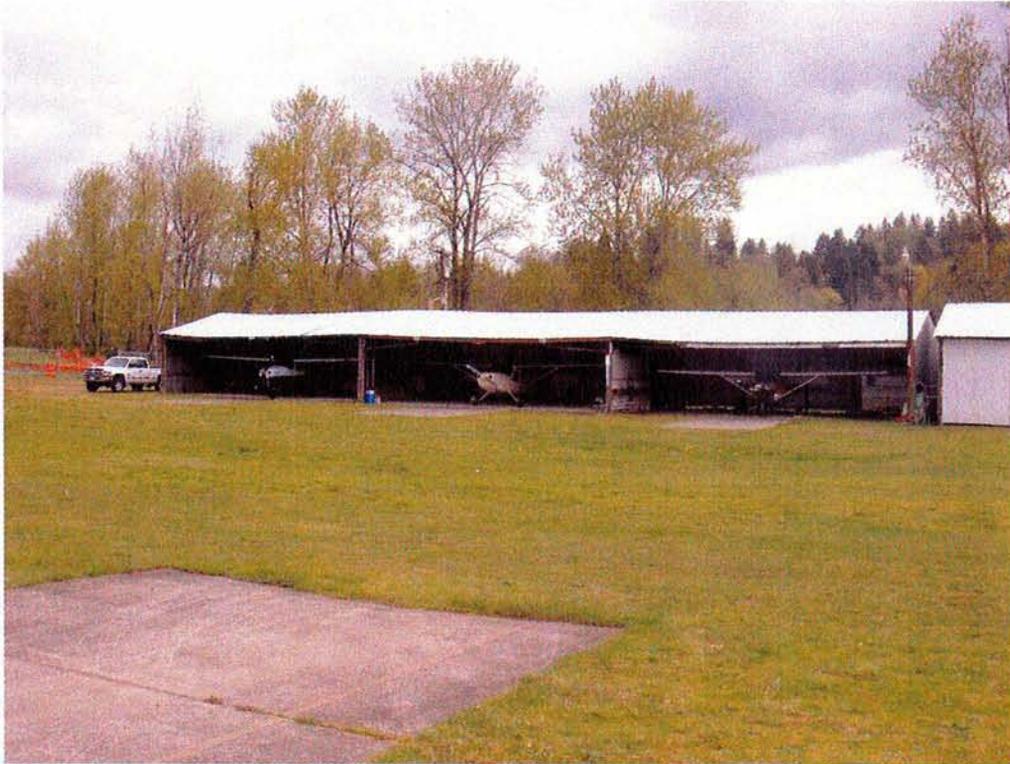
Photo #1
Building A, Hangars 1 Thru 3

Buildings A and B are located end to end on the east side of the airfield and may or may not have been constructed at or about the same time, but appear to be approximately more than 30 years old. Building A is 32' wide x 120' long. Building B is 32' wide x 160' long. Both buildings measure 14-1/2' to the gable peak with 9-1/2' walls. Each building has a pole frame type construction with three post lines supporting a gable-truss type, wood framework that was constructed to be post

supported at the center as well as the front and rear post lines. Roof purlins consist of 2x6 members at 2' to 2'-6" on center single spanned up to 20' with a galvanized corrugated metal roof. The exterior posts generally consist of creosote treated double 3x6 members and interior posts consist of pressure treated 6x6 members. The posts are embedded into the ground and are situated at an alternating 10' and 20' on center spacing with the exterior post lines enclosed by galvanized corrugated metal siding. (See Photos #1 and #2)

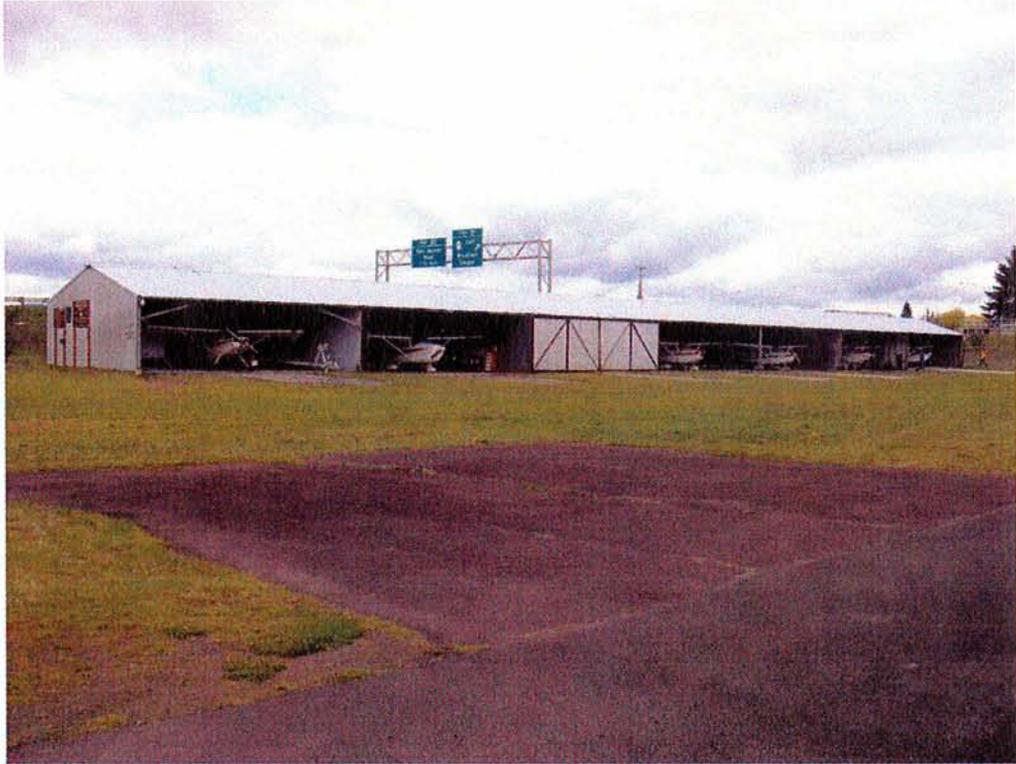
Photo #3
Building C, Hangars 9 Thru 15

Building C is located on the west side of the airfield and appears to have been constructed in the early to mid 80's; measuring 30' wide x 280' long, with 14-1/2' to the gable peak and 9-1/2' walls. This building also has a pole frame type construction with three post lines supporting double pre-manufactured trusses situated at an alternating 12' and 16' on center spacing. The roof purlins consist of 2x6 members single spanned up to 16' at $\pm 2'-6"$ on center with a galvanized corrugated metal roof. All of the posts generally consist of pressure treated 6x6 members embedded into the ground with the exterior post lines enclosed by galvanized corrugated metal siding. (See Photo #3)

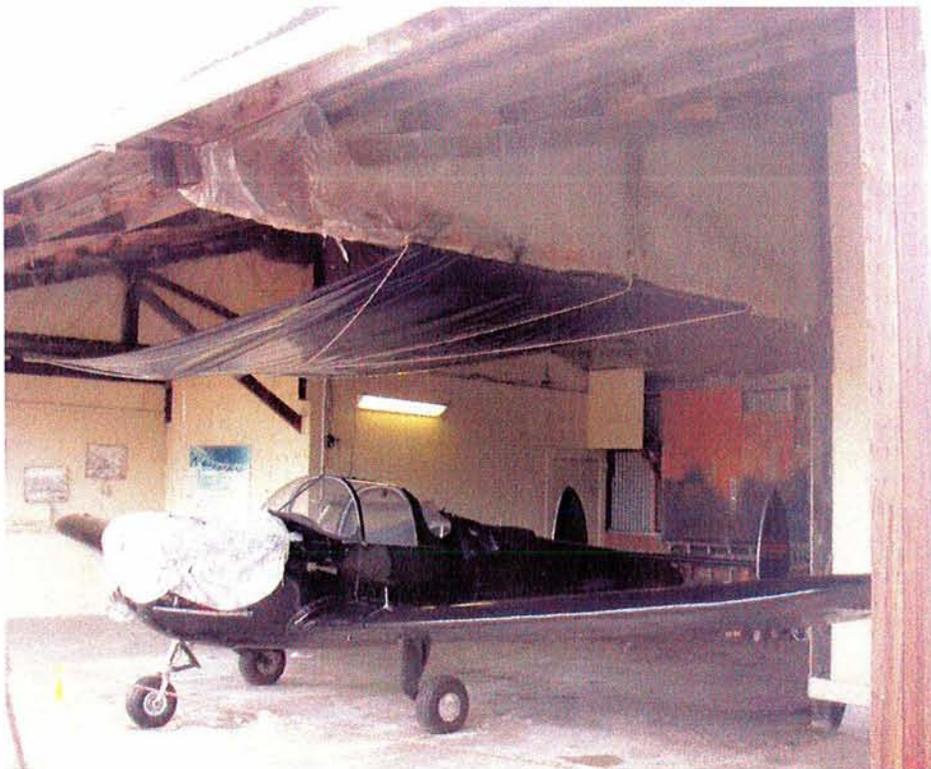
Buildings A and B have been typically modified at the hangar bay openings by removing exterior supporting posts to accommodate the required bay openings. A few of the hangar bay openings have door systems of different construction installed and many others are open to the elements. In some locations, replacement 4x4 posts were installed with hinges at the exterior truss bearing point to apparently allow the post to be moved up out of the way and then returned to a supporting position. However, each of the posts installed in this manner have been tied up in the open position and provide no support. In a few locations, the original posts have been cut off above the ground and spliced to replacement posts. In building A, all of the hangar openings and missing posts are located along the west wall line. In building B, the hangar openings and missing posts are alternated between the west and east wall lines. (See Photo #4)

Photo #4
Cantilevered Framing Typical, Hangar 8

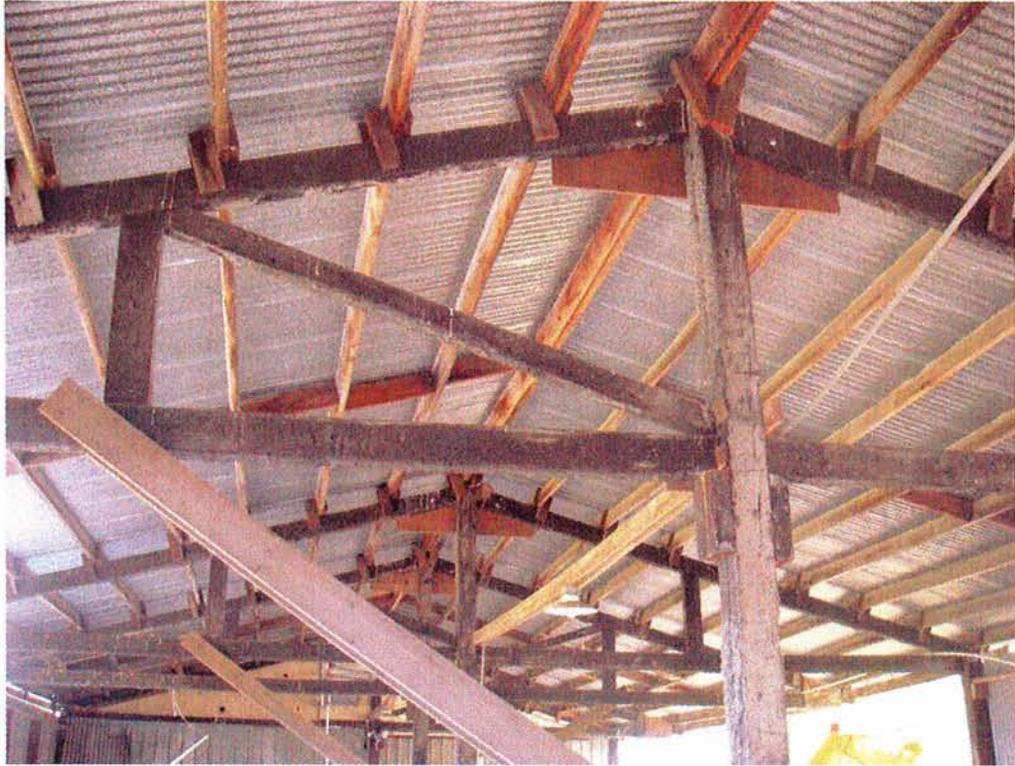
The gabled, wood framework supporting the roof joists generally consist of creosote treated 3x6 wood members framed into the interior bearing post from each side and connected at the eaves to form a truss type configuration. At locations where the exterior post was removed or modified, the tails of the truss-type framework is cantilevered out 16' with a 16' back span. An intermediate vertical member is present at each side near mid-span and a diagonal member is typically installed on the cantilevered side. Connections at the tails and panel points vary, but generally consist of plywood gusset plates at one or both sides with 3/8"-1/2" through bolts and varied nailing patterns. Many interior panel connection points for the vertical and diagonal members have no gusset plates or obvious connection. (See Photo #5)

In several areas the truss type frame work has been modified further with additional vertical and diagonal scab members and or strapping in various configurations to provide additional rigidity. On the cantilevered end side of the framework, additional diagonal knee braces have been installed in various configurations. These braces typically consist of single or double 2x6's attached to the interior post and out to near mid span of the framing. These connections also vary with through bolts in some locations and minimal nailing in others. Many of the installed knee braces are buckling out of plane up to 1" or more and several nailed connections are beginning to separate. At a few locations, 1/2" steel tie rods with angle clips, between the top and bottom chords, were installed in place of knee braces. The angle clips are bending slightly and crushing at the back of the through bolt connection. (See Photos #5 and #6)

The gable truss-type framework supporting the roof joists are not supported or constructed as true trusses. Typical truss design for hand built trusses requires careful attention to connections at the joined members. The observed geometry and existing connections do not even closely appear to be adequate. This is evident in the necessity of the numerous additional supporting knee braces, tie rods and scabs that have been installed to the framework over time. The design and connections of which are also not entirely sufficient as several are failing. As a result, the roof framing is deflected and sagging in many areas under dead load alone. Increased or full required design vertical loading could be expected to cause full or partial collapse in many areas.

Photo #5
Truss Type Framing Support. Buildings A and B

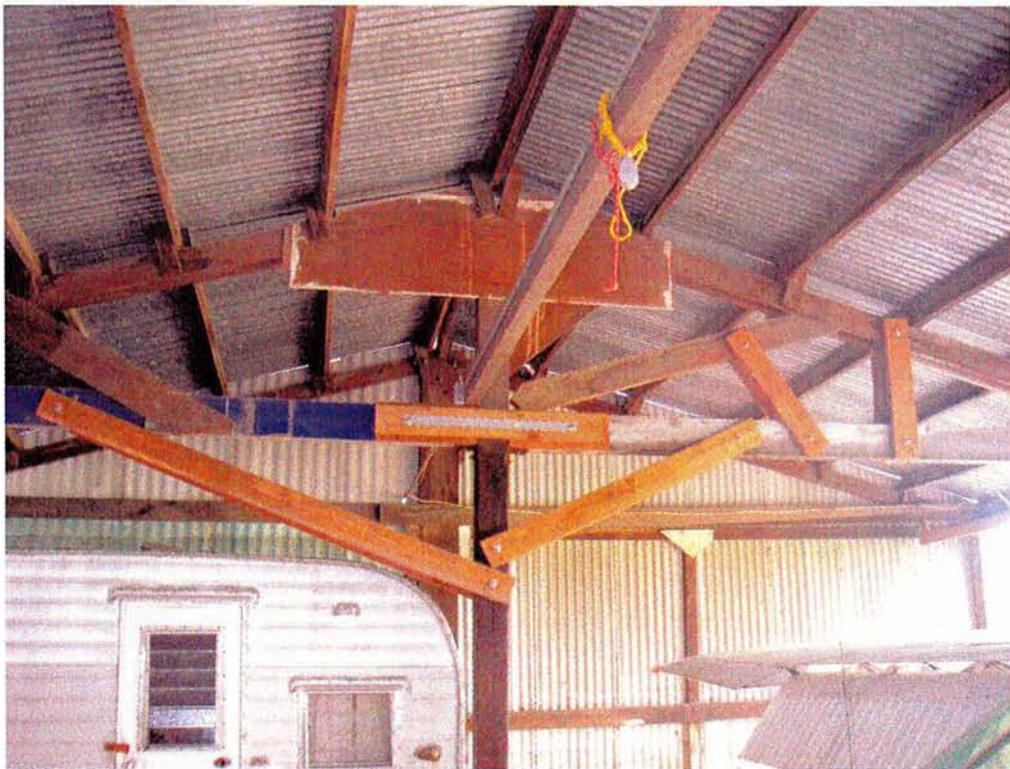
Photo #6
Multiple Band-Aids

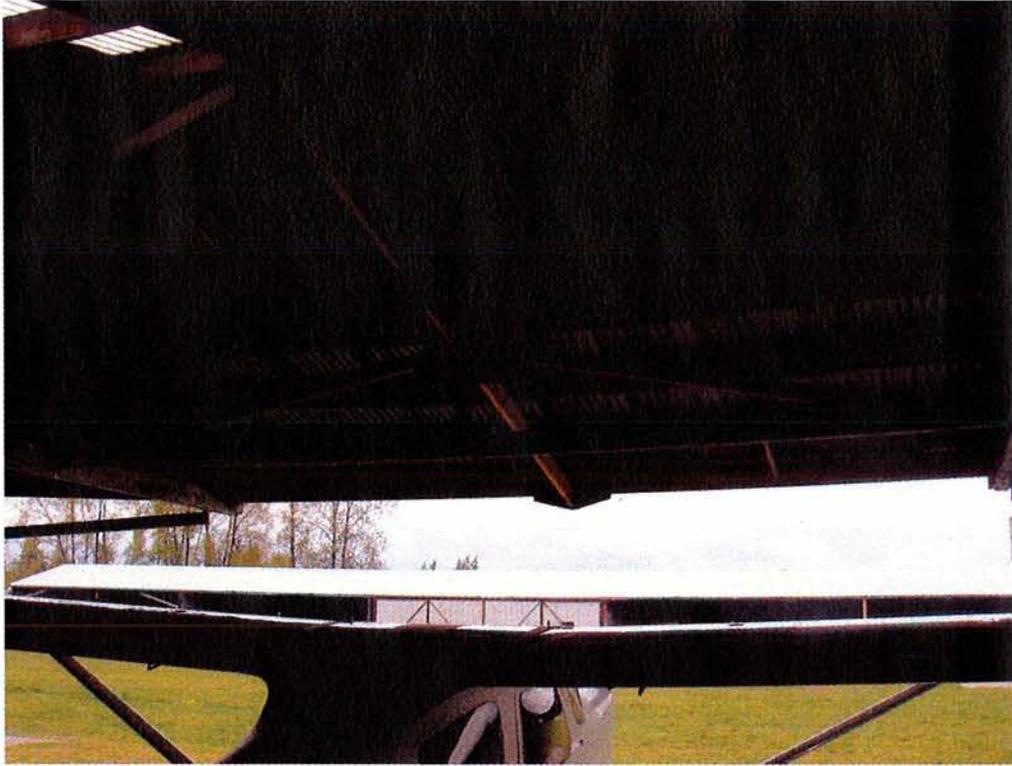
On the exterior of the building, obvious and excessive deflection is evident at the ridge roof line and along the eaves, but most predominant at the hangar bay openings where the roof framing is cantilevered. Obvious sagging can be seen with a measured downward deflection of up to 2-1/2". Many of the rim joists are scabbed and spliced in these areas. In building A, hangar 2, sagging roof purlins have been reinforced with an intermediate truss running between the framing over the post lines and the sag in the roof is still apparent. (See Photo #7)

Photo #7
Additional Truss Work At Hanger 2

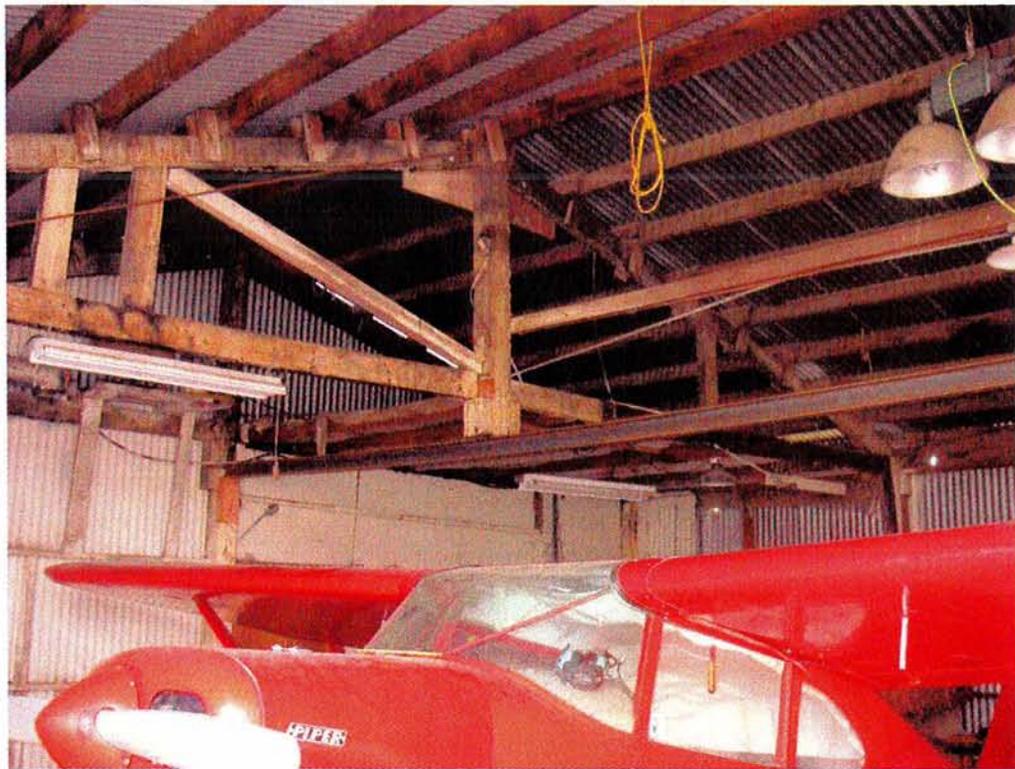
In building B, hangar 4, an interior post has been cut just below the roof framing support. Support for the cut post has been provided by a steel W4x13 steel member that is spanning 30'. This is a cantilever support location for the roof framing. The steel member is deflecting downward 3", outward 1-1/2" and is bearing at each end over scabs nailed to existing posts. Connections at the bearing points consist of bent over 16d nails and there is no noted connection to the cut post above. (See Photo #8)

During examination of the structures, it was noted that in hanger 4 of building B, the interior supporting post had been cut out and a steel member had been installed to carry the vertical load. The W4x13 steel section, as installed, spanned 30' unsupported with no connection to the cut post and under dead load alone, was deflected downward beginning to buckle. Follow-up communication at that time indicated possible imminent partial collapse and required that the hanger be evacuated and closed off to public access until temporary repairs, providing adequate support, could be installed. This requirement is still in effect until a designed repair is obtained and installed.

Photo #8
W4x13 Steel Section Deflected Downward And Buckling, Hanger 4

Buildings A and B are already showing signs of roof framing failure under dead load alone and past modifications indicate that this has been an ongoing problem. More recent modifications with the post removal in hangar 4 have created a situation requiring closure of the hangar bay. This hangar bay must remain closed until proper support has been restored.

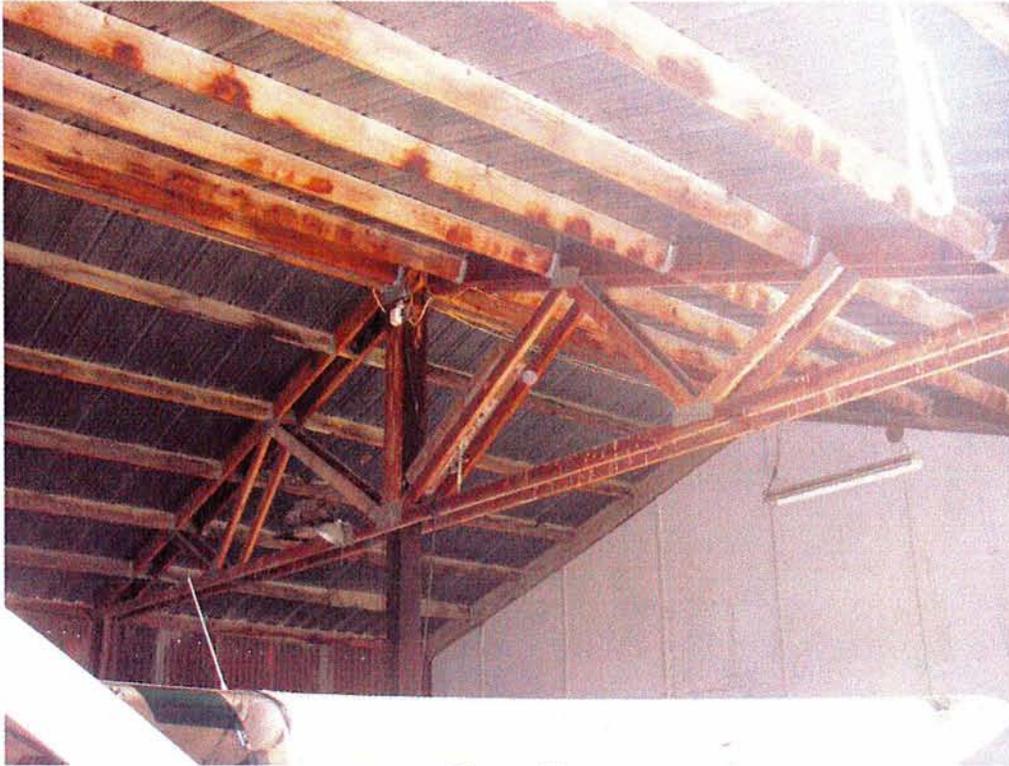
Roof joists, on a 2'-6" on center spacing, span up to 16' between lines of double pre-manufactured trusses and sheathed walls. Trusses generally consist of 2x6 top chords with 2x4 bottom chords and web members that are connected at panel points with pressed plates. At hangar bay openings, the trusses bear at the rear wall and at nailer blocks to the interior posts, but cantilever up to 15' out to the hangar bay openings. Vertical web members at the center of the trusses also appear to be nailed to the interior post. No lateral truss bracing is present. (See Photo #9)

The trusses provided at the support for the roof purlins were most likely not originally designed to carry cantilevered loads. Although they appear to be holding up adequately under dead load only at this time, with no obvious or noted problems, as pre-manufactured trusses, they were most likely designed to be fully supported at each end and in the center with a snow load of 20 or 25 psf.

Calculations and analysis of the truss configuration, with 15' of cantilever span, indicate that the trusses may be capable of carrying the existing dead load only, depending on the grade of wood used for construction. This would require that the wood members used for construction be of high structural grade (DF Select Structural or MSR 2250). Based on the observed condition and performance from the time of construction, it is reasonable to believe that they are adequate for supporting the present dead load, but the grade of lumber used in the trusses should be verified.

However, analysis indicates that the existing installation of the trusses and connection to the supporting posts are inadequate to support or resist snow and wind loading. Inadequate bracing and connections to the posts make collapse due to loss of support or buckling of compression members very possible under heavy loading.

Photo #9
Double Truss Cantilevered Over Open Hangar Bay, Building C

Designed repair and retrofitting needs to be provided to insure that the structural integrity of the roof is maintained and able to support the necessary loads.

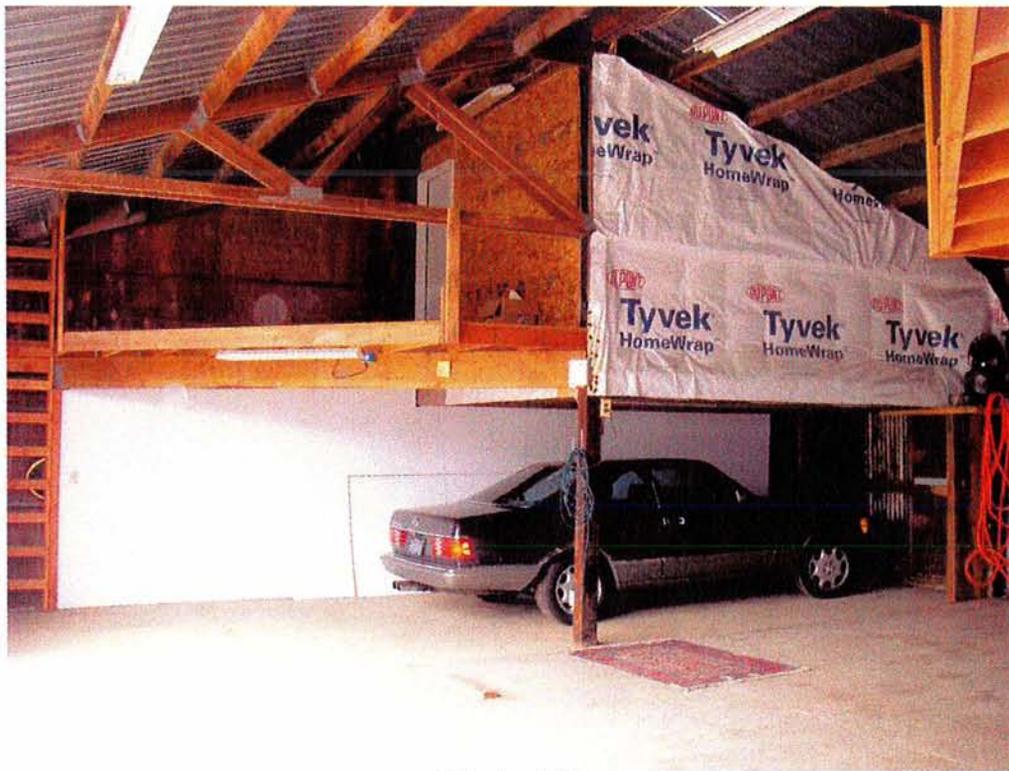
In hangar 13, wood framed storage mezzanines have been constructed at each side of the bay running from the front to the rear wall and are accessed by ladders. On the south side of the bay, there is an enclosed storage or office space supported by the mezzanine. Framing for the mezzanines consists of 3/4" plywood over 2x6 and 2x6 rough sawn members spanning up to 15' between wall lines and wood beams. The beams are attached to the existing posts with field bent Simpson Strong Tie brackets. (See Photo #10)

On the interior of hangar 13, the recently wood framed mezzanines do not outwardly appear to meet current code requirements. Typical framing for this purpose is usually required to be designed for loads in the area of 50 to 100 psf. to accommodate office or light storage loads.

Photo #10
Mezzanine With Enclosed Storage Space, Hangar 13
