2010

OBSI Testing of MnROADs I-94 WB Exposed Aggregate and Diamond Ground Test Sections

Preliminary Draft: Not for Distribution

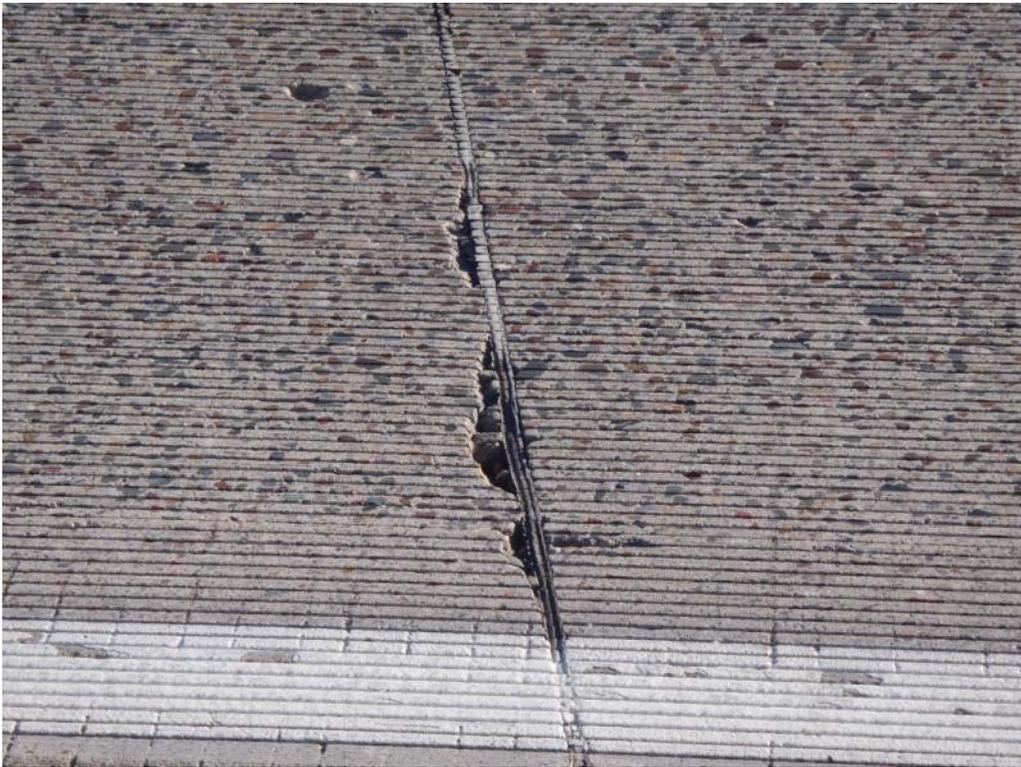
Photos of each of the test sections are included in Appendix 1 thru 5. It should be noted that the CDG, NGCS, and NGCS LITE sections, previously constructed on a 14 year old existing pavement, are exhibiting surface distress as indicated in Appendix 2 thru 5. The pavement distresses may be affecting the time series results. For the last two evaluations the tested wheelpath has been shifted to the left to avoid some of the potholes. However, it is also evident that the sealant continues to fail which can cause additional increases in measured levels which are not a result of changes in texture. For the Montecello sections backer rod was lying on top of the pavement surface at several joint locations in the EB direction.

Figure 2-1 Spalling in NGCS LITE Texture (Cell 9)

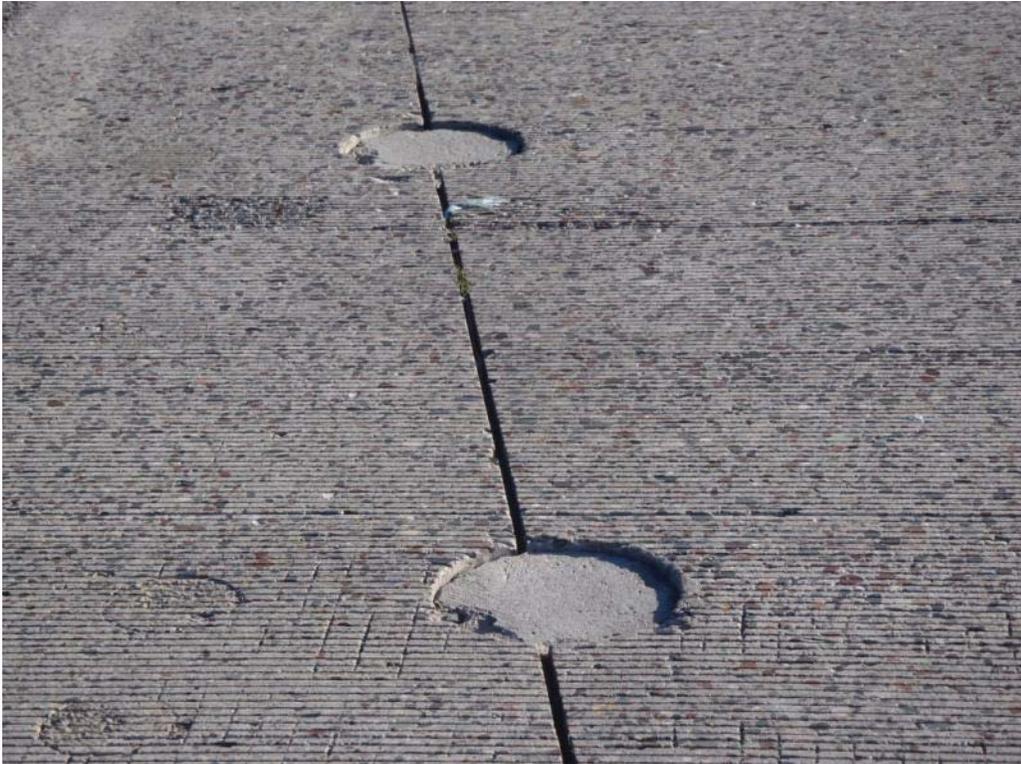
Figure 2-2 Depressed 12 "Core Hole Repairs and Existing Transverse Tining

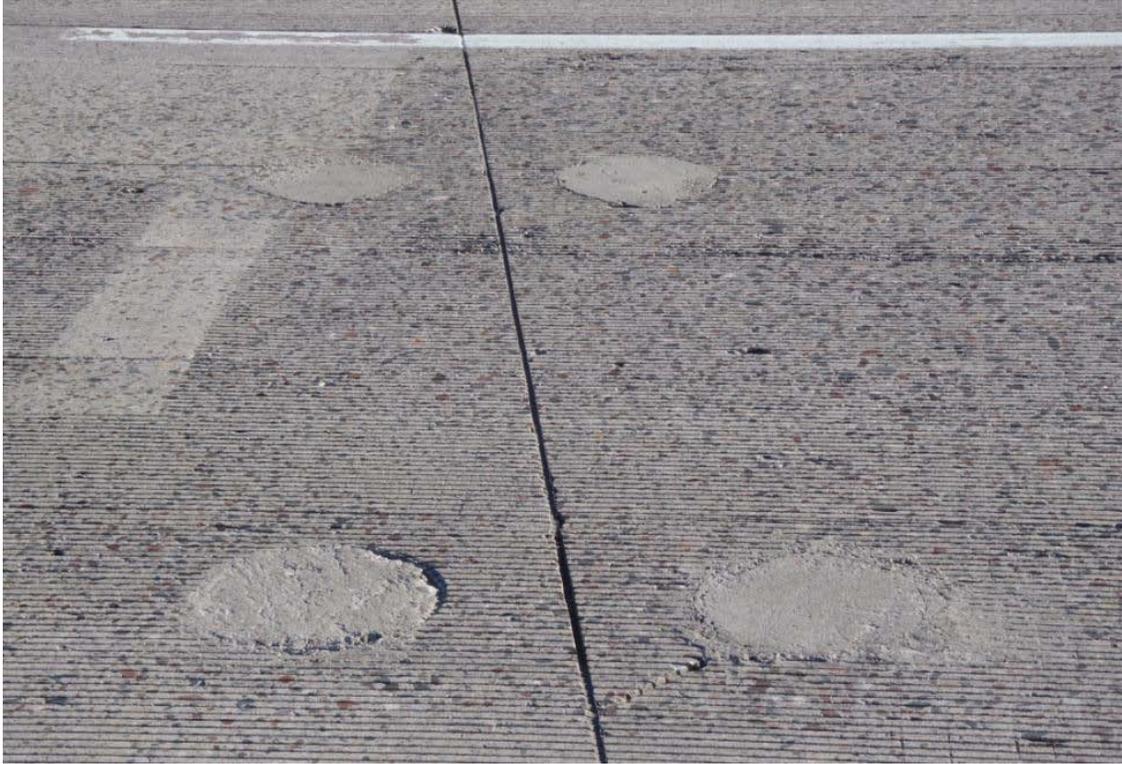
Figure 2-3 12" Core Holes with Good Patches

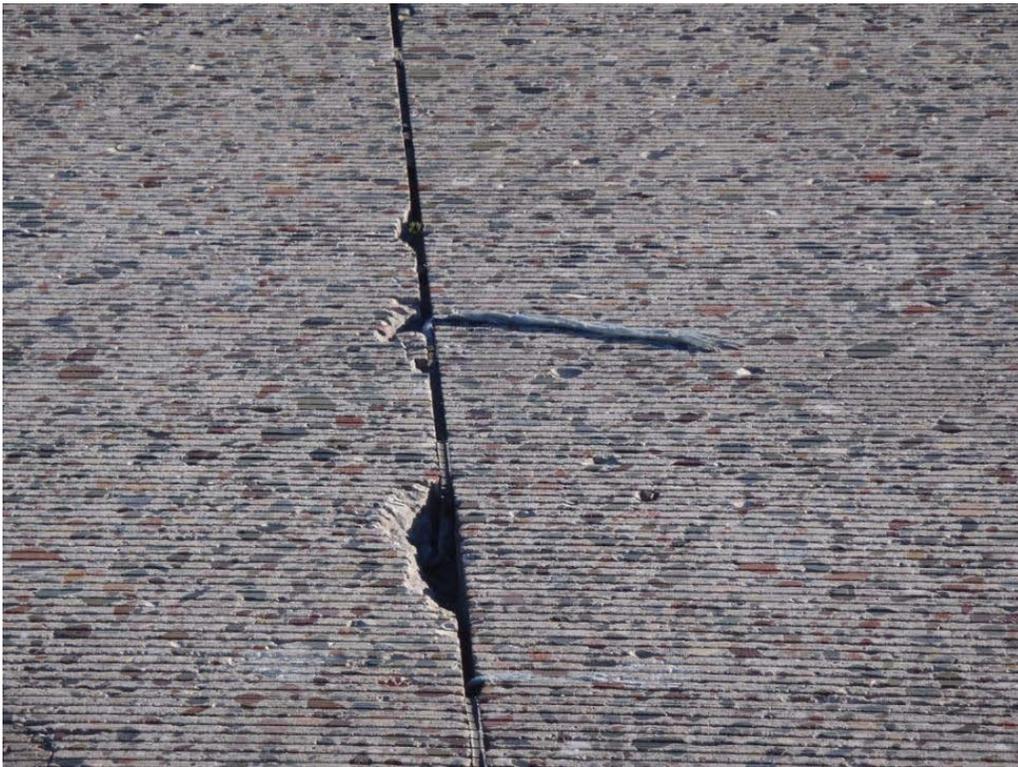
Figure 2-4 Spalling at Joint and Backer Rod Exposed on Pavement Surface

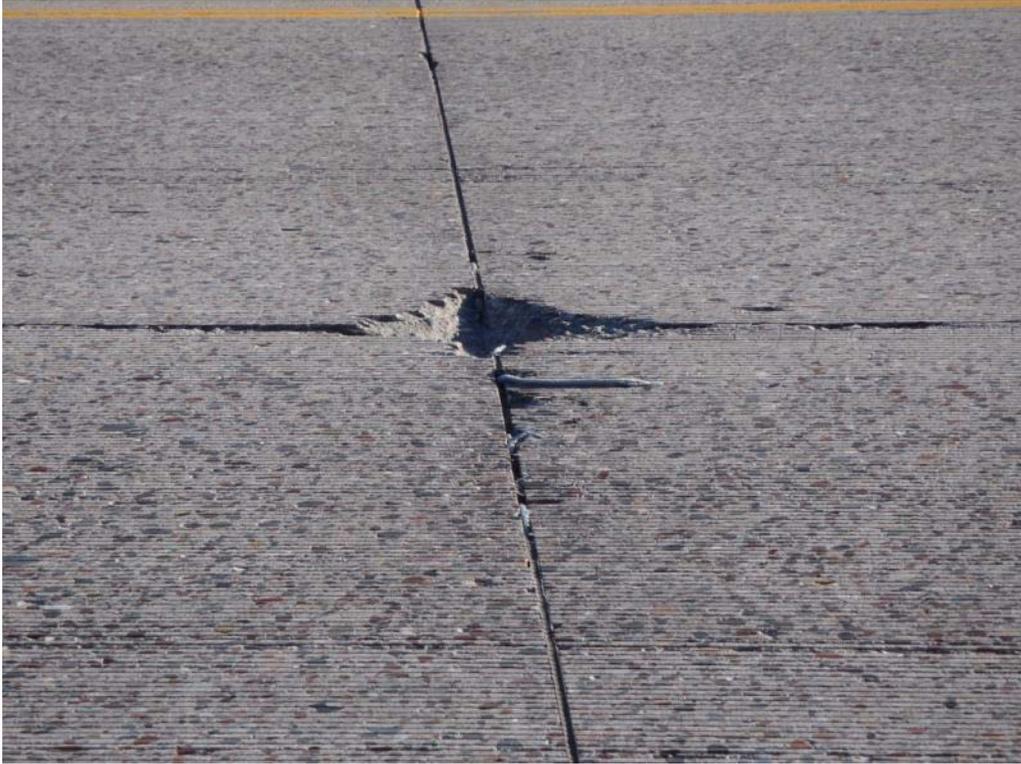
Figure 2-5 Spalling and Backer Rod Failure

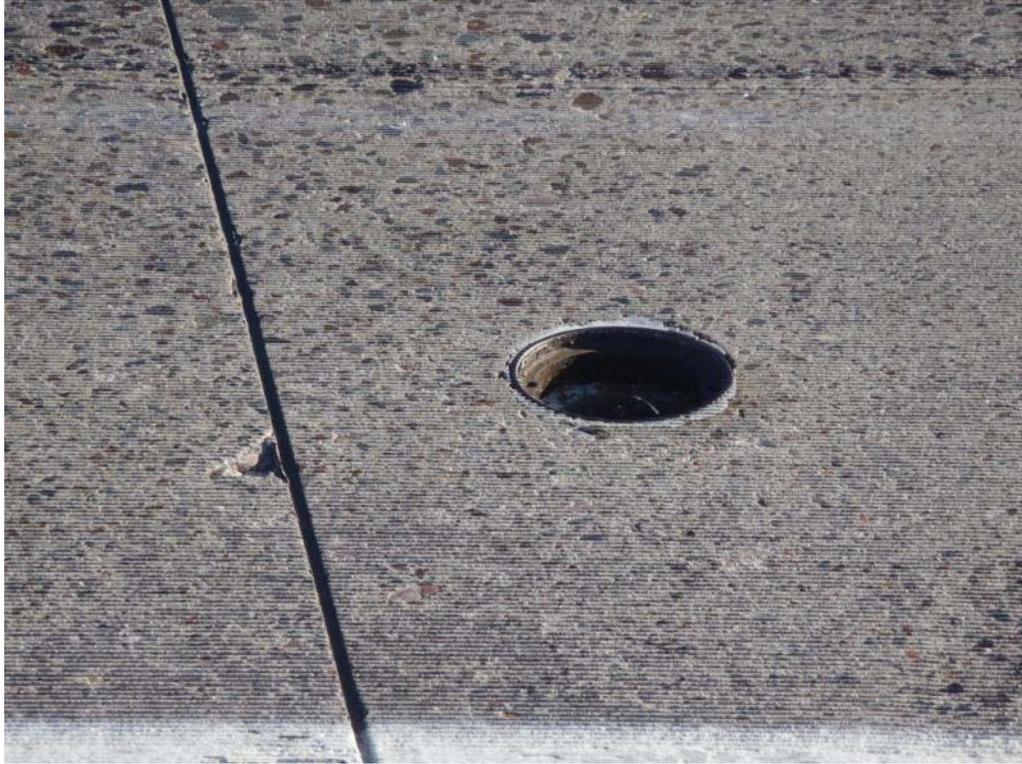
Figure 3-1 Hand Hole in Test Area

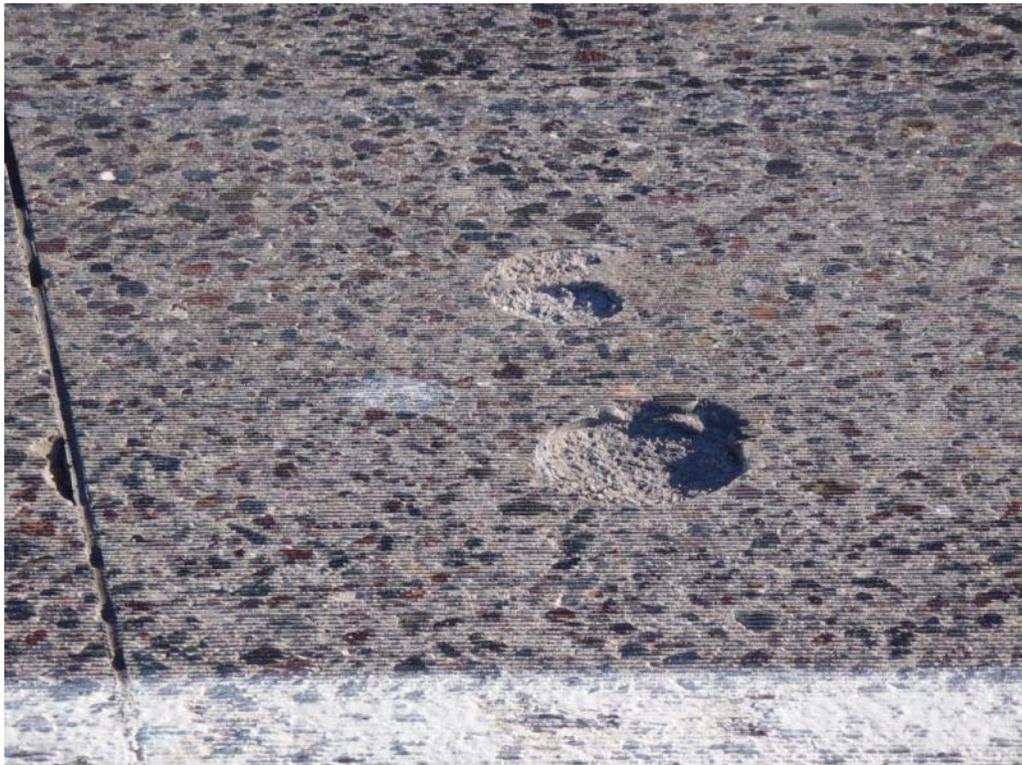
Figure 3-2 6" Core Hole Repairs

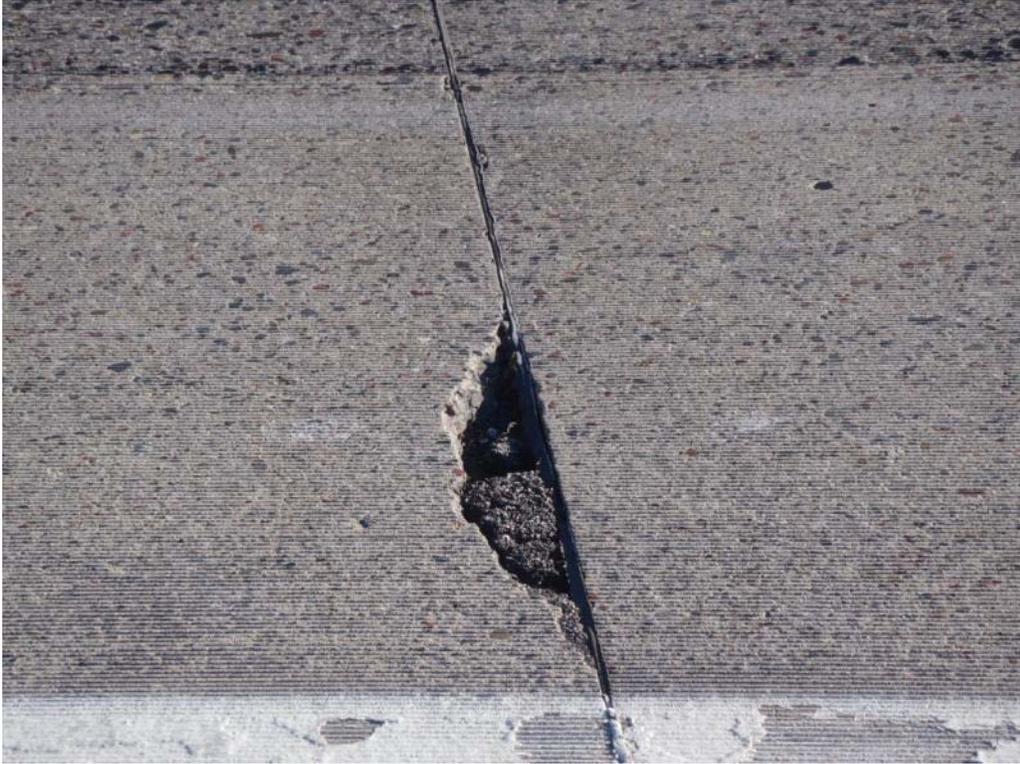
Figure 3-3 Spalled Joint and Failed Repair

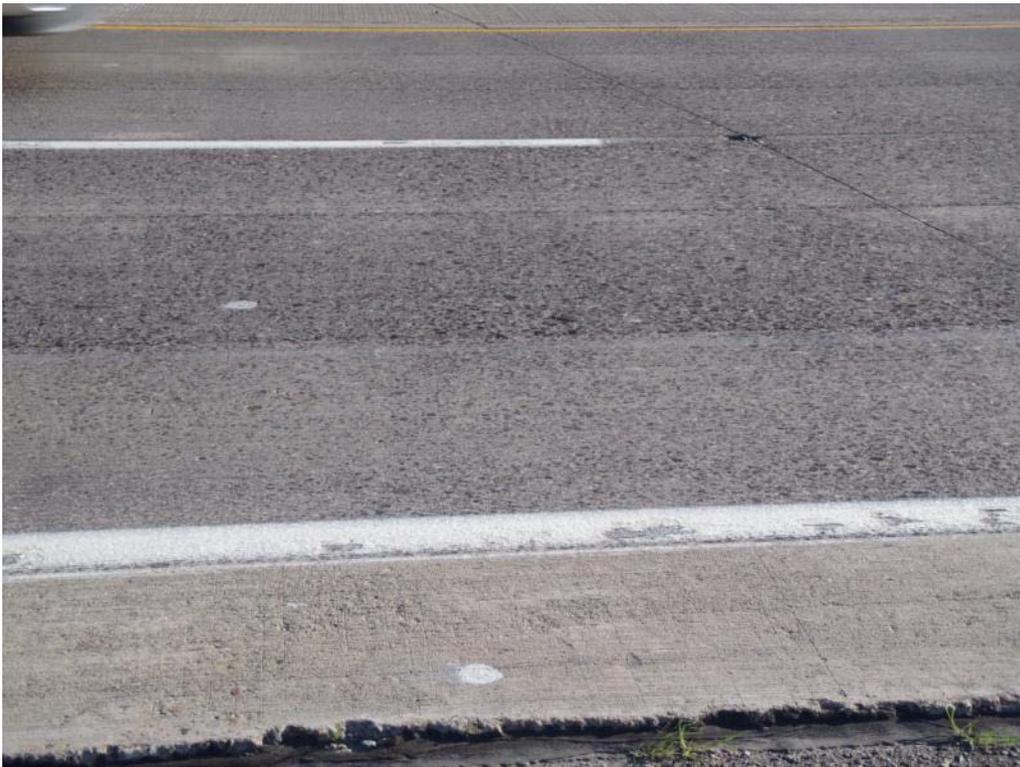
Figure 3-4 Texture in Outside Pass Appears Different

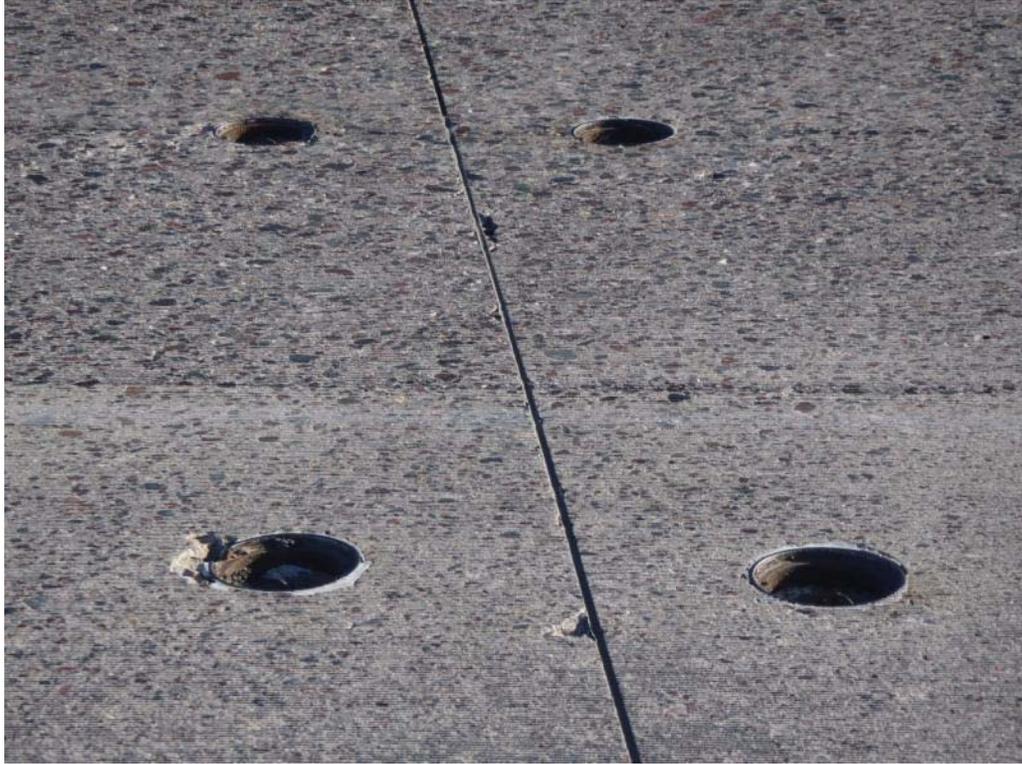
Figure 3-5 More Hand Holes in Section

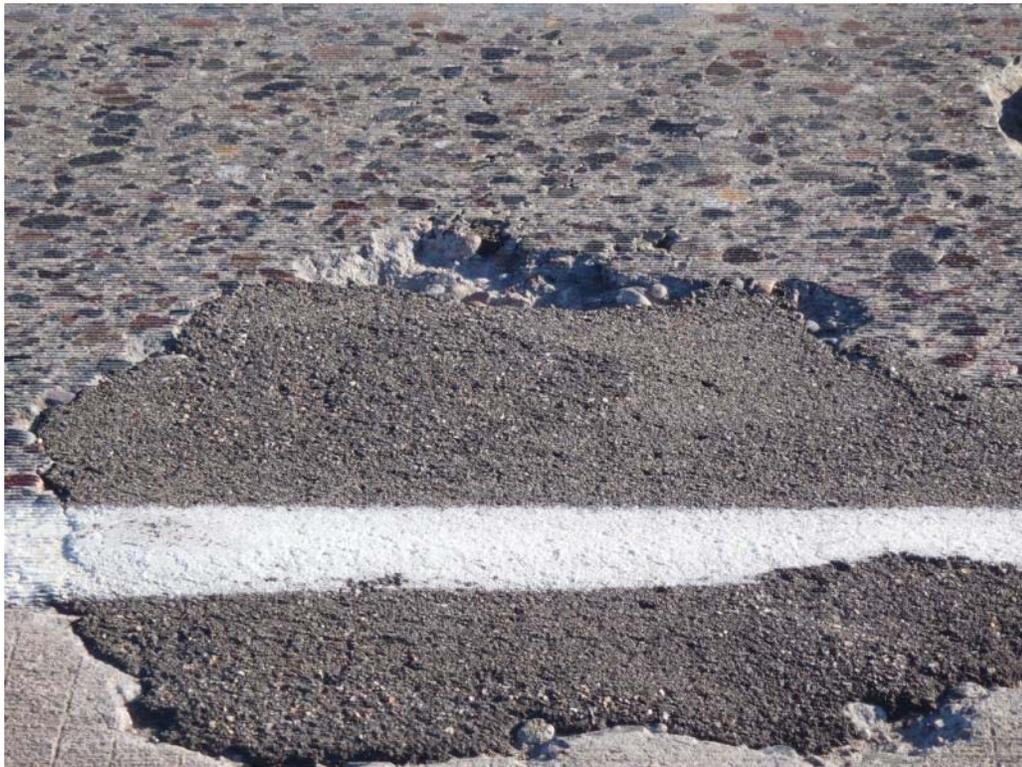
Figure 3-6 Pot Hole Repair at Edge of Pavement

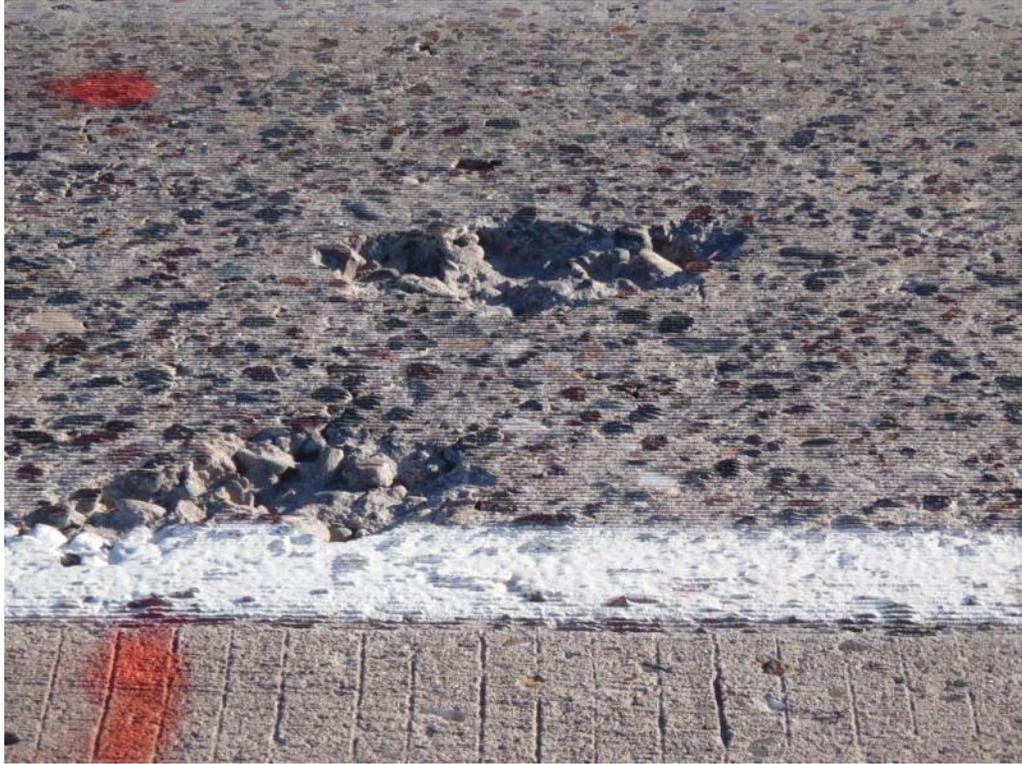
Figure 3-7 Spalls on Surface of Roadway

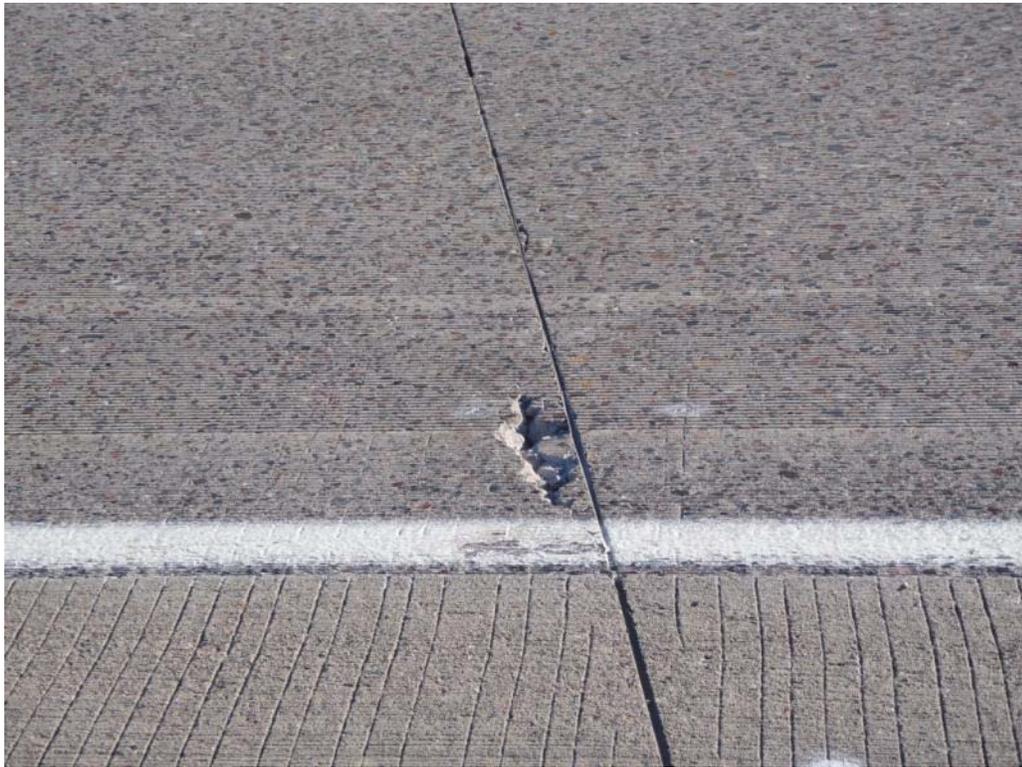
Figure 4-1 Spalling at Joint

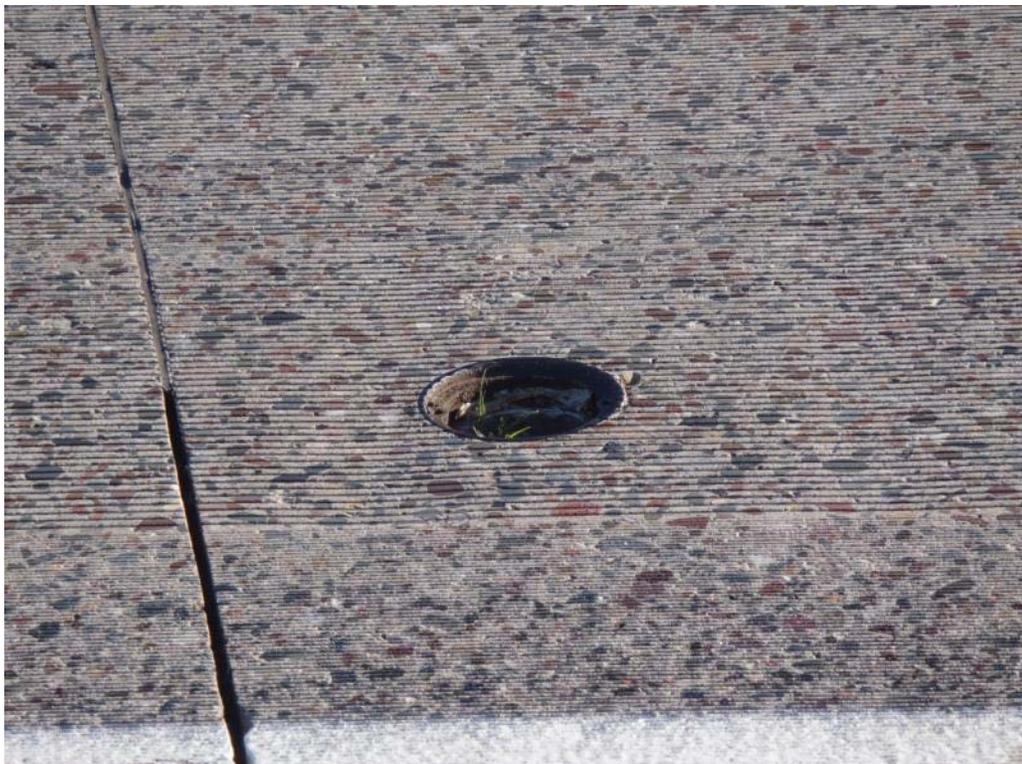
Figure 4-2 Hand Hole with Grass and Sealant Failure in Transverse Joint

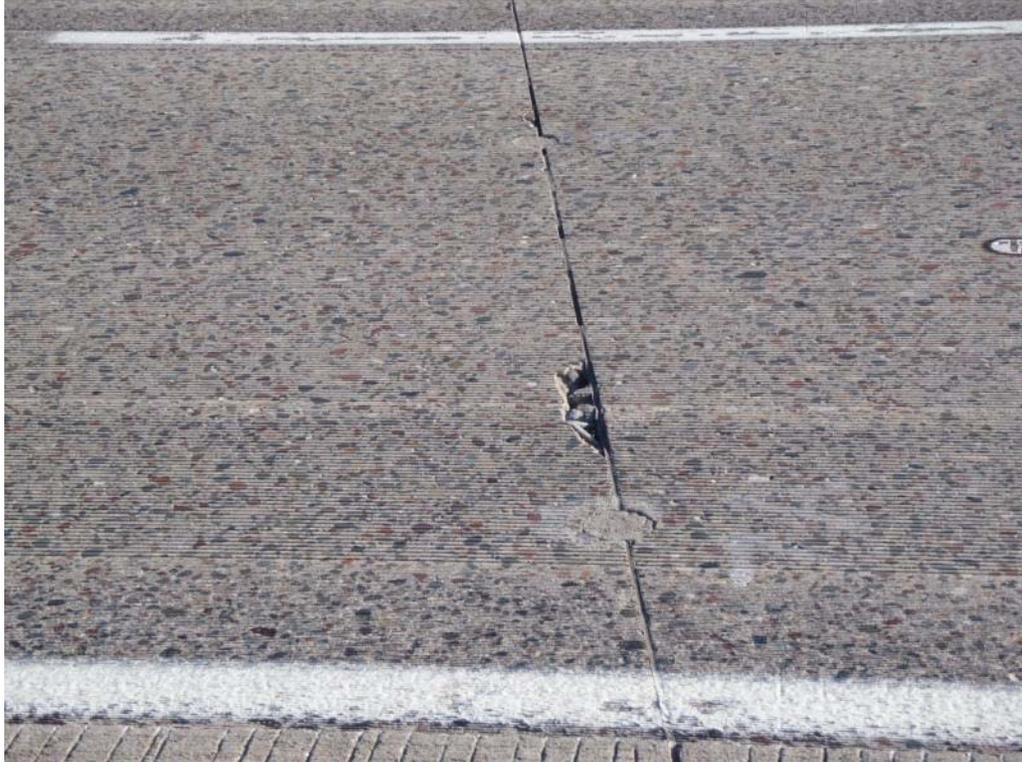
Figure 4-3 6" Core Hole Repairs and Spalling at Joint

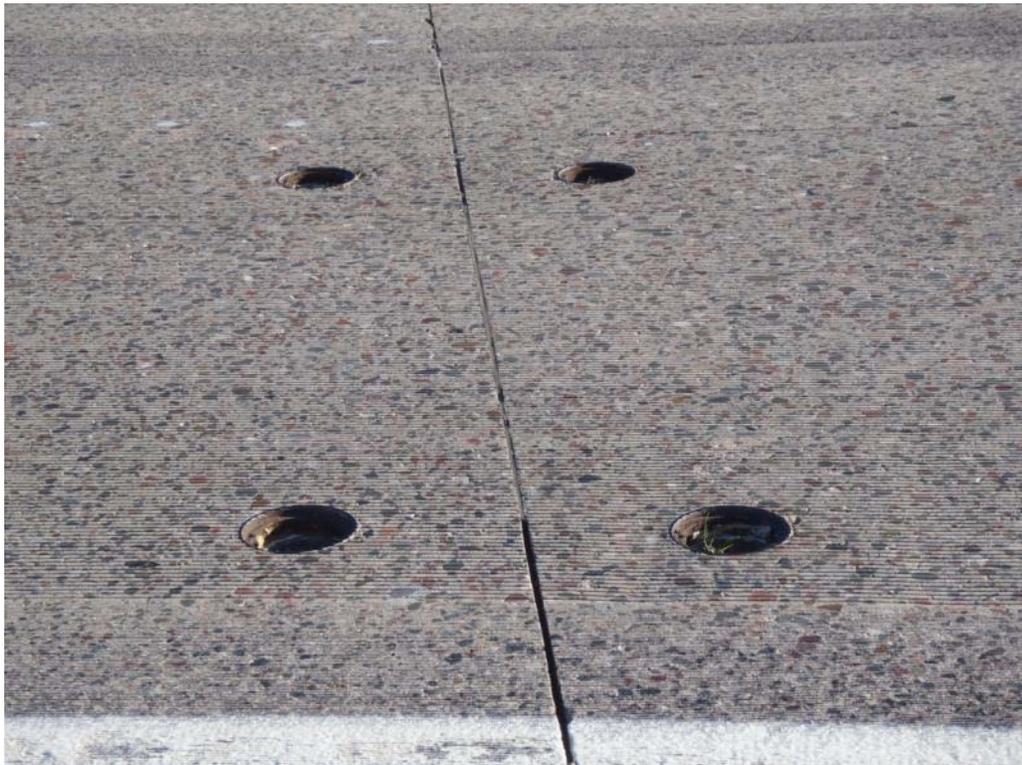
Figure 4-4 Hand Holes in Pavement

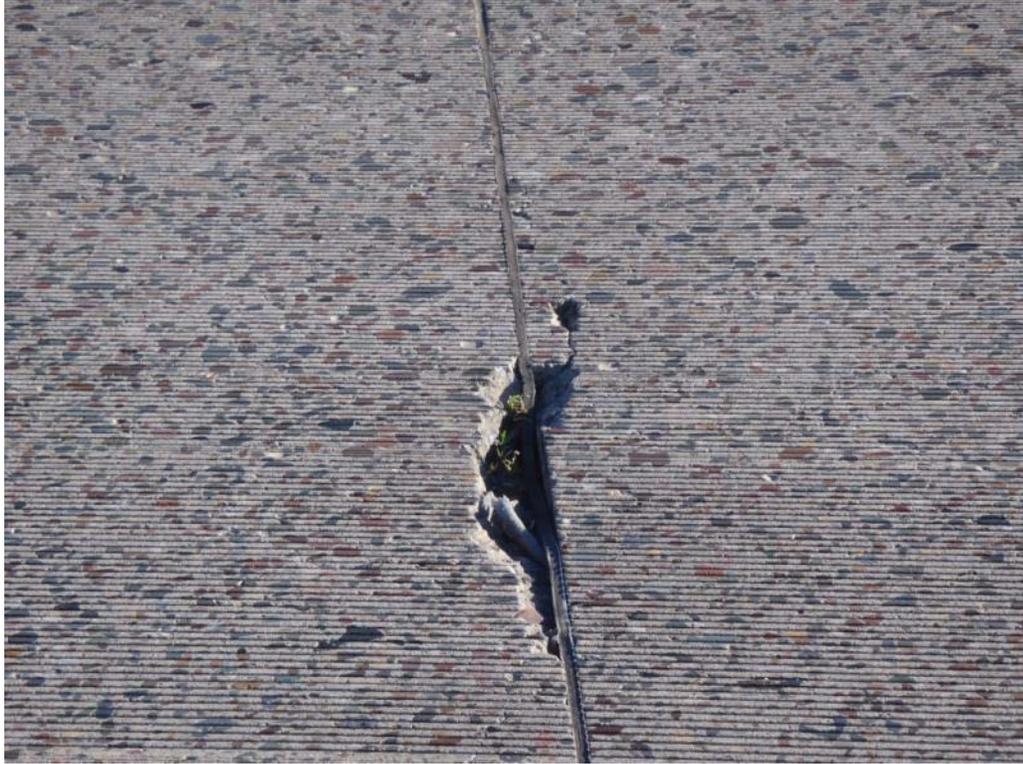
Figure 4-5 Spalling at Joint

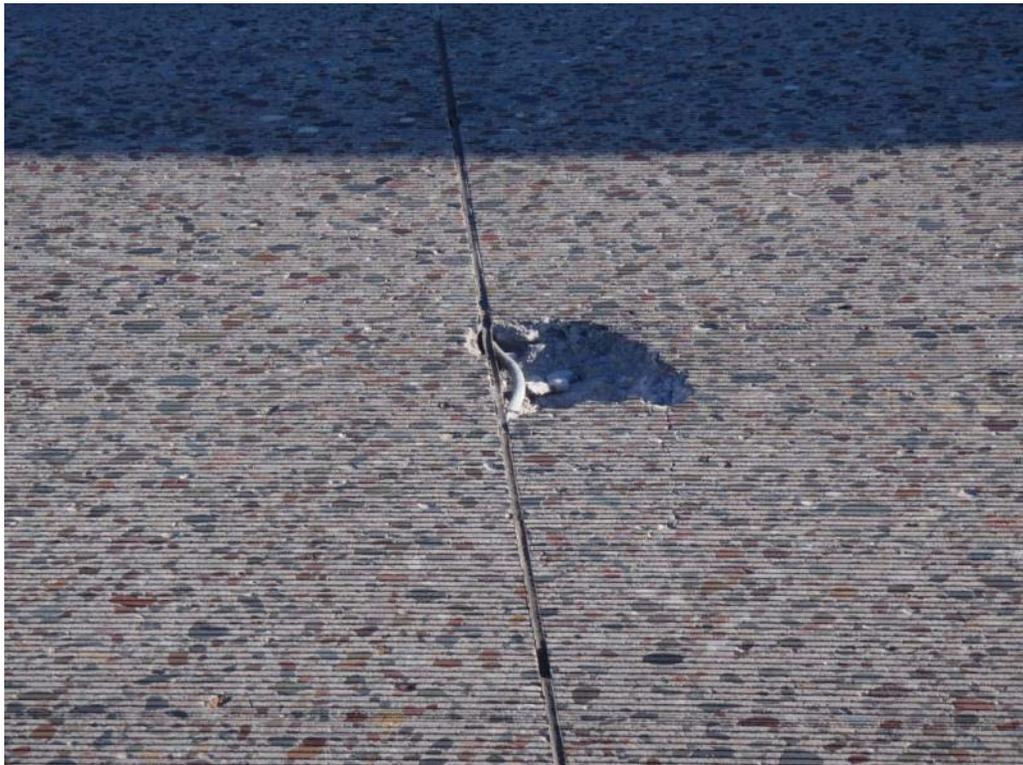
Figure 4-6 Spalling at Joint

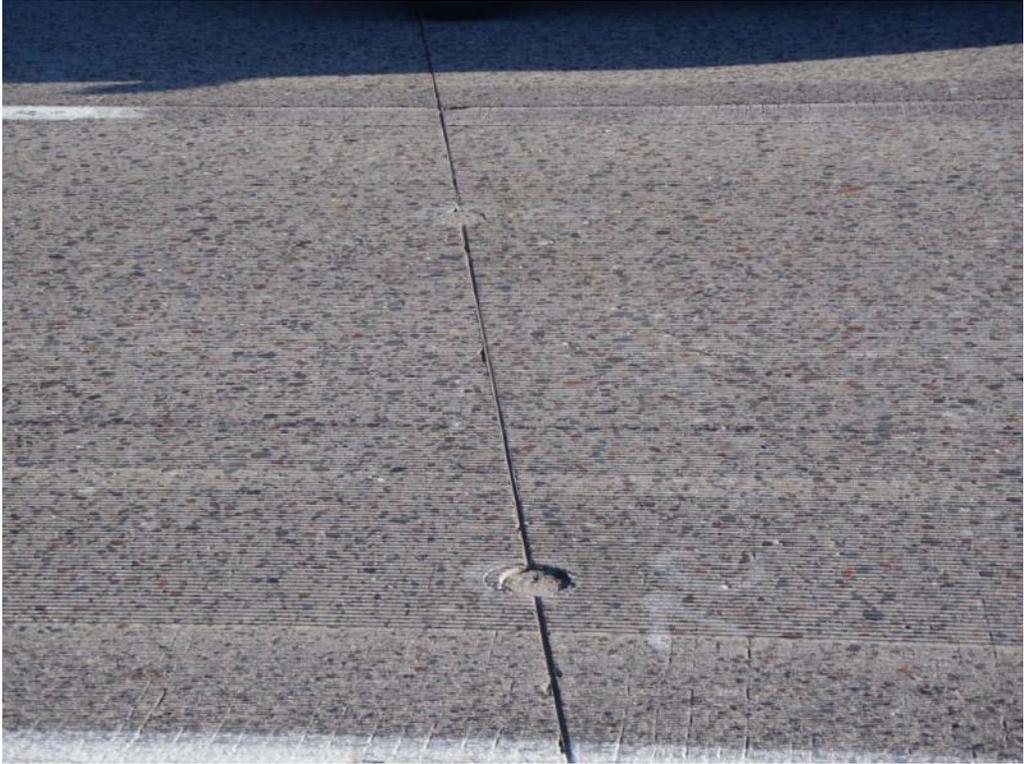
Figure 4-7 6" Core Hole Depression

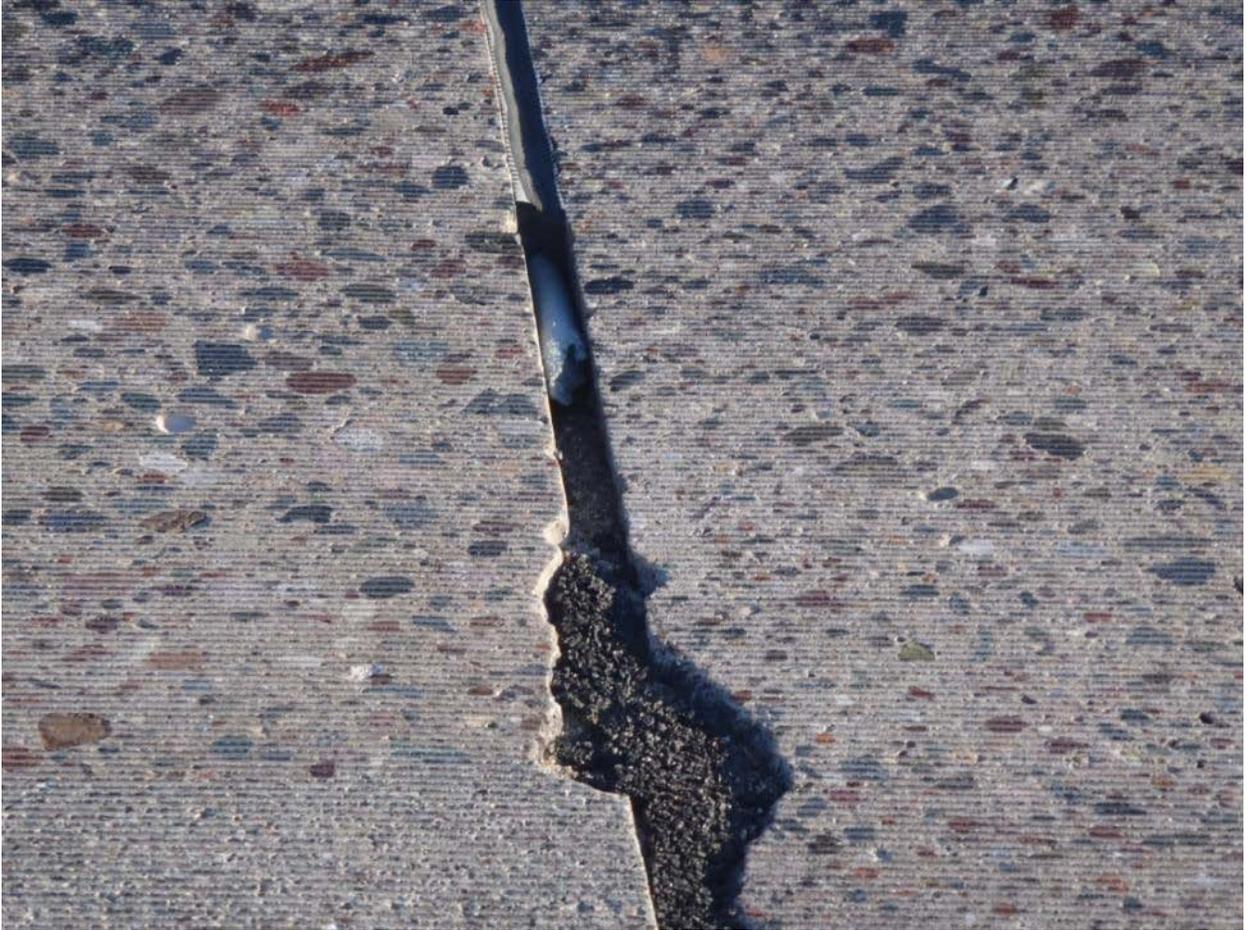
Figure 5-1 Spalled Joint and Failed Sealant in Wide Joint

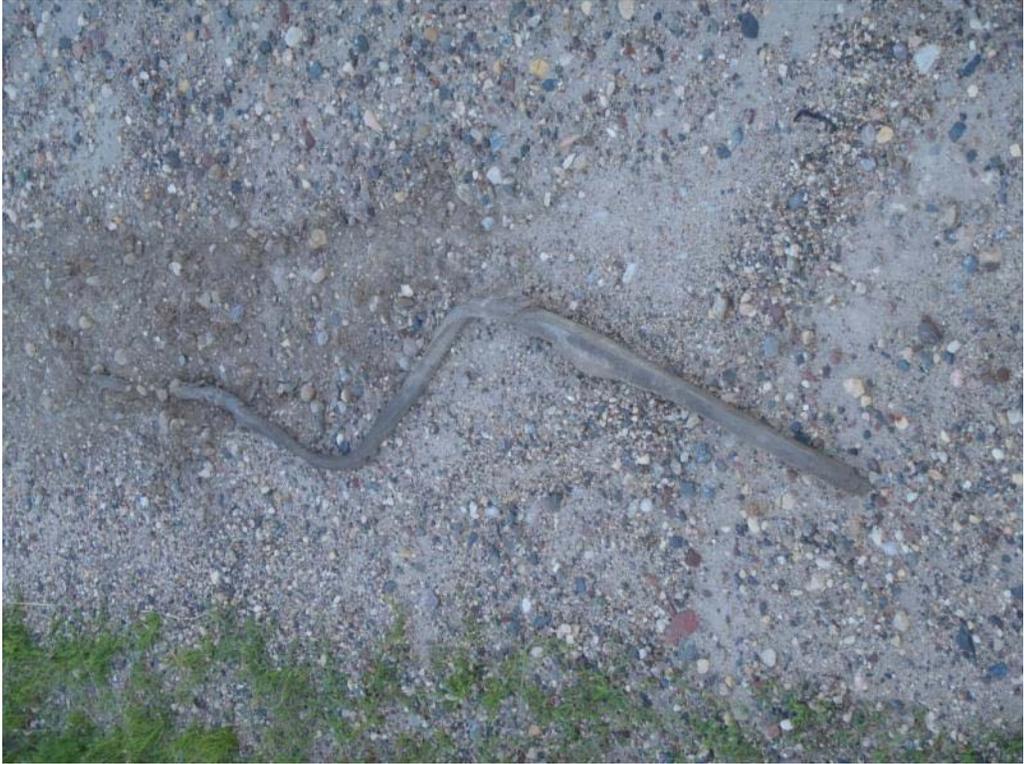
Figure 5-2 Failed Sealant on Shoulder of Roadway
