2007 Western Bridge Engineers' Seminar

Fracture Critical and Fatigue Prone Inspection of the West Fremont Bridge Approach Structures

Portland, Oregon

Mark Libby, PE – HDR Engineering, Inc.

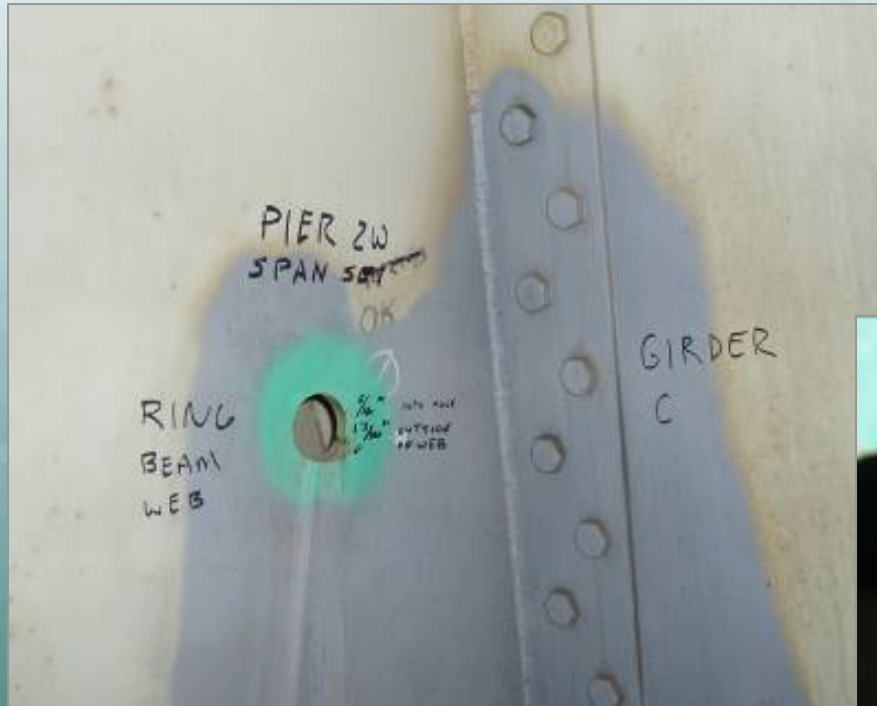
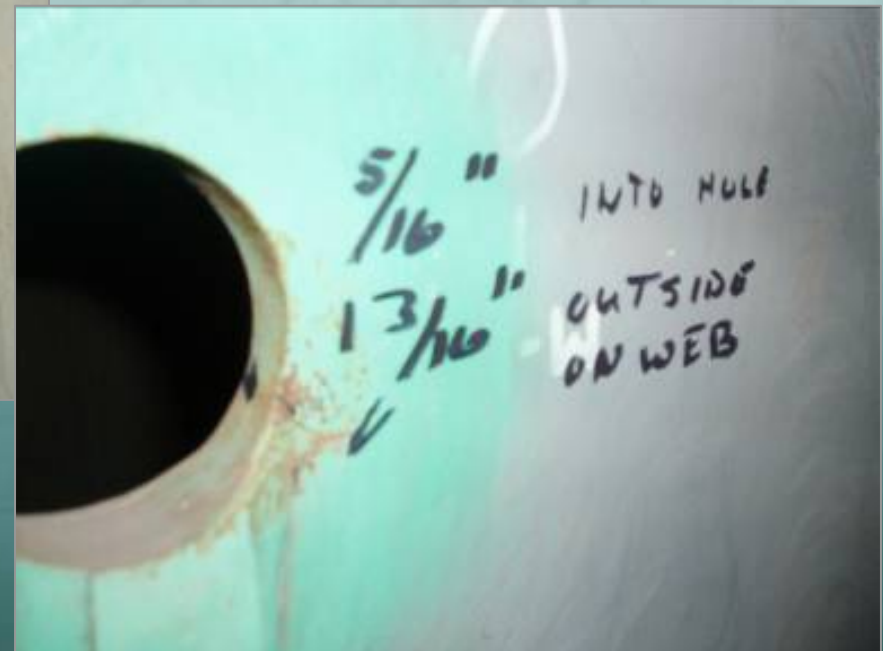
- Crack propagating from arrest hole

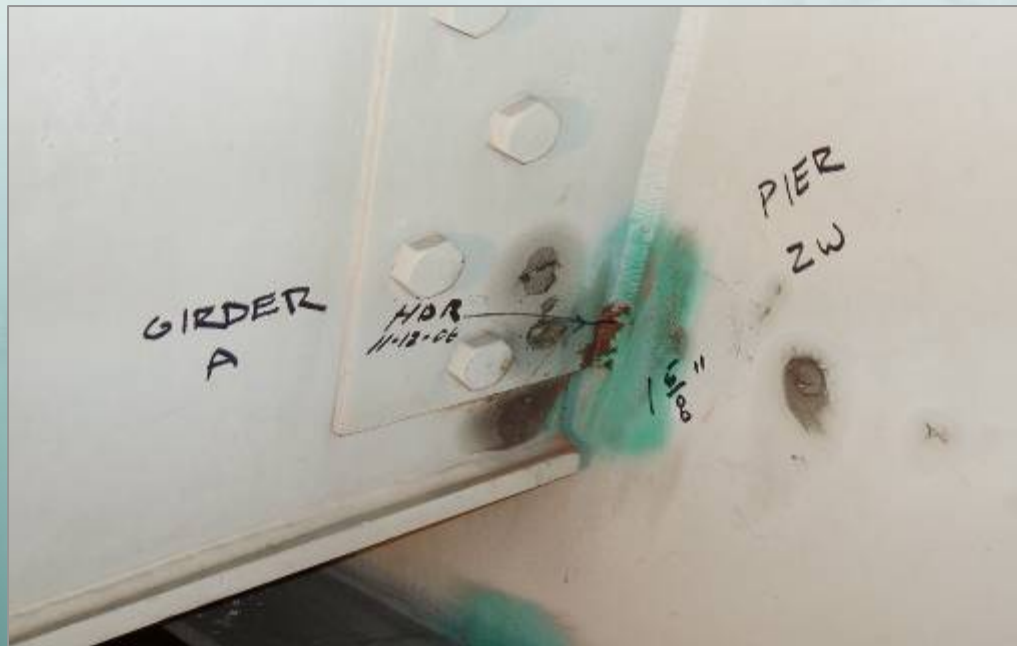
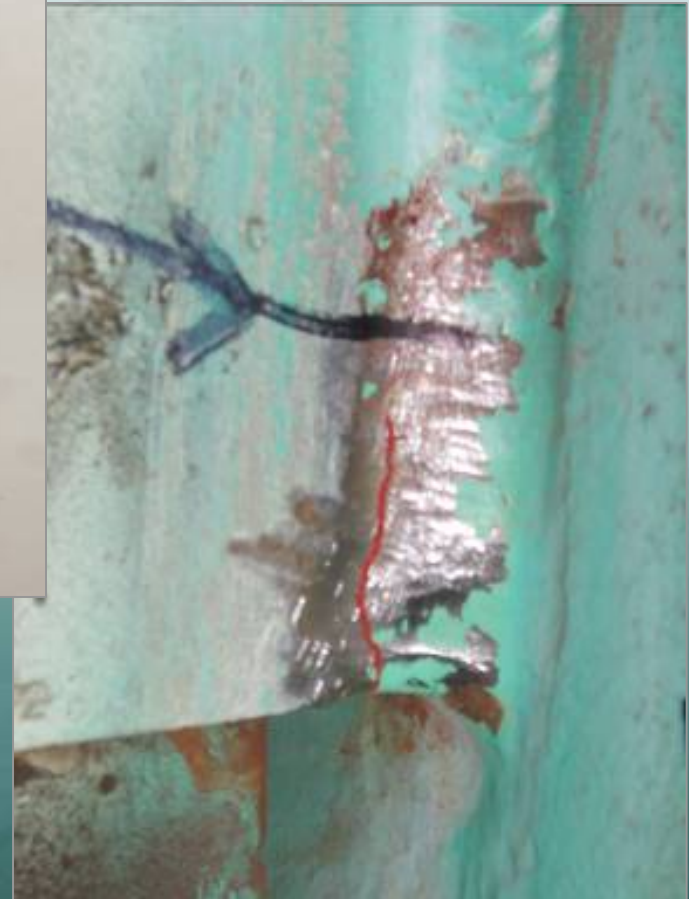
- Crack in weld between cross beam web and girder connection plate

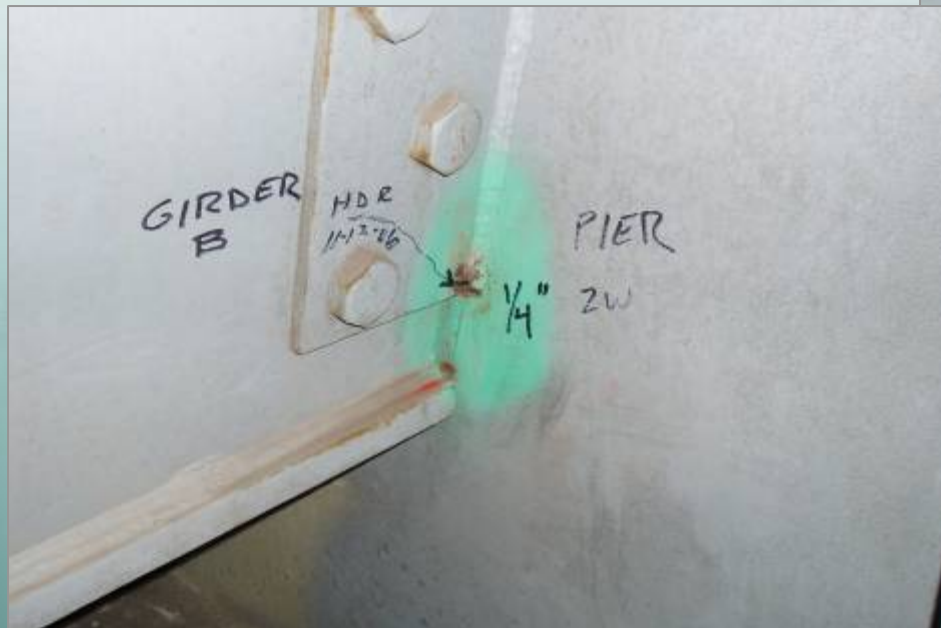
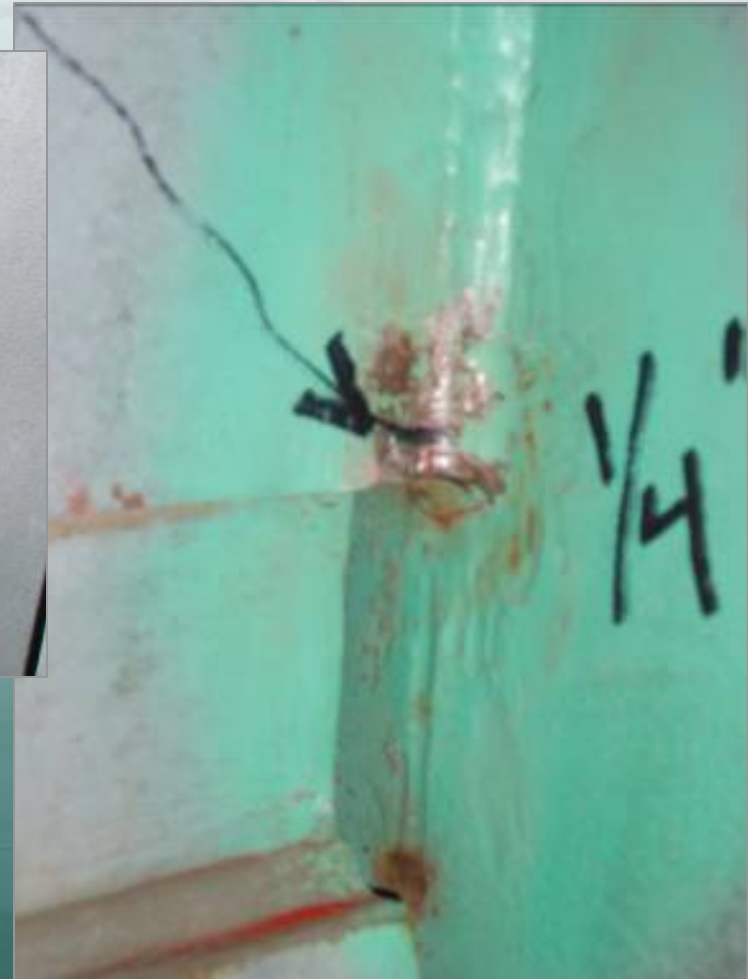
- Crack in weld between cross beam web and girder connection plate

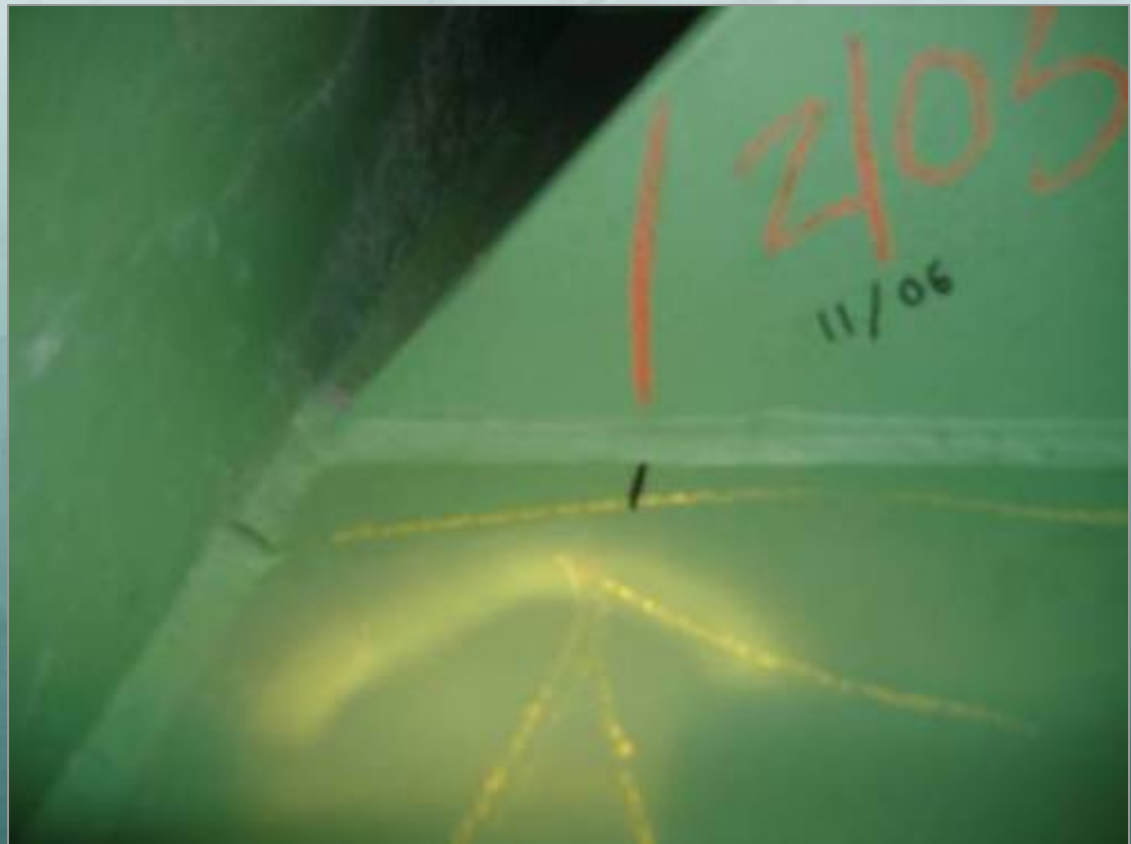
- Crack in weld between longitudinal stiffener and girder web near intersecting weld detail

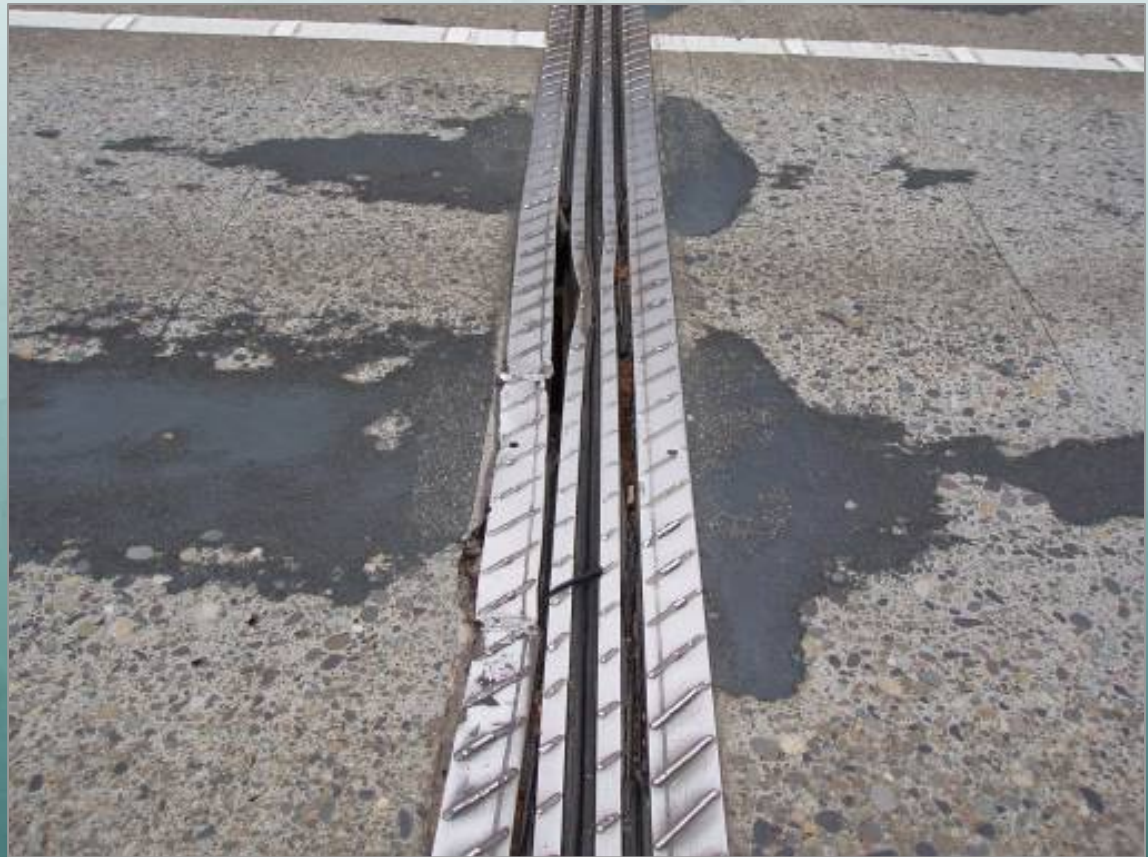
- **Failing expansion joints throughout west approach structures**

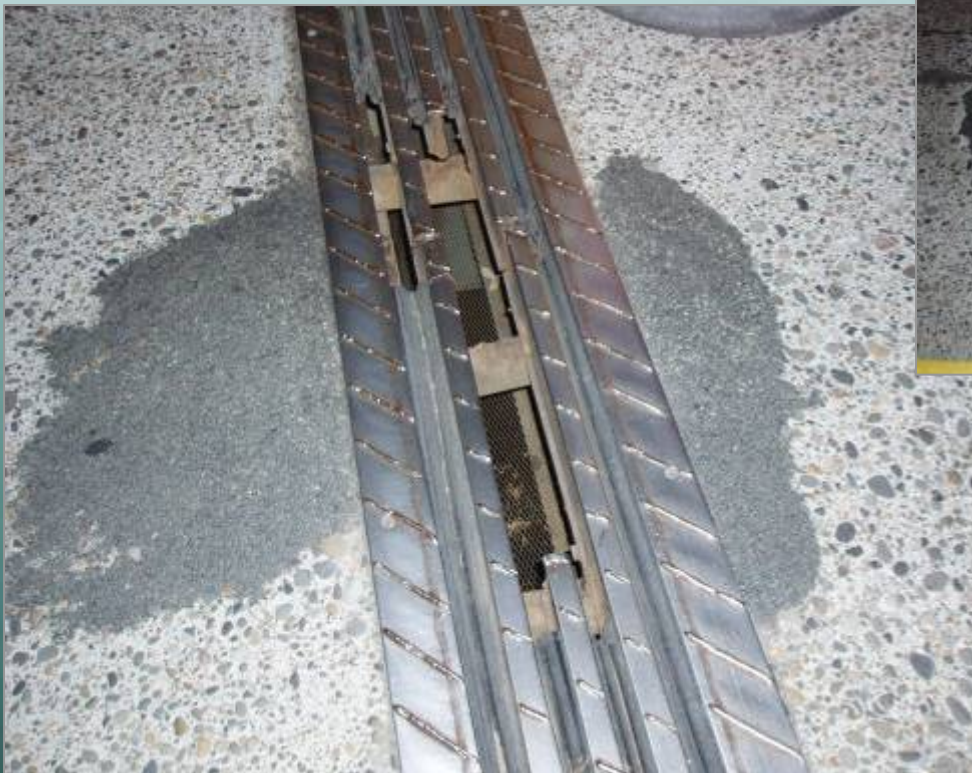
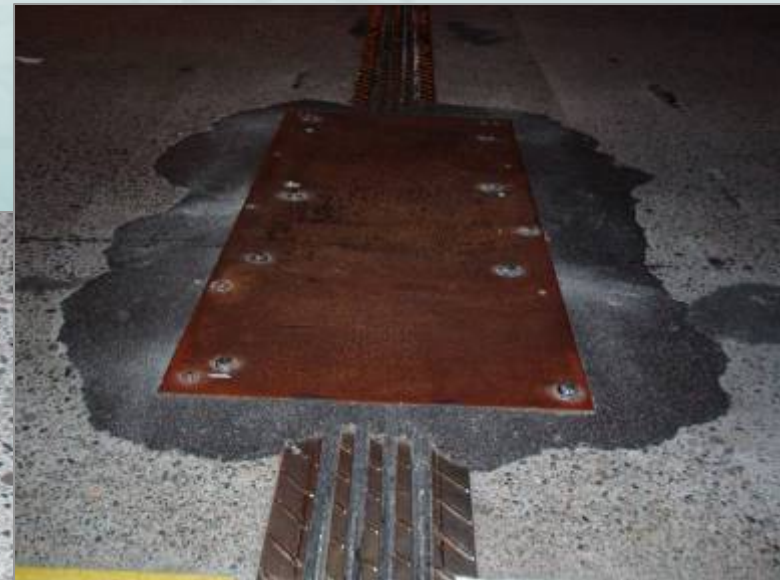
- 40" section of rail and gland missing

- Maintenance crews respond quickly

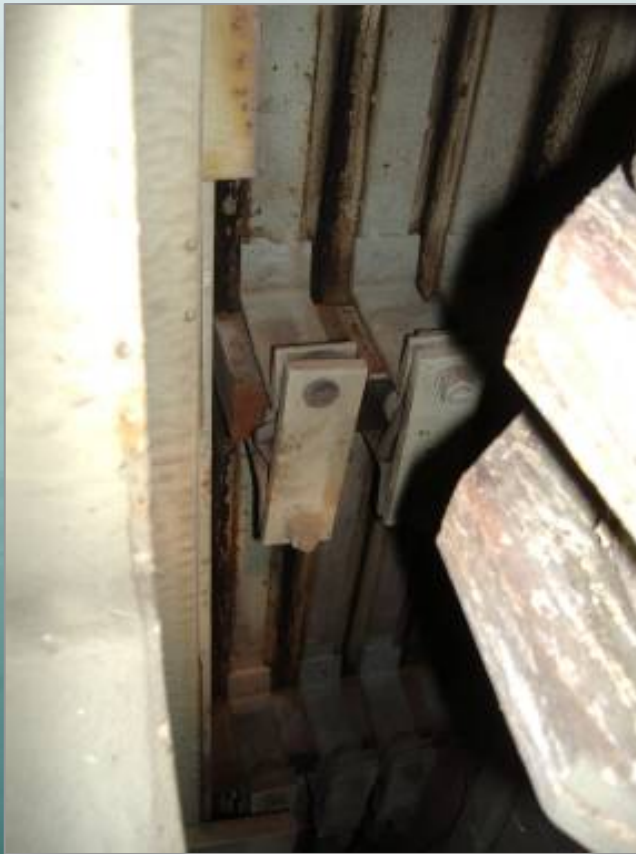
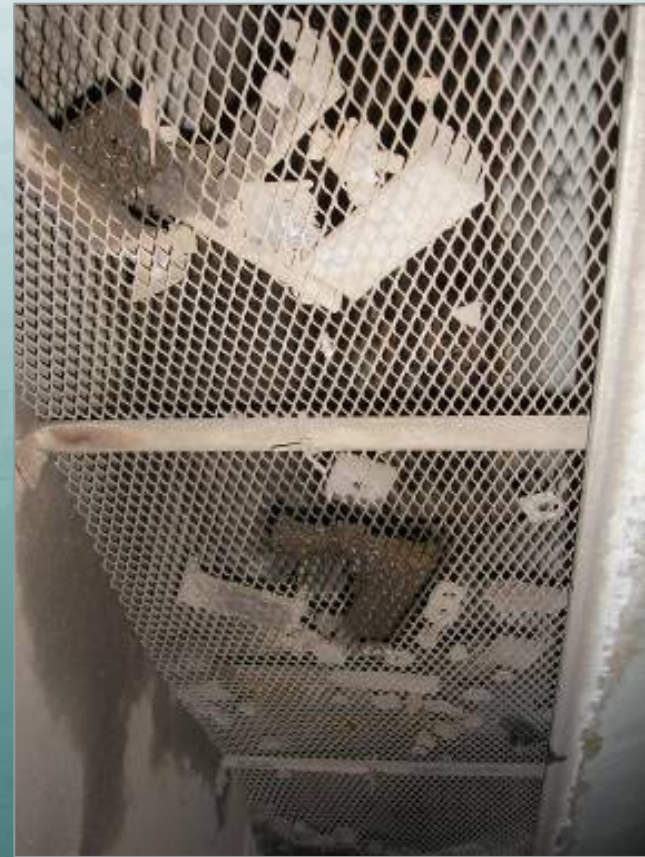
- Broken joint hardware accumulates on pigeon screens

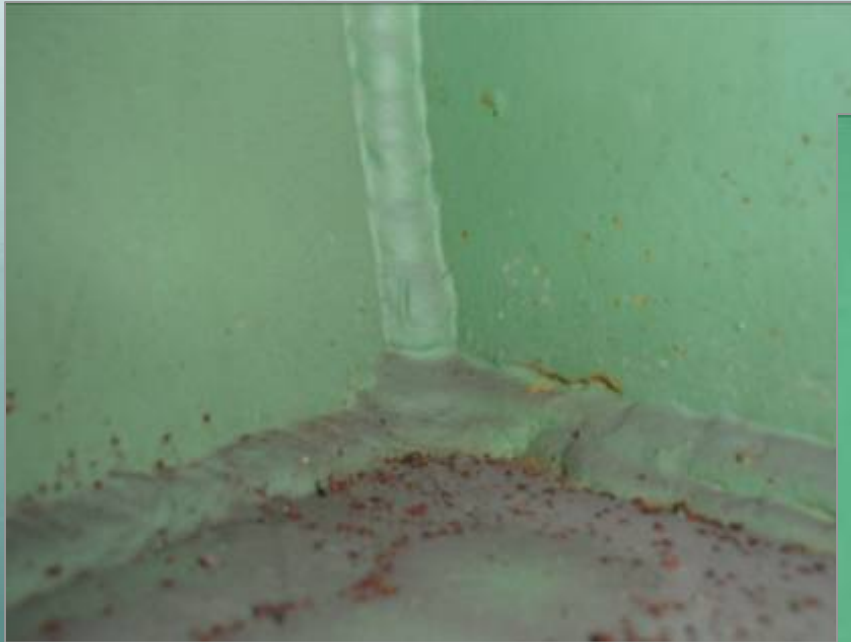
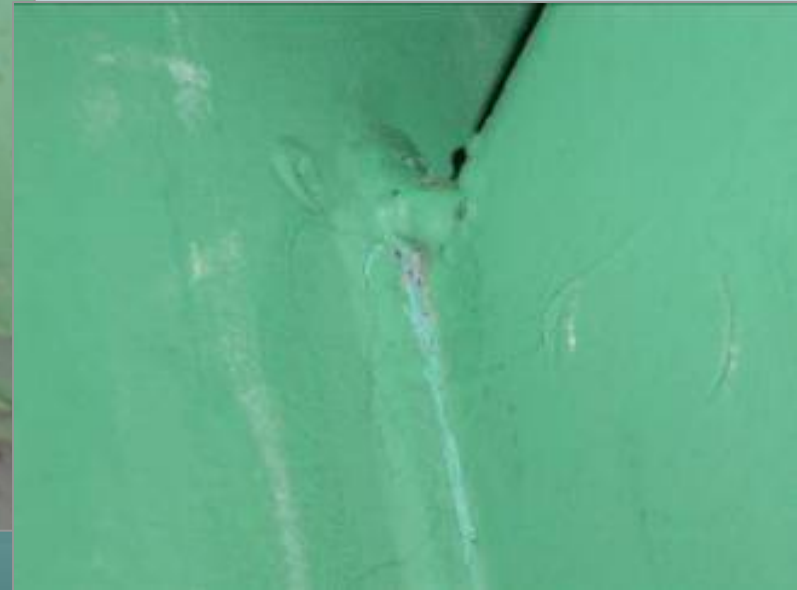
- Weld defects present at several locations

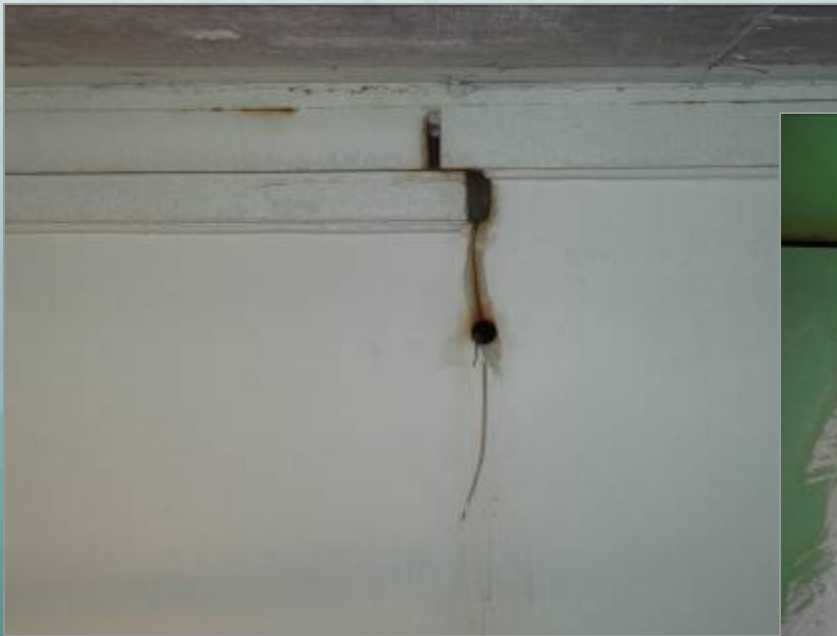
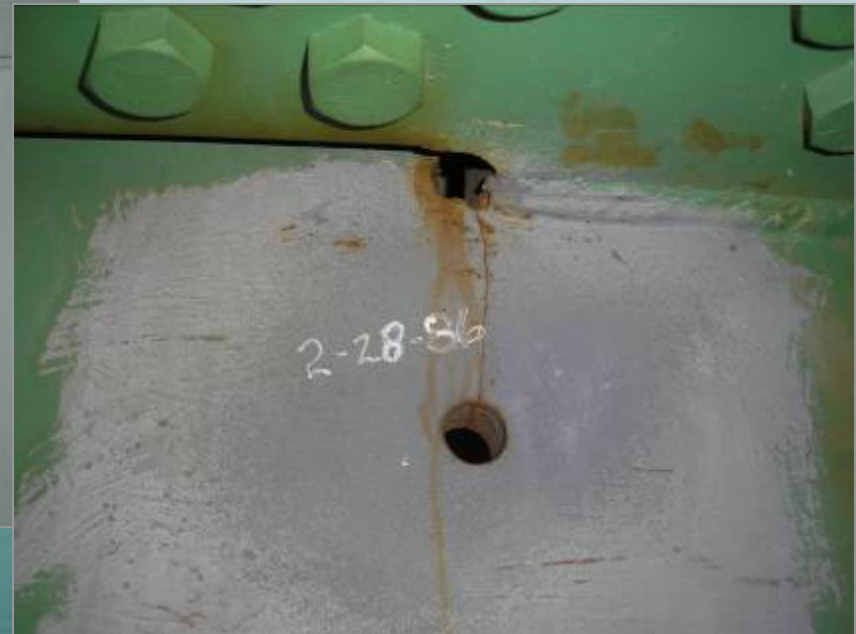
- Previously arrested fatigue cracks in ring beams

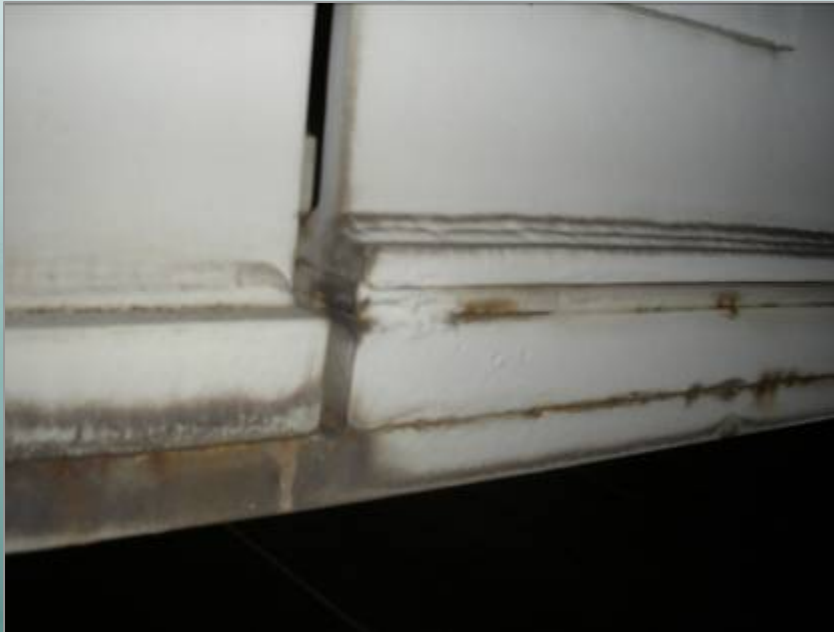
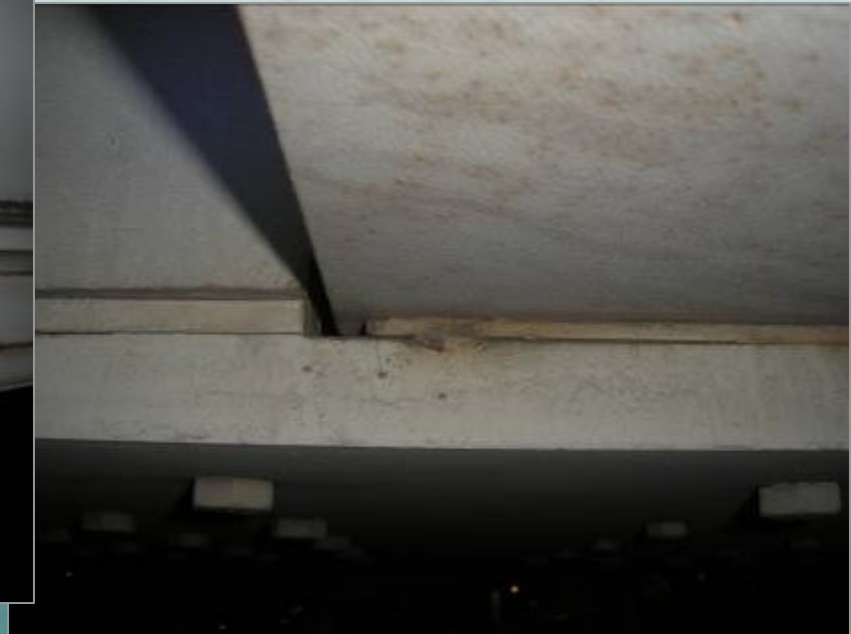
- Tack welds between the ring beam bottom flanges and splice fill plates

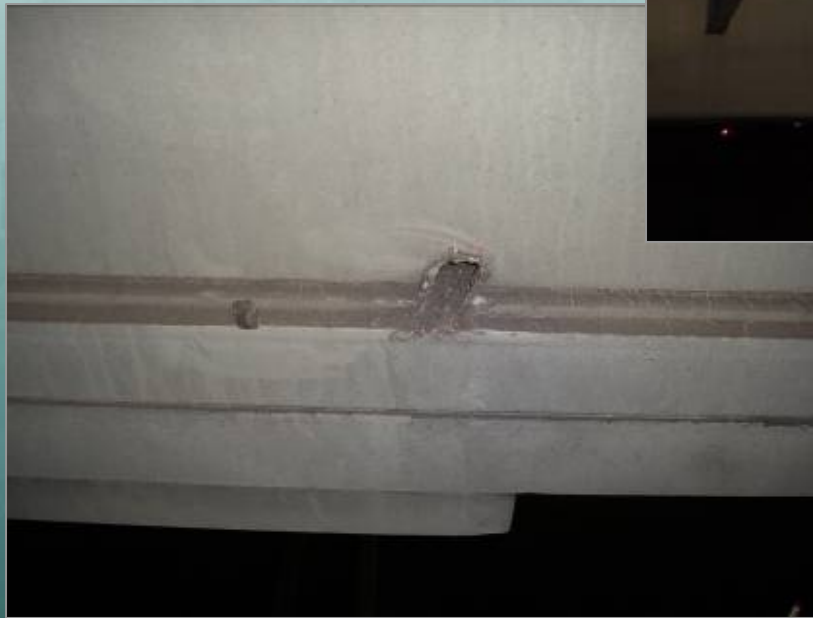
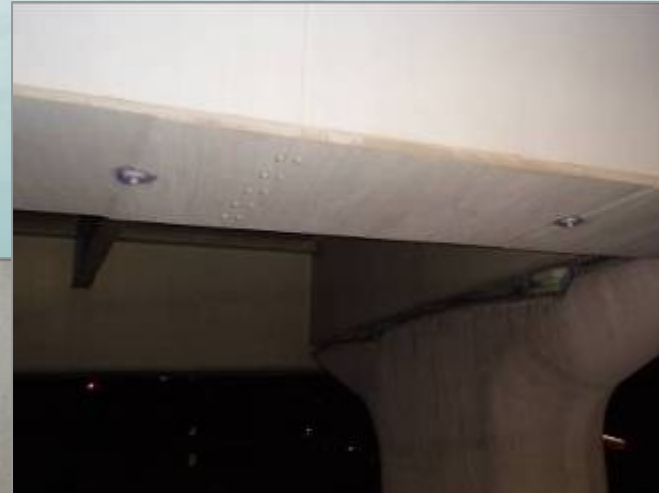
- Torch-cut drain holes and plugged coupon samples

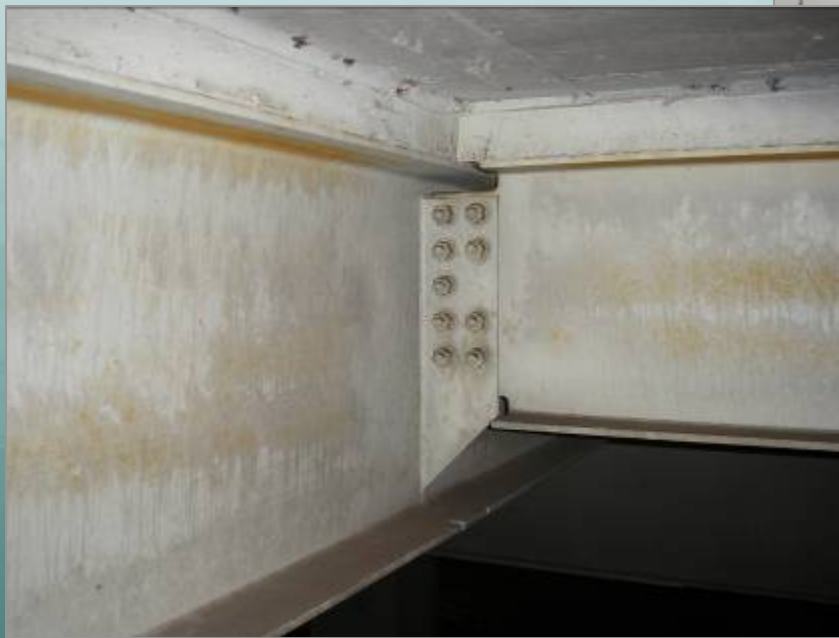
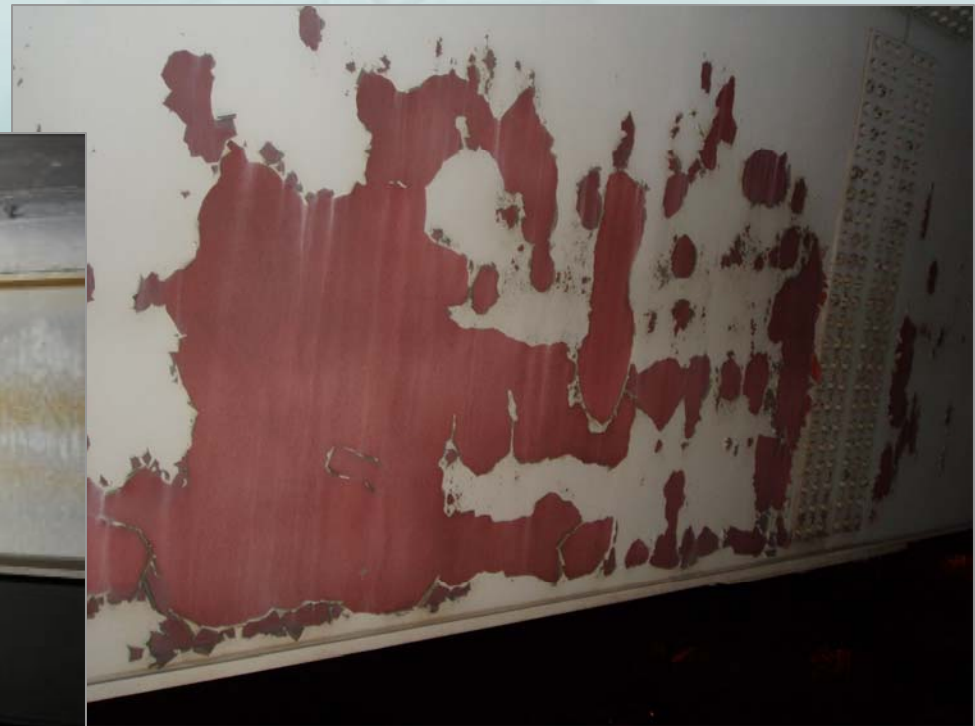
- Peeling paint and light surface rust

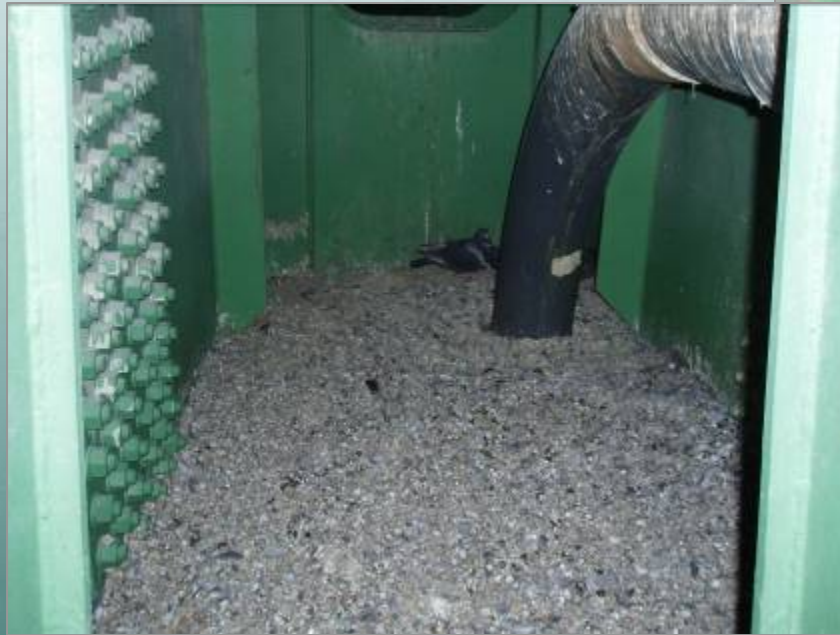
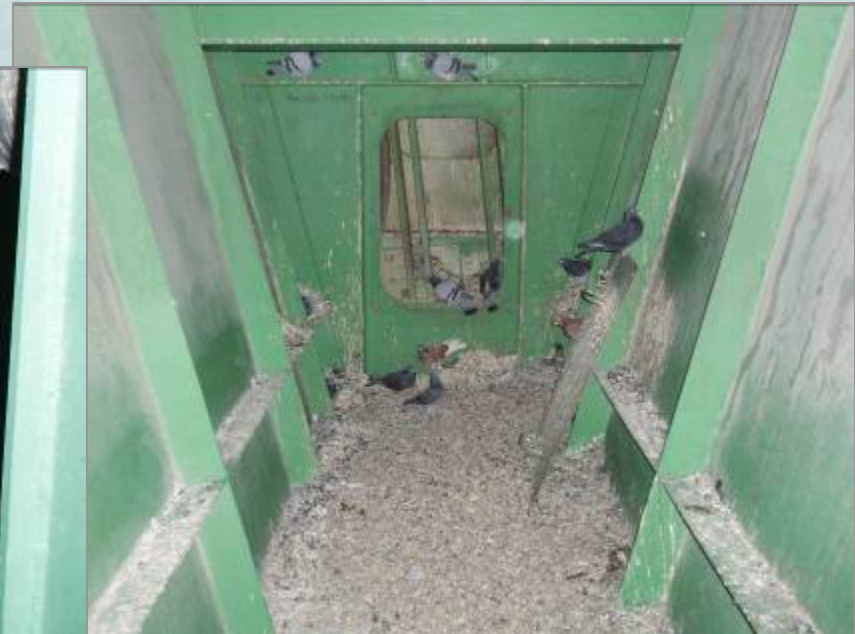
- Significant accumulations of pigeon debris

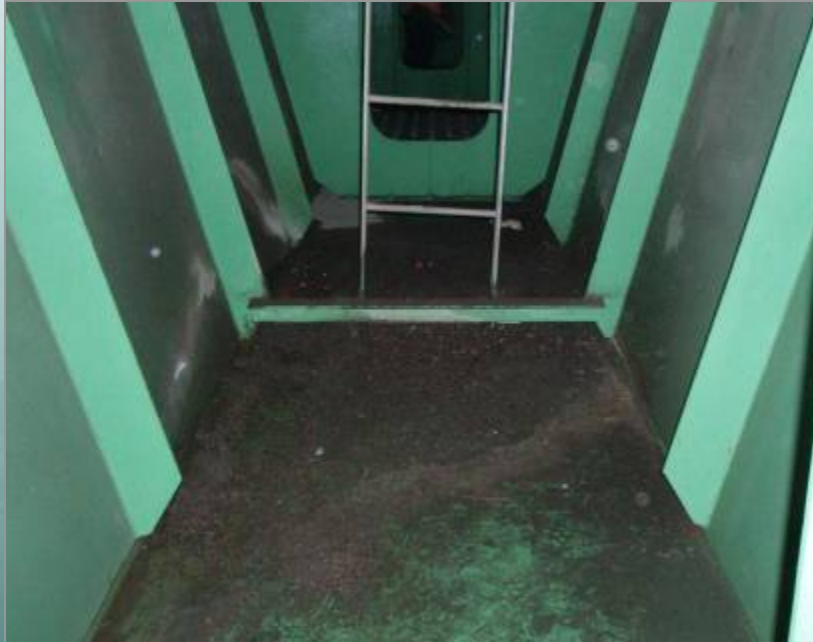
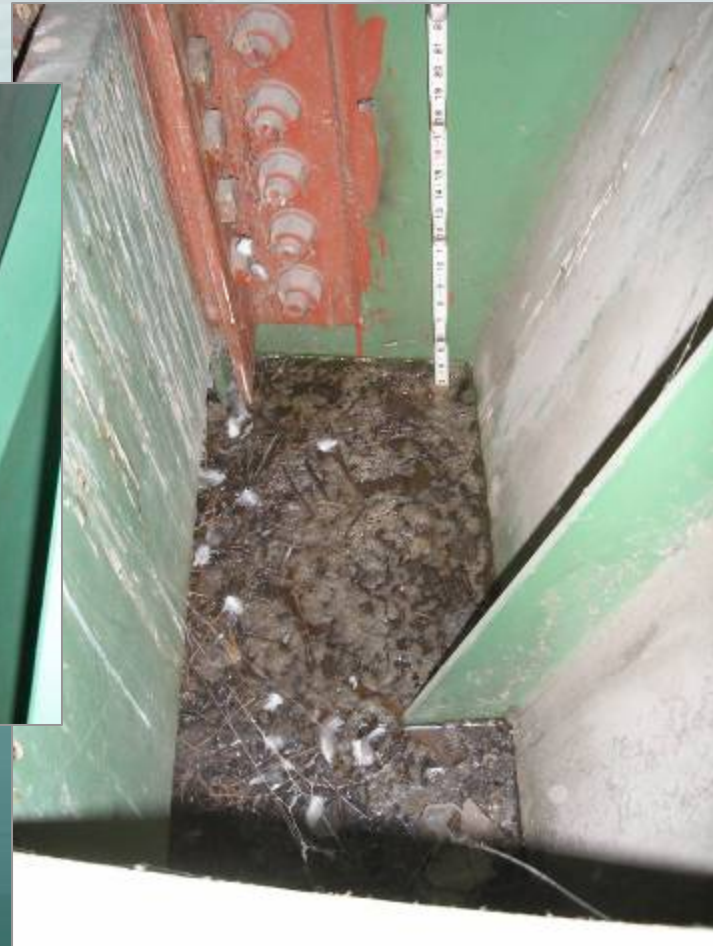
- Roadway debris and standing water
