Bill Williams River Bridge Fire Damage Assessment & Repair

Martha Davis, PE
Paul Tremel, PE
HDR Engineering

September 25, 2007

Western Bridge Engineers' Seminar
Boise, Idaho

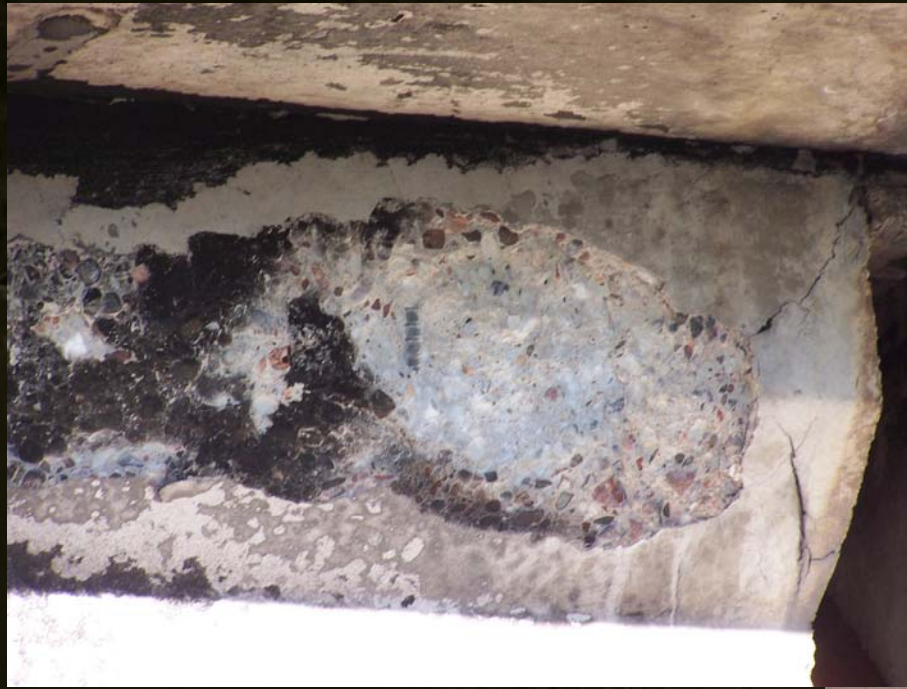
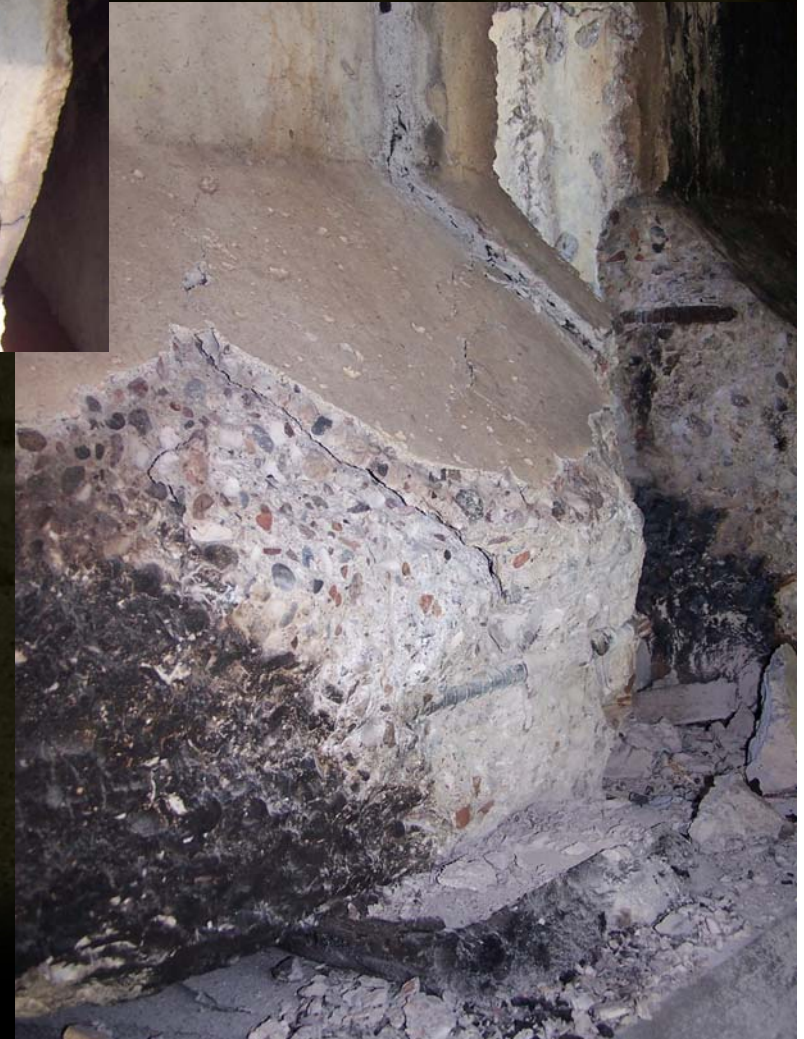
Inspection: Girders

- Spalled concrete on top and bottom flanges
- No visible deflection

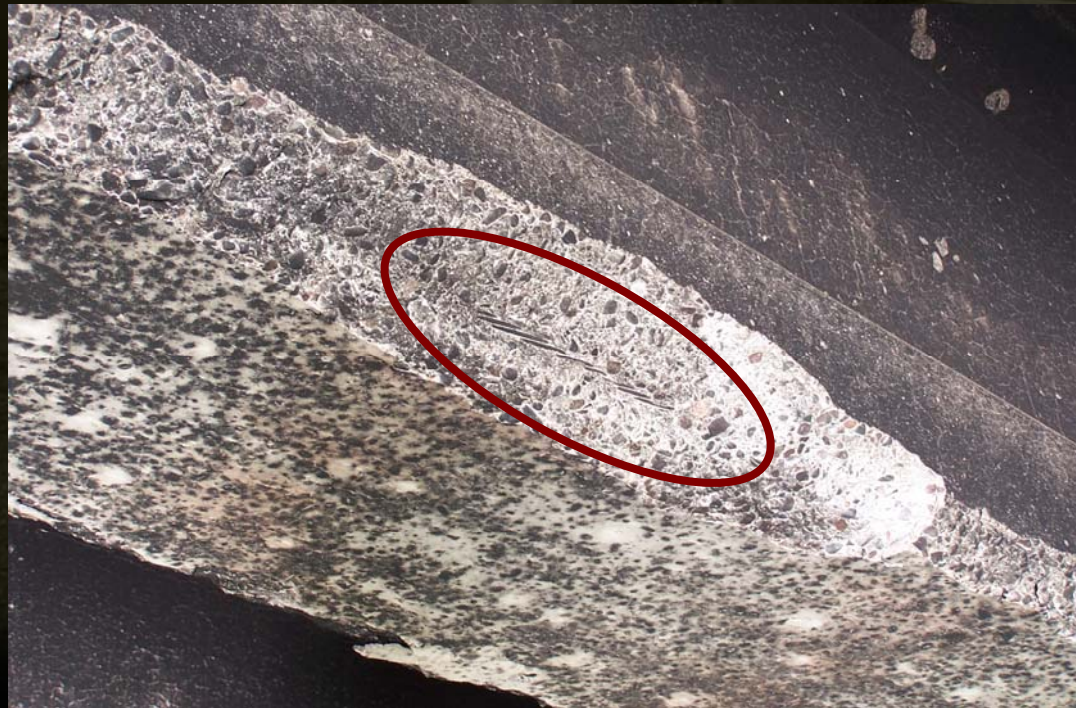
Inspection: Girders

- Exposed mild reinforcement
- Several locations of exposed prestressing strands

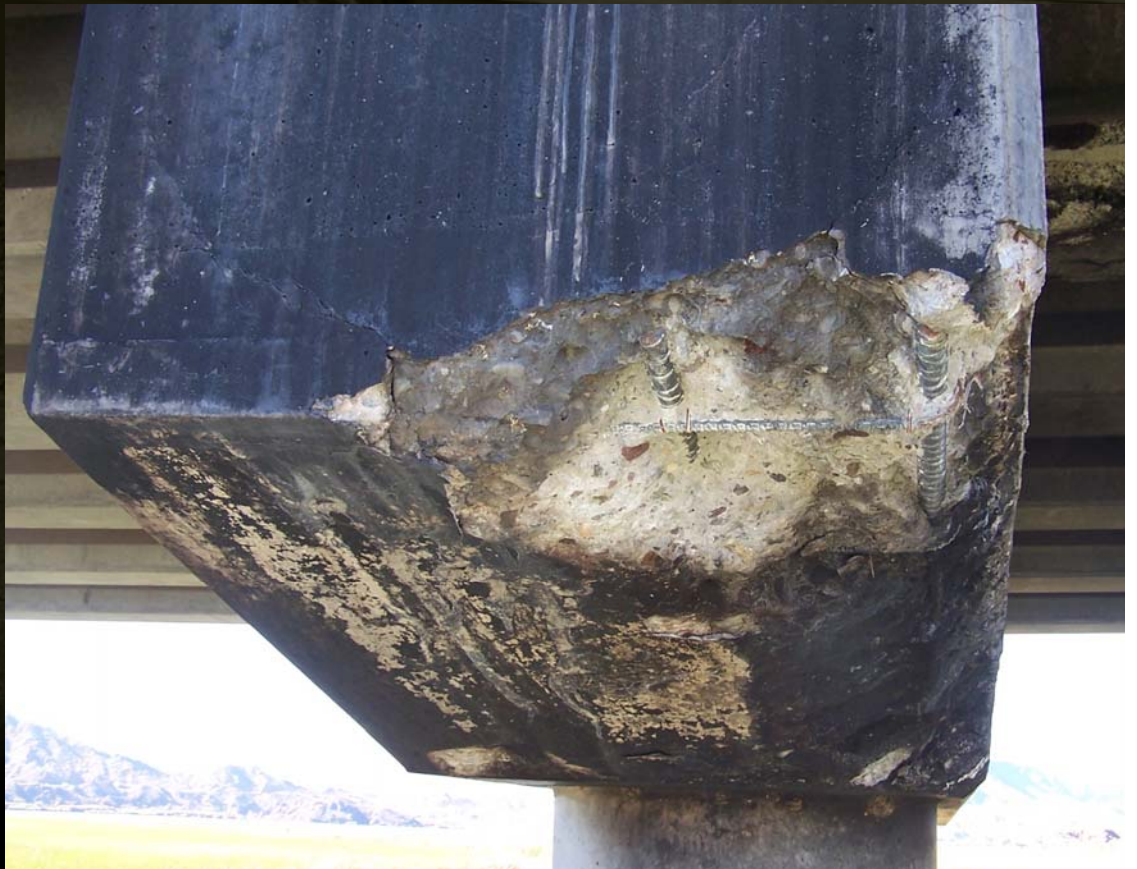
Inspection: Pier

- Pier Cap
- Pier Columns
