MONROE STREET BRIDGE FUNDING

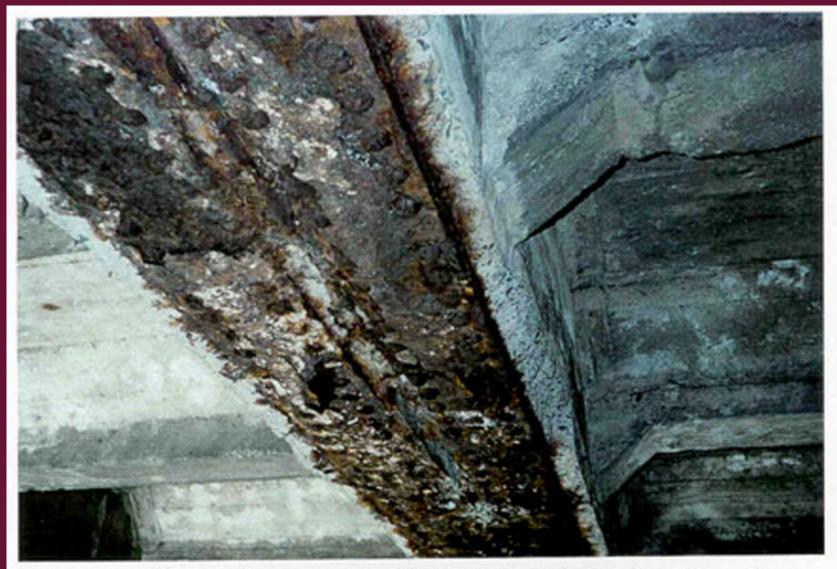
Photograph no. 25 - Looking at underside of floorbeam 14, Main Arch Span. Note: Concrete cover spalled exposing corroding steel member, rivet corrosion and loss of section.

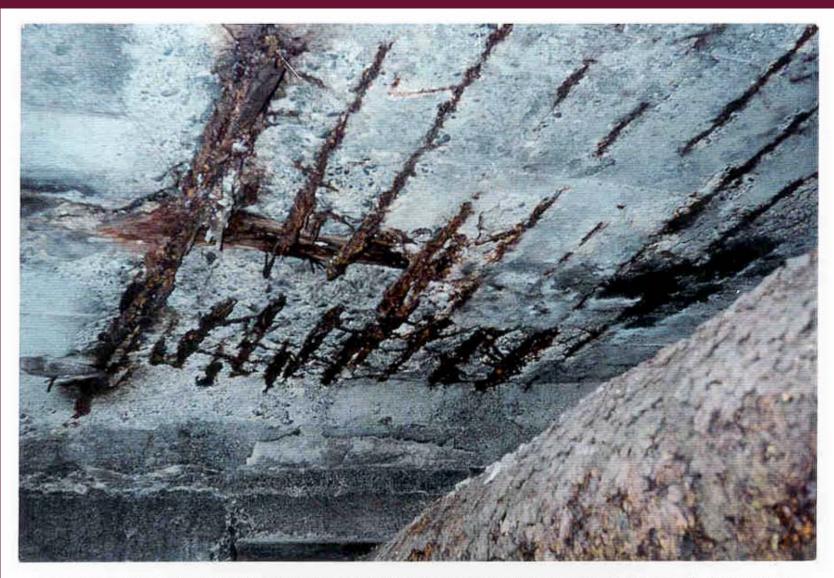
Photograph no. 3 – Looking at the underside of the deck in span 5 of the North Approach Spans. Note: Spalling concrete, exposed corroding reinforcing steel, and loss of reinforcing.

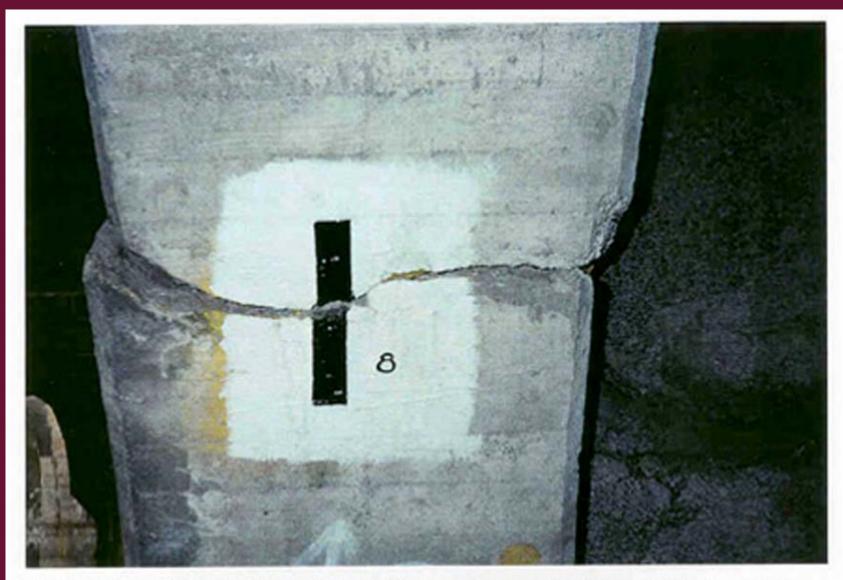
Photograph no. 60 - Looking south at pier 3 column for spandrel arch 2, North Approach Spans. Note: Severe crack width and offset.
