Gold Mines and CIDH Piles

September 21, 2009 Caltrans Division of Engineering Services Sacramento, California

Angels Camp Hwy 49 Bypass

Murphys Grade Rd UC

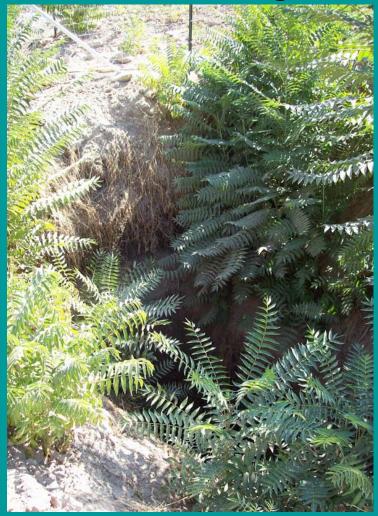
Location of abandoned shaft located during performance of project geotechnical investigation.

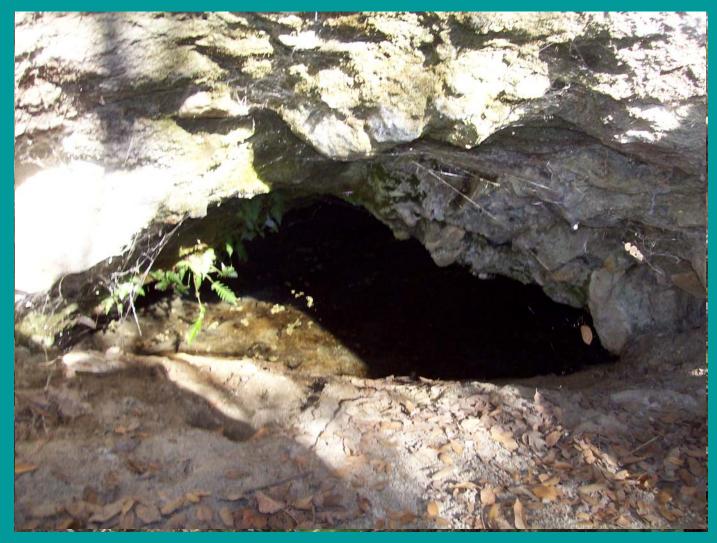
Prominent feature stood out to the south of Murphy's Grade Road.

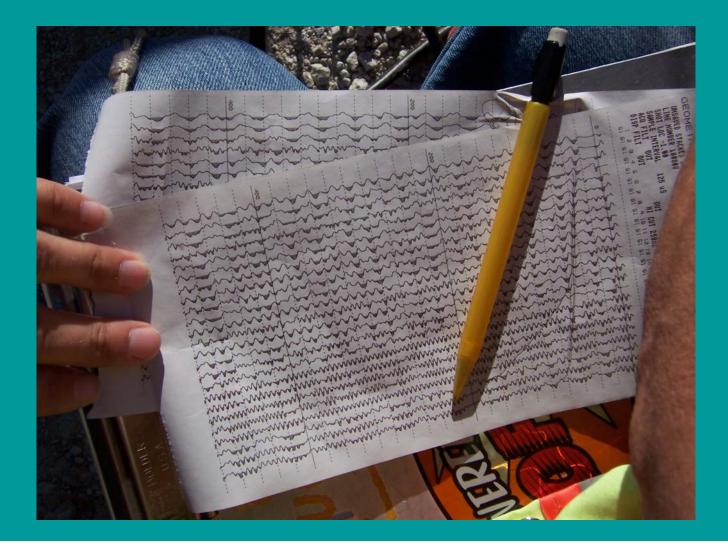
Results concluded that there was not a large scale void beneath the bent cap.

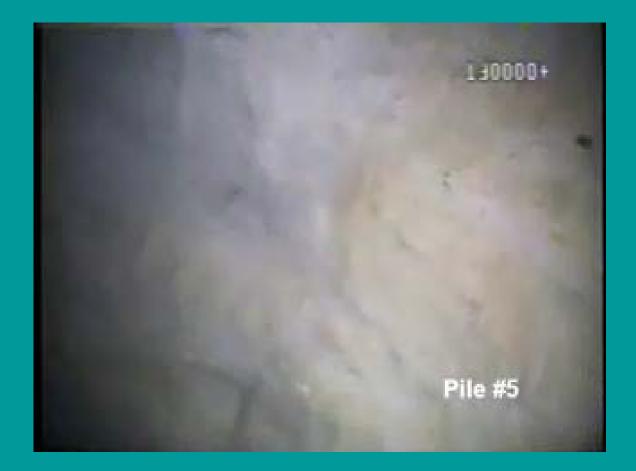
Piles 3, 5, 6, 11 and 12 were downhole logged as well as the abandoned shaft at Station 18+60.

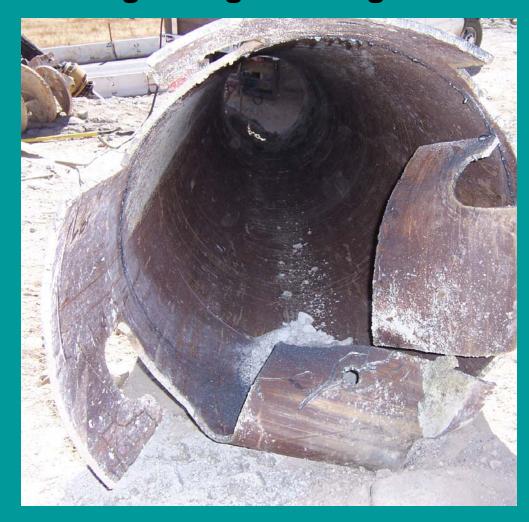
But when the casing is below the water line, they can't see the top of casing to align the auger in the shaft

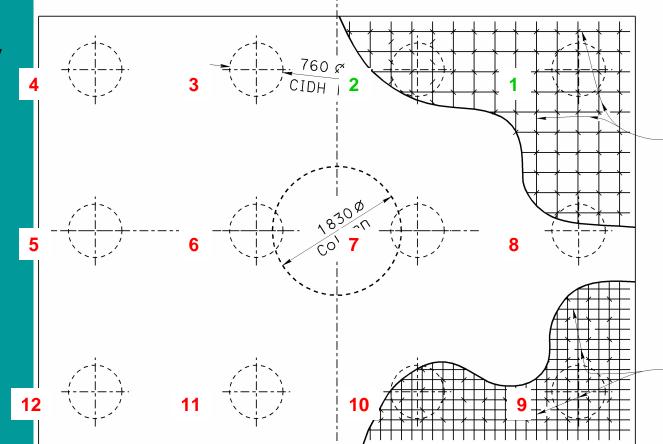
Pile 6 had an anomaly

The casing for this pile had a plate welded to the bottom and no additional length was required Concrete was placed in the wet condition Requiring density testing Pile 6 became an extraordinary case. Pile 3 had 2 truckloads of concrete placed in it. That concrete had filled an area all around it Auger bit broke off while drilling pile 6

As allowed by the Specials when anomalies present: I talked with the Bridge Designer, Corrosion Specialist, Geotech Designer

Adjacent piles gave sufficient strength to the footing. Pile 6 anomaly mitigation was not required. Remaining footings were completed without incidence...
