# Unknown Foundation Testing and Emergency Repairs for the Lake Cushman Bridge

Kathy Van Hecke, US Forest Service  
Dan Stromberg, Collins Engineers

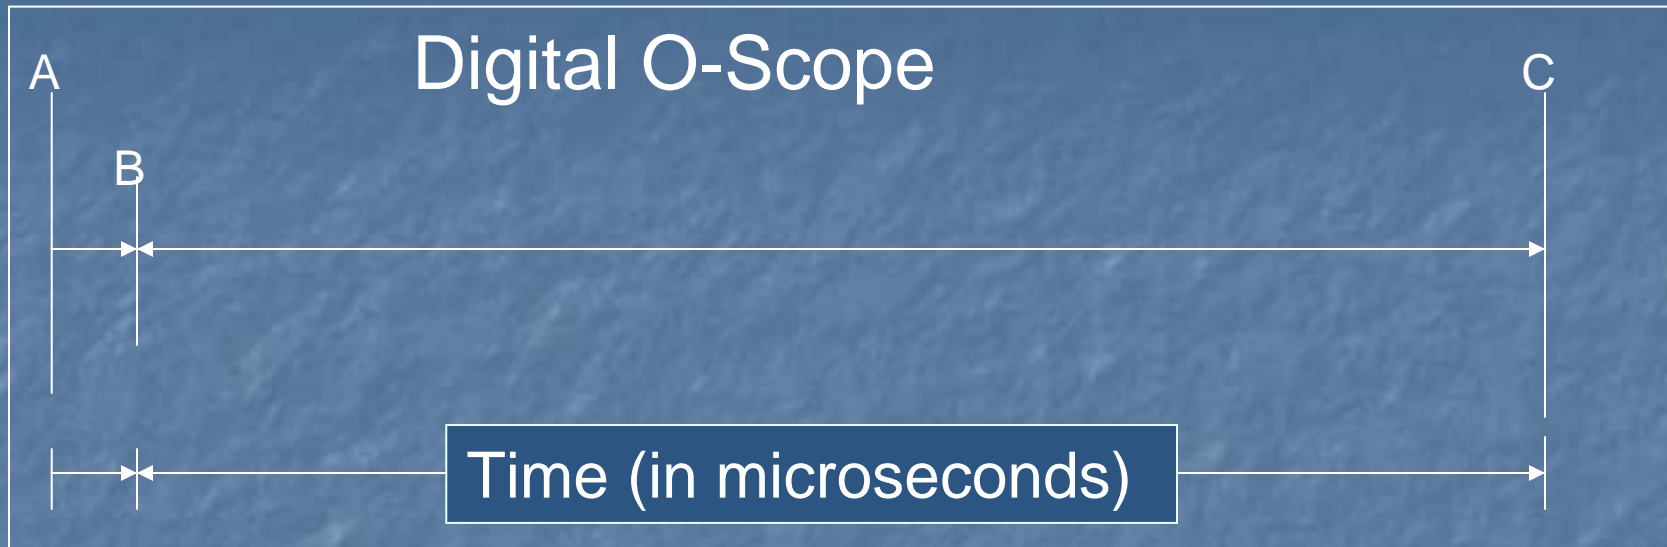
Graphic of Reflected Energy on O-Scope

A. Initial Impact...Starts Timing Sweep

B. Reflection...Top of Pile or in cap

C. Reflection...Bottom of Pile or  
Reflection from discontinuity

Length of Pile is B to C:  $\text{Time}/2$
