## **Oregon DOT's FRP Bridge Decks**

### By Steven Lovejoy

Department of Transportation

### ODOT has 3 Bascule Bridges with FRP Decks

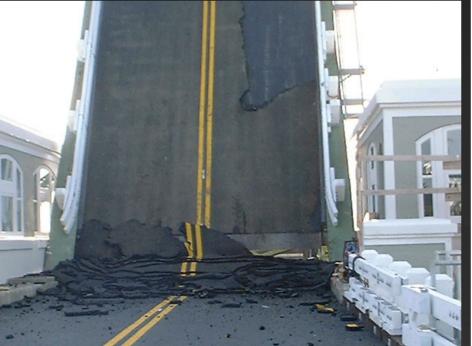
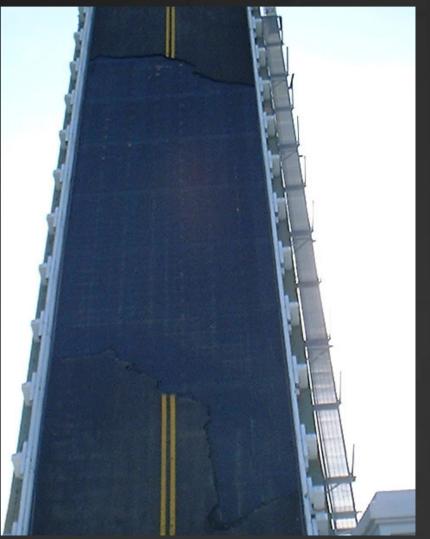
# **Result Were Spectacular!**

- Upper layer of asphalt was semicompacted with voids in the lower layers
- Water filled the voids with the span in the horizontal position under heavy rains
- Sun came out and warmed the deck greatly reducing the creep strength of the tack coat
- Raising the span caused the water in the voids to follow gravity

- Water could not easily escape the asphalt and pore pressure raised putting the tack coat in tension
- Author witnessed water jetting out of the lower sections of the deck as the asphalt debonded

- An epoxy concrete was selected as the lowest risk system given the limited testing program
- A 2 inch thick wear surface was then installed
- 77,000 lbs of counter weight had to be added

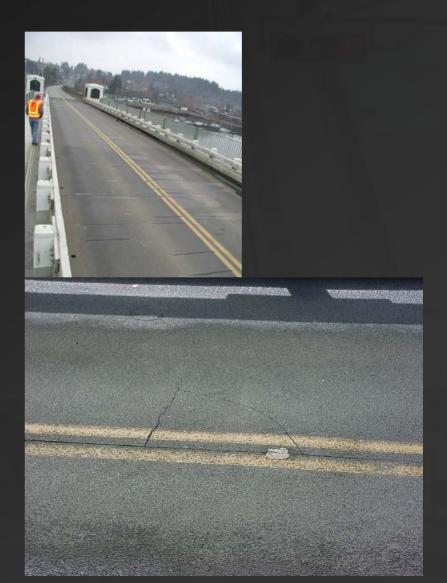
- Both decks developed lateral cracking in the wear surface within a year of service
- Old Young's Bay bridge was the worst of the two

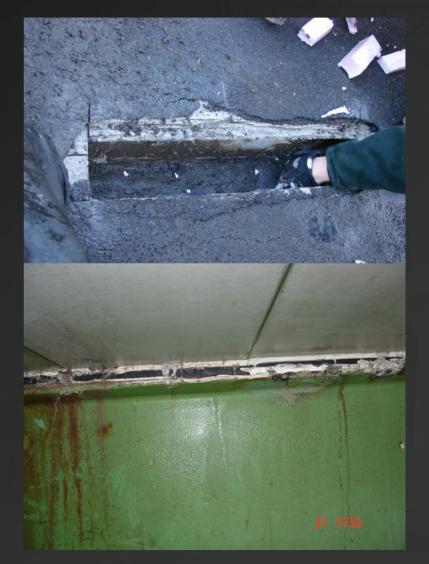
- By 2007 the deck has suffered punch through in a few location
- The deck to stringer connections are breaking apart
- A replacement project is in design

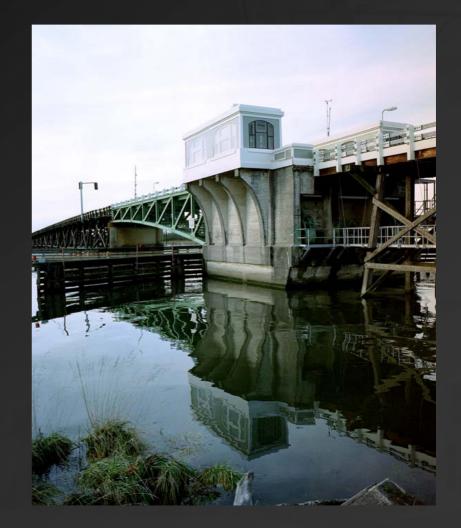
- FRP installed 2002
- Epoxy concrete shows cracking within 1 year
- Wear surface is in very poor condition after 9 years
- FRP deck and connections appear sound after 9 years

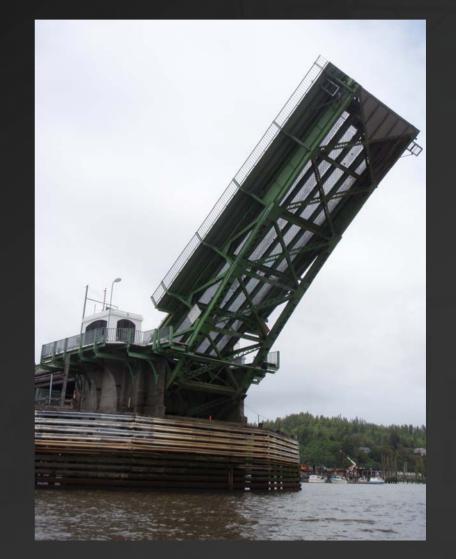
- Epoxy concrete deck shows cracking before 1 year of service
- Severe cracking after 4 years
- Deck and connection failures after 5 years
- Replaced with steel grid after 8 years

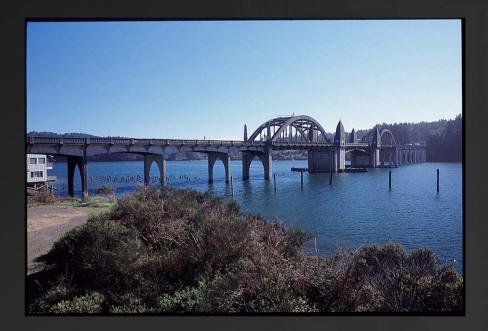
- Installed in 2005
- Wear surface is in good condition with minor to moderate wear after 6 years
- Connection details show minor and localized degradation
- Very heavy traffic
