Rehabilitation of Historic West Monitor Truss Bridge

Western Bridge Engineers' Seminar
September 26, 2011

Jennifer Reinheld, PE

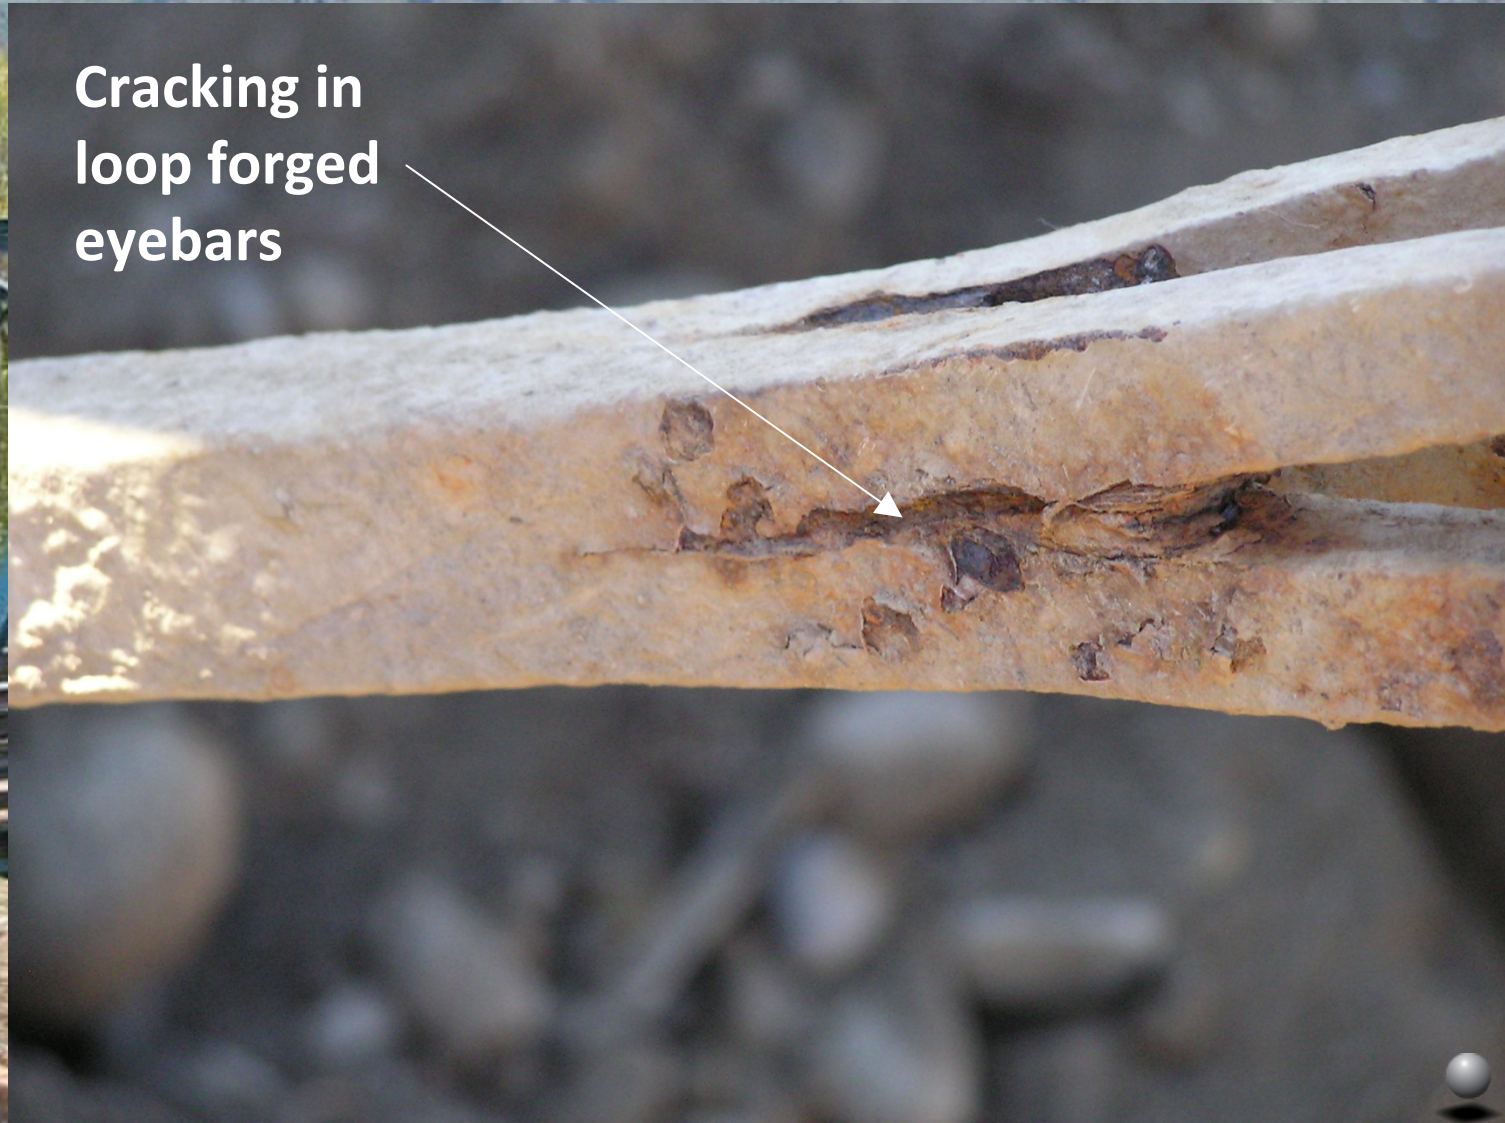
Cracking in
loop forged
eyebars

Replace existing eyebars with new. Size and shape of new eyebars match existing to give appearance of no change.

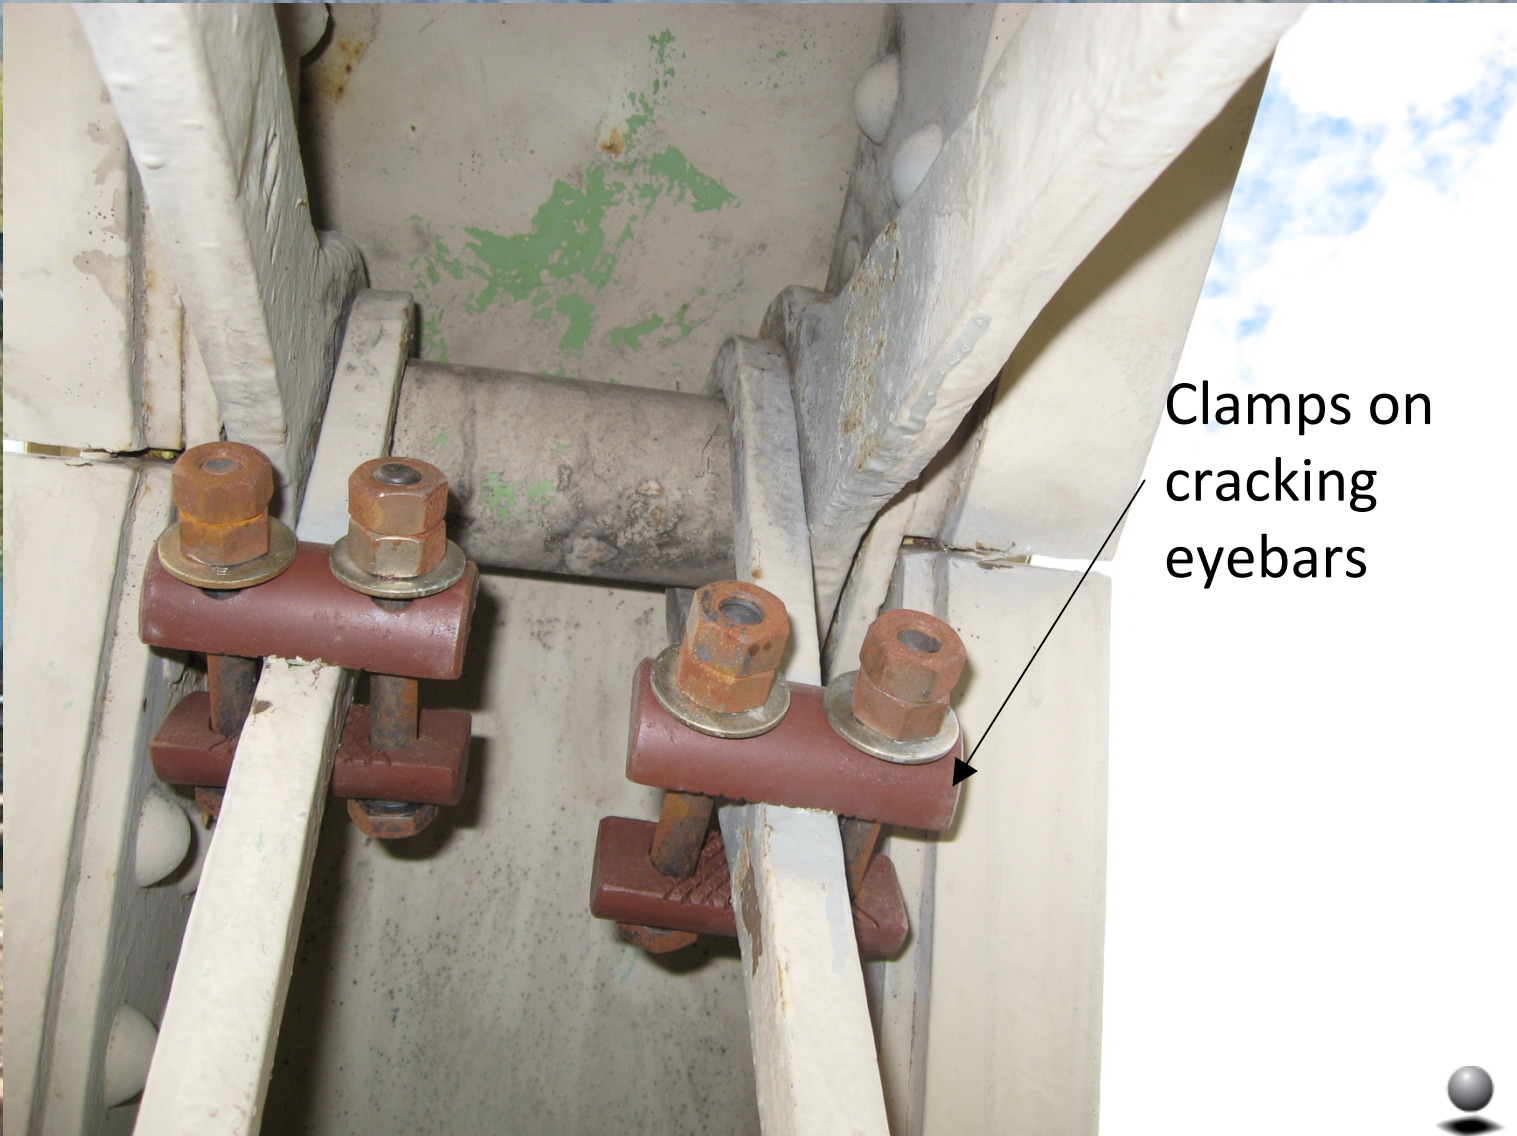
Clamps on
cracking
eyebars

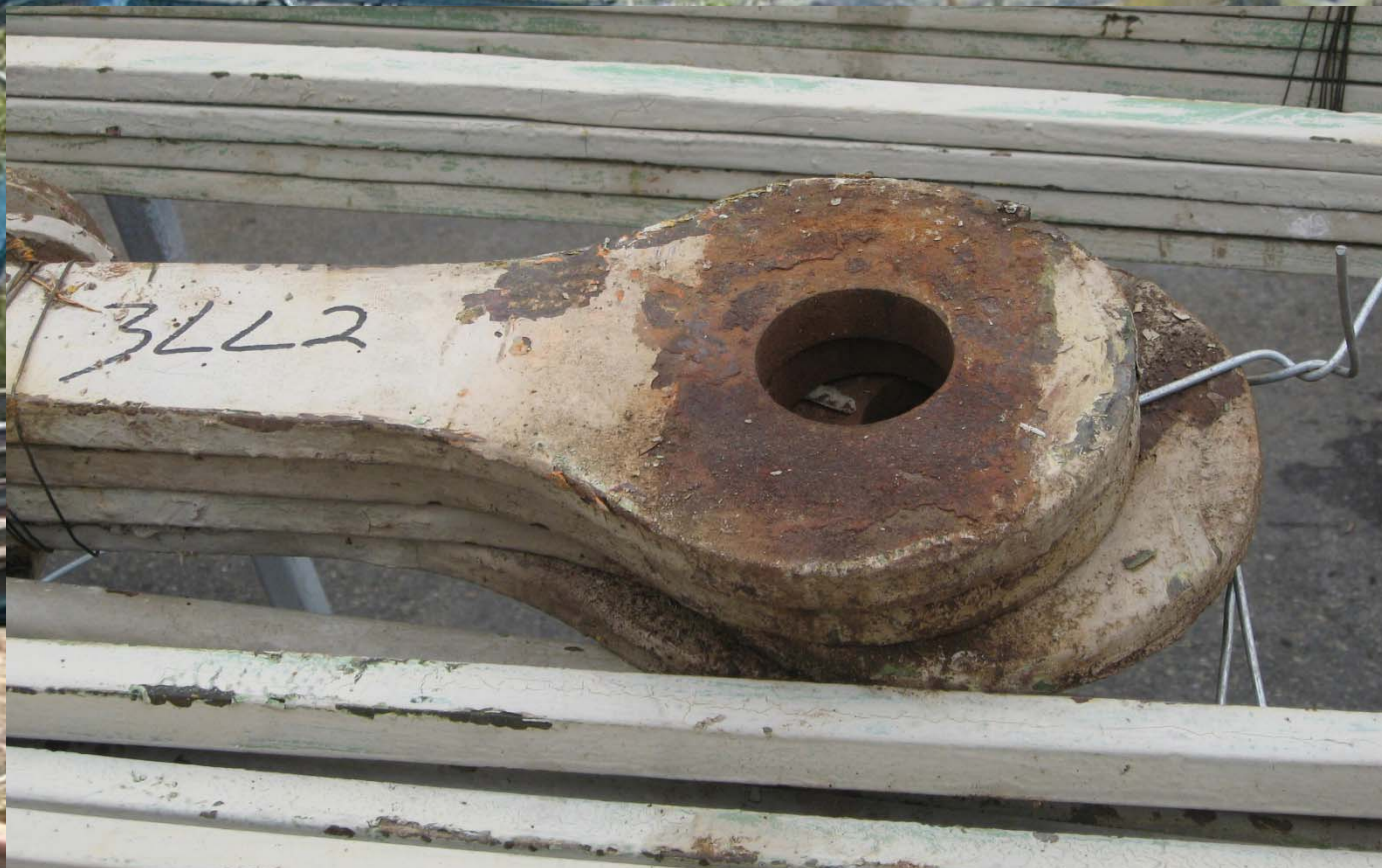
Incomplete forging and defects (forge welds, cracks, gouges, and holes) at bottom chord eyebars

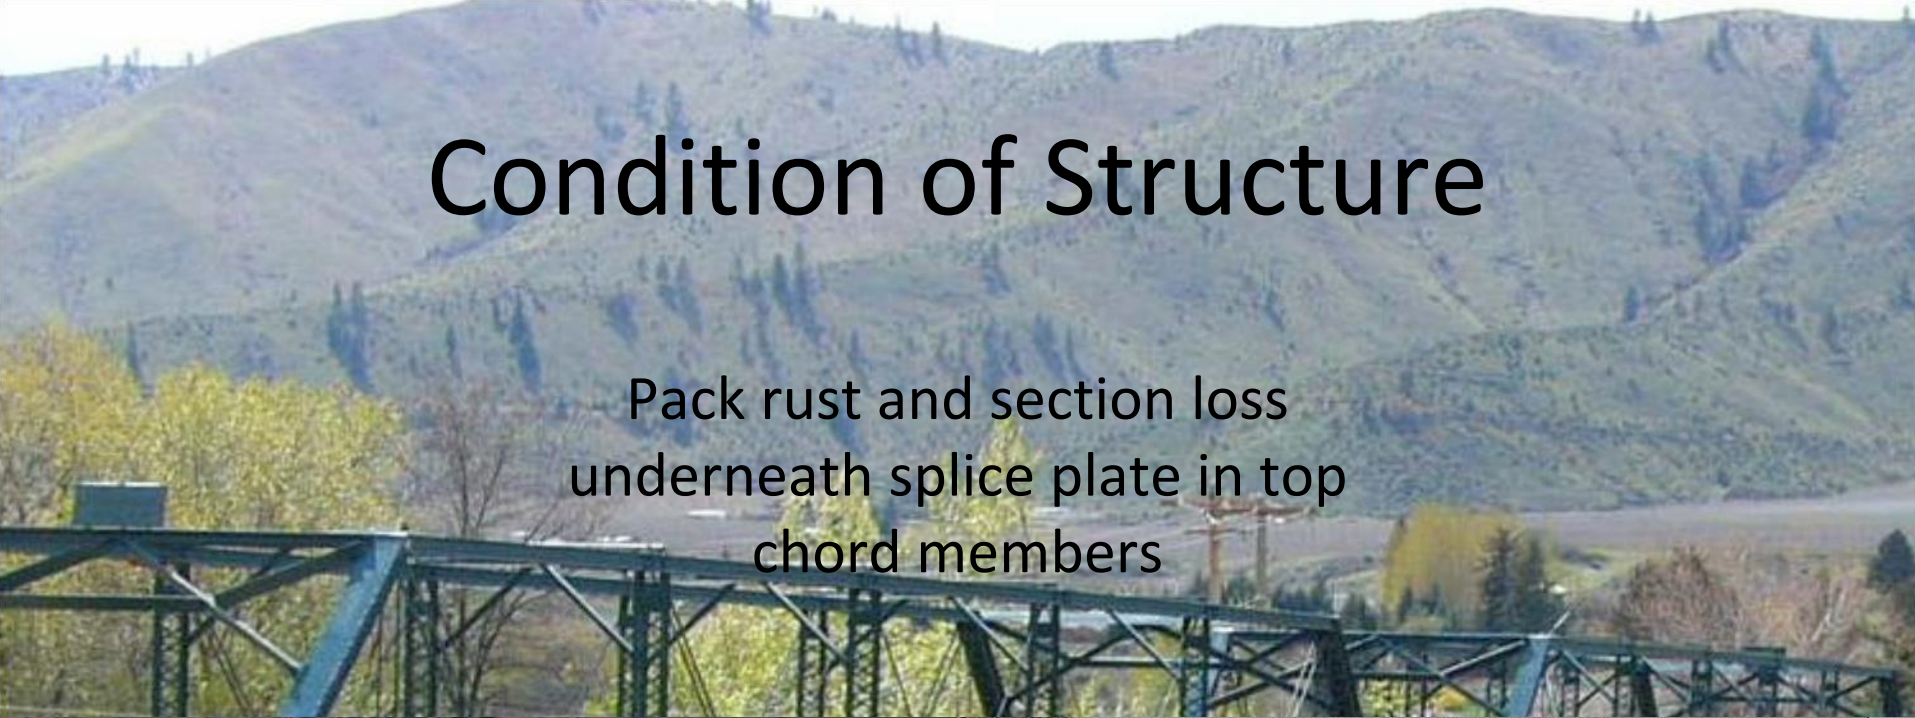
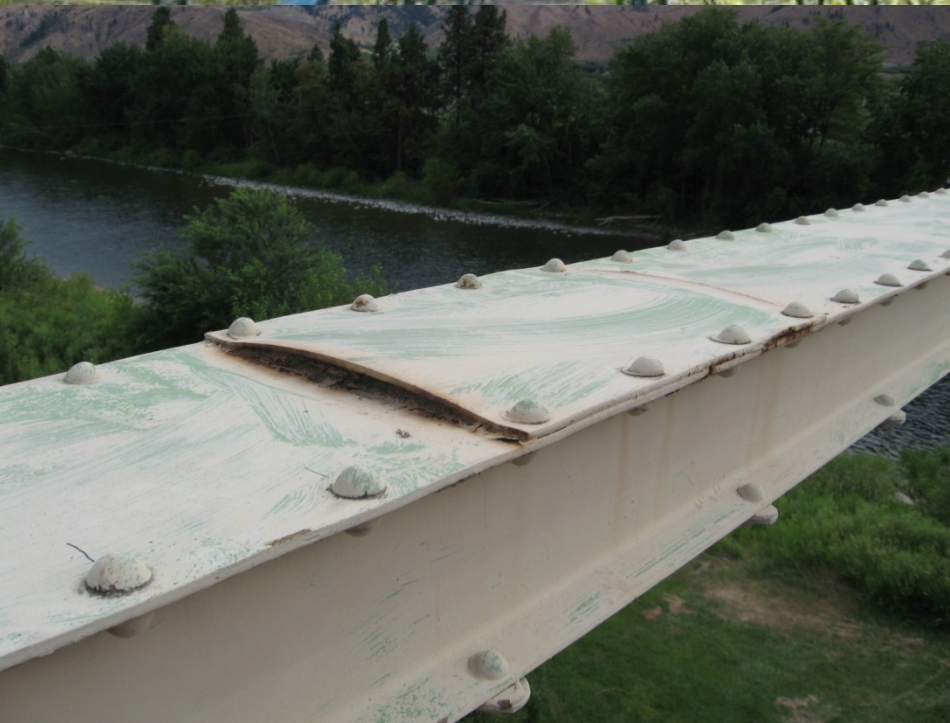
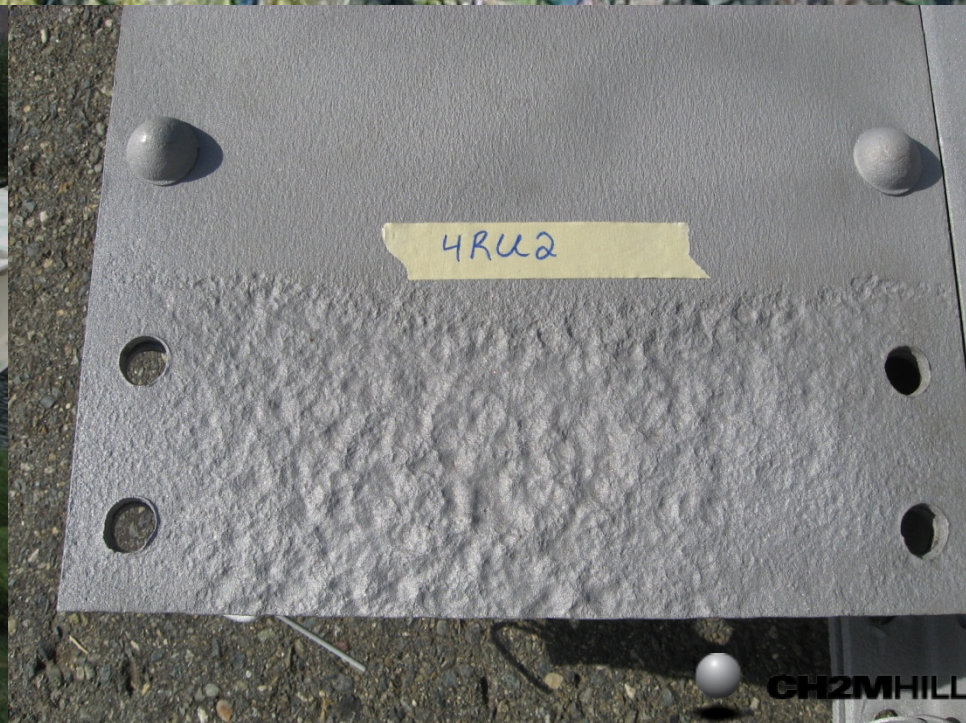
Pack rust and section loss
underneath splice plate in top
chord members

- Reused top chord members, replaced splice plates
- Reused original floor beams, strengthened with new plate on top flange
- Reused original bearing plates
- New pins match existing
- Replaced corroded floor beam and cross bracing connection at Pier 5 to match existing

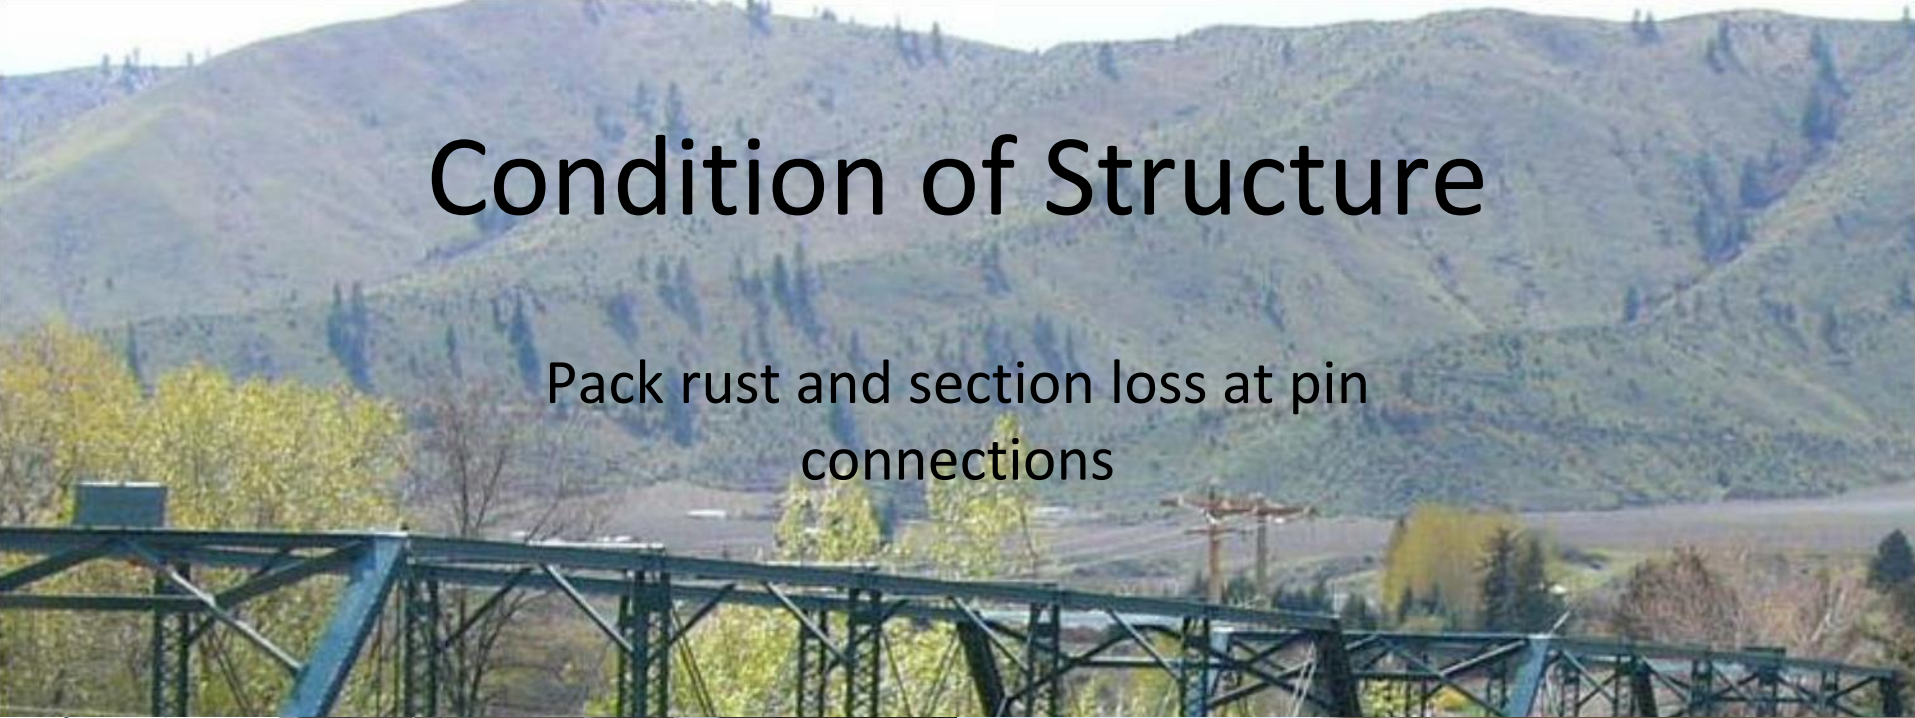
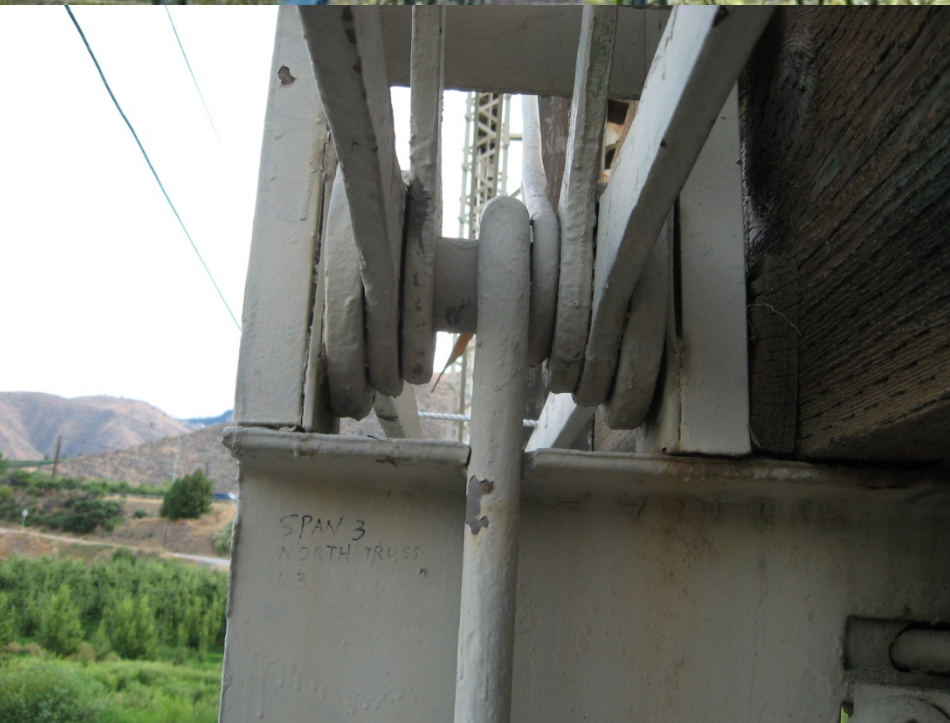
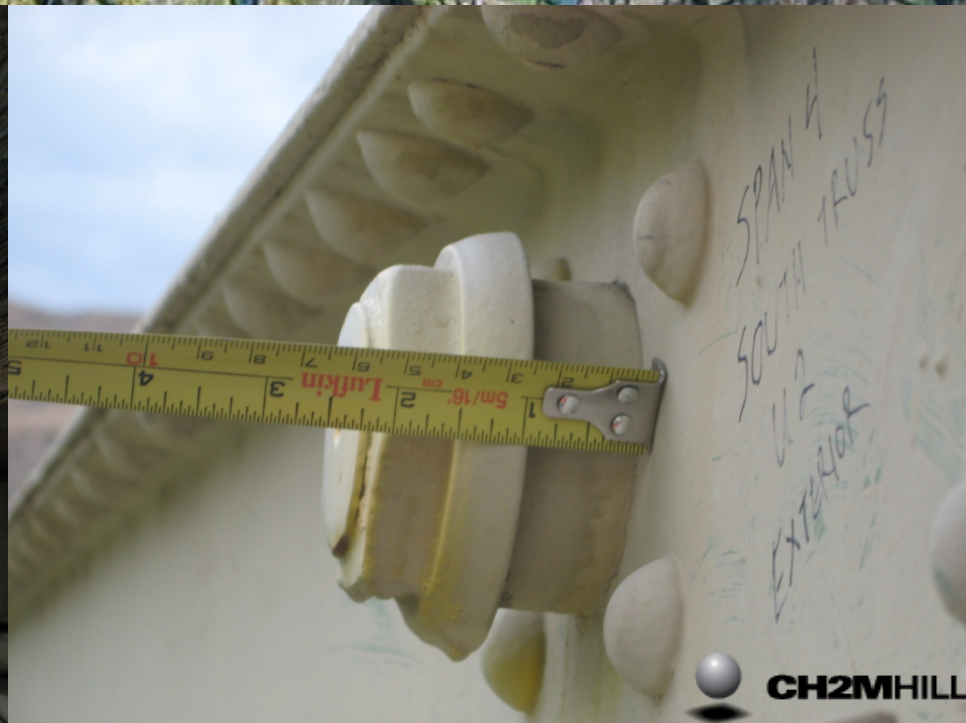
Pack rust and section loss at pin connections

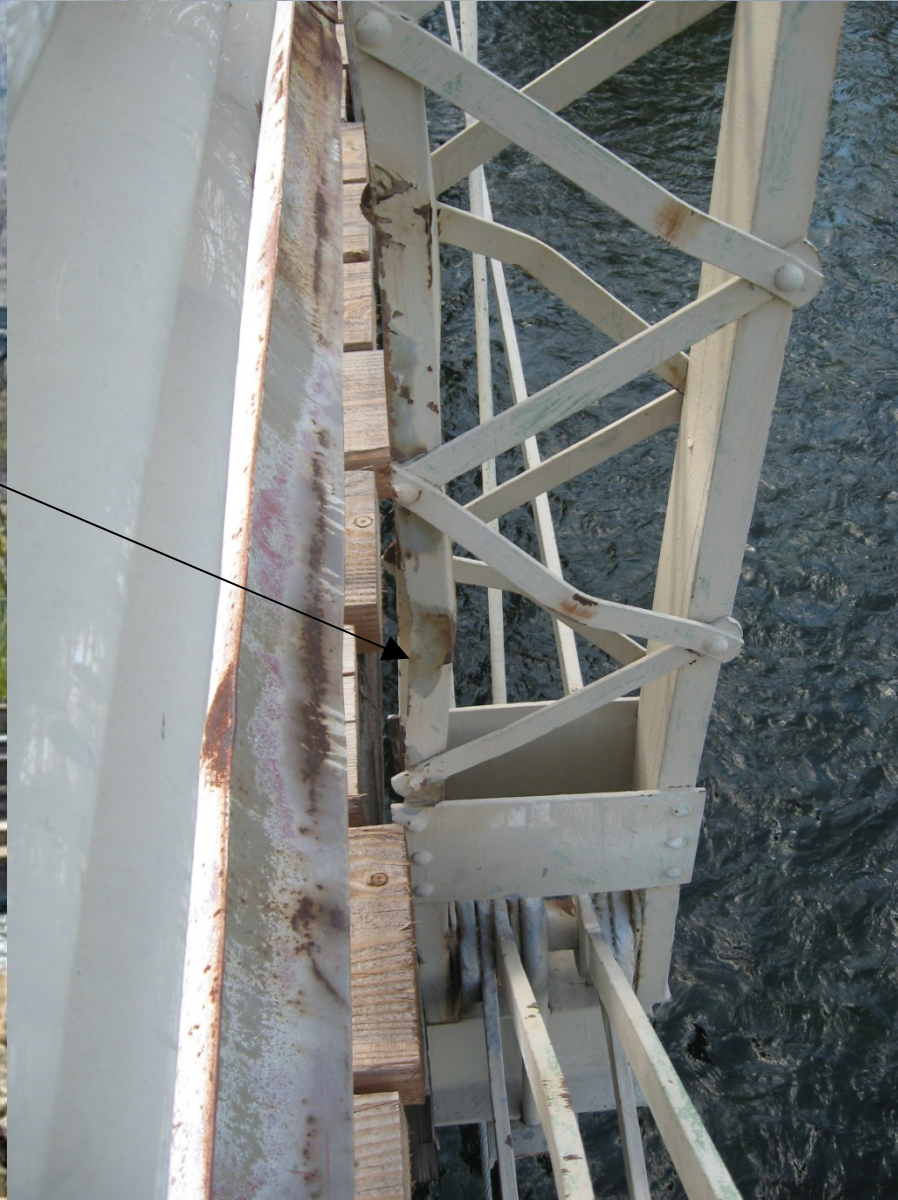
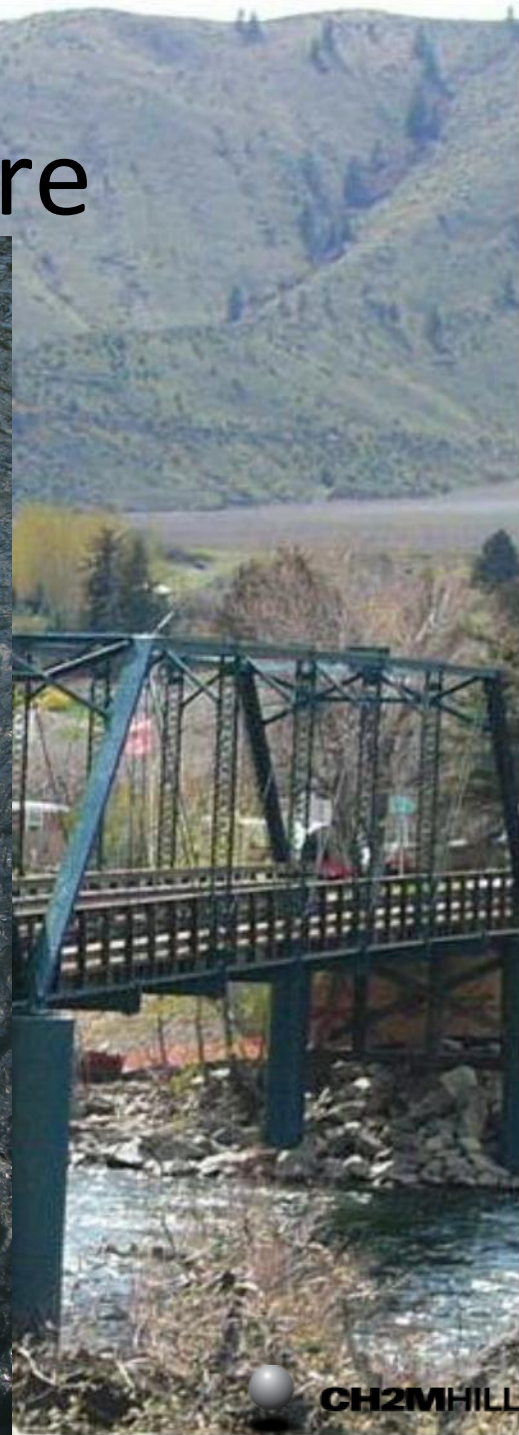
Impact
damage to
vertical
members

Original vertical compression members were reused and repaired where required. New channels were welded at bottom of member in locations with worst corrosion. New doubler plates were added.

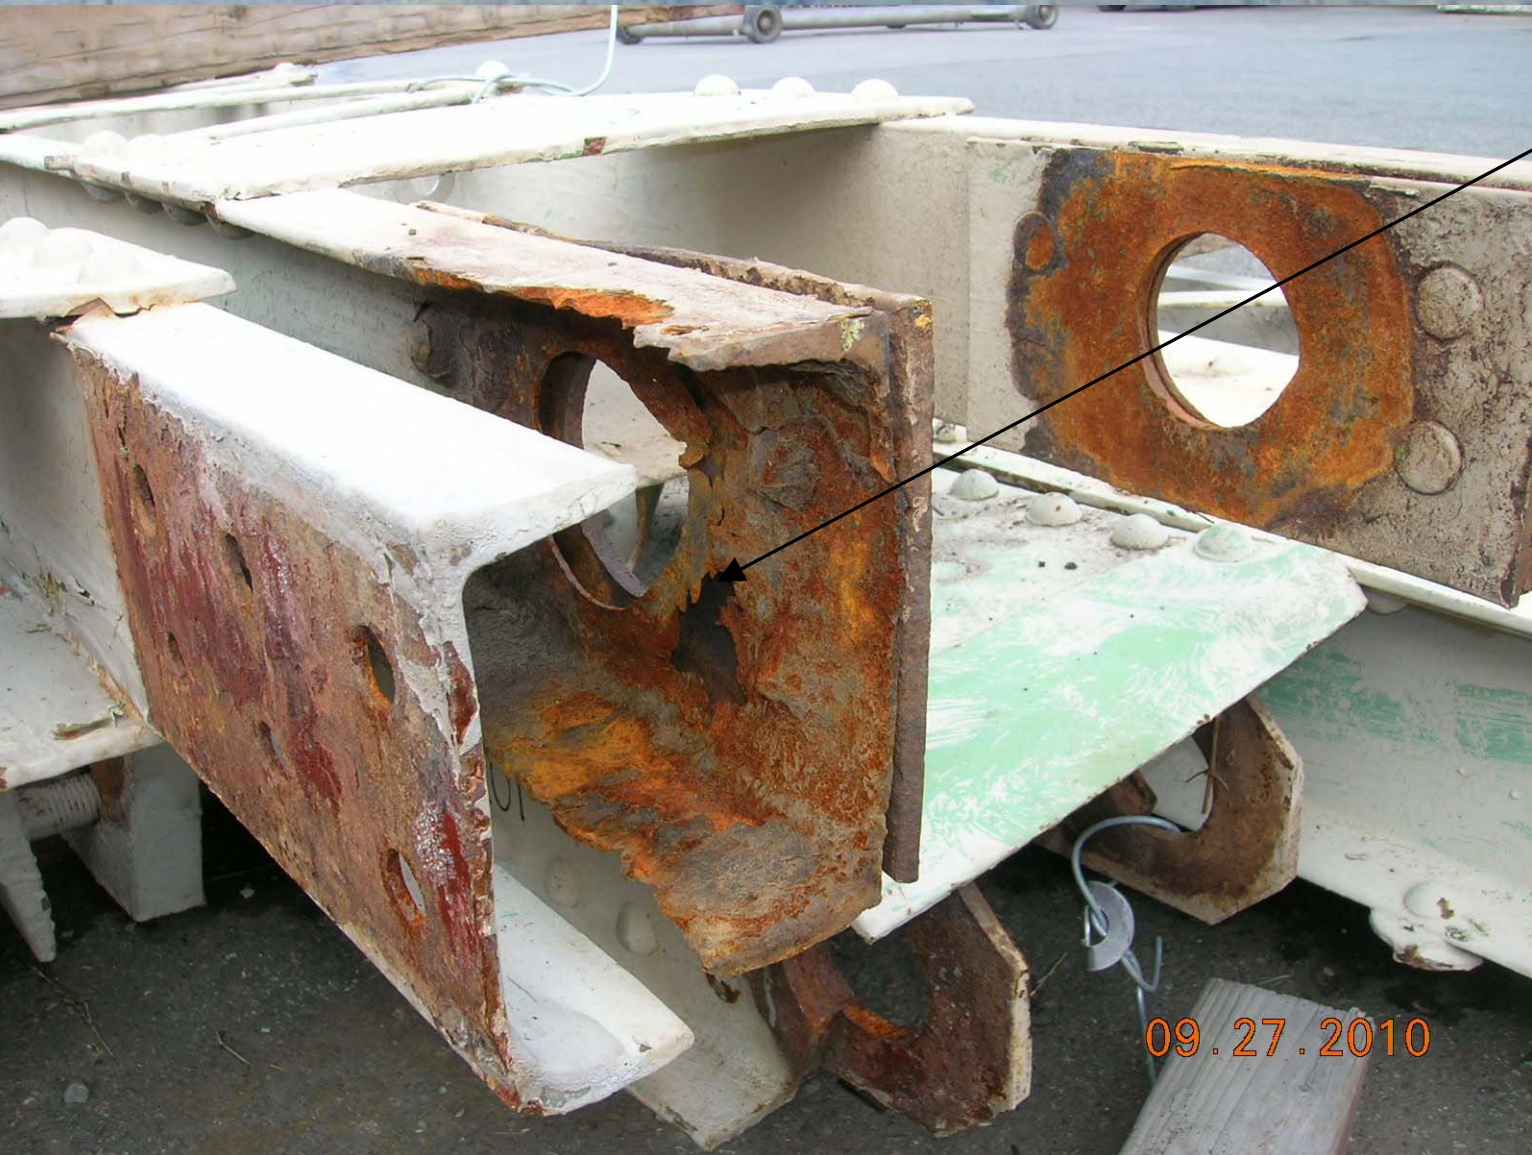
Significant section loss at bottom connections of vertical members

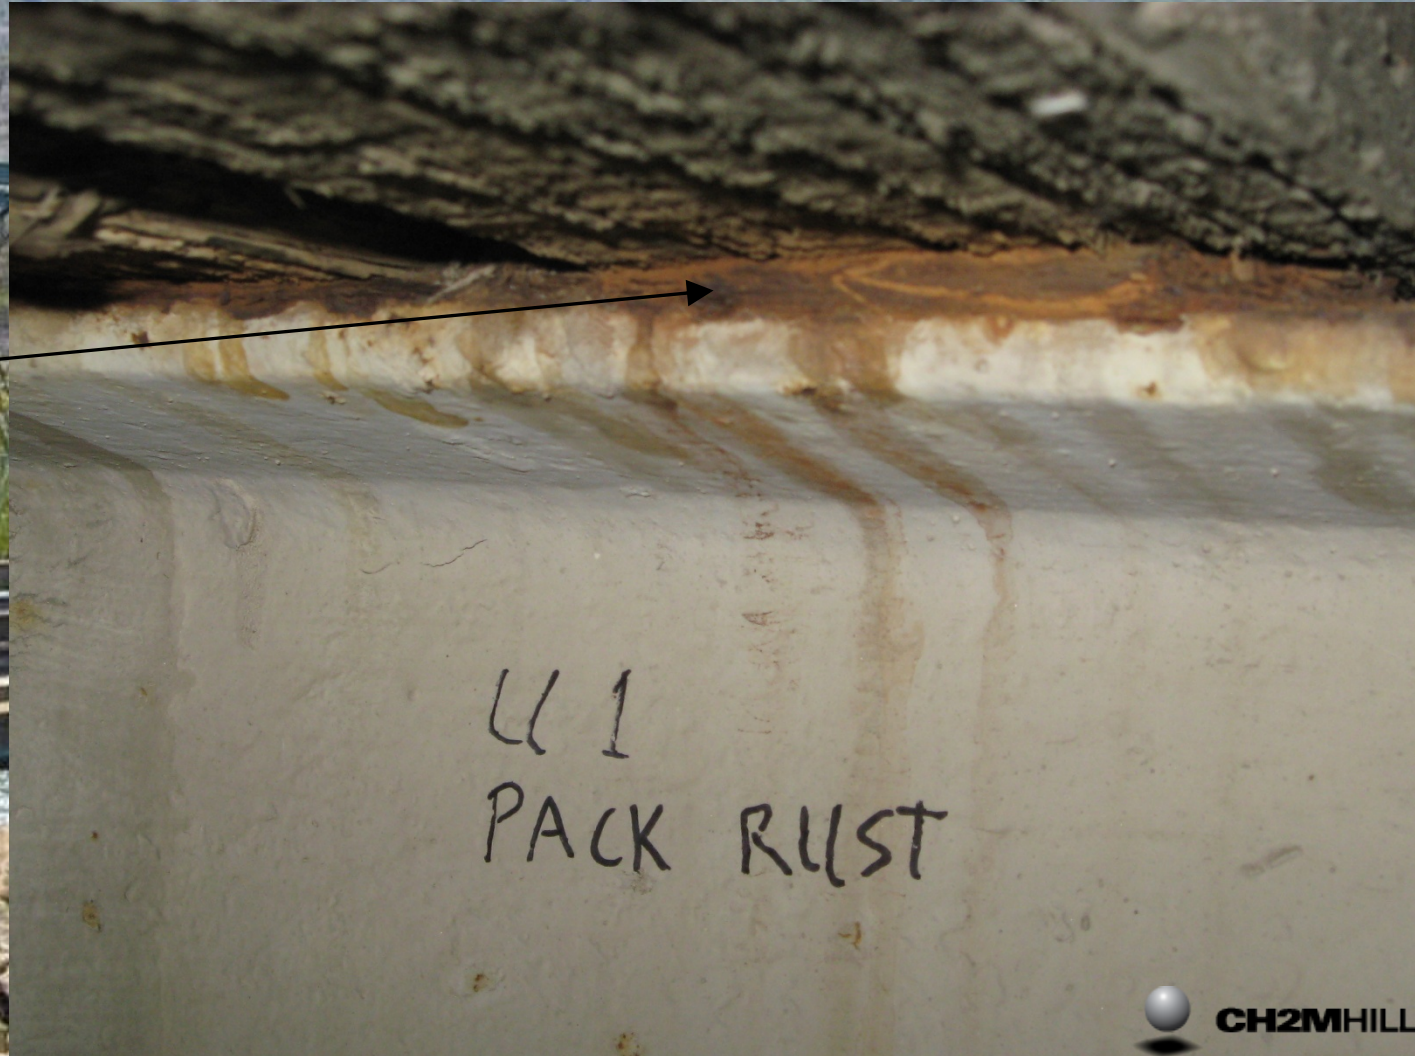
Lamellar
rust at
interface of
floor beams
and deck
stringers

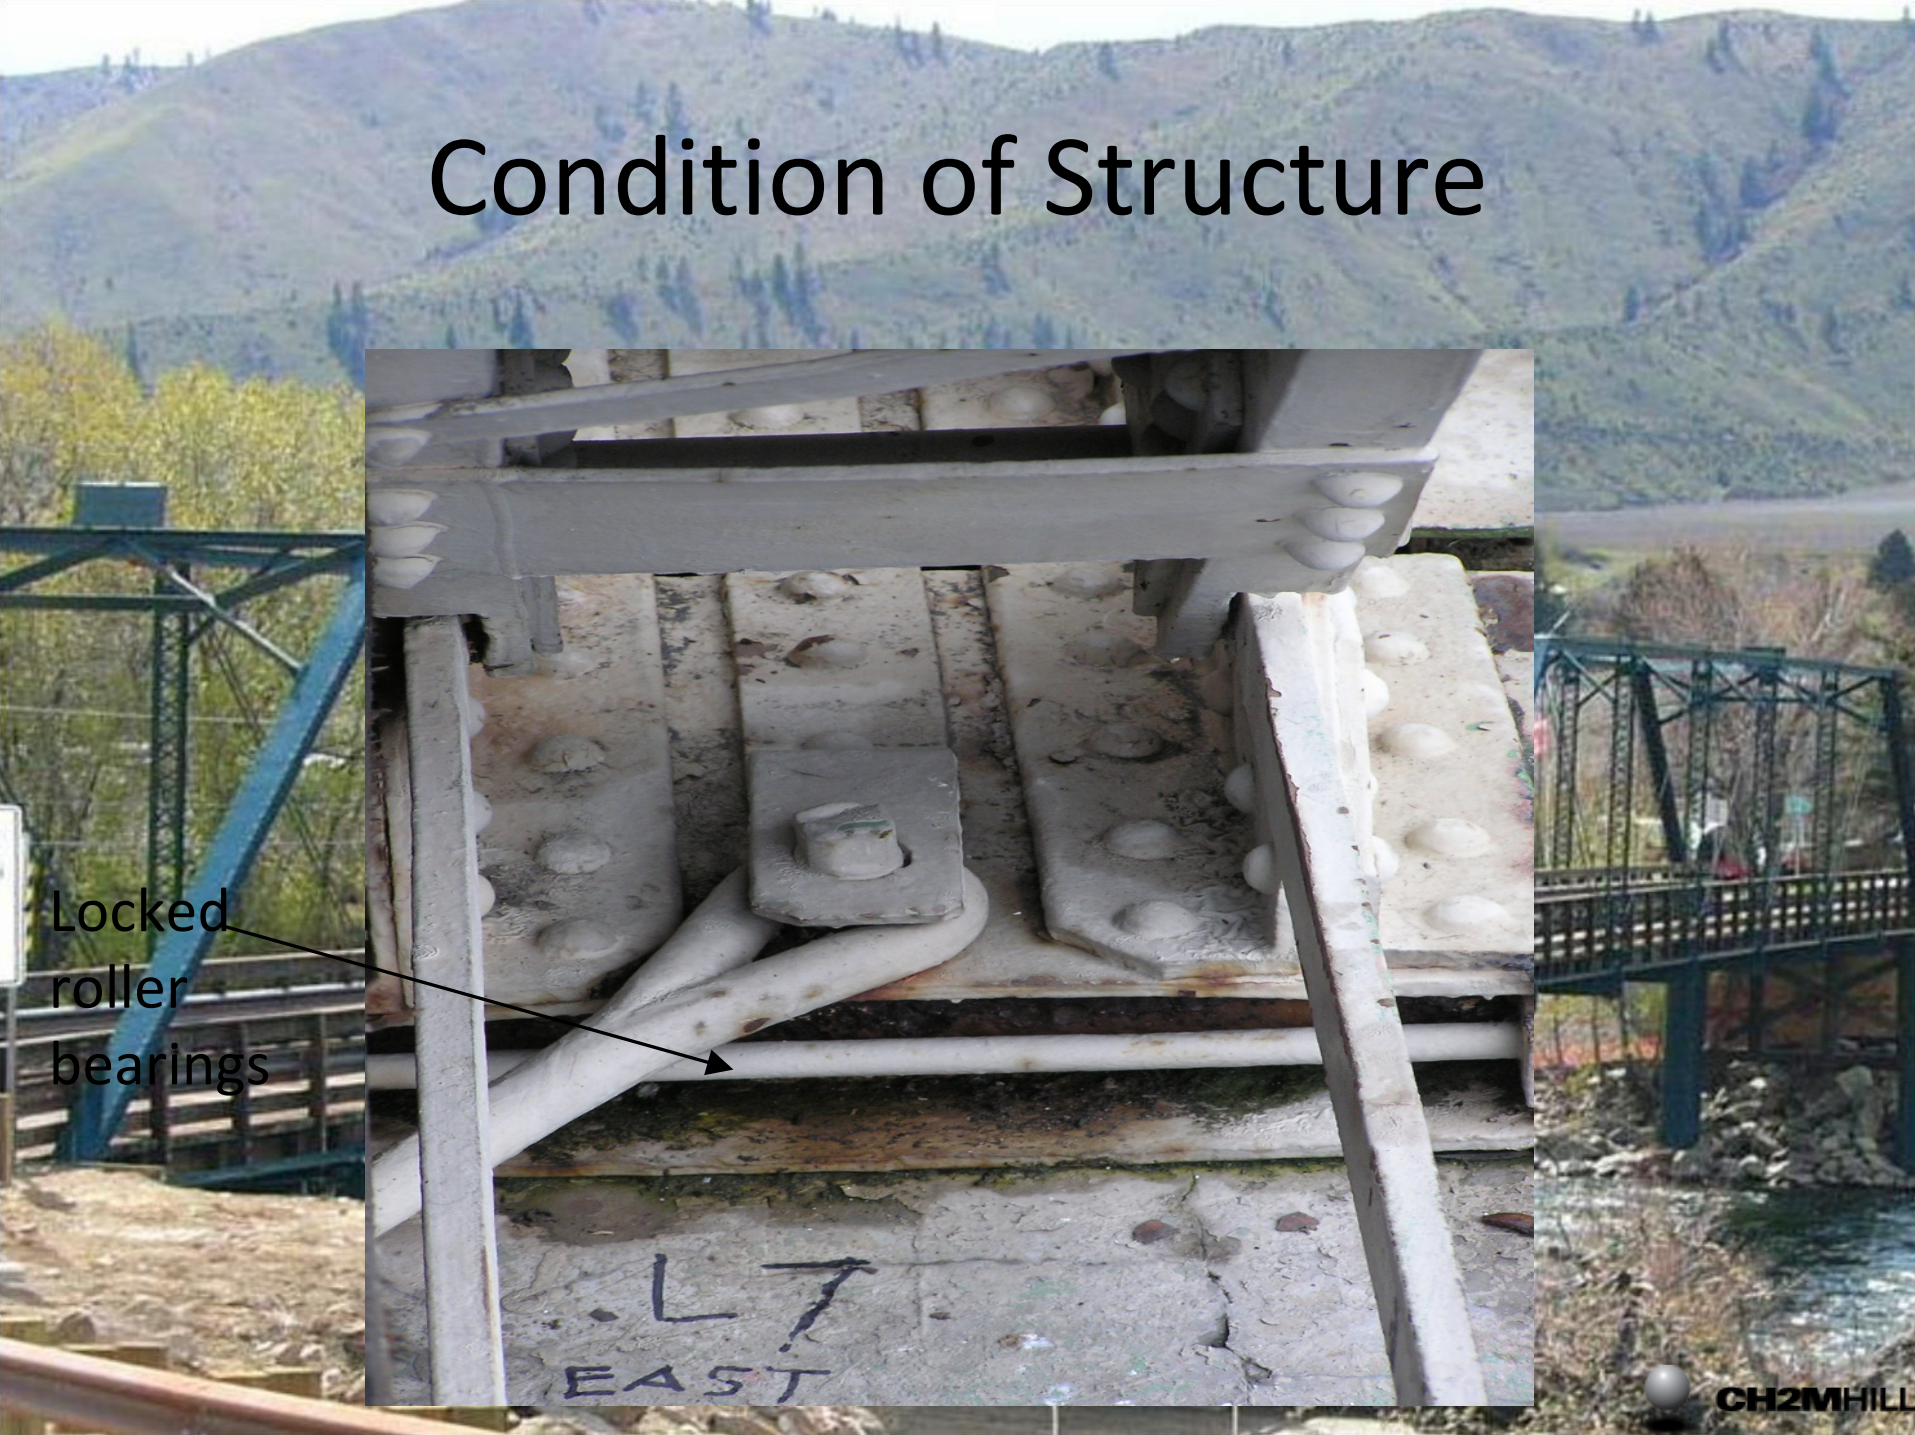
L7
EAST

Locked
roller
bearings

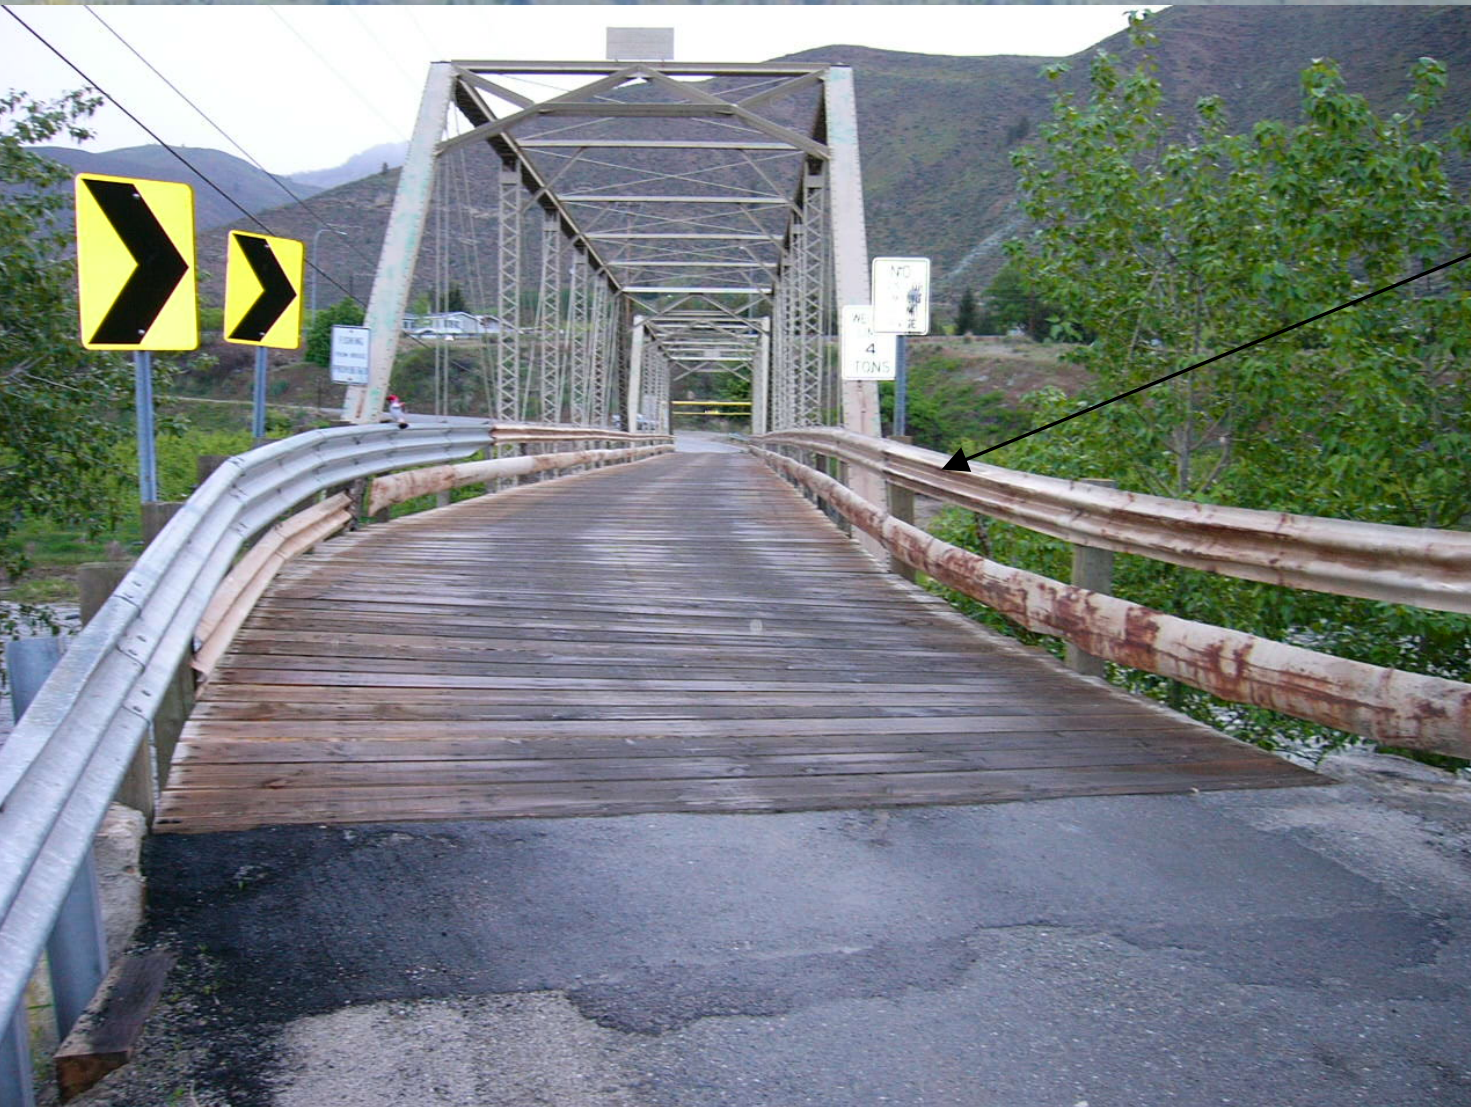
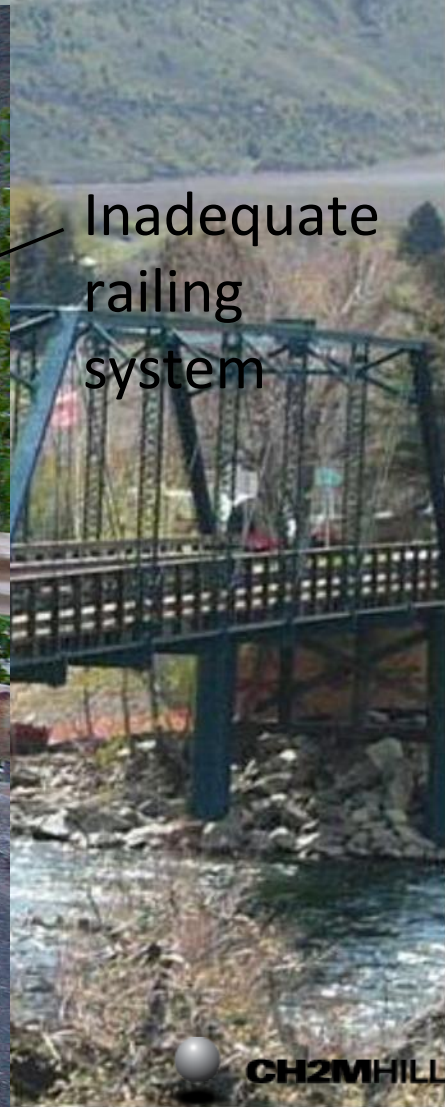
Inadequate railing system

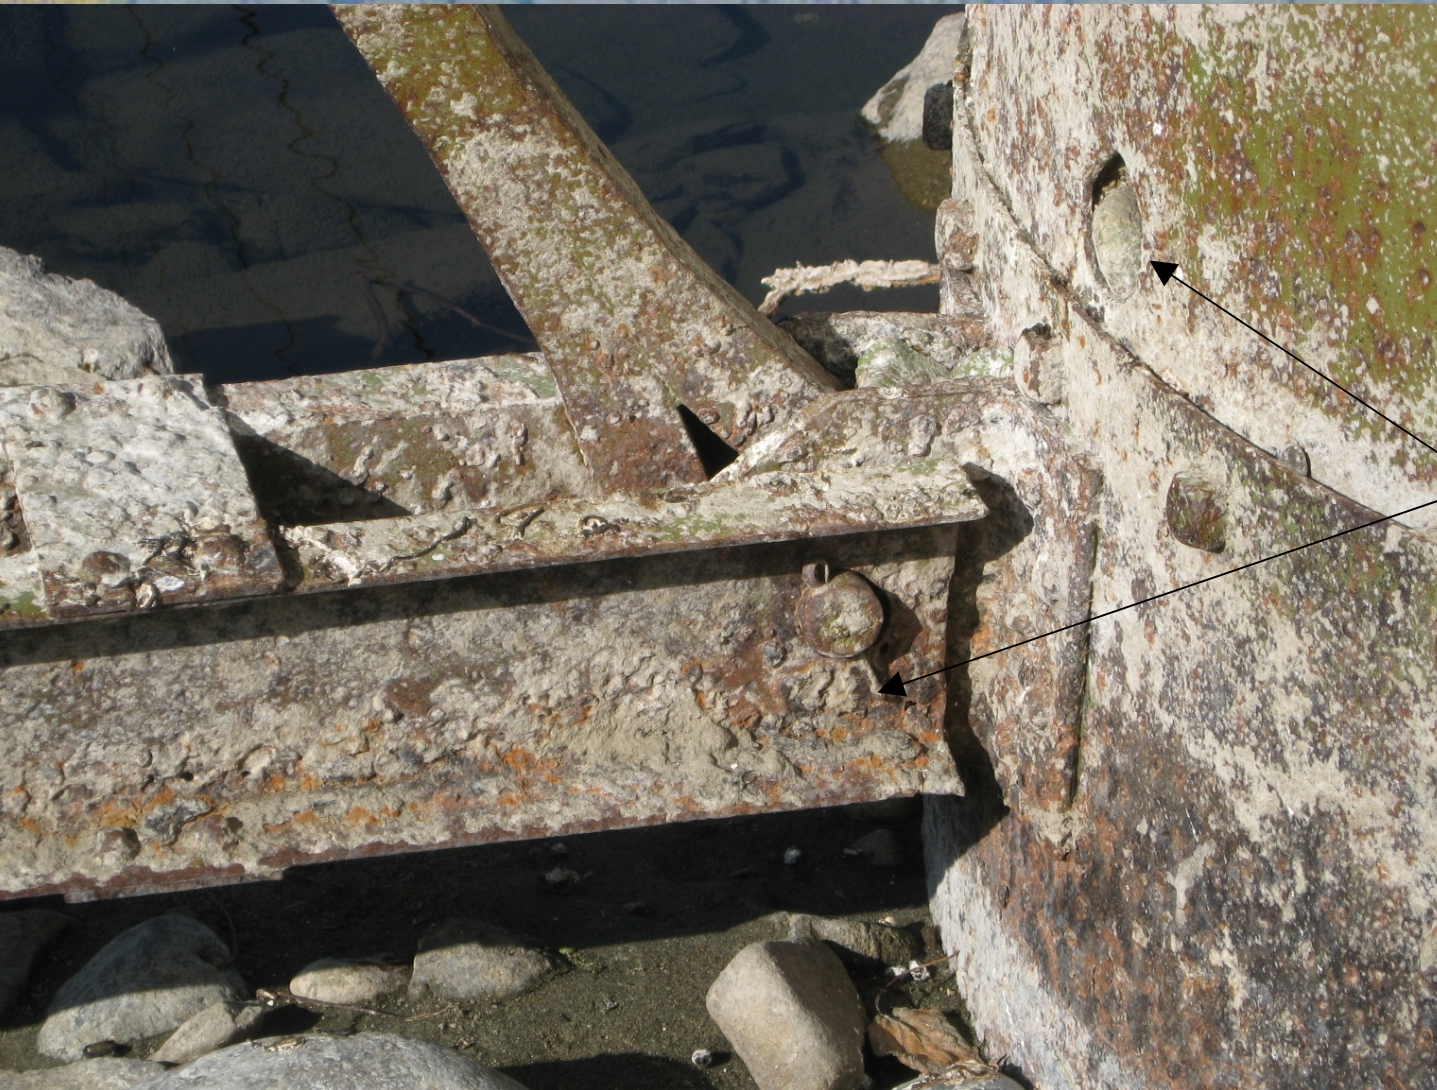
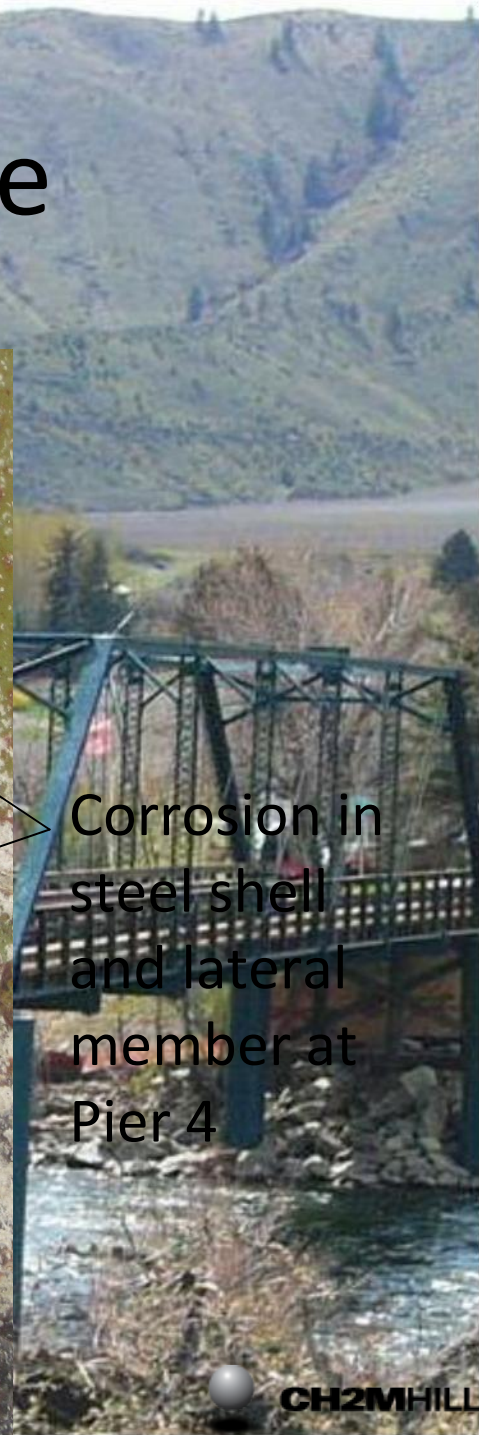
Corrosion in steel shell and lateral member at Pier 4

Existing piers cleaned and repainted. New steel plate welded to existing to repair corrosion at Pier 4.
