Arizona Department of Transportation

Emergency Rehabilitation of I-10 Mescal Road TI UP

Navaphan Viboolmate, PE
ADOT Bridge Group Design Section Leader

I-10 Mescal Road TI UP MP 297.17

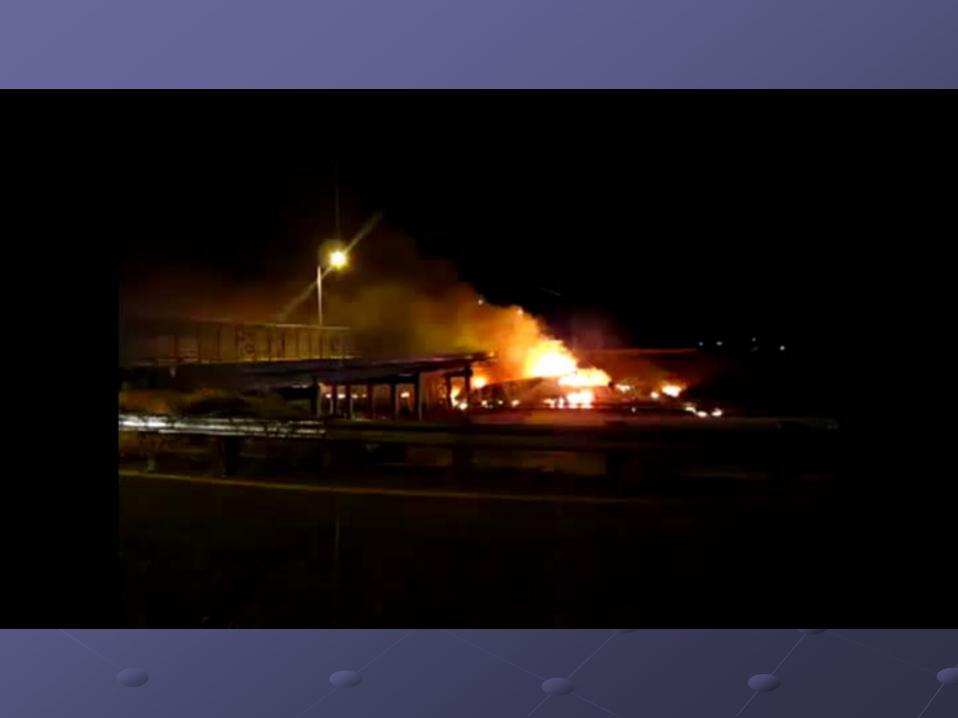
- March 15, Approximate 11:00 pm
- Two semi-trucks collided under the bridge
- Magnesium fire lasted approximately 6 hours

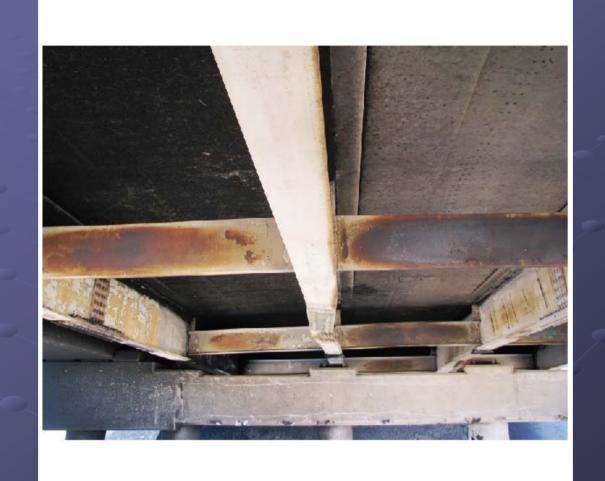
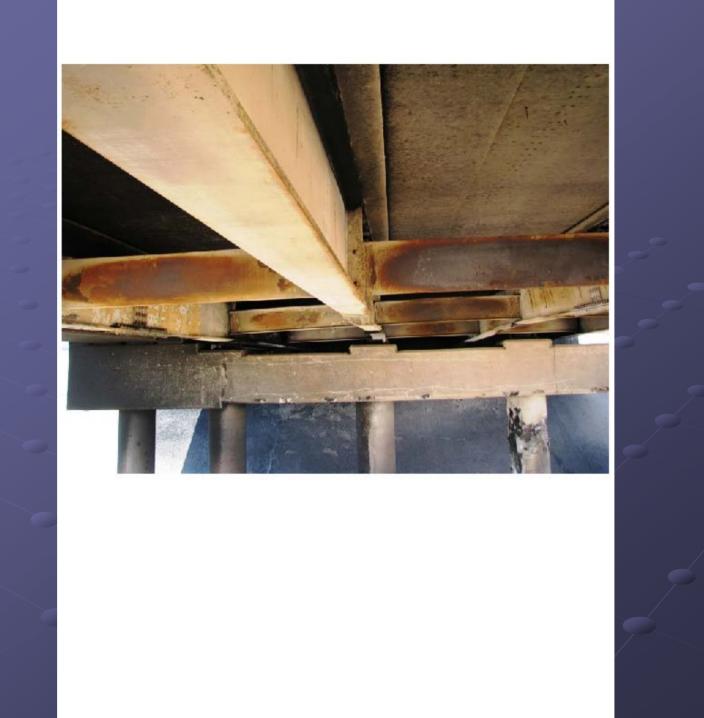
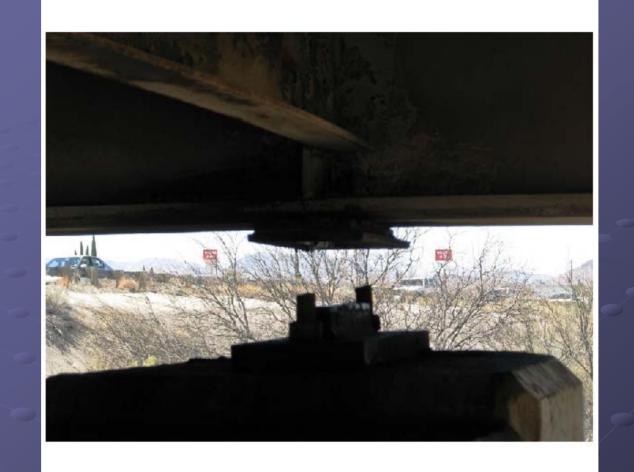
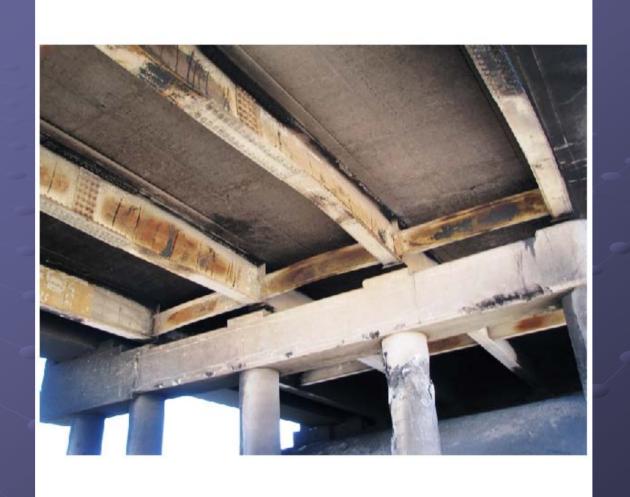
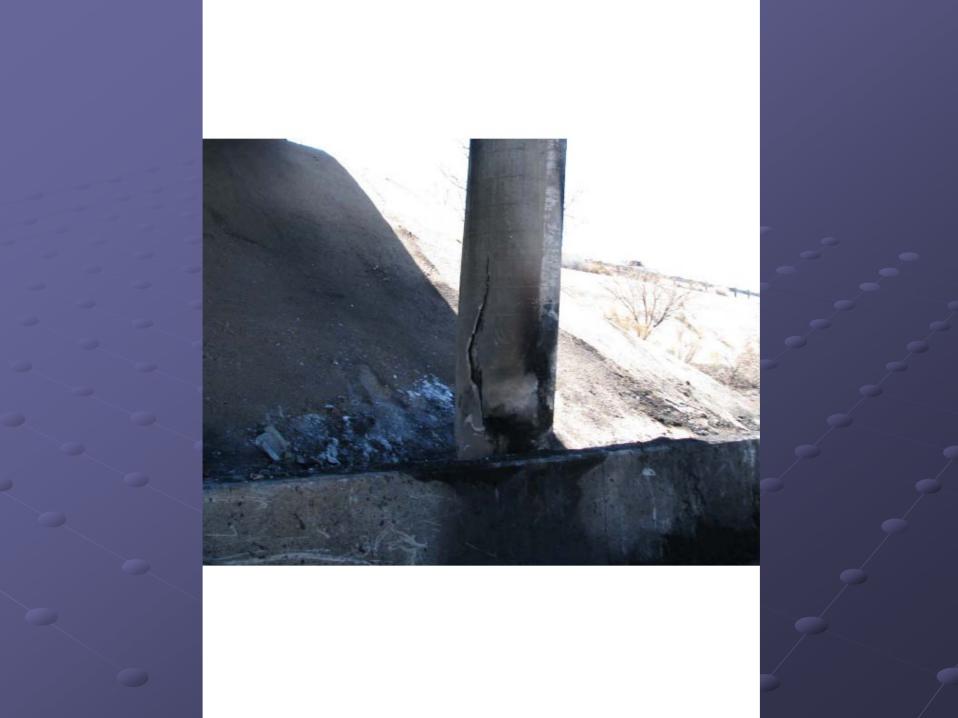
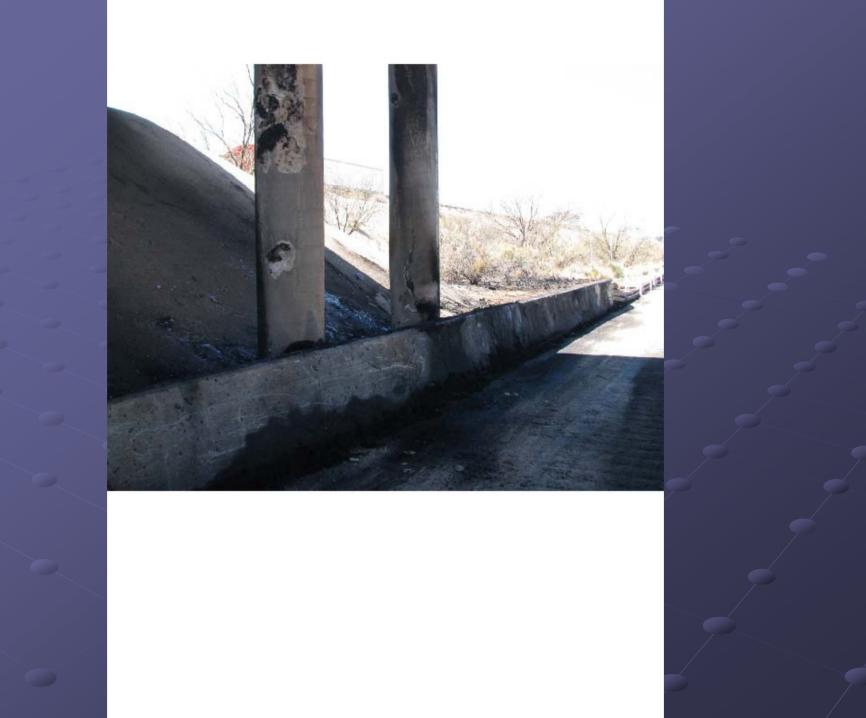
- Approximately 6" upward deflection at pier 1
- Approximately 2" Lateral deflection
- Concrete spalls from columns and pier cap

- Steel Girders have to be replaced
- Replace all pier caps
- Replace columns at pier 1
