The Feather River

A Case Study in Scour Analysis, Real-time Monitoring and Field Measurements of Active Scour

Western Bridge Engineers' Seminar
Phoenix, AZ
September 28, 2011

Br. No. 18-0009

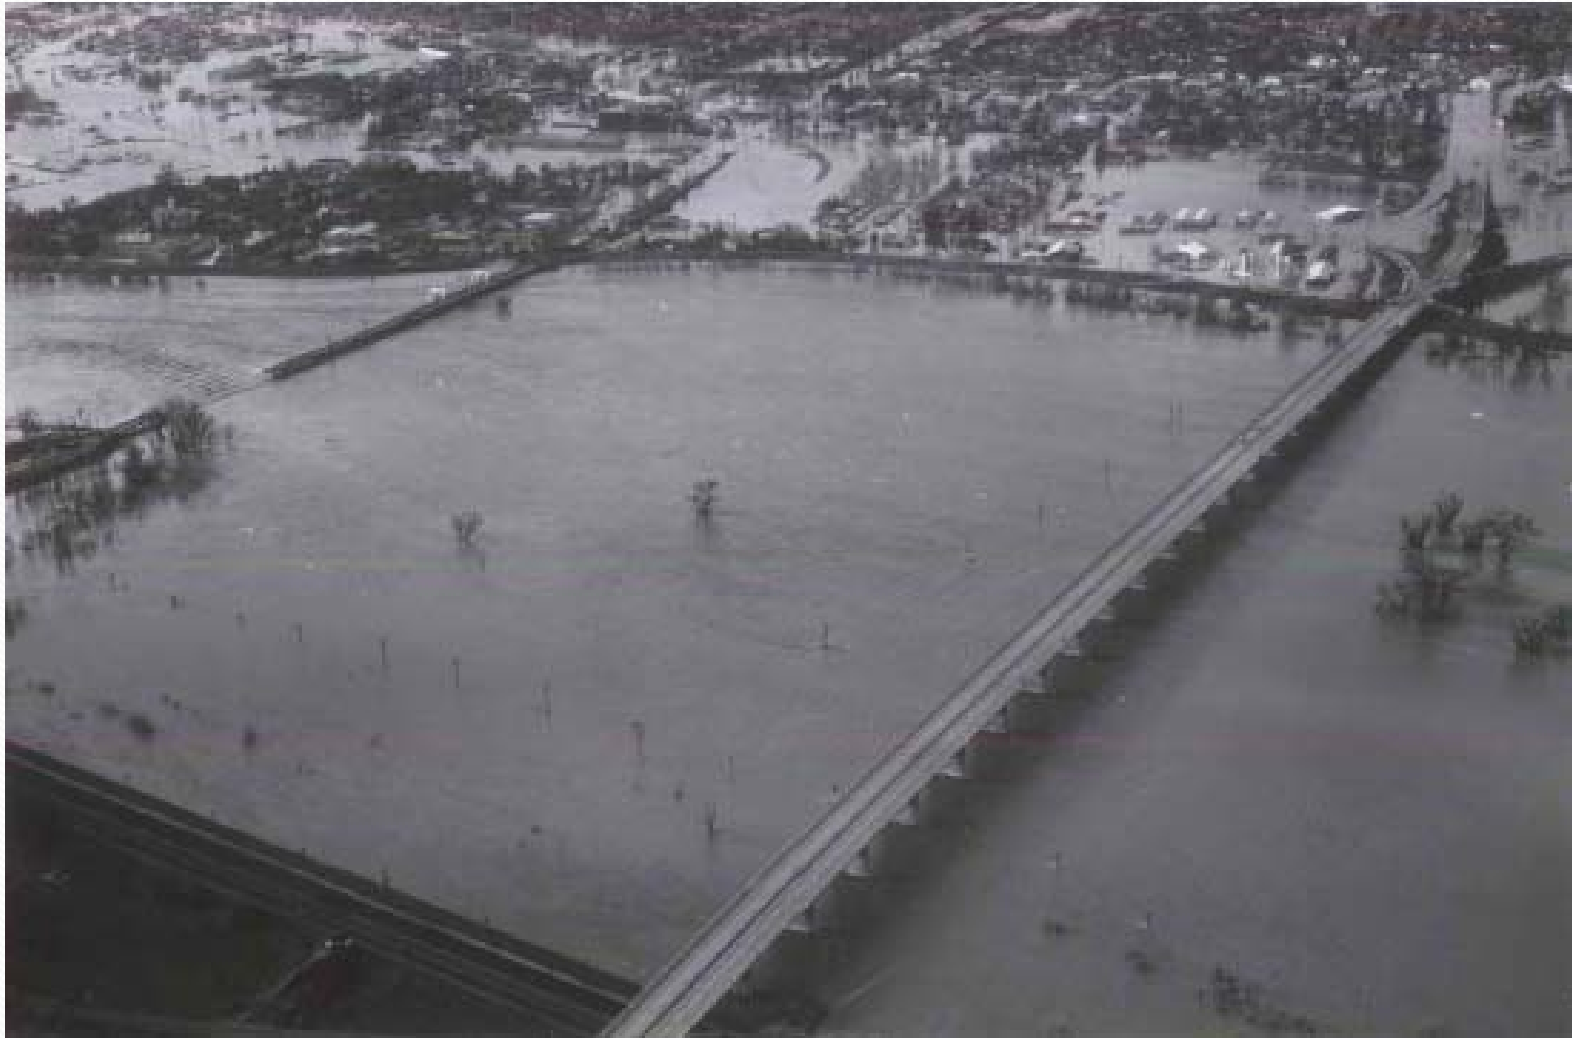
1955 Flood Damage in the Overbank

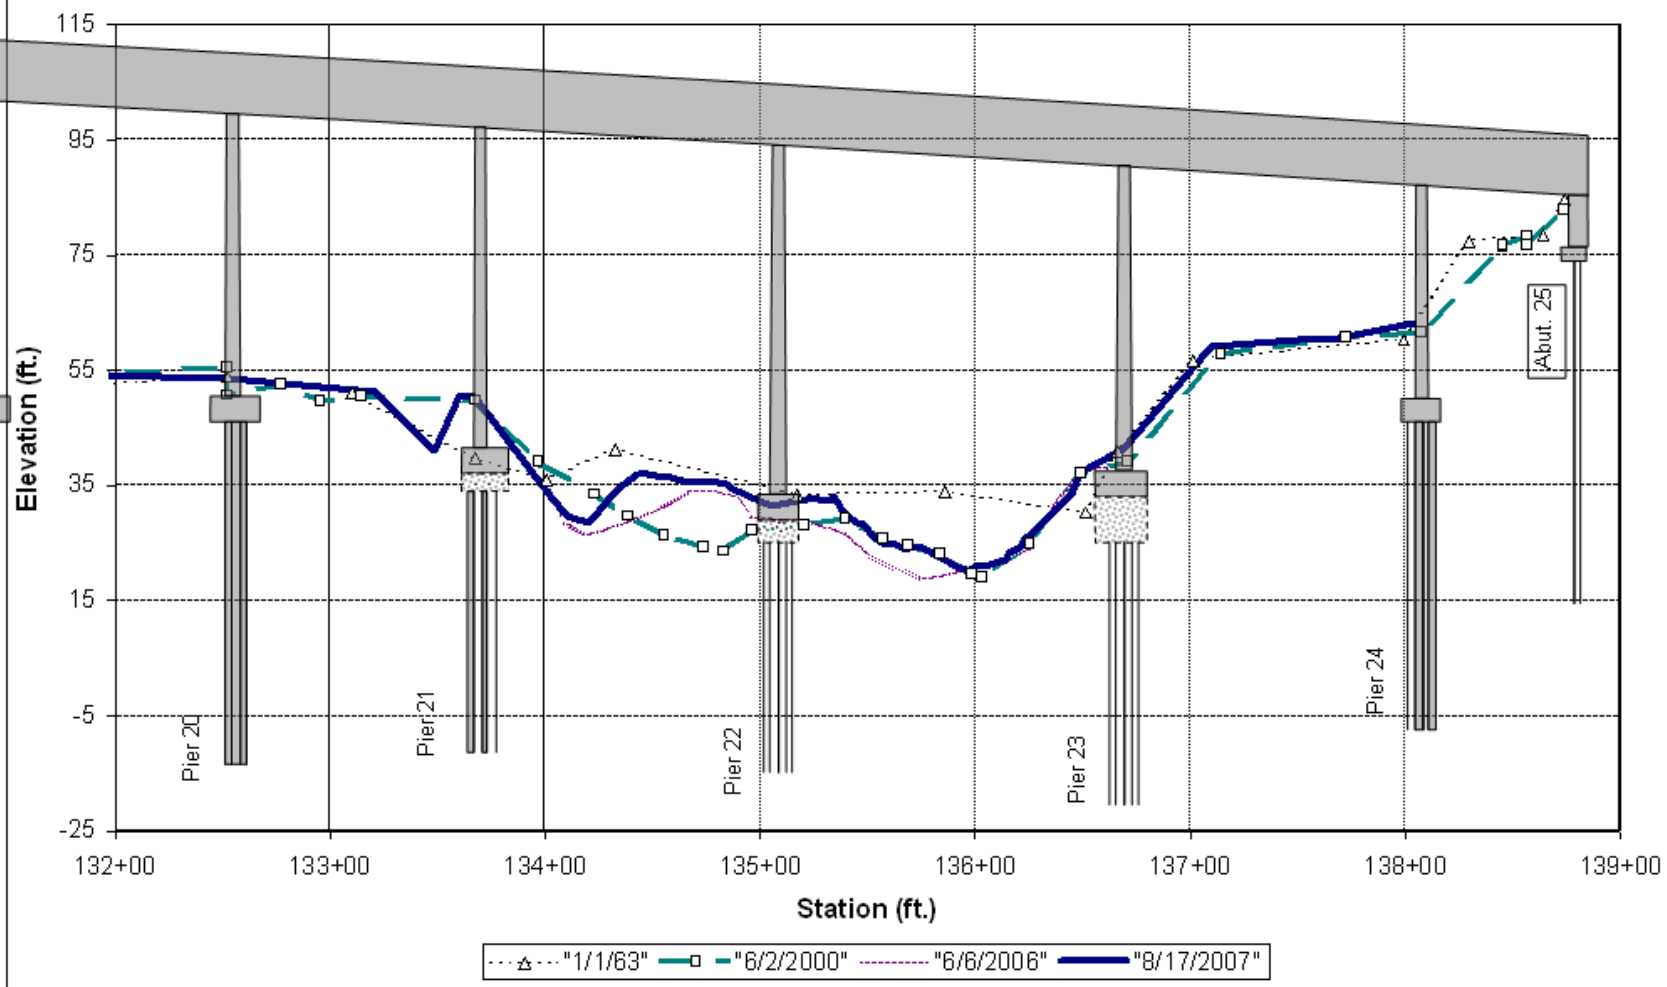
Cross-sections show the river has deepened about 14 ft in the main channel , but been laterally stable

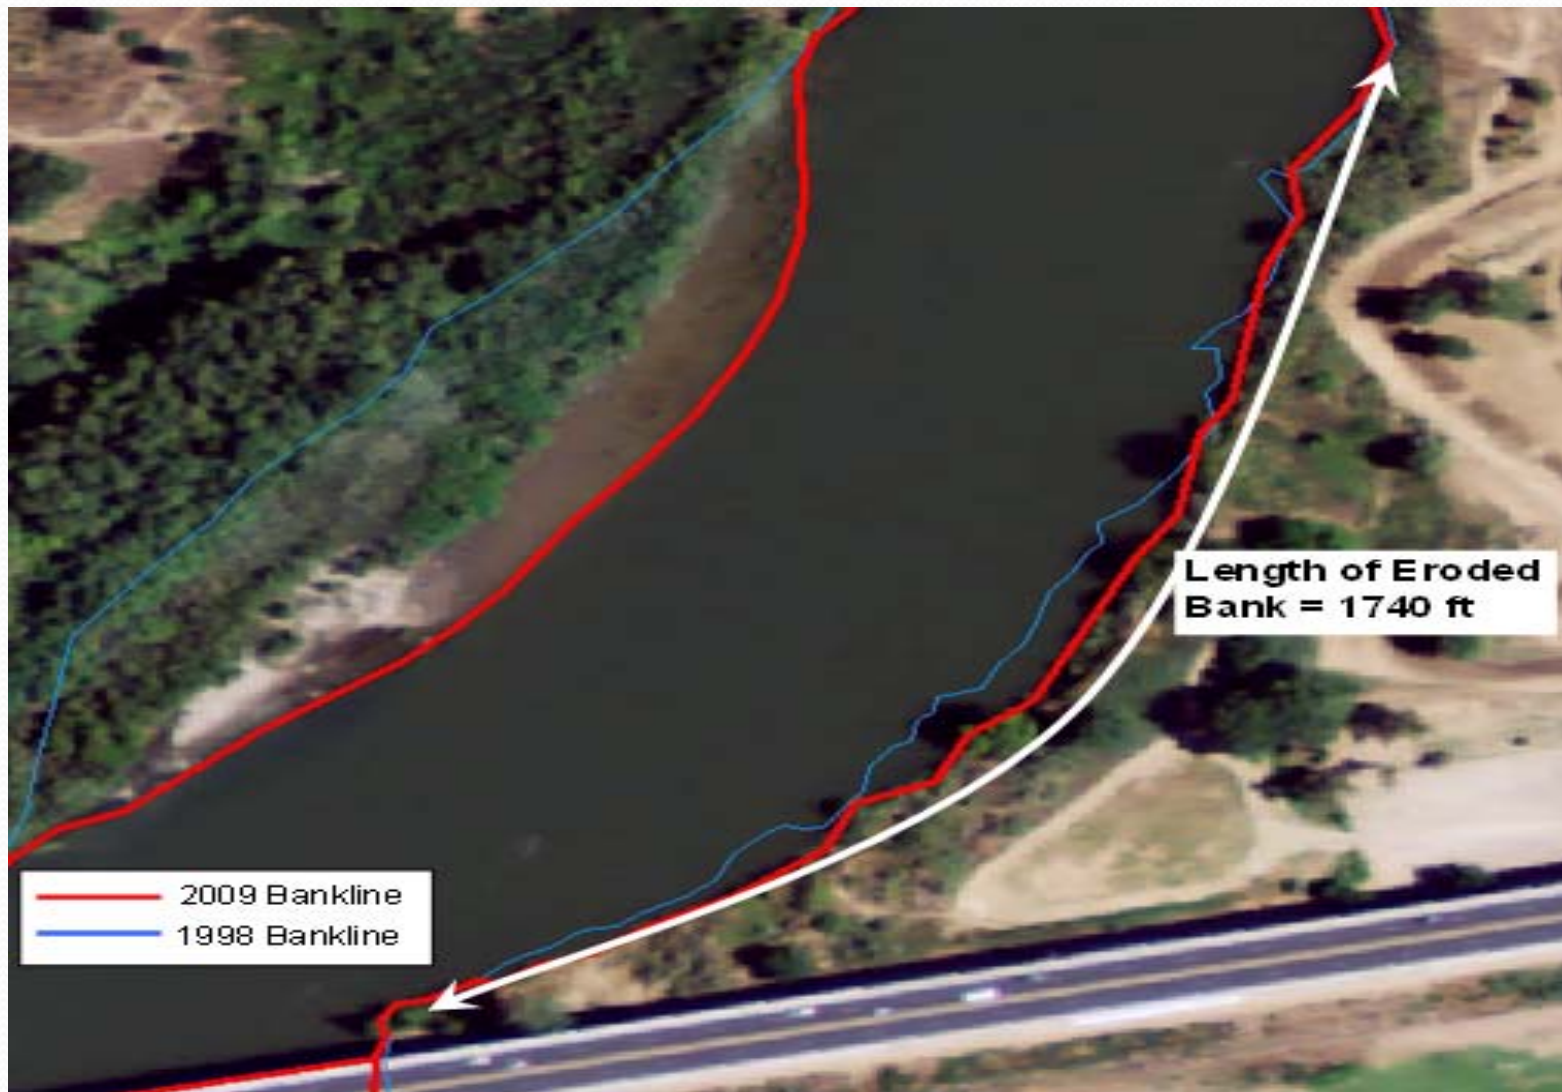
Bank erosion between 1998 and 2009

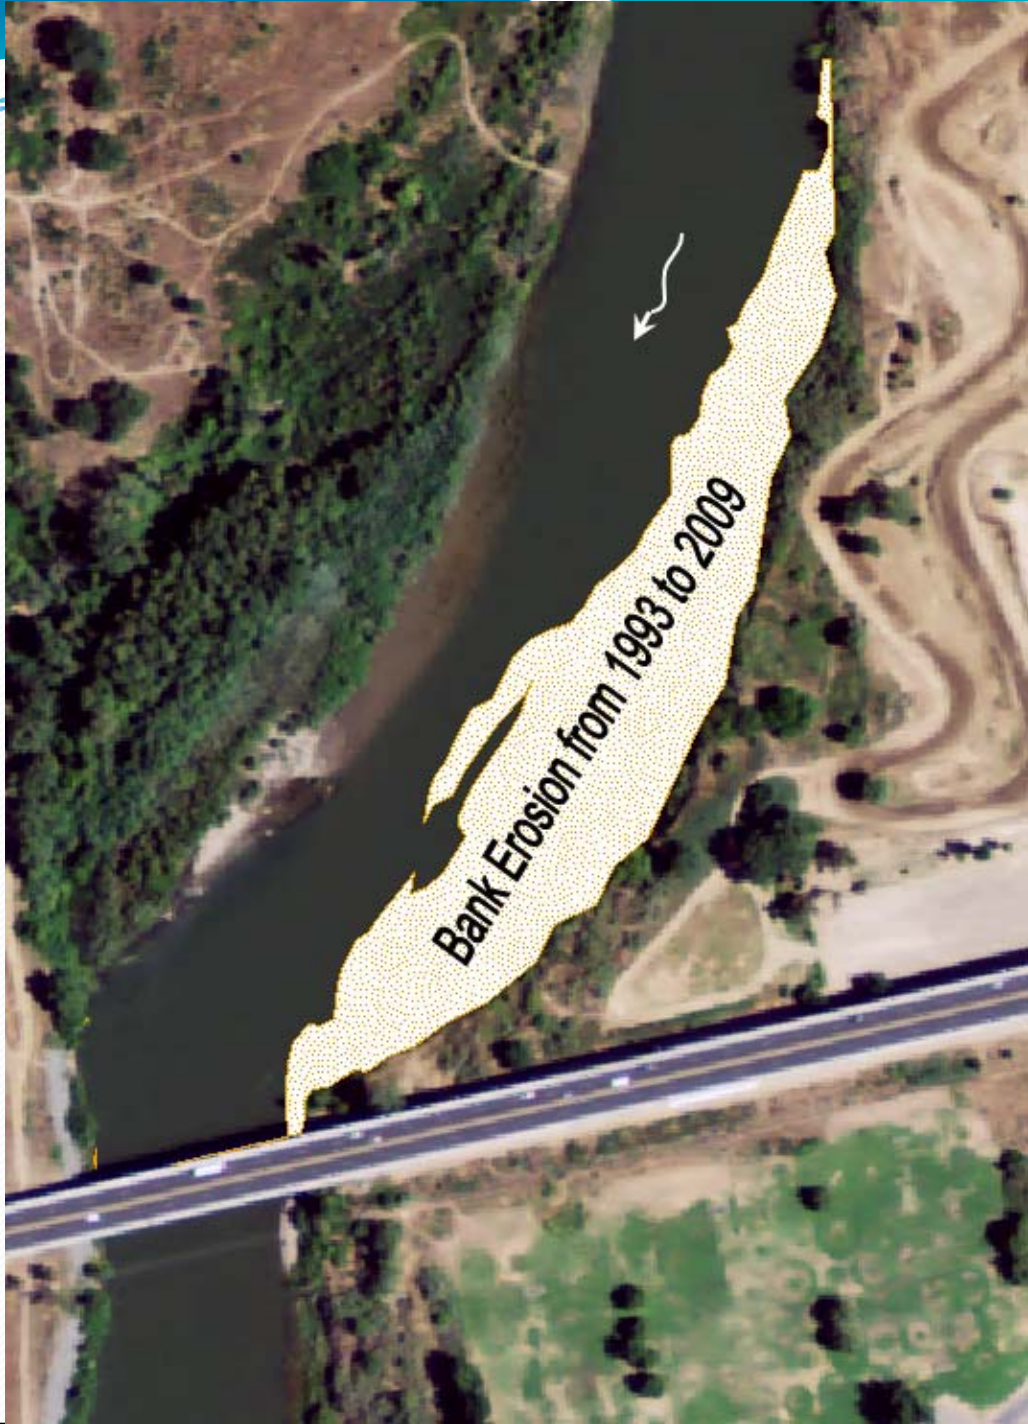
Bank Erosion from 1993 to 2009

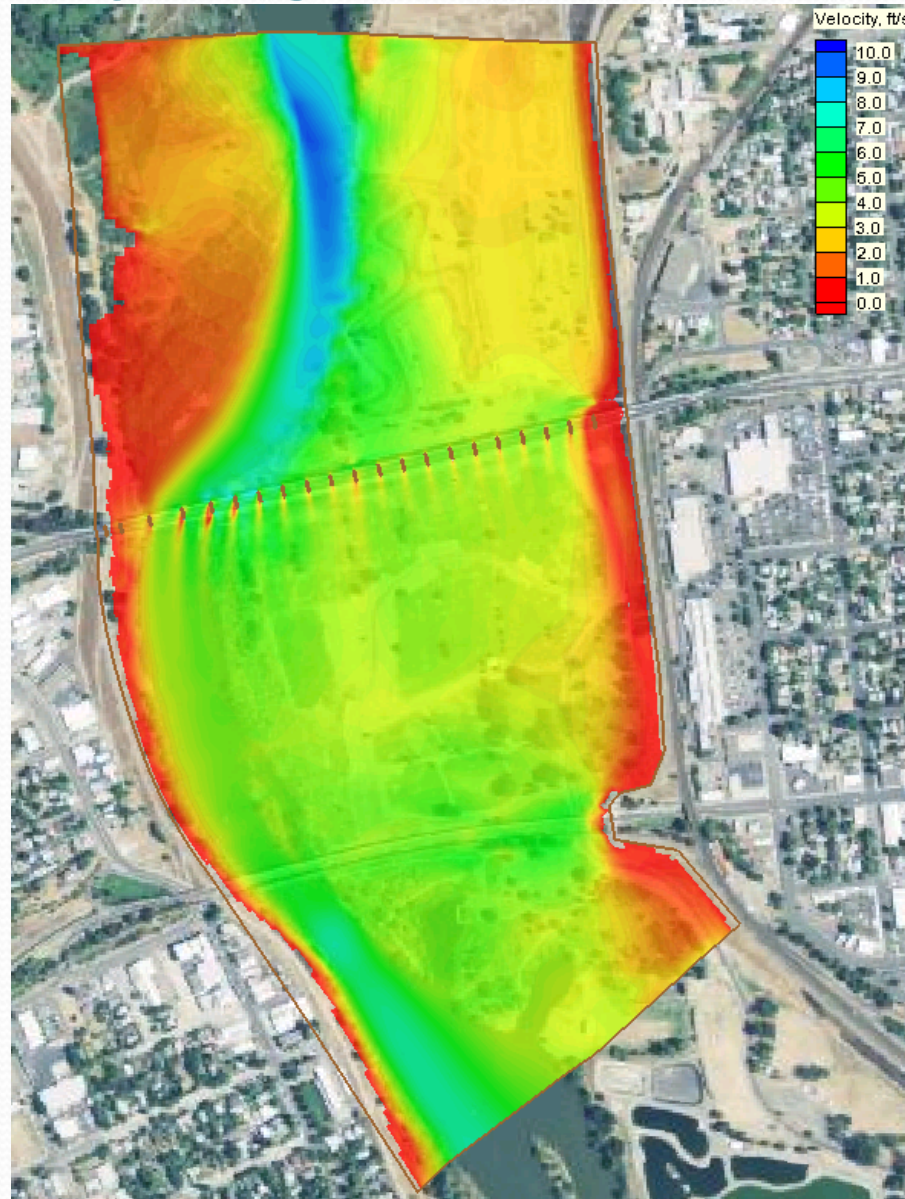
Hydraulic Skew – 40 to 50 degrees typical

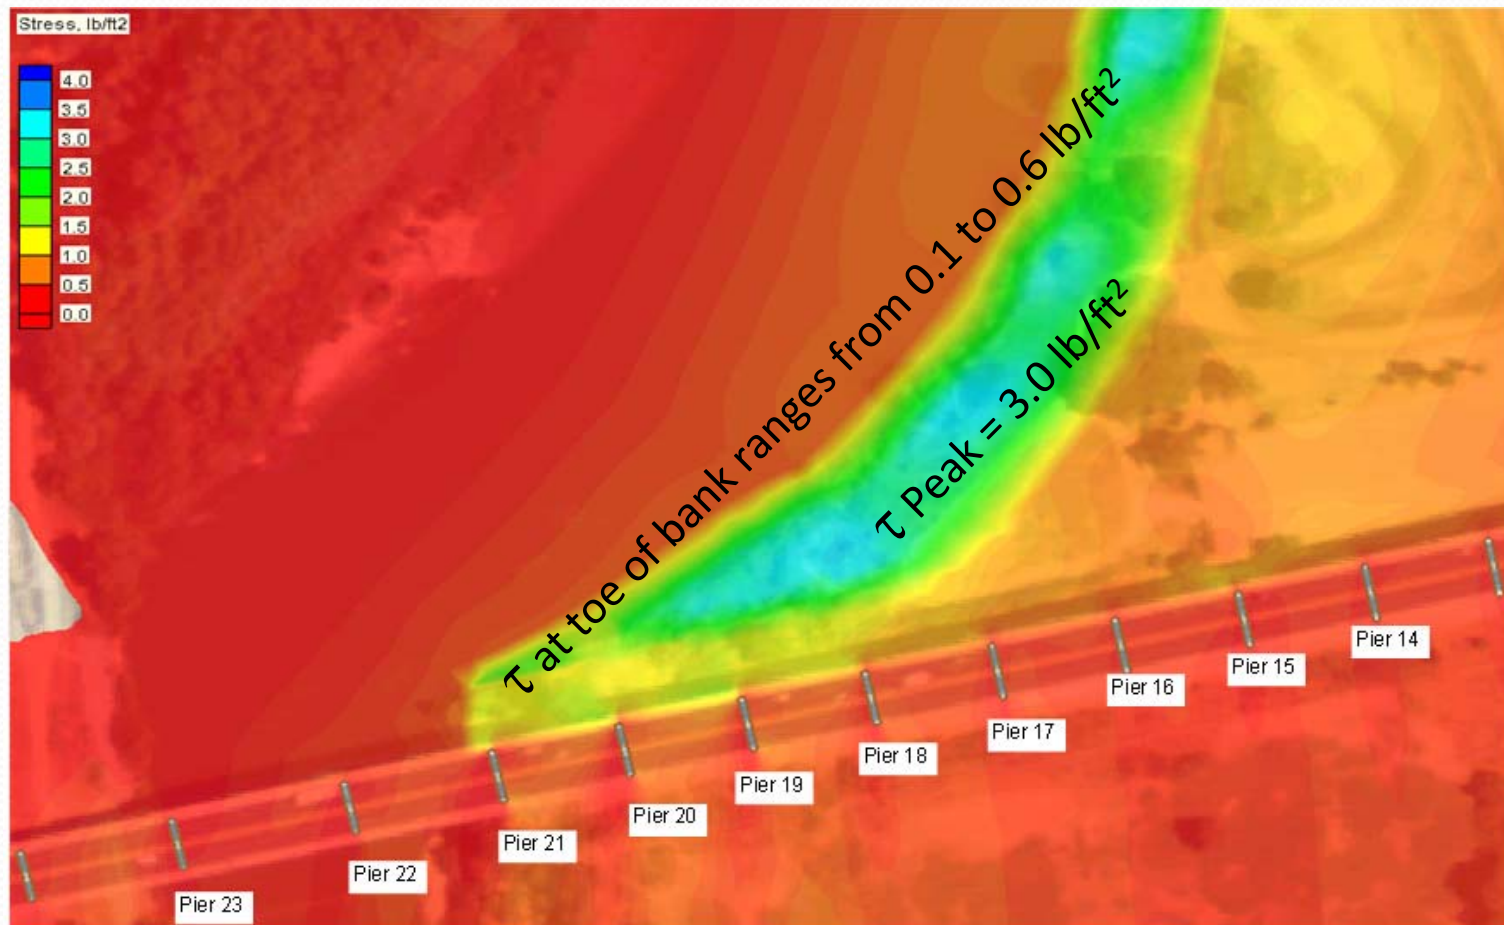
Shear Stress along the East Bank

→ Stress at the bank will exceed τ_{cr} and easily erode the bank

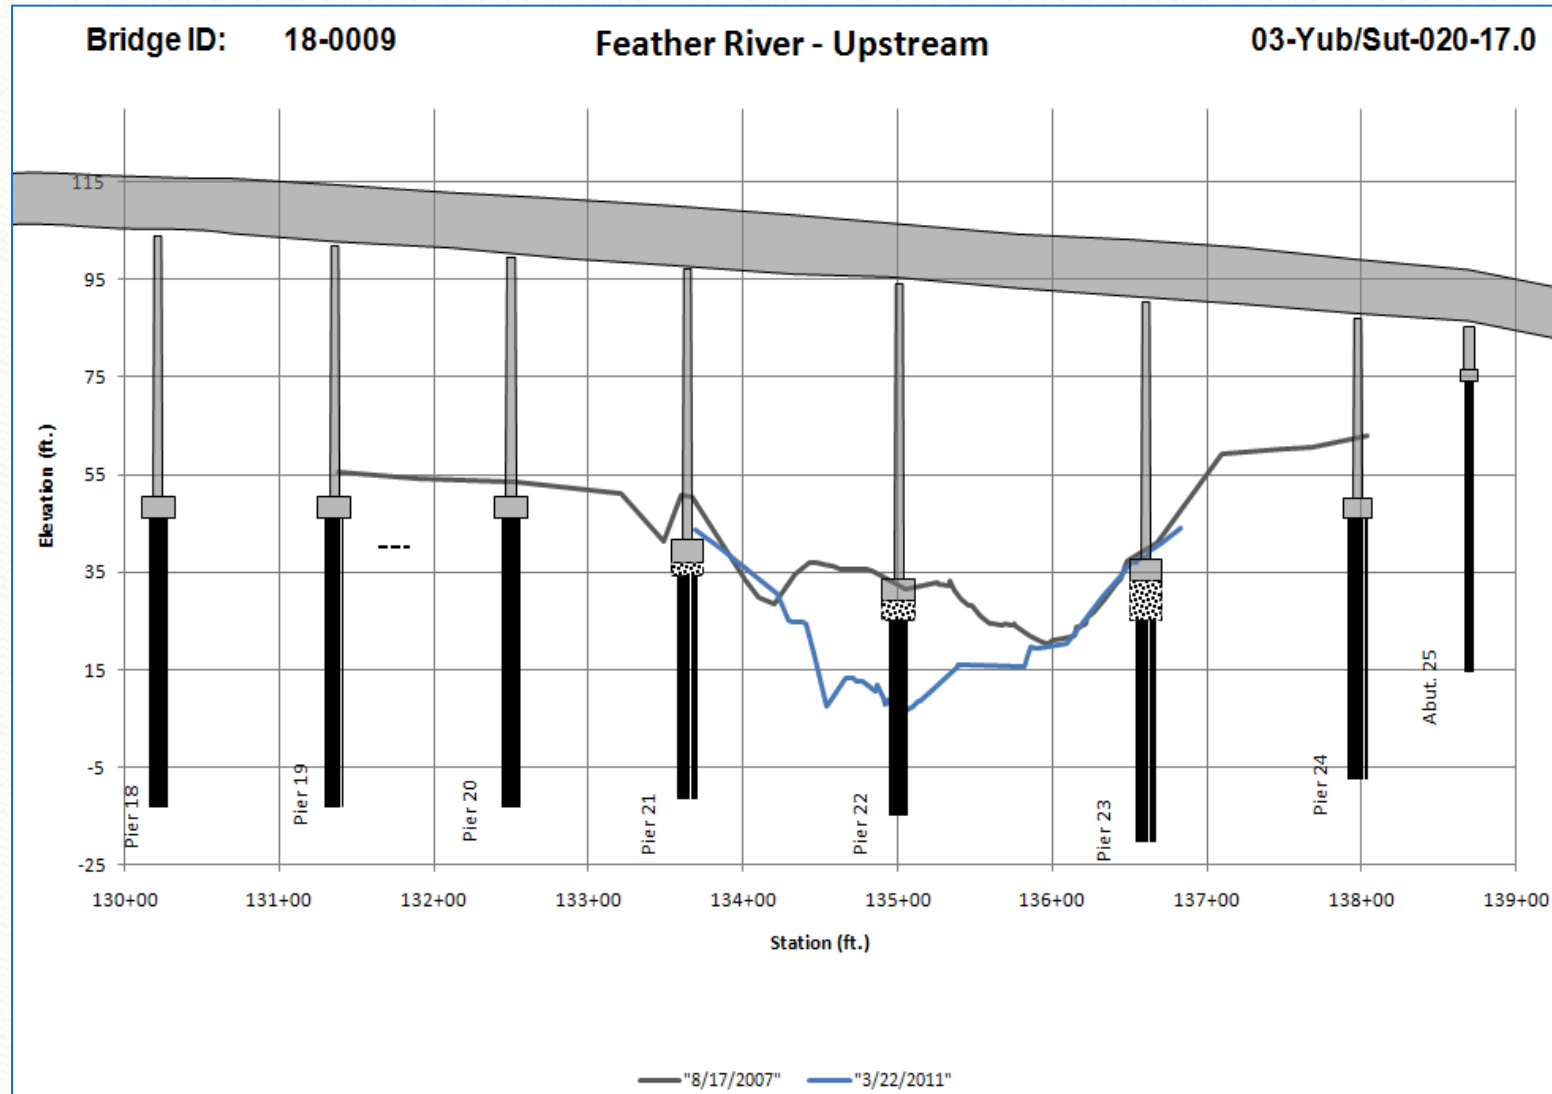
Change is X-Section

Approximately 30 feet change at Pier 22

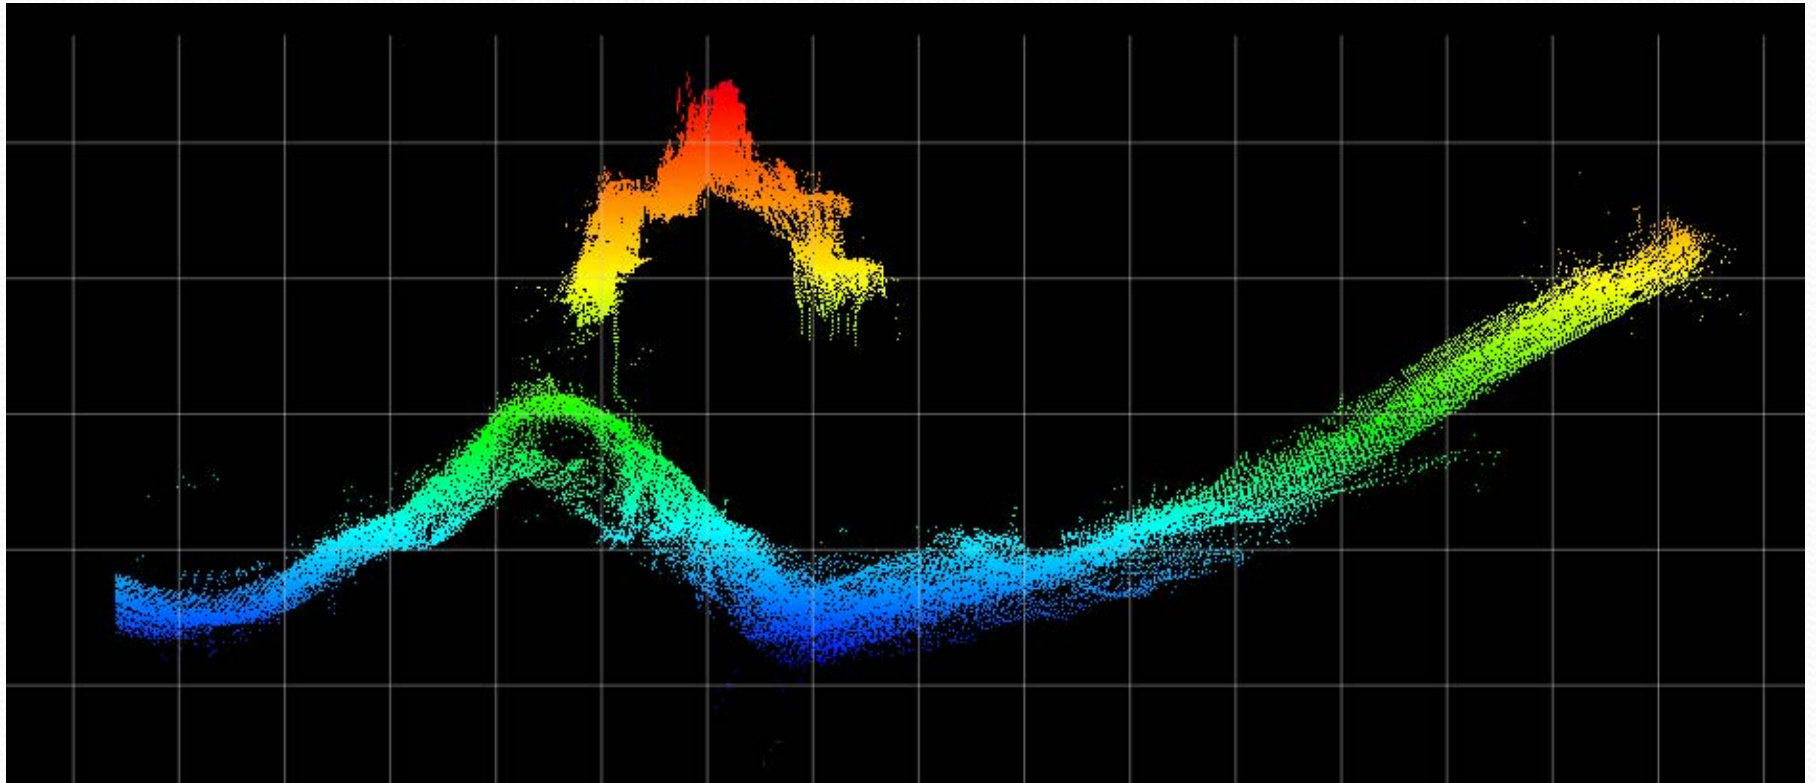
Downstream Section

- Survey confirmed 30 feet of scour present at upstream side of the pier
- Less scour at the downstream, west side which explained by structure was not showing signs of distress
- Monitoring and Mitigation was still justified
