2012 Hagwilget Suspension Bridge Refurbishment

New Hazelton, BC, Canada

By: Jeff Mellor, M. Eng

Refurbishment Works Summary

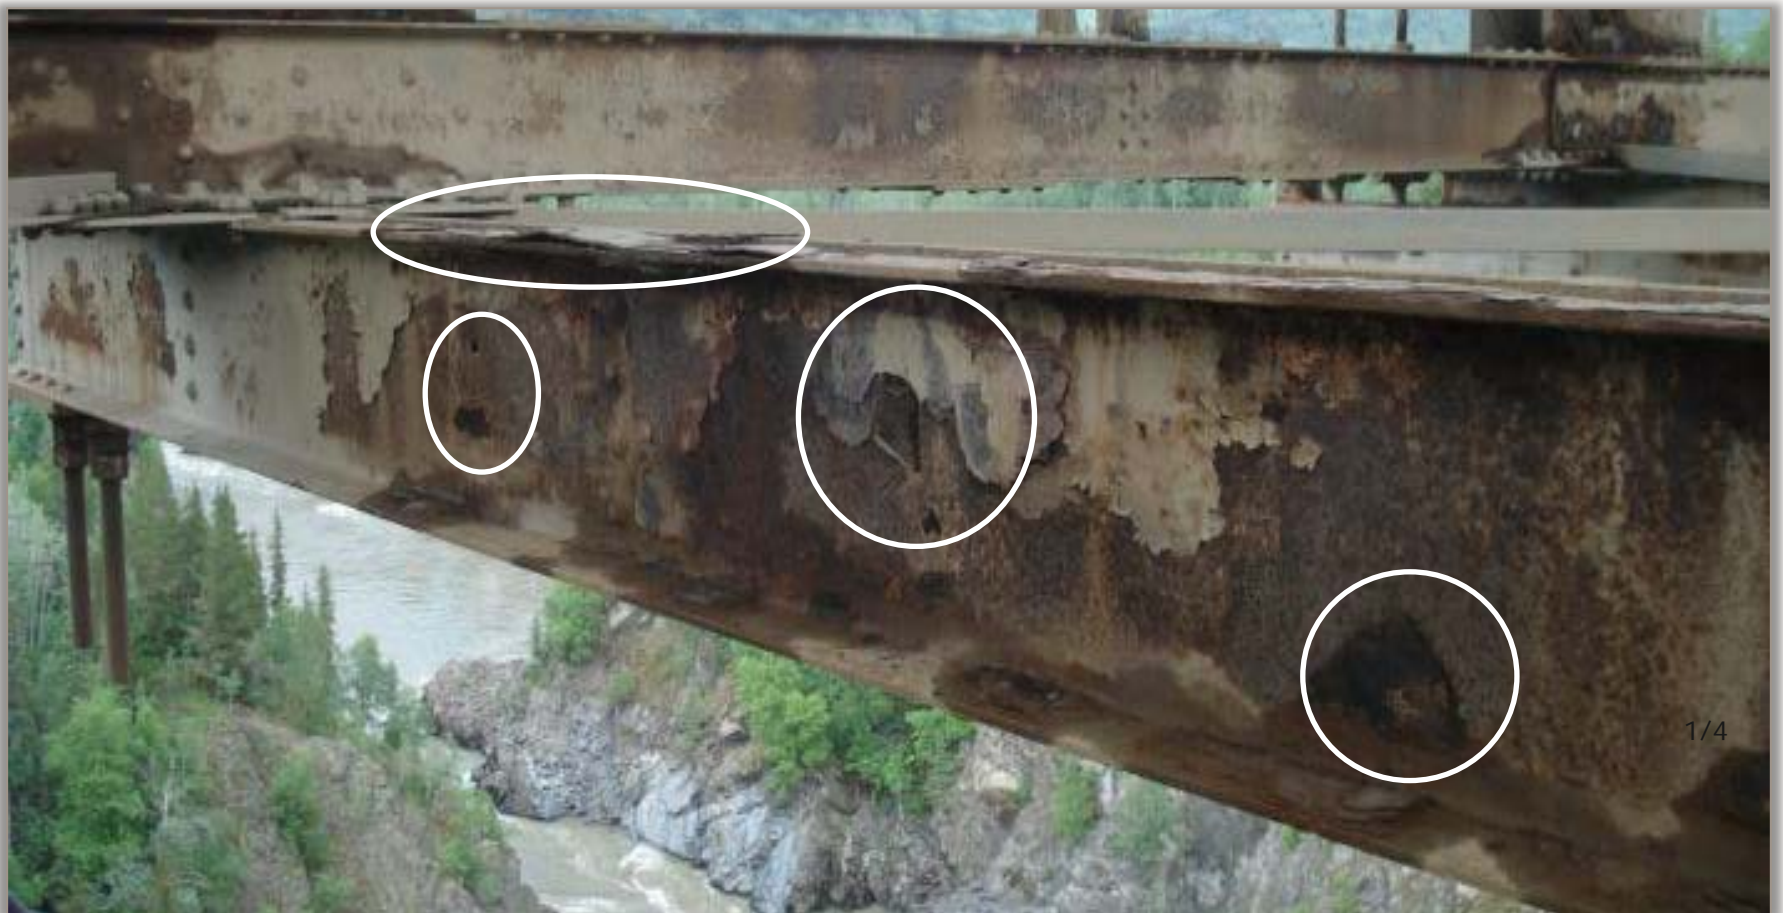
Why Replace the Needle Beams?

- Significant section loss to flanges.
- Significant web section loss with through holes.
- D/C estimated 1.15-1.39 in worst areas.

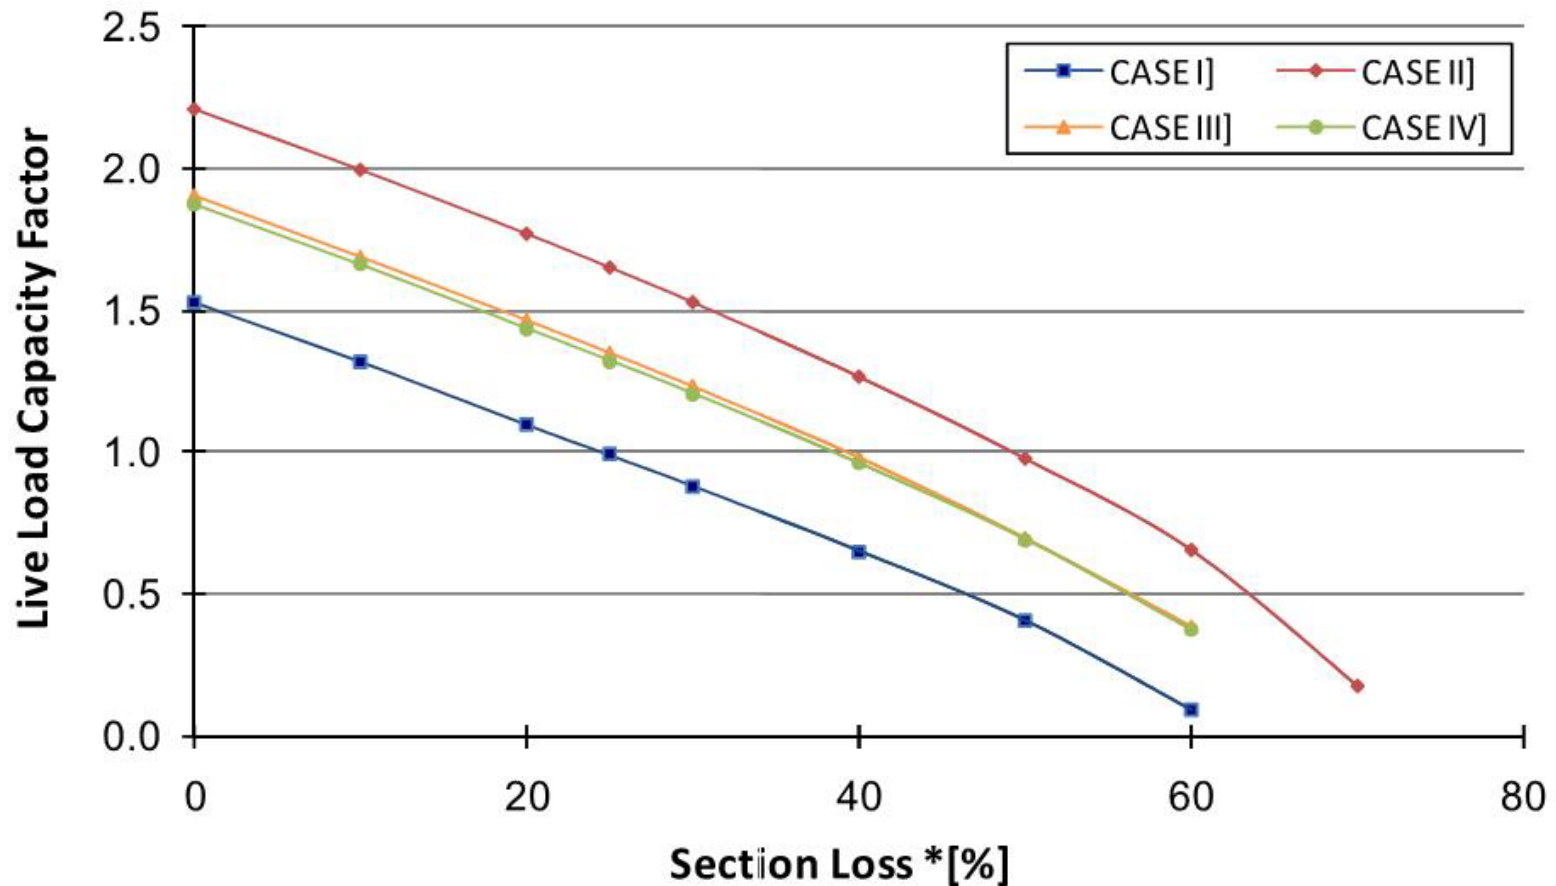
Buckling Analysis

Live Load Capacity Factor vs. Section Loss

* Reduction in thickness of both flanges and web

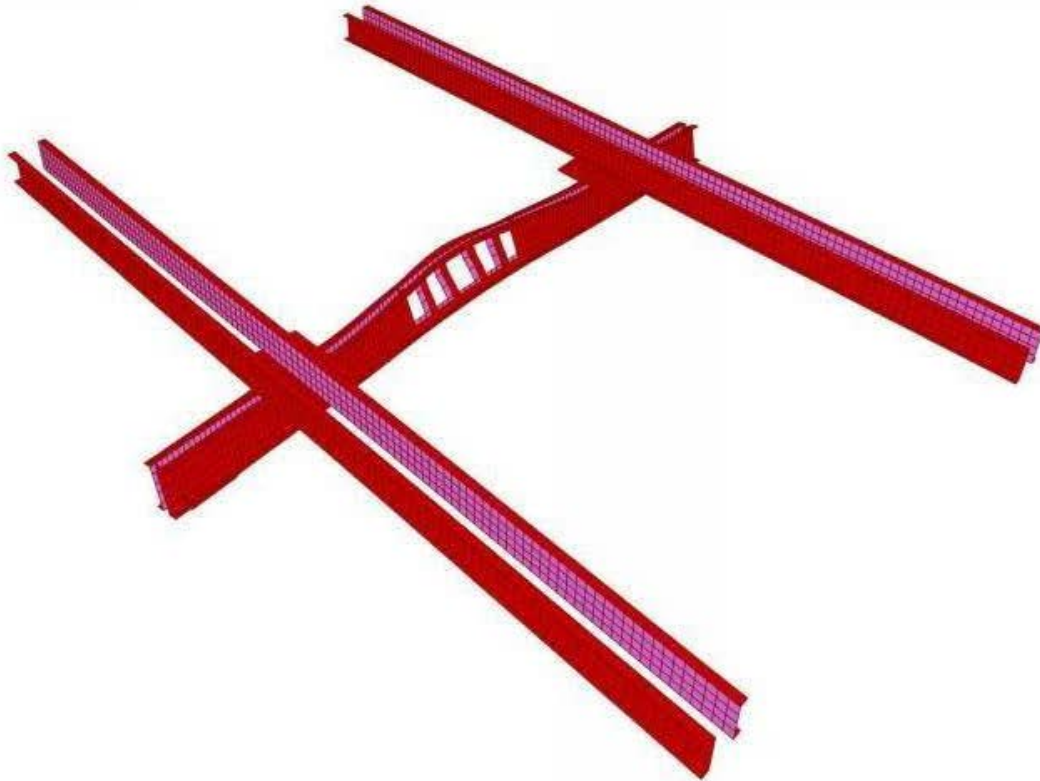
Buckling Analysis

▶ Case III

D/C : 1.15

LLCF : 0.76

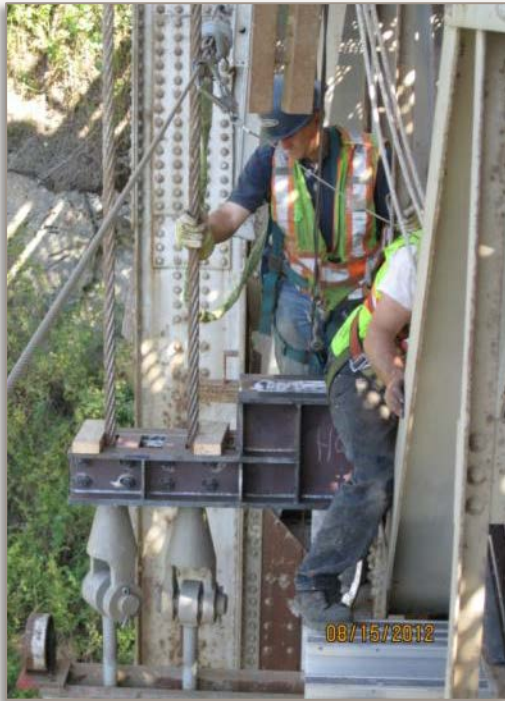
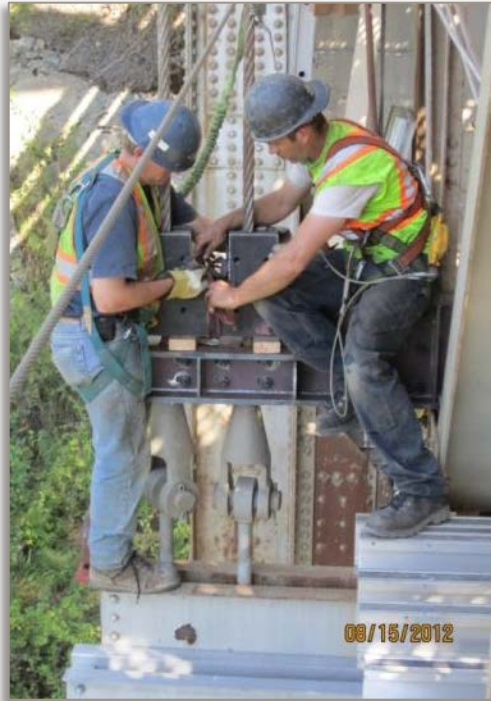
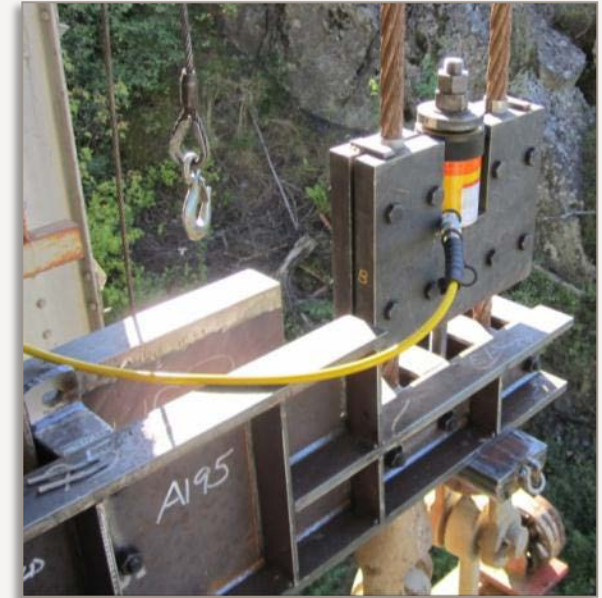
Temporary Works Installation

- $< 30''$ between highest spelter socket top & lowest point of main cable hanger clamp at midspan.
- Temporary Needle Beam limited to 7" at spleters & jack fully inset into hanger clamp.
- Temporary Needle Beam halves spaced to allow spelter tops to come up in between.

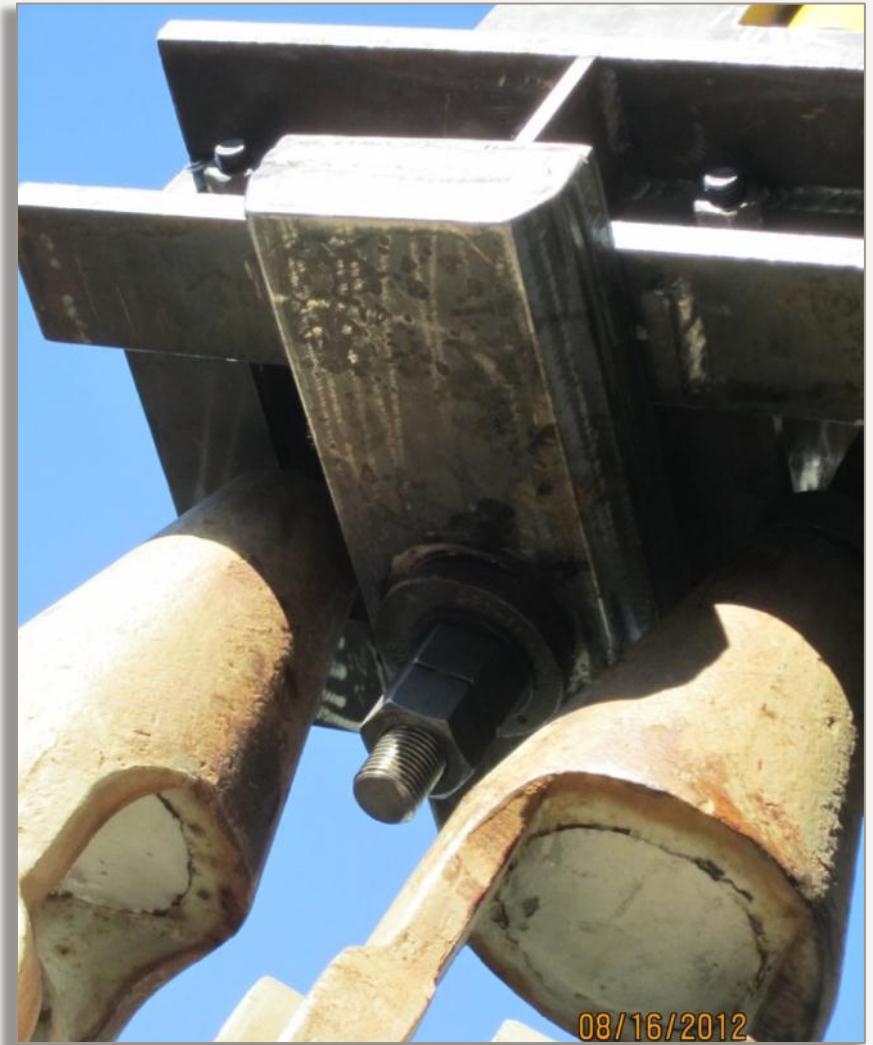
Just Clearing...

- Bearing bar chamfered to clear spelters.
- Spelters up in between the 7" temporary needle beams.
- Varying hanger skew eccentrically positions spelters to centerline of the temporary needle beam.
- Box diaphragms between temporary needle beams visible.

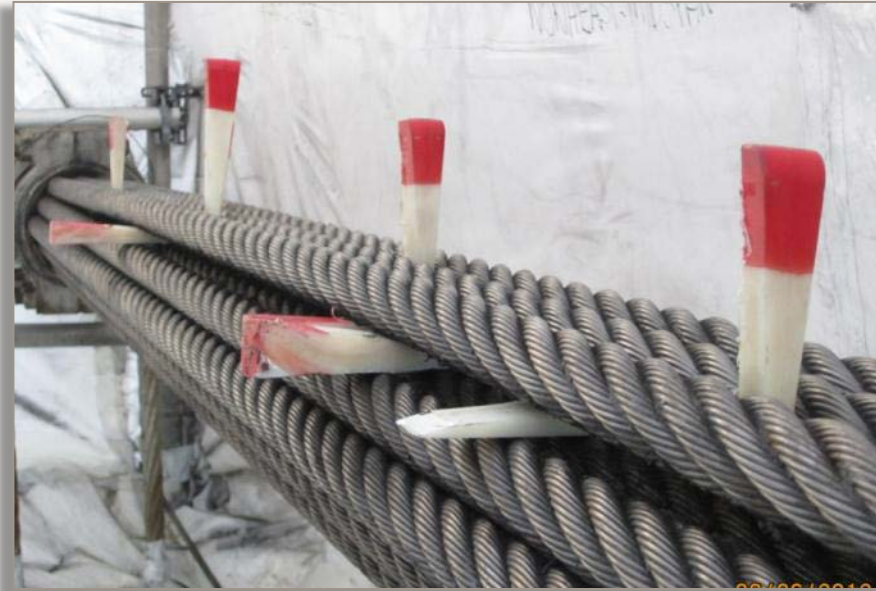
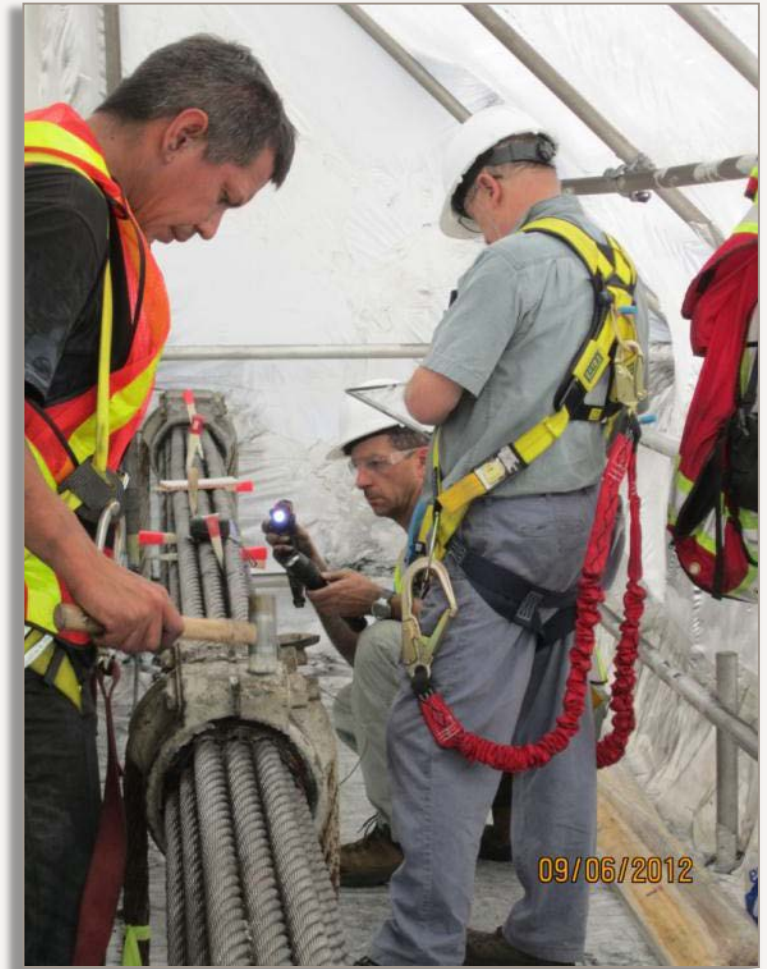
Main Cable Inspection

- Un-galvanized 19 x 1-1/2" wire rope.
- Packed in raw linseed oil & graphite.
- Generally, minimal corrosion & pitting.
- Tower saddles showed most severe loss.

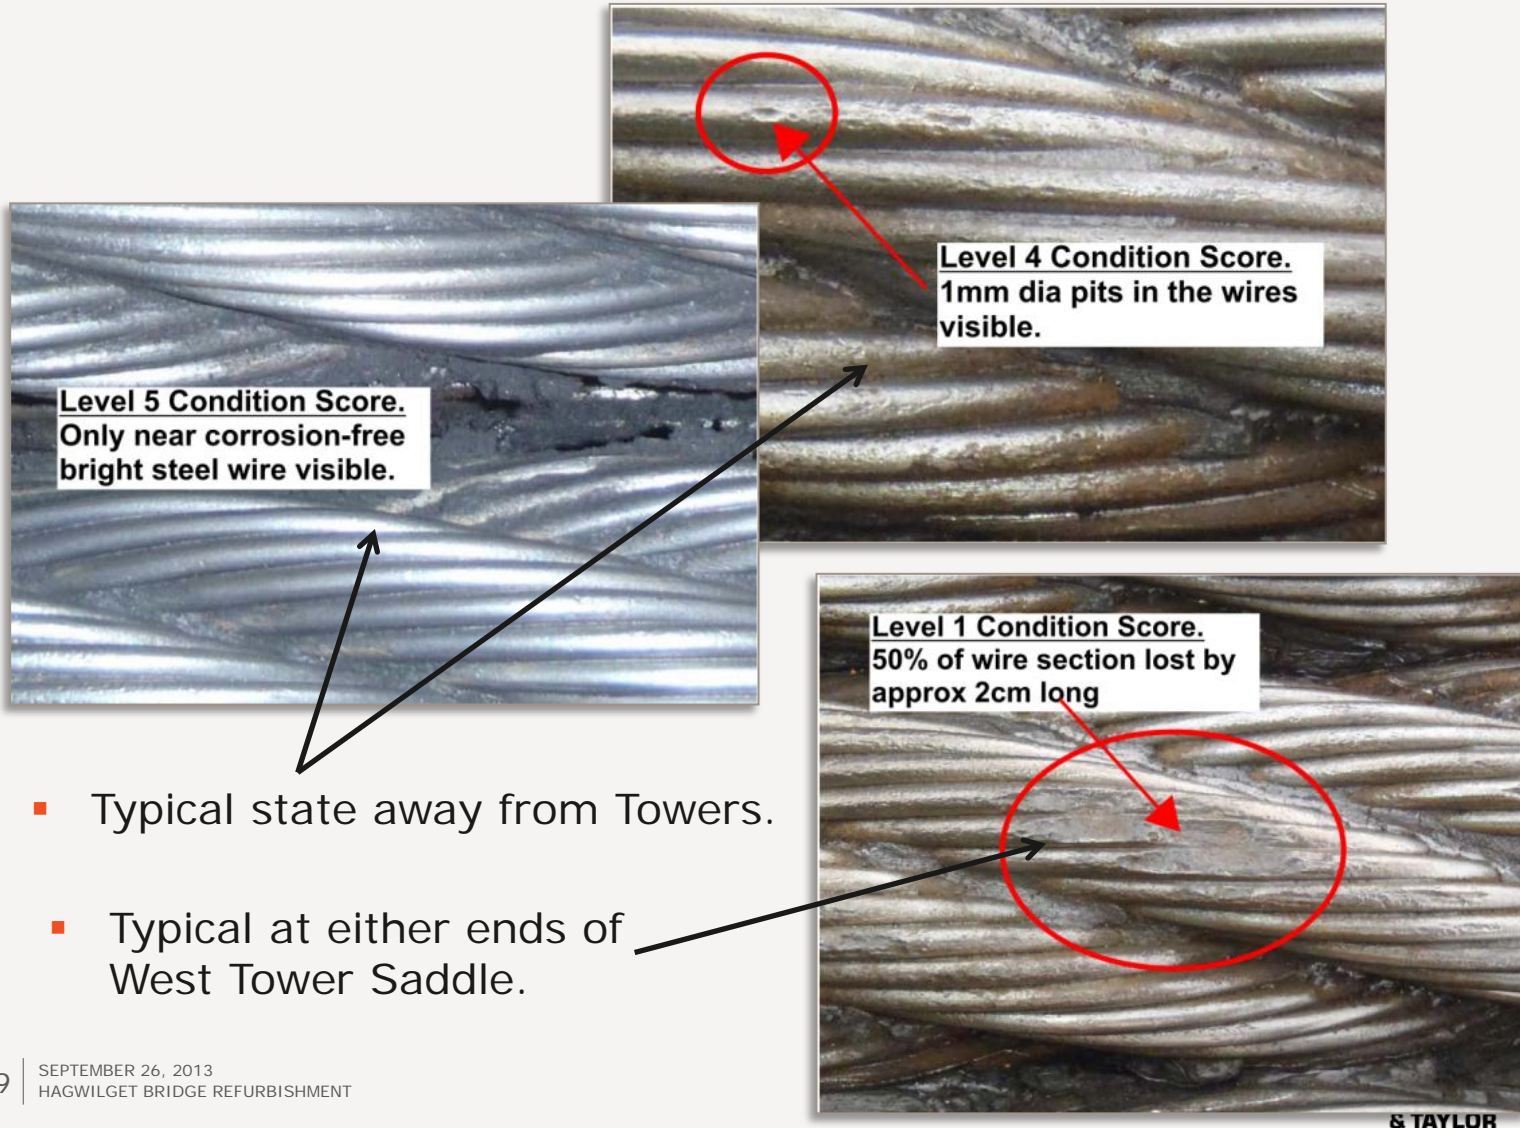
The adjusted D/C for the range of section loss noted during the inspection is 0.51 to 0.65.

- Typical state away from Towers.
- Typical at either ends of West Tower Saddle.
