# Oregon City Arch

## Rehabilitation

Presented by **Jason Kelly, PE &**  
**Eric E. Bonn, PE**

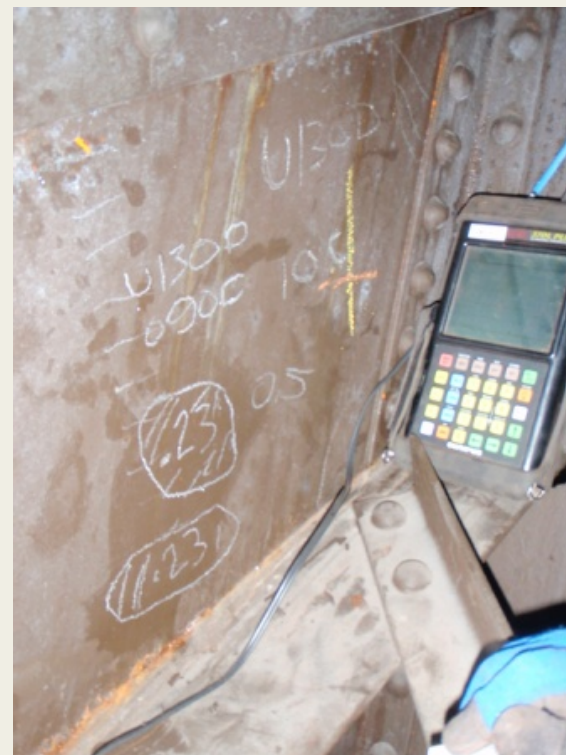
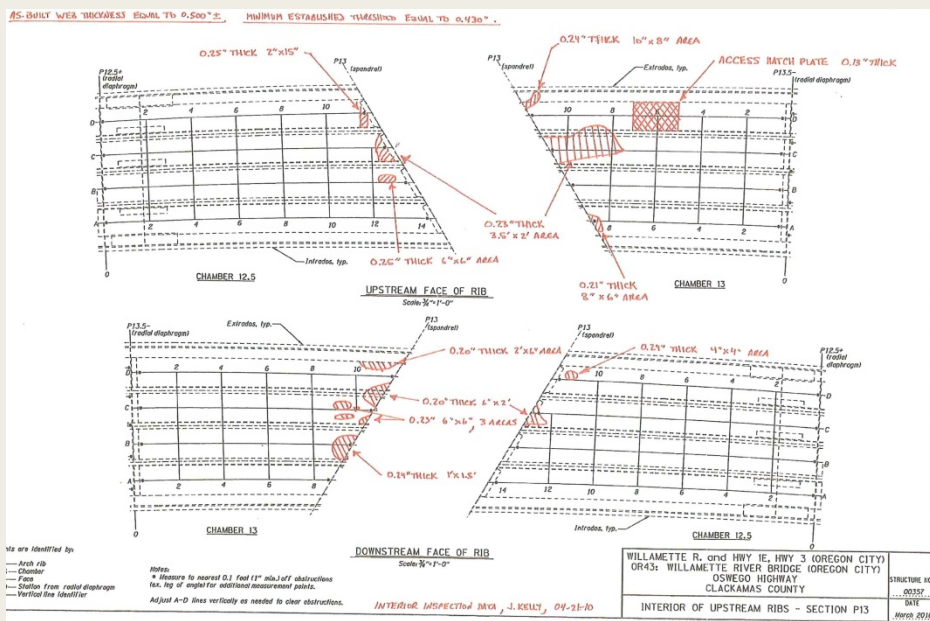
- Arch Ribs in Fair Condition
  - P13 Upstream Webs Poor.
  - Isolated areas on top flanges.

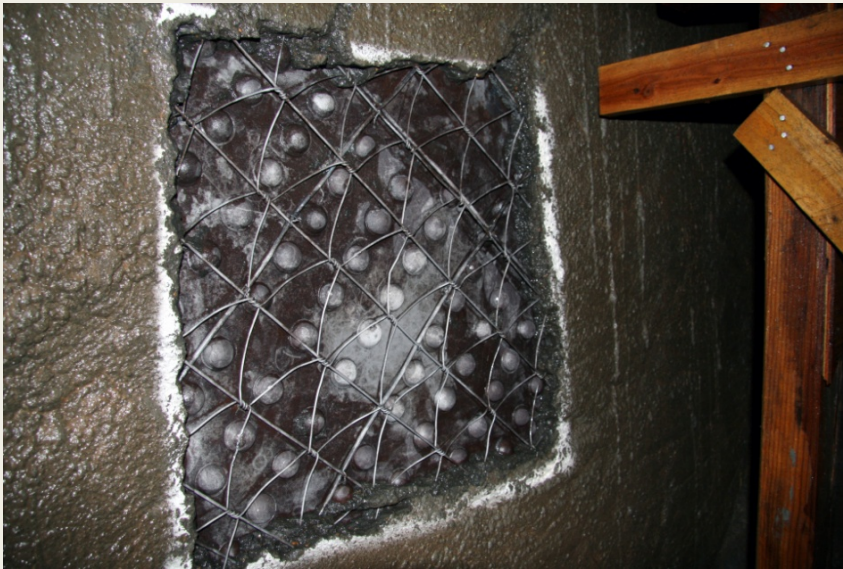
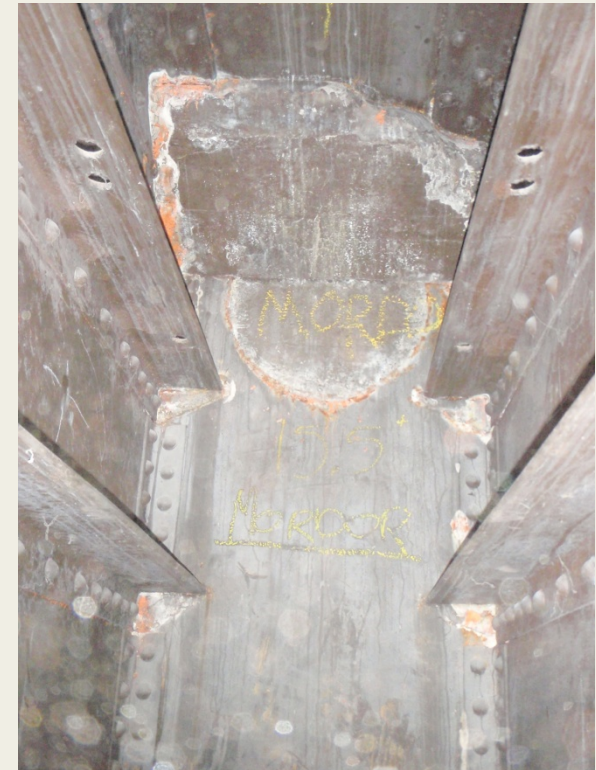
- Plug Connection at Base Good.
- No damage found at Foundation.

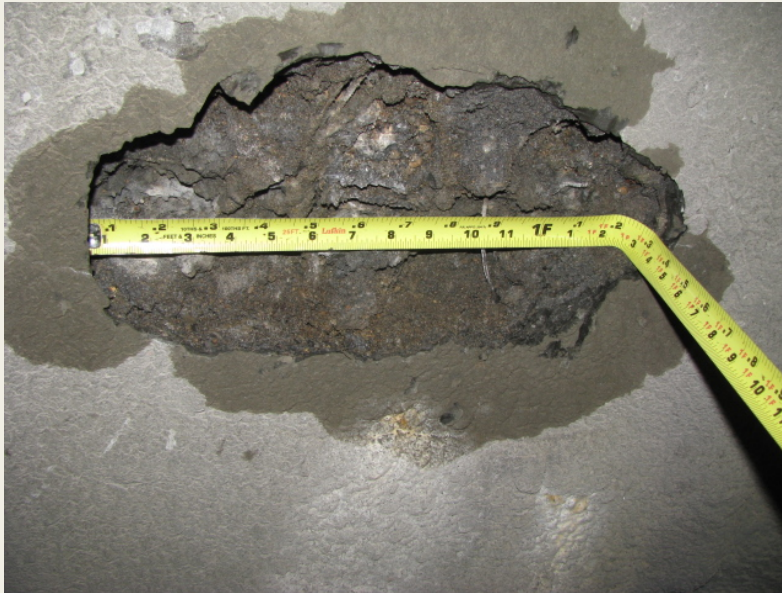
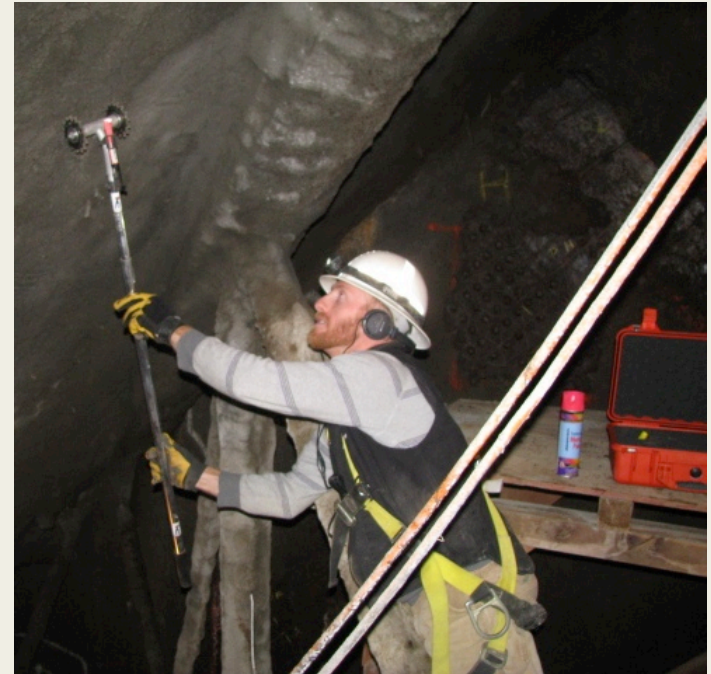
- Delamination Survey
  - Hammer sounding
  - Rotatory percussion for overhead areas

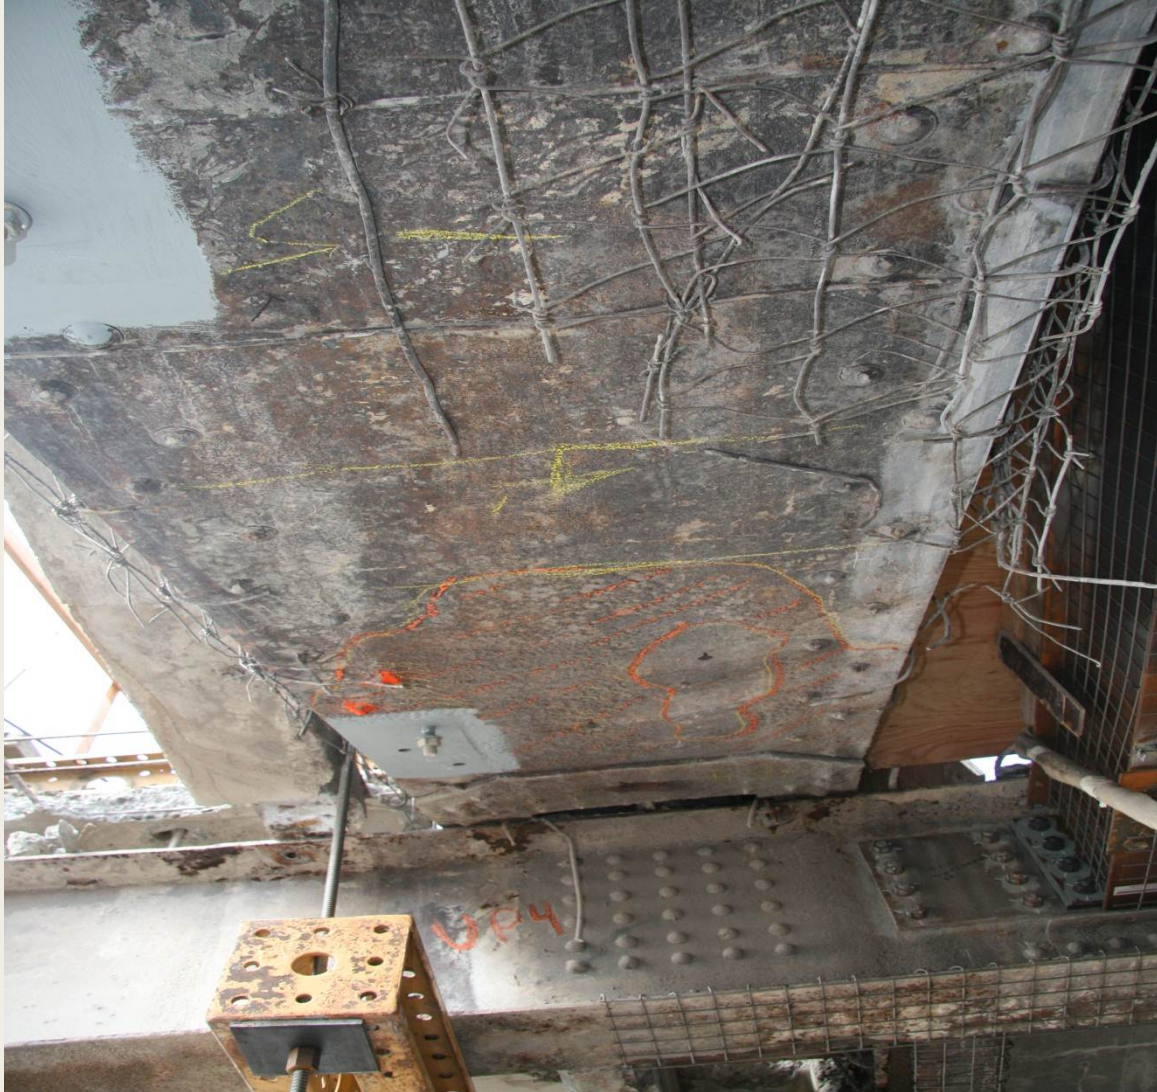
- Bottom Plate Corrosion
  - Criteria
  - Survey Extent
  - Note Interference
  - Design Repair

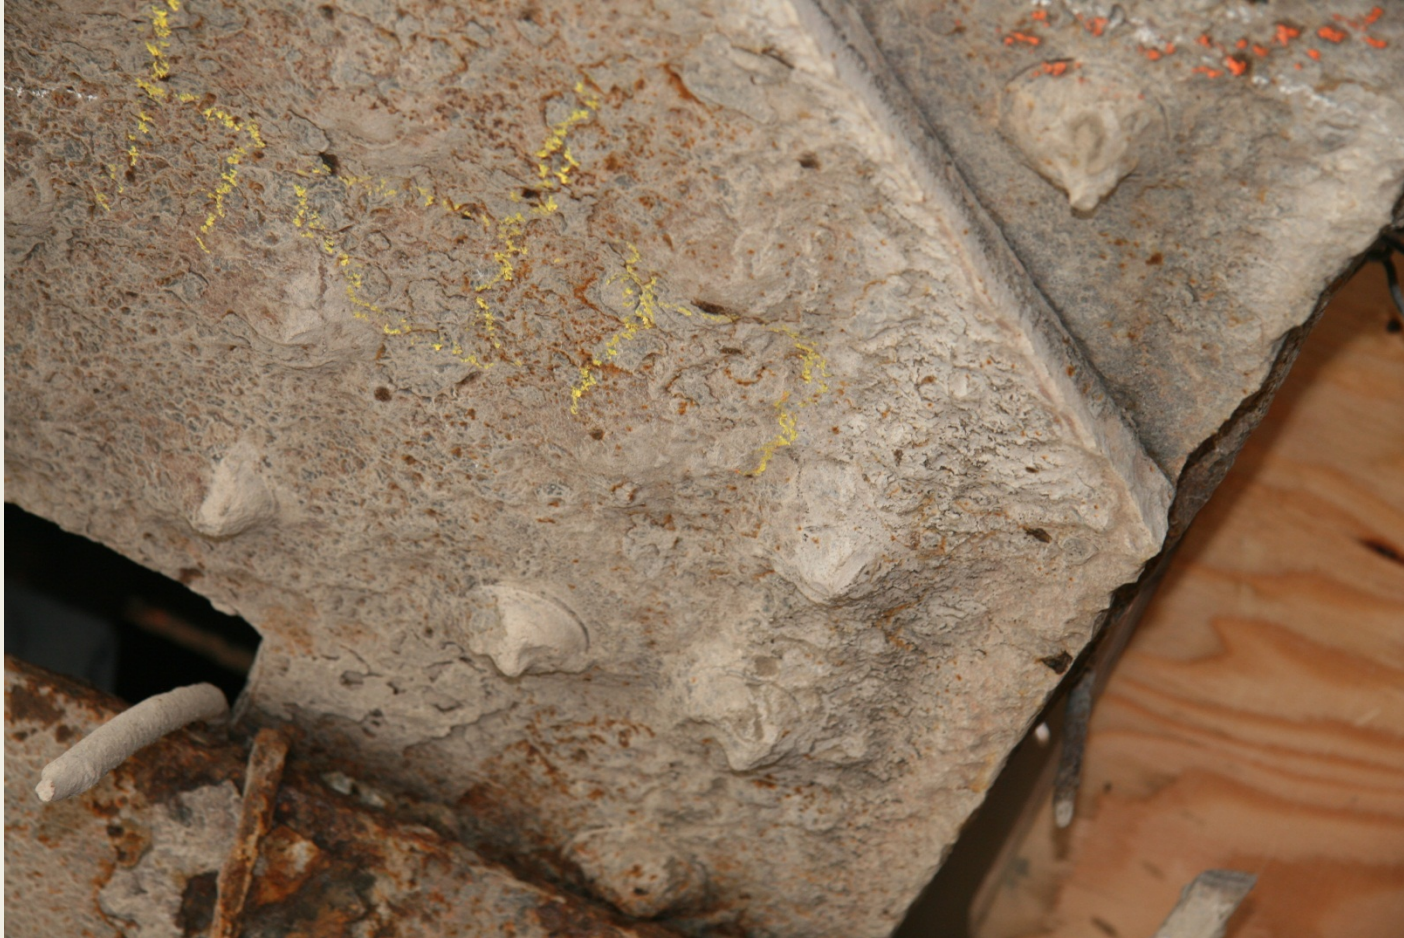
- Typical corrosion damage

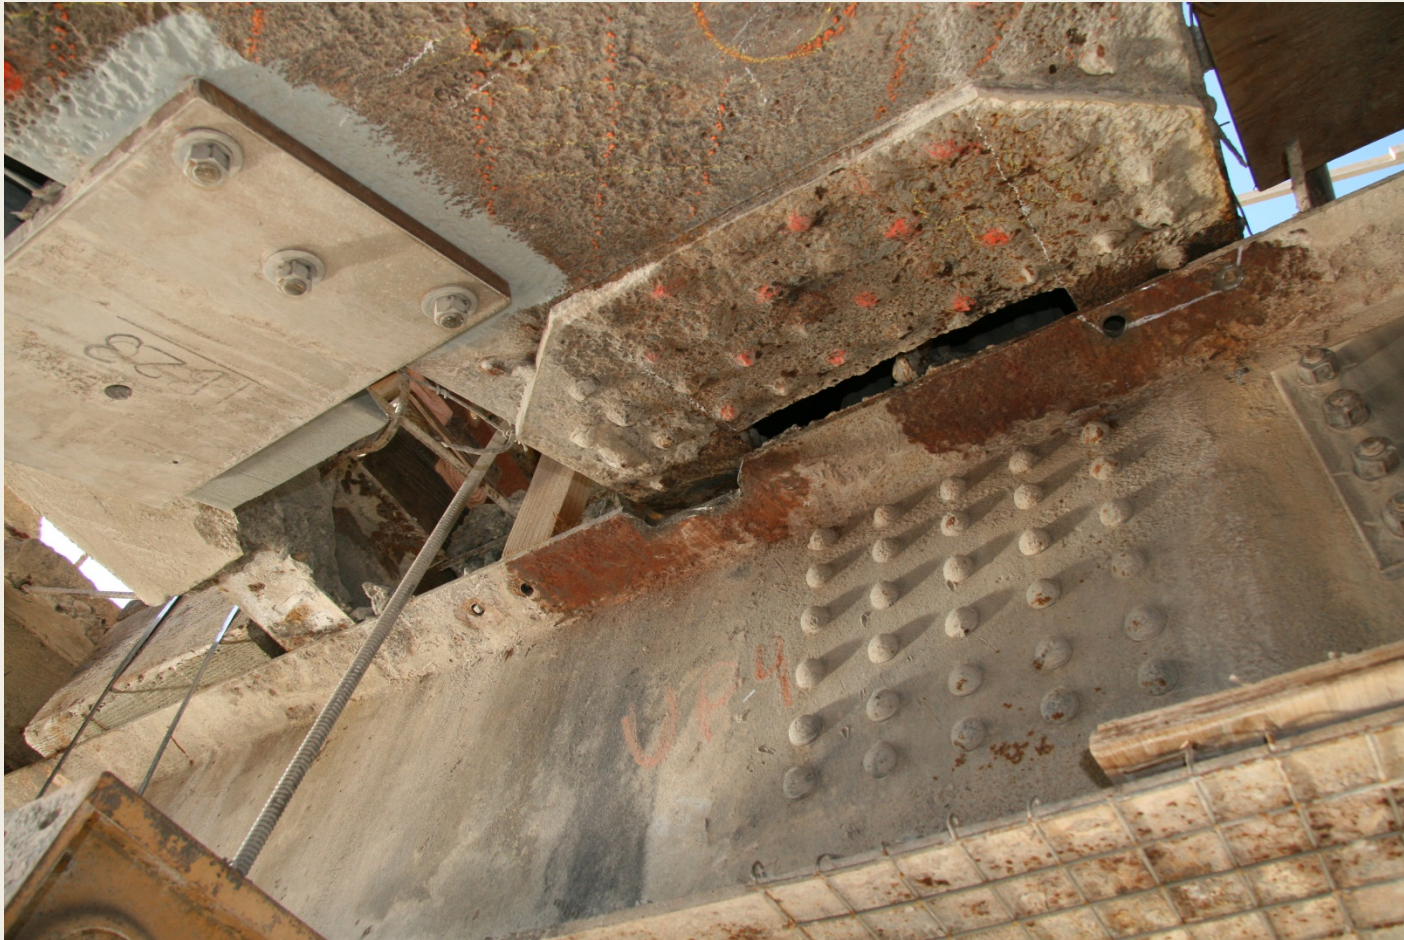
- Interference – Strake Tab, Floorbeam

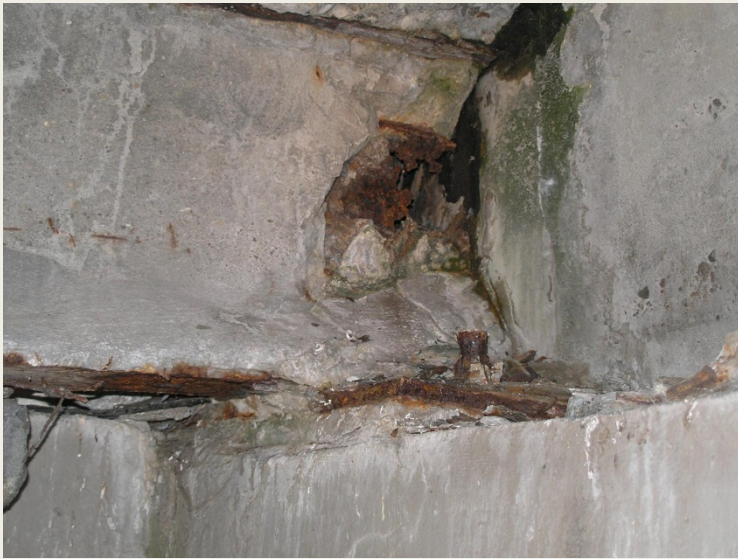
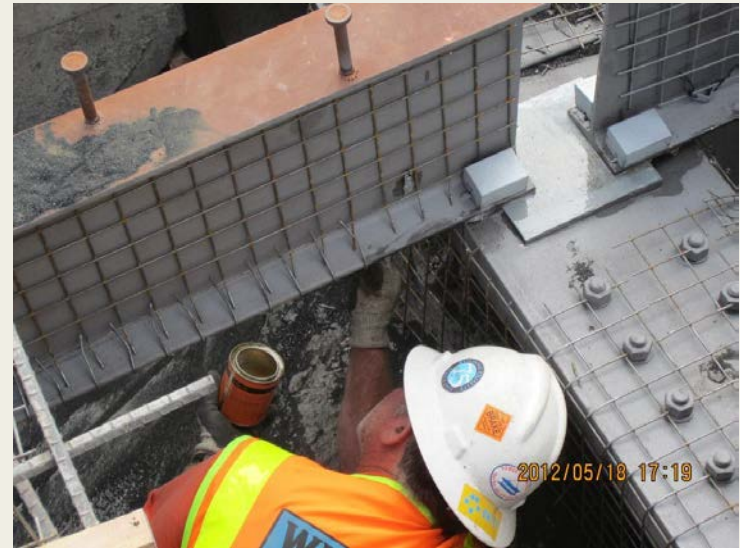
- Existing stringer ends completely corroded at joints, relocated exteriors and repaired others with fish plates.

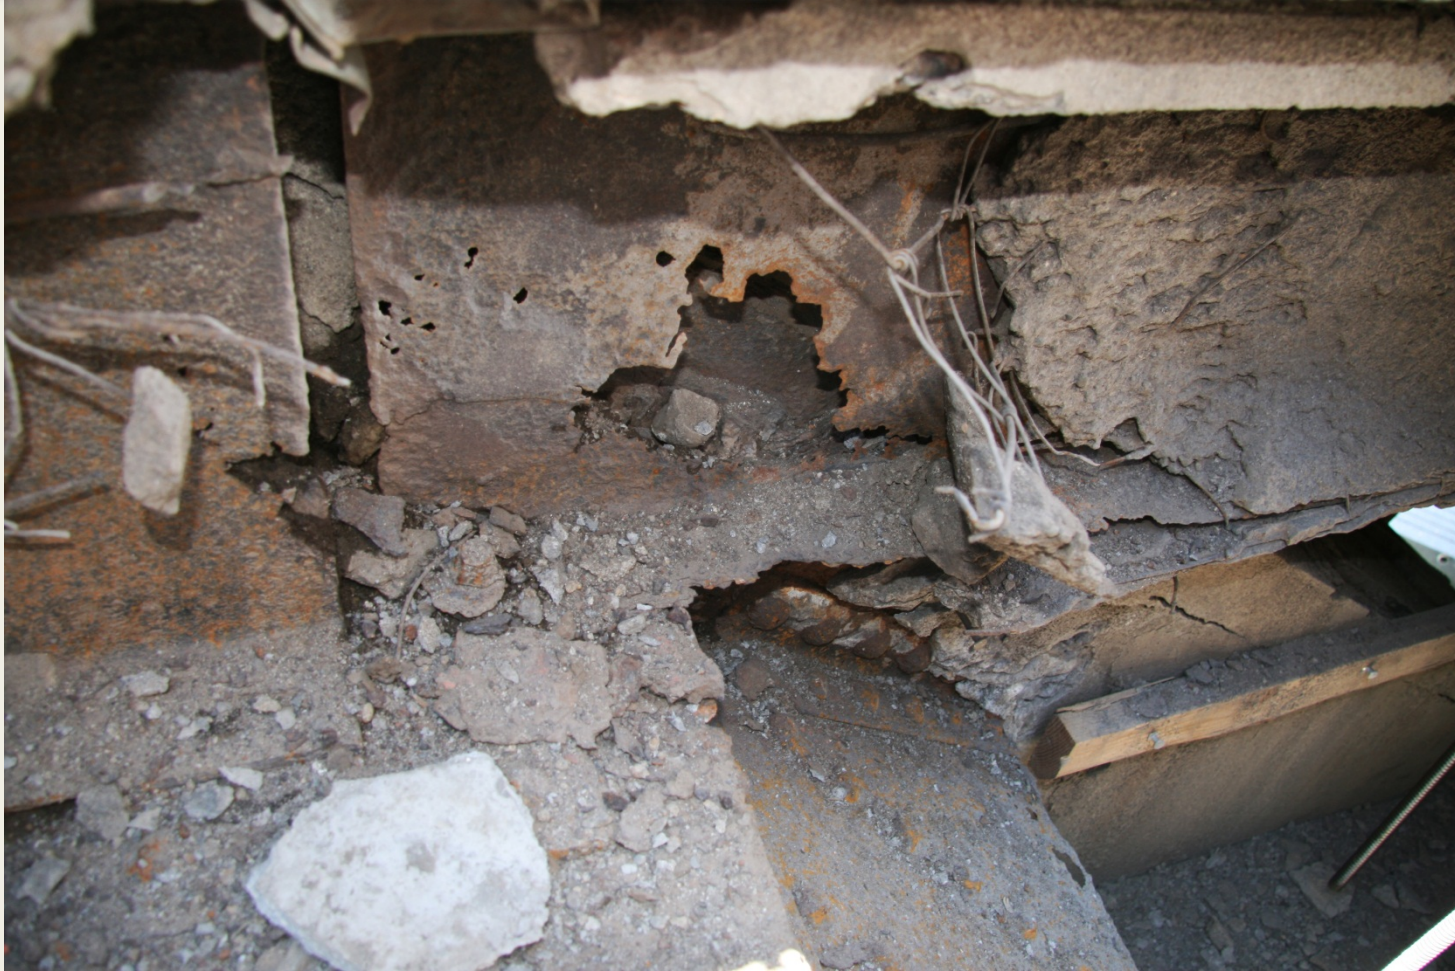
- Existing damage – This stringer replaced

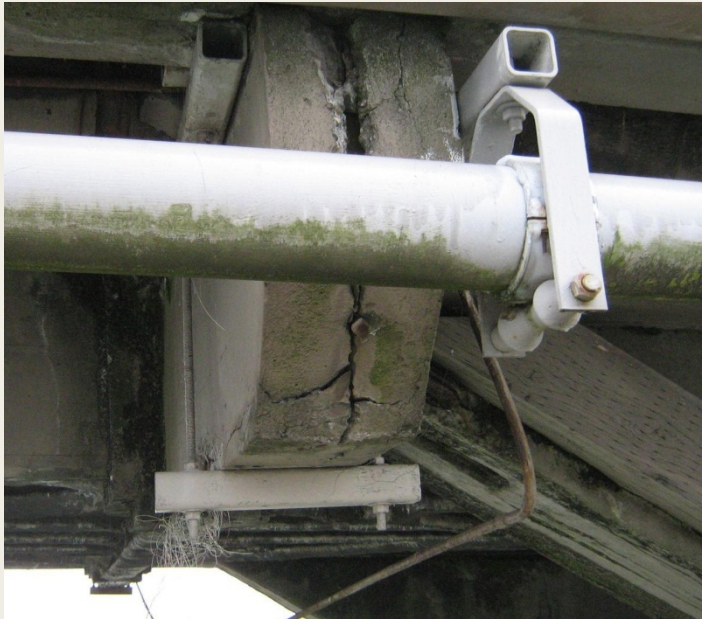
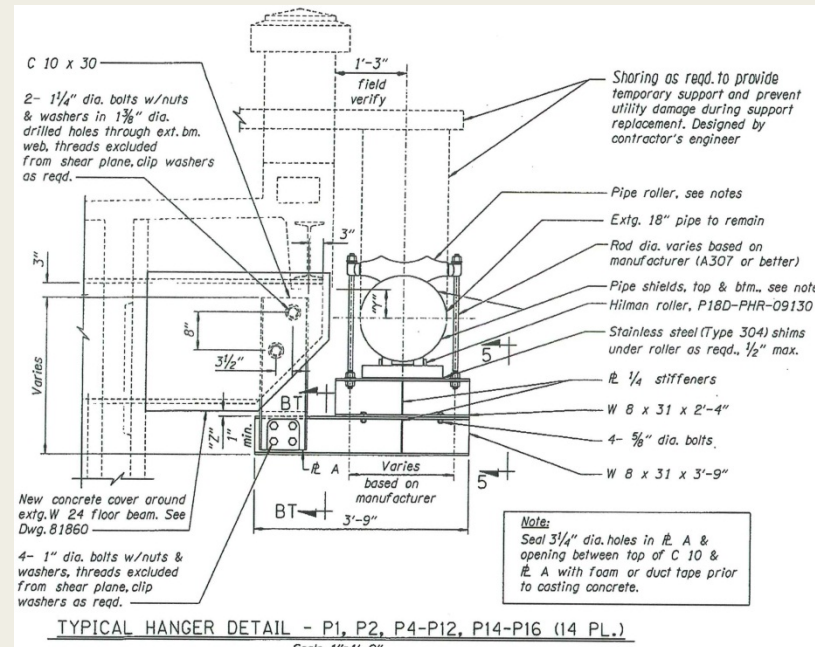
- 18-inch sanitary sewer line
- Maintain operation at all times
- Heavily deteriorated supports

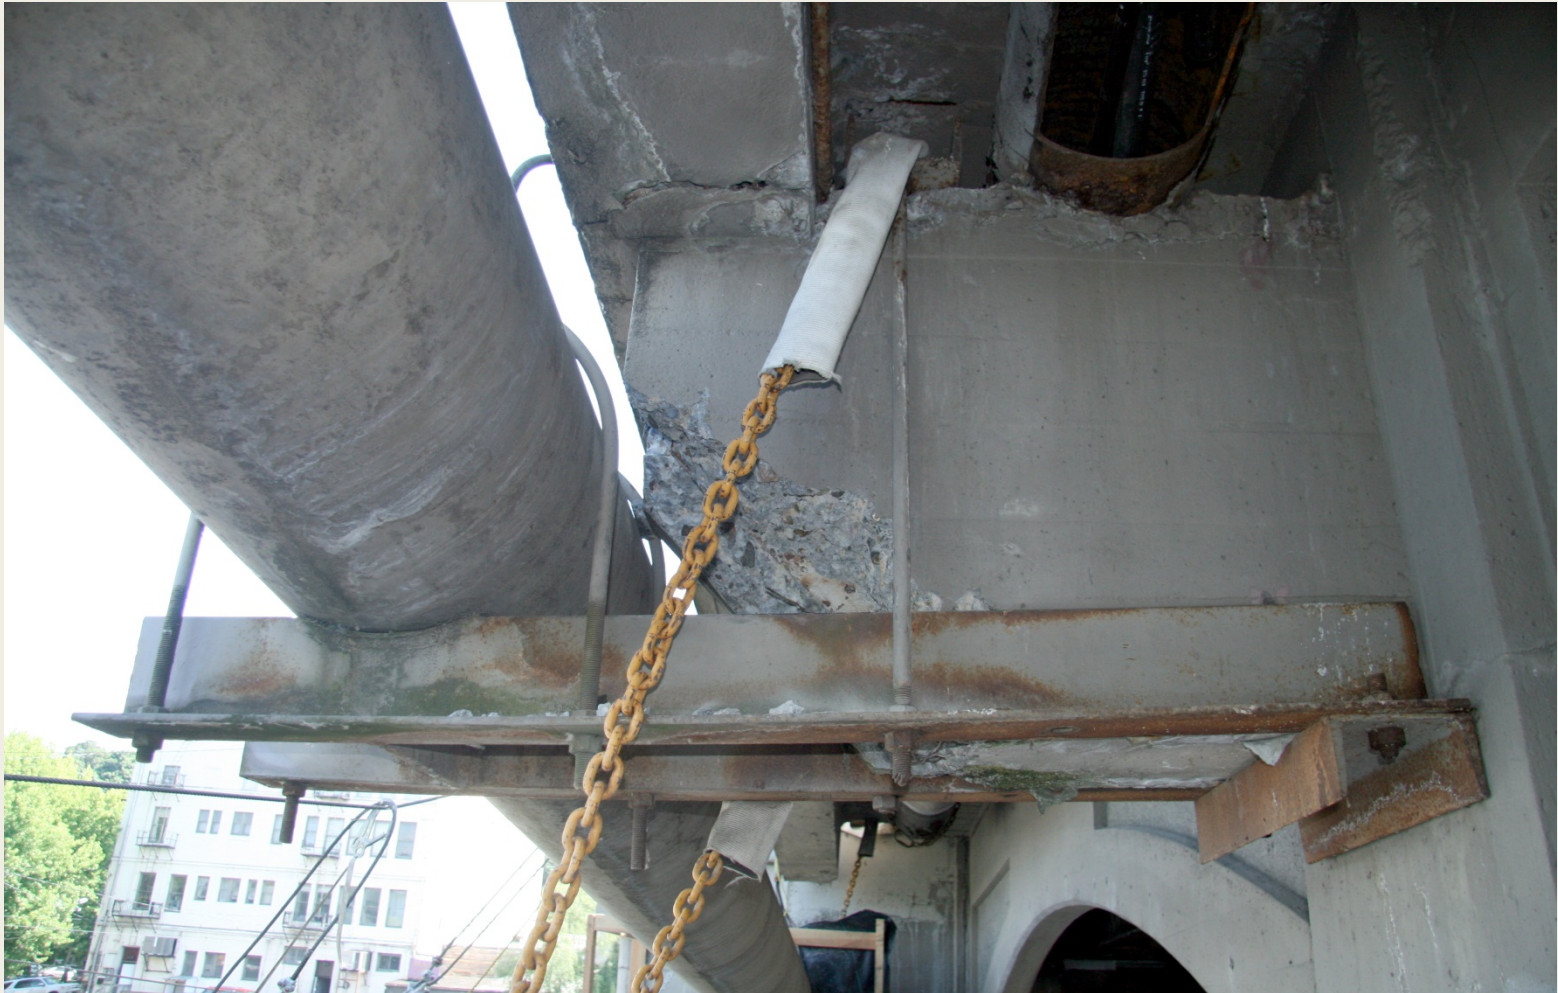
- Existing hangers and concrete damage
