Precast-Prestressed Bridge Girders Damaged by High Load Impacts

Richard Brice, PE

Western Bridge Engineers' Seminar
September 2013

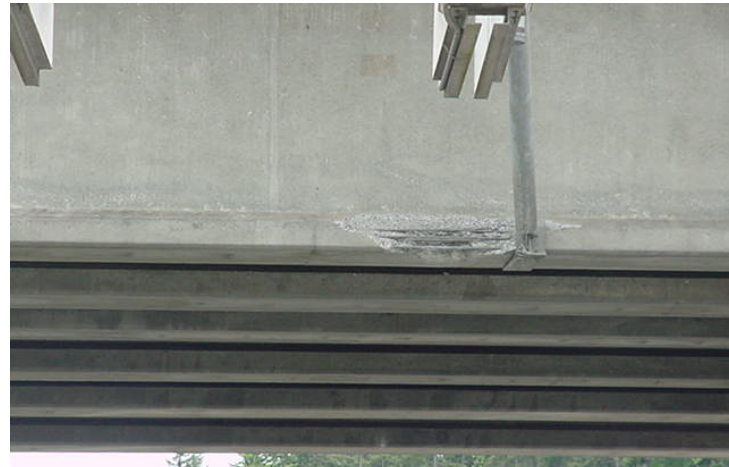
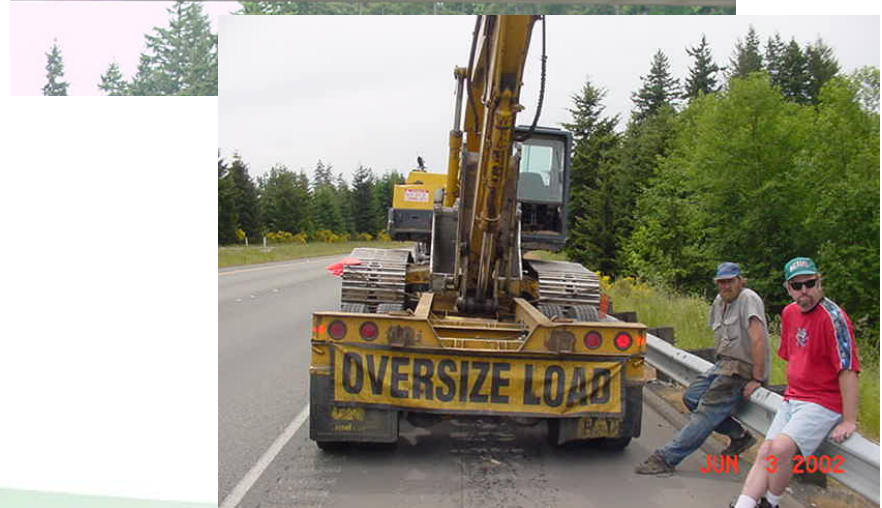
SR 3 – Trigger Avenue Undercrossing

- Hit by excavator on low boy trailer
- Minor damage
- Spall was repaired with concrete patching and repair mortar
- Repaired by WSDOT maintenance personnel

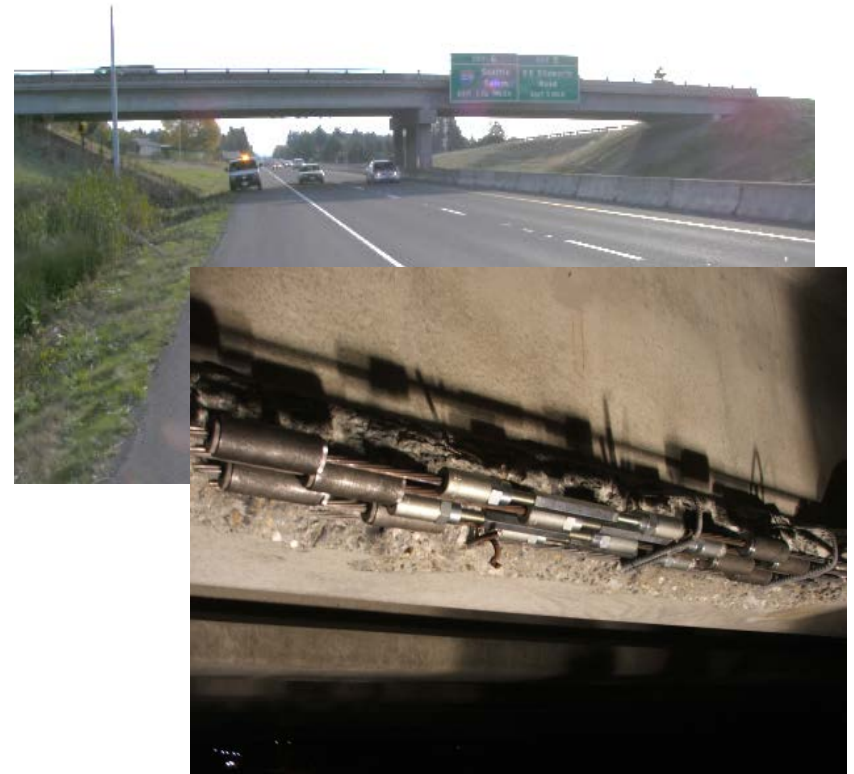
SR 14 – Lieser Road Bridge

- Hit by an excavator on flat bed trailer, 2005
- 7 of 8 girders damaged
- 5 interior girders – minor spalls repaired by WSDOT crews
- 2 exterior girders – severe damage. Girders were removed and replaced under contract
- \$623,000 = \$6,184 per ft of girder
- Hit again 2008 – one girder moderately damaged, 4 severed strands, repaired by WSDOT

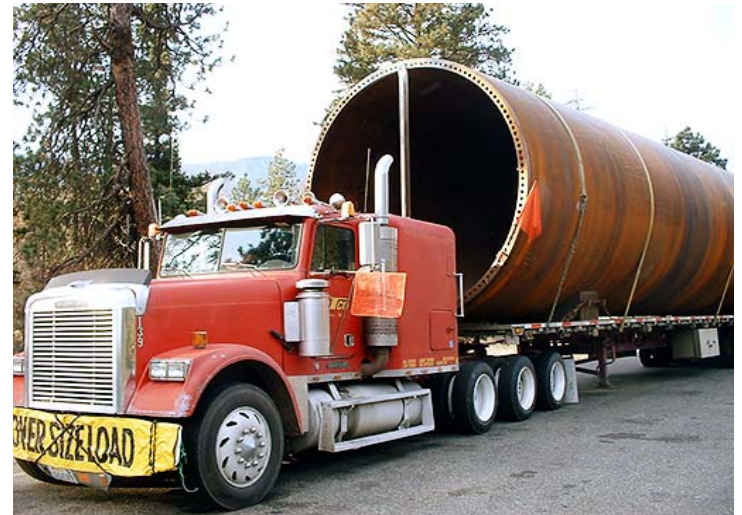
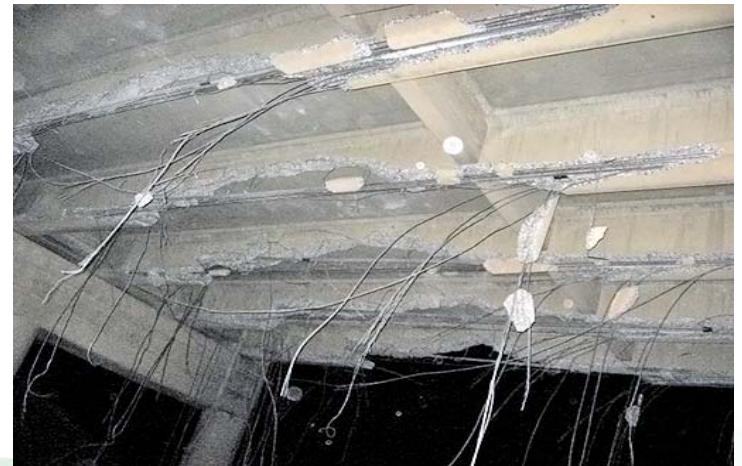
I-90 – Easton Road Bridge

- Hit by wind turbine support column
- All 6 girders damaged beyond repair
- 45 day repair challenge by Secretary of Transportation
- Accelerated Bridge Construction (ABC)
- Non-standard configuration of pre-decked bulb-tee girders
- Located in mountain pass (late fall)
- Repaired under contract
- \$703,000 = \$2,379 per ft of girder

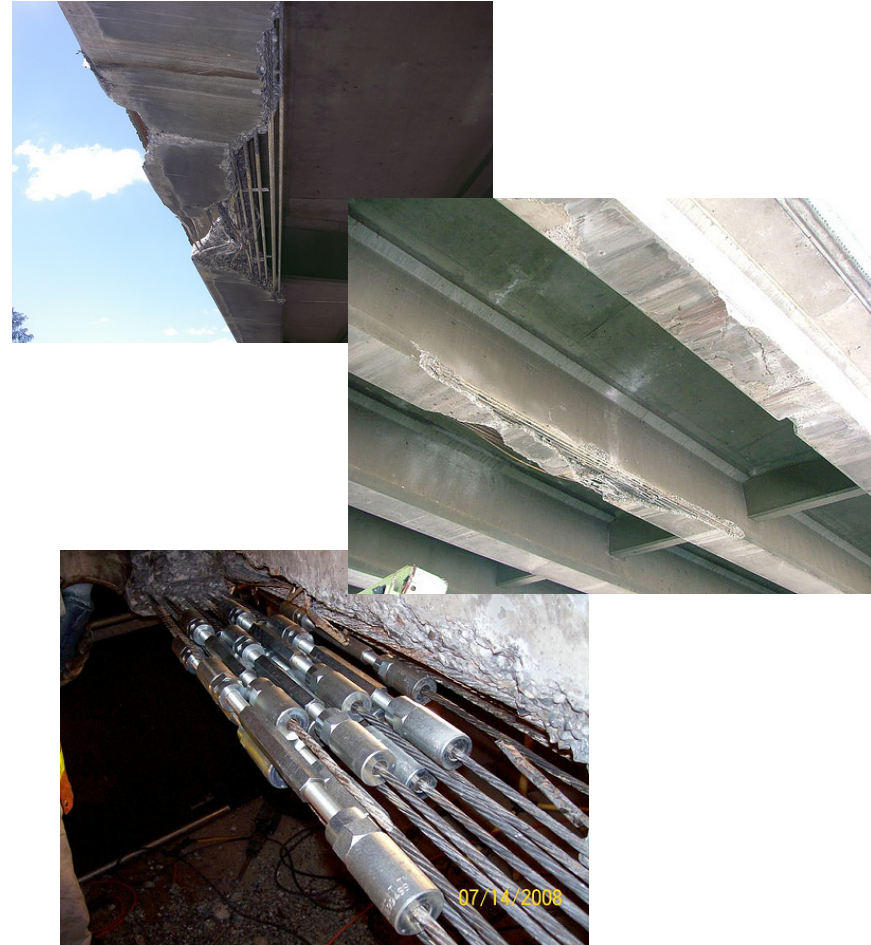
I-5 – Chuckanut Drive Overcrossing

- Hit by excavator (17 ft load, 15'-5" clearance)
- Exterior girders on both sides where damaged.
- All but one interior girder were not hit
- Several strands were severed
- WSDOT crews made temporary repairs by splicing strands
- Final repair was total span replacement
- \$723,000 = \$2,939 per ft of girder

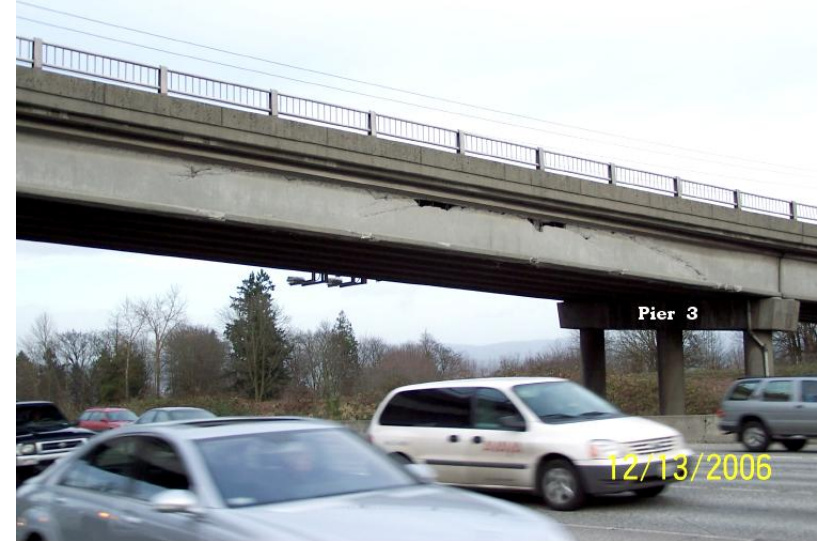
I-5 – South 178th Street Bridge

- Hit by high load transformer
- Vehicle traveling on ascending grade beneath structure
- Impacted last exterior girder
- Extensive damage to web
- Several strands were severed
- Remove and replace girder, deck, and railing
- \$895,000 = \$8,861 per ft of girder

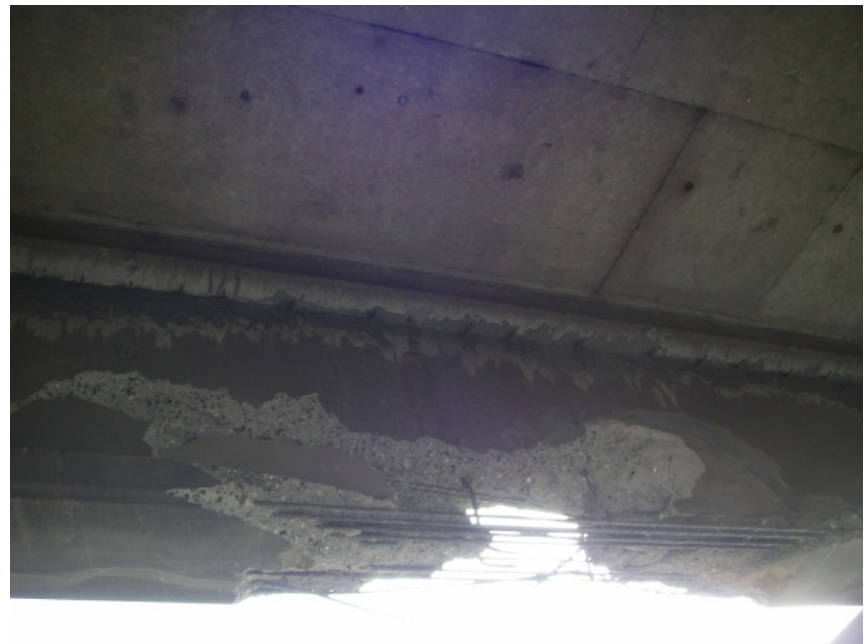
I-5 – 113th Avenue Bridge

- Hit by fork lift on flat bed trailer
- Single girder damaged because mast was torn from fork lift
- Exposed and severed strands
- X-Section – 4 girders at 8ft
- Closed bridge due to lack of redundancy and high volume of heavy truck traffic (nearby quarry)
- Replaced girder, deck and barrier
- \$488,519 = \$8,246 per ft of girder

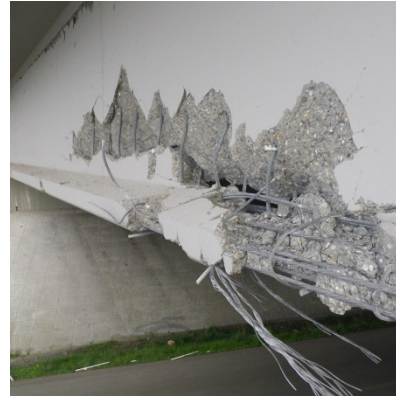
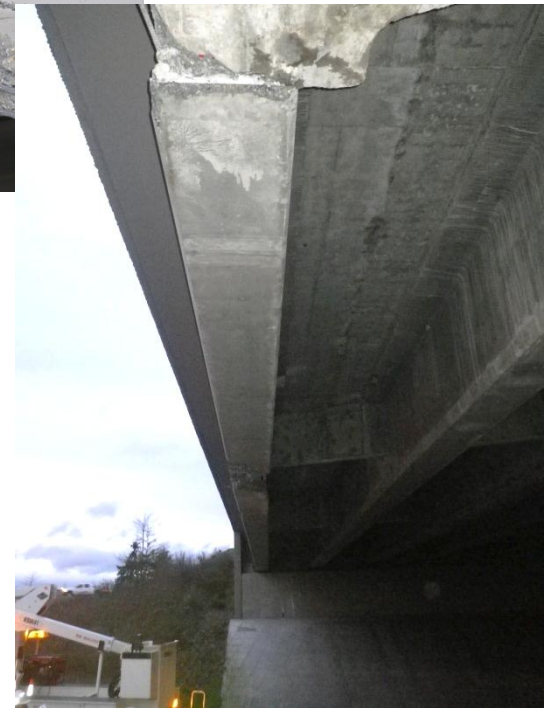
SR16 – Olympic Road Bridge

- Hit by fork lift on lowboy trailer
- Mast impacted last girder, pulling it away from bridge
- Pried girder away from diaphragms
- 3” permanent lateral displacement of bottom flange
- 1½” separation between bottom flange and pier
- \$851,318 = \$8,643 per ft of girder

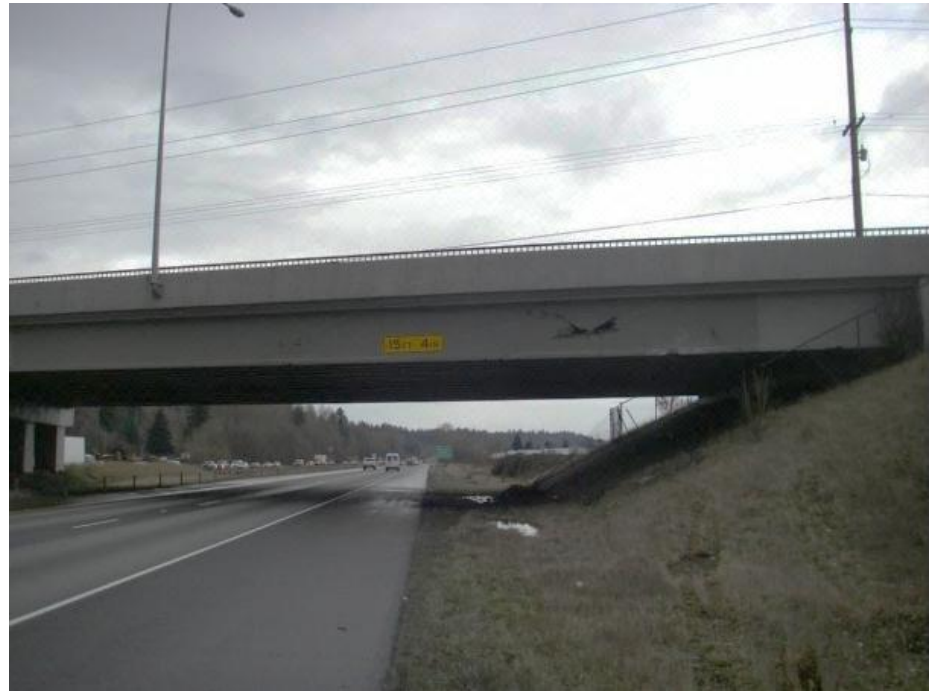
SR167 – 24th Street Bridge

- Side impact by errant tanker truck
- Bottom flange permanently displaced 3¼”
- Bottom flange spalled at abutment – loss of bearing
- 6 strands exposed and untensioned
- Broken and bent stirrups
- \$1,113,791 = \$8,328 per ft of girder

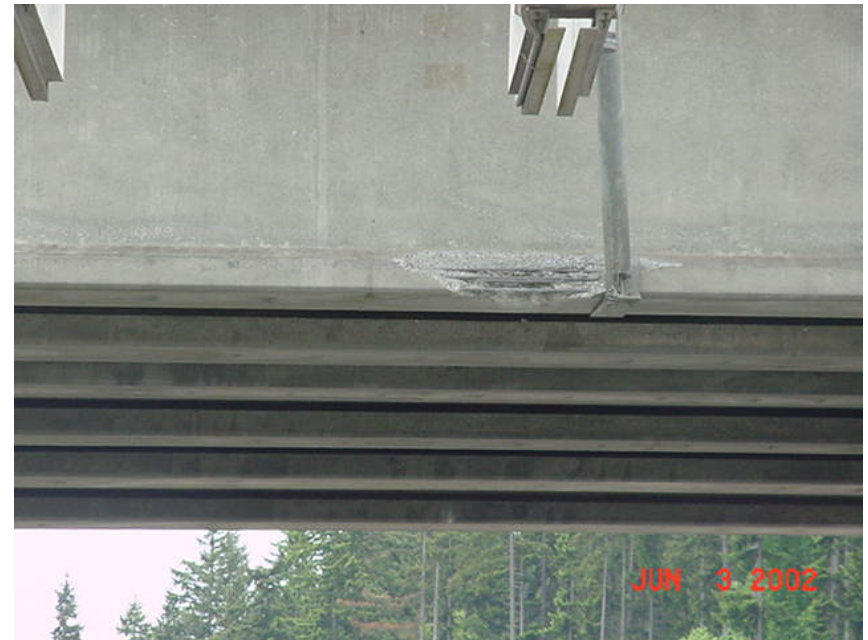
Minor Damage

- Characteristics
 - Damage is slight and limited to small areas of spalling on the outside surface of the concrete
- Repair
 - Damaged area shall be first thoroughly cleaned of any loose material and dried
 - Patch damaged area with epoxy-based repair product

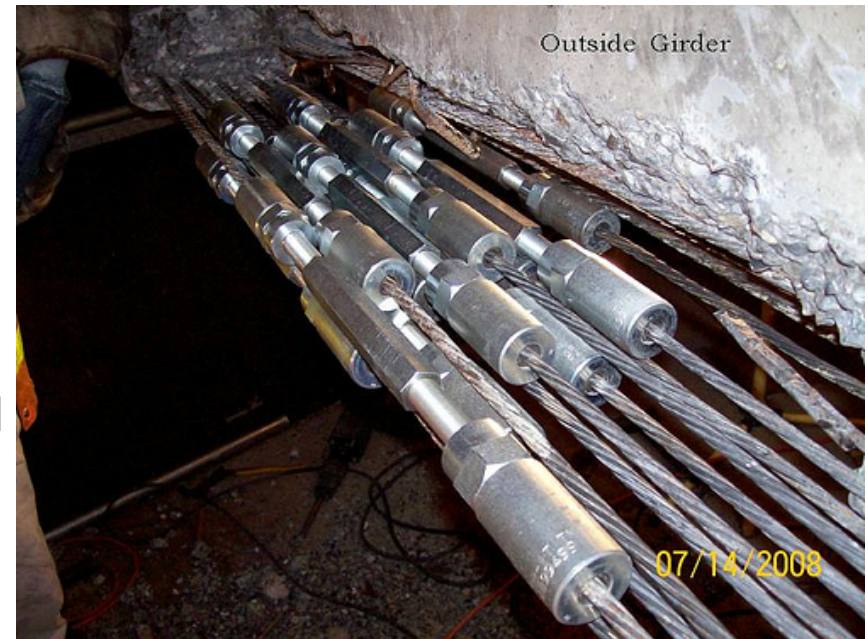
Moderate Damage

- Characteristics
 - Substantial section loss
 - Severed strands
- Repair
 - Clean and prepare girder for repair
 - Splice strands
 - Apply pre-load sufficient to restore prestressing to original levels
 - Repair section with concrete grout
 - Remove pre-load to restore pre-compression to concrete

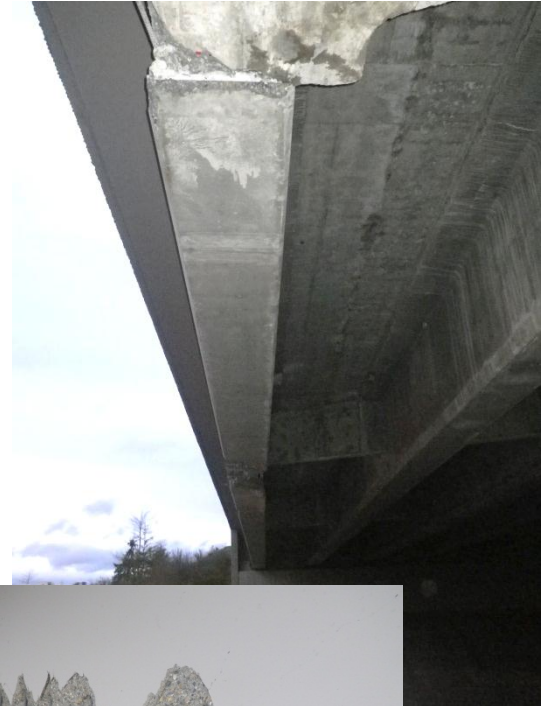
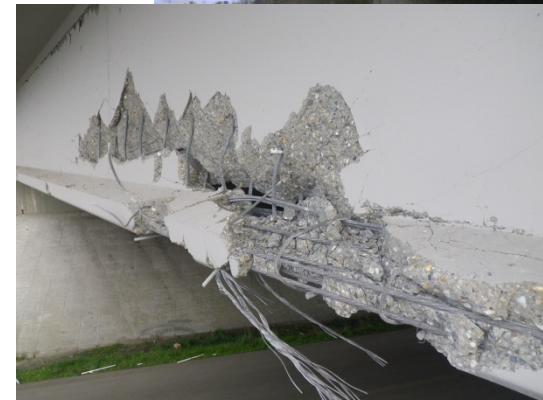
Severe Damage

- Characteristics
 - Extreme cracking
 - Considerable loss of prestressing
 - Excessive permanent lateral deformation
 - Loss of structural integrity
 - Yielding of stirrups
 - Separation between girder/deck or girder/pier interface
- Repair
 - Carefully removing deck, diaphragms and railing system to permit removal of girder
 - Preserve adequate reinforcement for splicing and development
 - Replace girder, deck, diaphragms, and railing
