Presentation to:
2013 Western Bridge Engineers' Seminar
Bellevue, Washington
September 5th, 2013

Speakers:
Nicholas Cioffredi, PE
Frank Block, PE

DIEFENBAKER BRIDGE, PRINCE ALBERT, SK FRACTURE INVESTIGATION & REPAIR

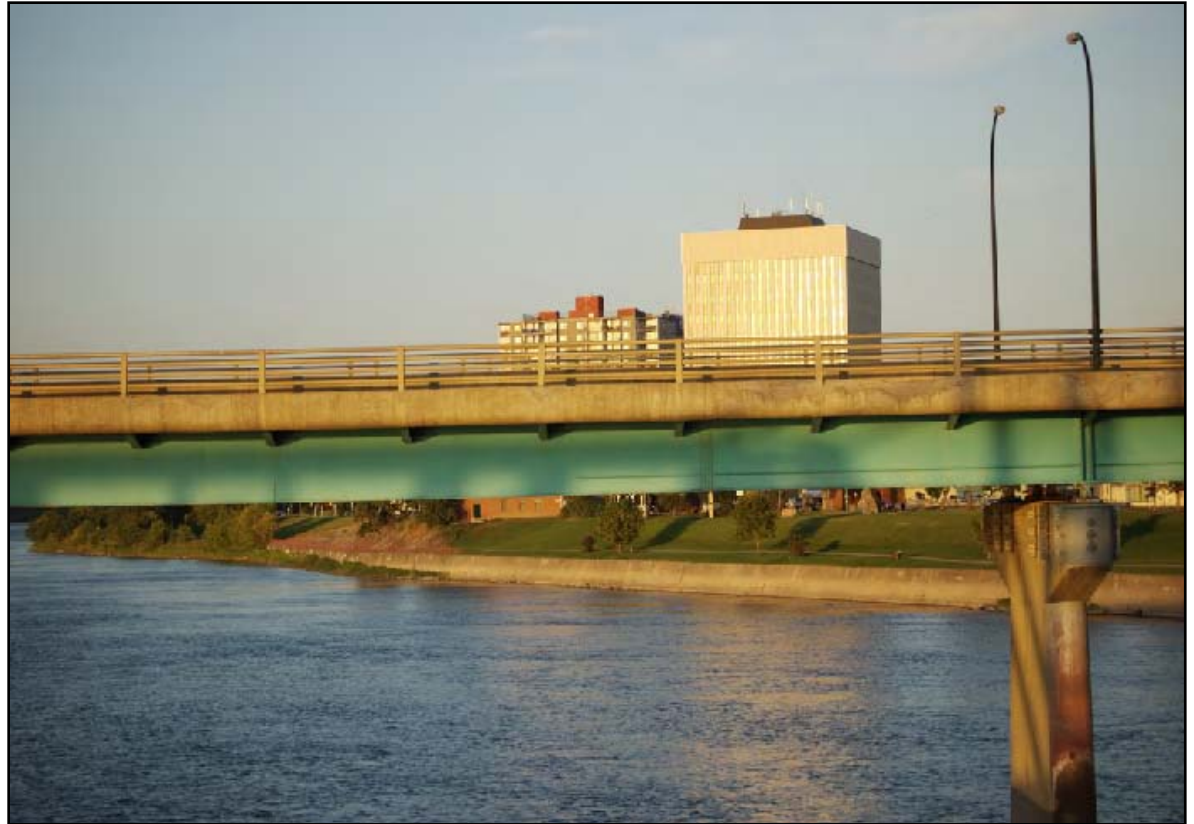
Canoeist Observation

- August 29th, 2011
- What would you think if you looked up and saw this?
 - Notify Police!

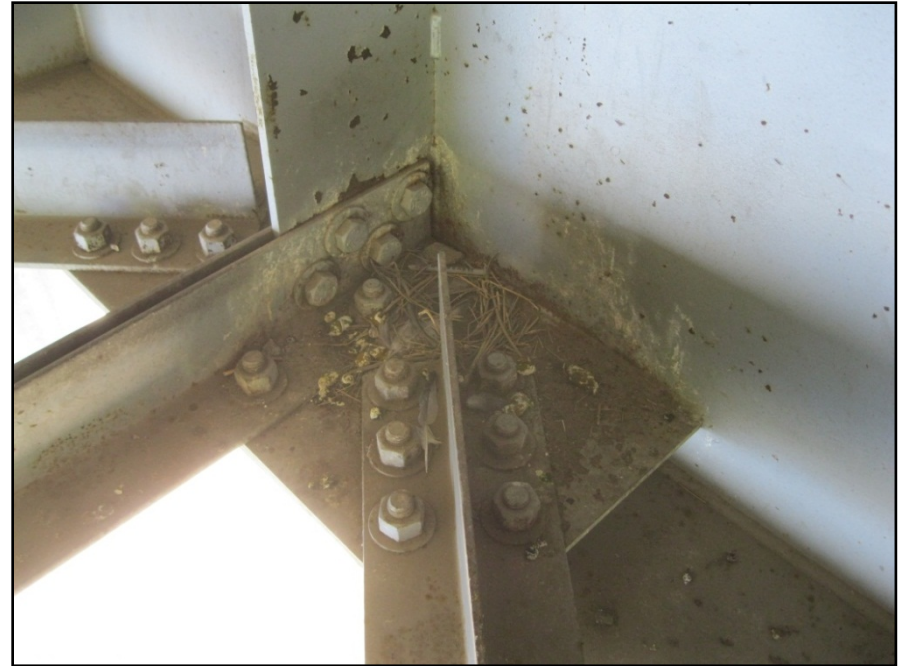
- Diefenbaker Bridge
 - Overwhelming Similarities
- Fracture at Gusset Plate
- Gussets Connected via Vertical Stiffener
- Gusset-to-Web, Top Fillet Only
- Vertical Stiffener Stitch Welded Above, Cont. Below GP

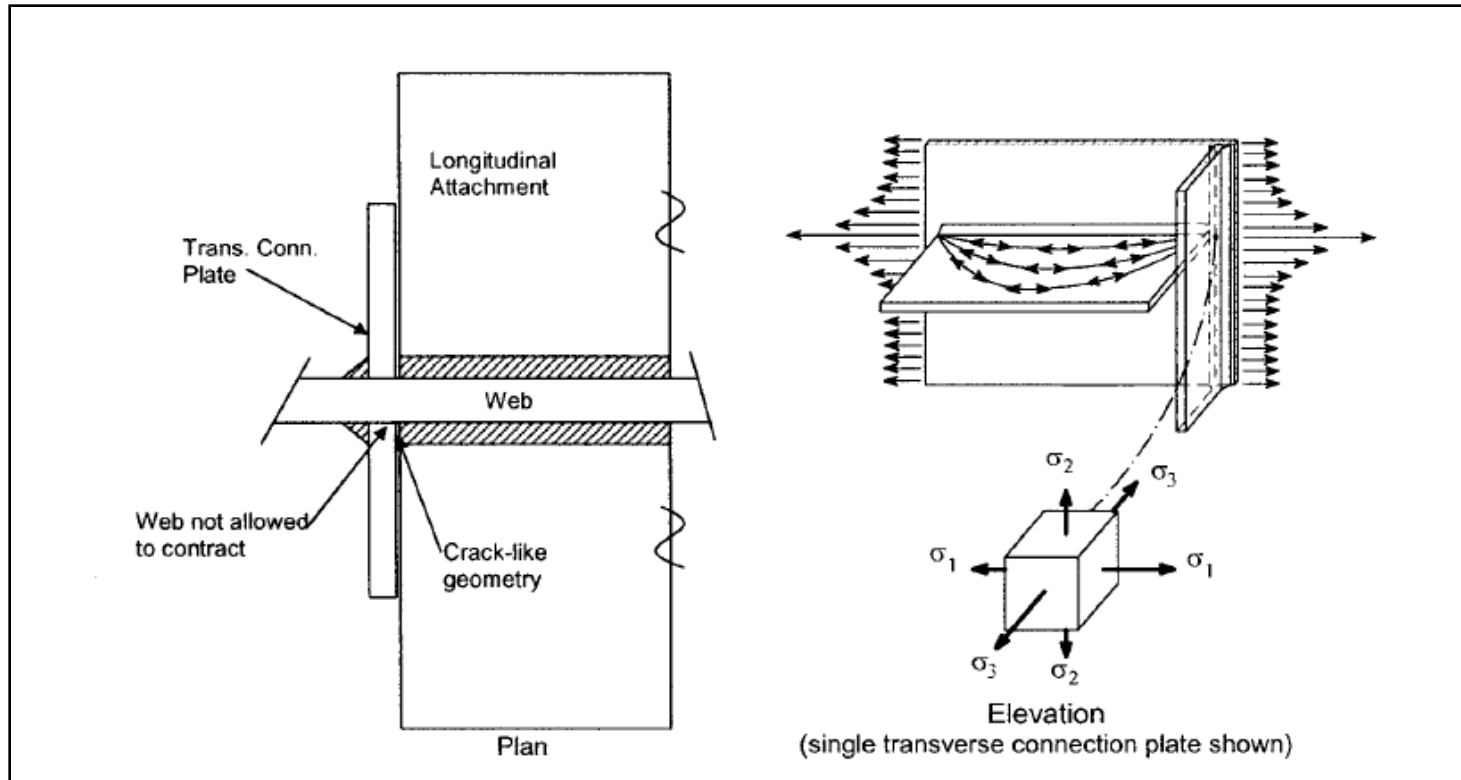
Insufficient Yielding Allowed by Small Web Gap

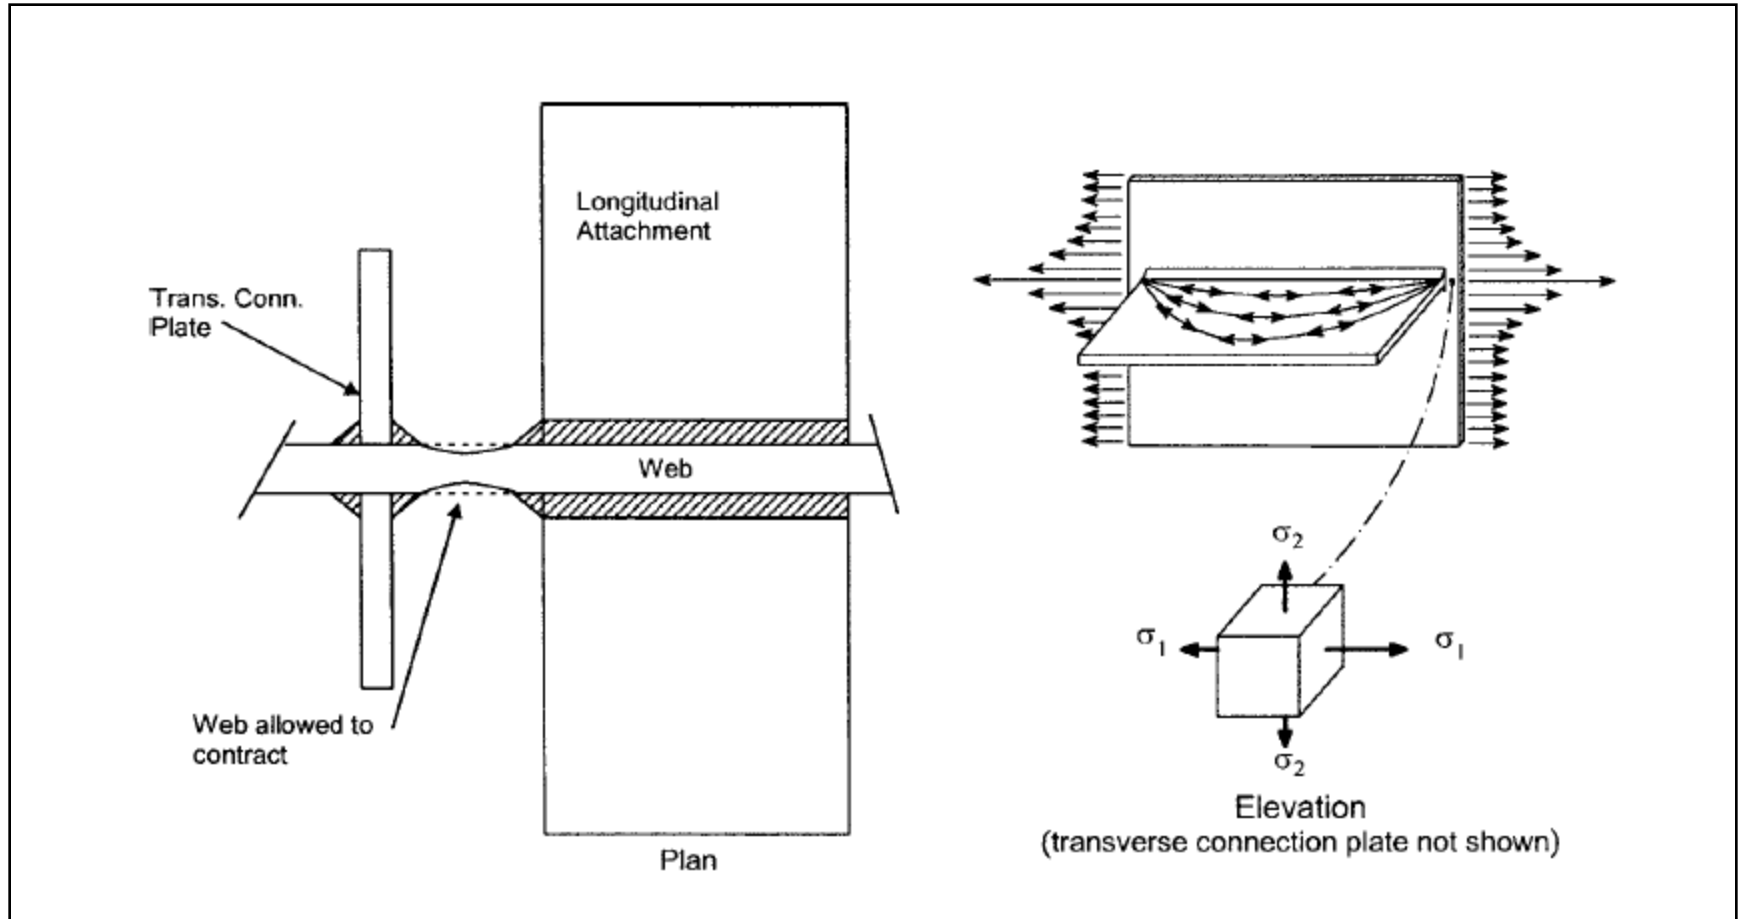
Sufficient Yielding Allowed by Larger Web Gap

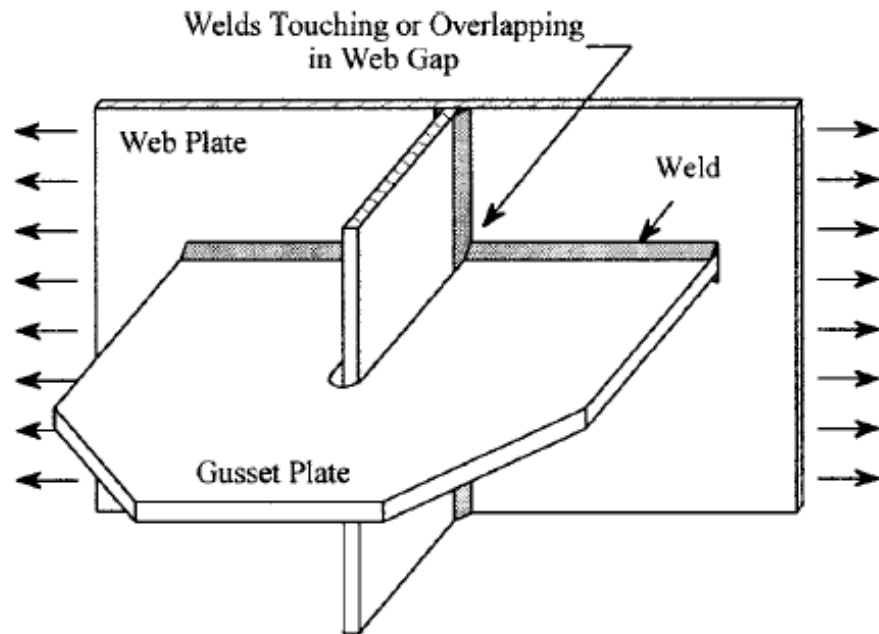
Fig. 11. Illustration of typical lateral gusset intersection with transverse connection plate susceptible to CIF

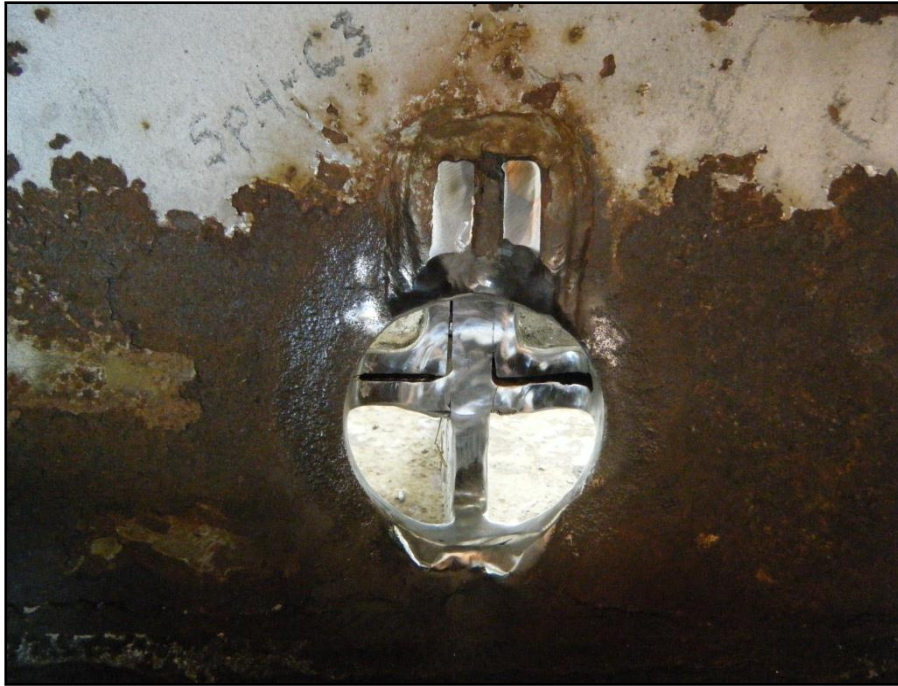
Crack Indications Found at Multiple Locations
