# LAUREL STREET OVERCROSSING

## RETROFIT AND REHABILITATION

Western  
Bridge  
Engineers'  
Seminar

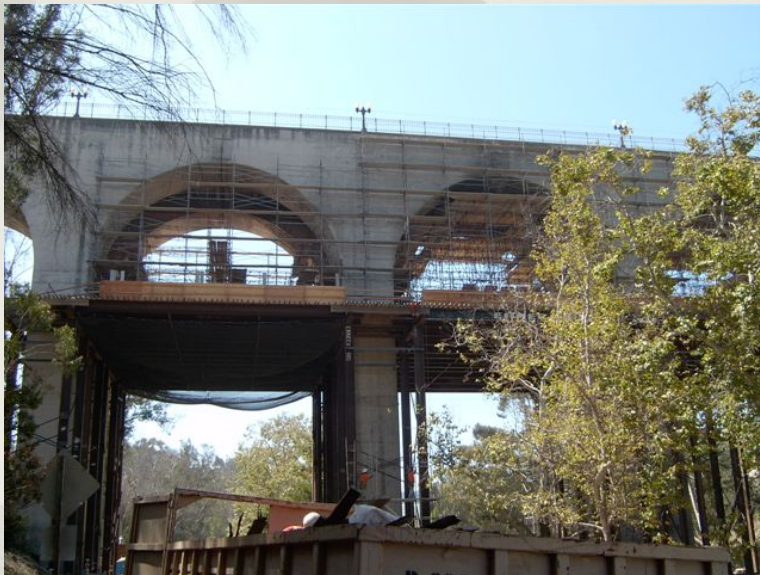
# EMERGENCY REHABILITATION AND FIRE

**THE FIRE**

- 1) At 4:32 a.m., a caller reports a fire at the bridge. The fire appears to have started at the base of a column.
- 2) Fire spreads to the interior wooden structure.

The historic Cabrillo Bridge in Balboa Park caught fire early yesterday, burning inside its hollow structure. State Route 163 below the bridge and bridge access were closed while fire crews investigated and tackled the bridge's smoldering infrastructure. The fire was extinguished at 4 p.m.

- Wooden frame burned
- Original wood infrastructure
- Hollow interior
- Steel-reinforced concrete
- Access door

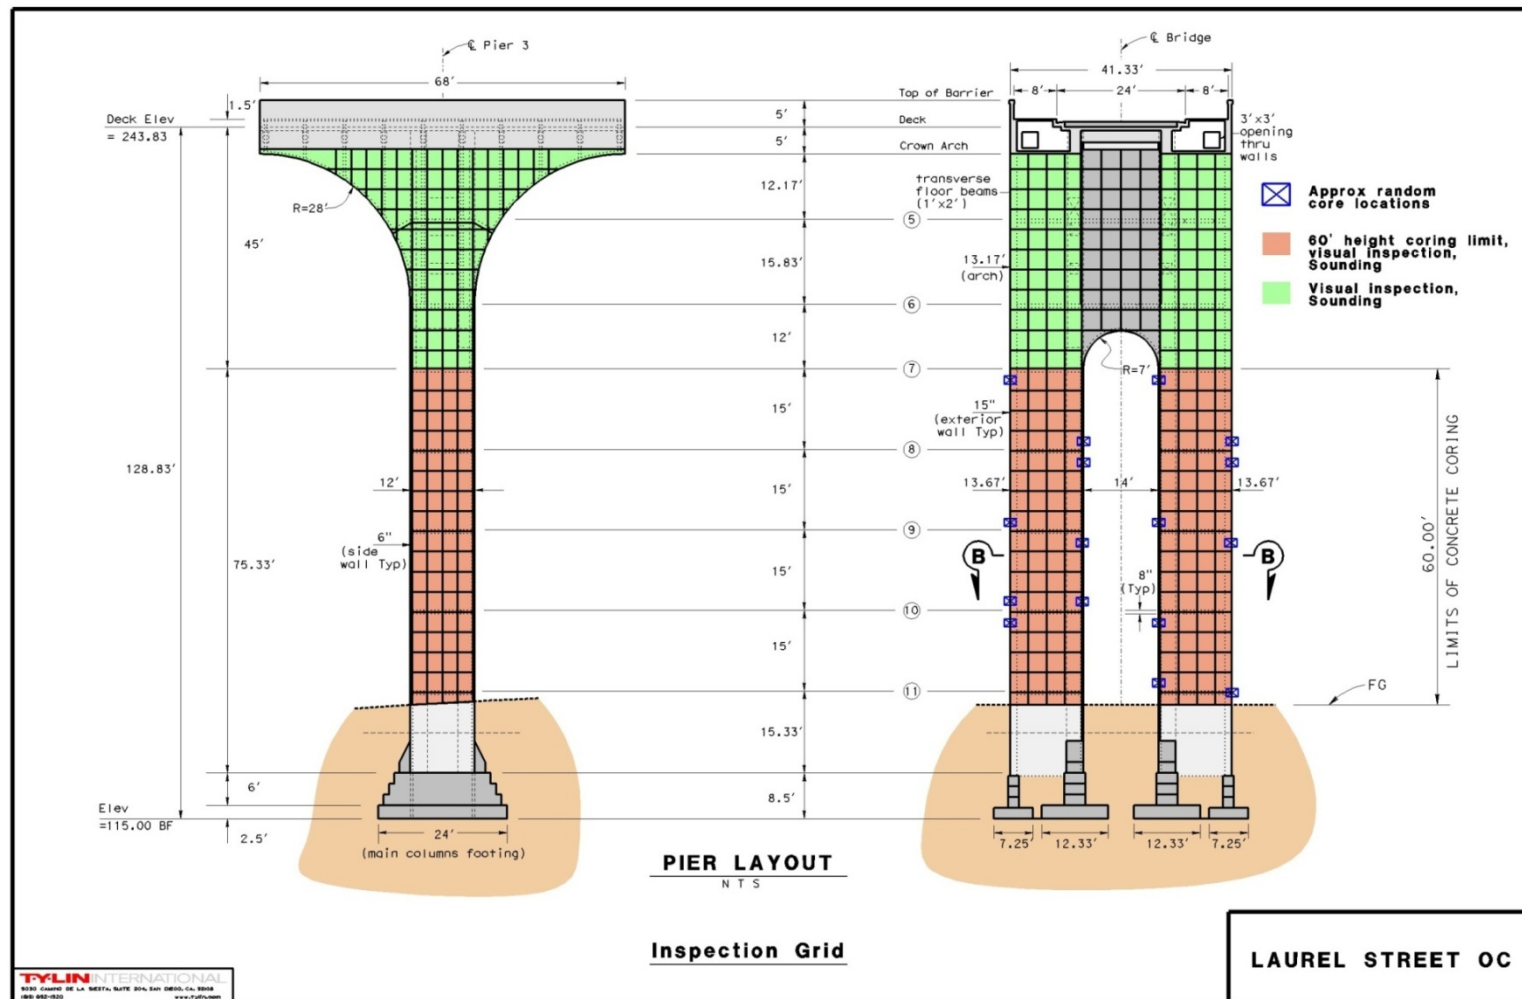
# SURFACE MAPPING

- Surface mapping
- Rock pockets
- Spalling
- Settled aggregate
- Efflorescence through joints
- Aided in cost & quantity estimating

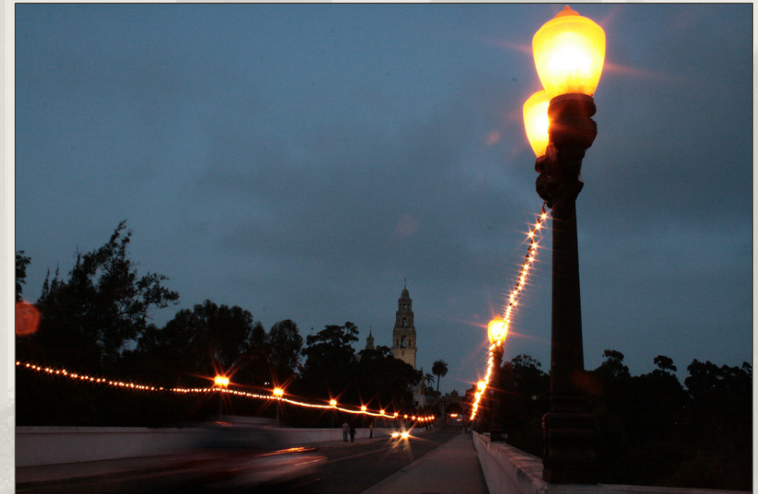
- High voltage distribution line on catwalk
- Electrical transformers in abutments
- Exposed wiring inside and outside bridge
- No interior lighting

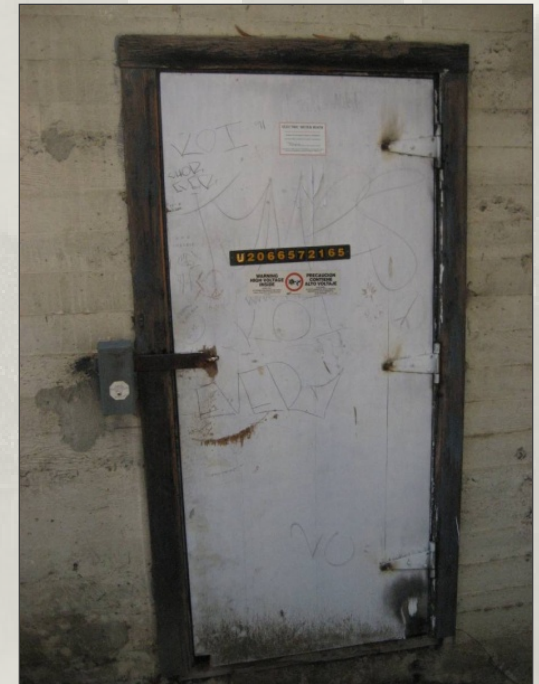
- Wood catwalk is deteriorated, no railings
- Some piers inaccessible
- Eroded interior abutment slopes
- Broken drain pipes
- Doors need replacement
