Southbound US-191 Cold Creek Canyon Bridge

Mile Post 154.9 Structure Number 258

Arizona Department of Transportation

Bridge Management Section

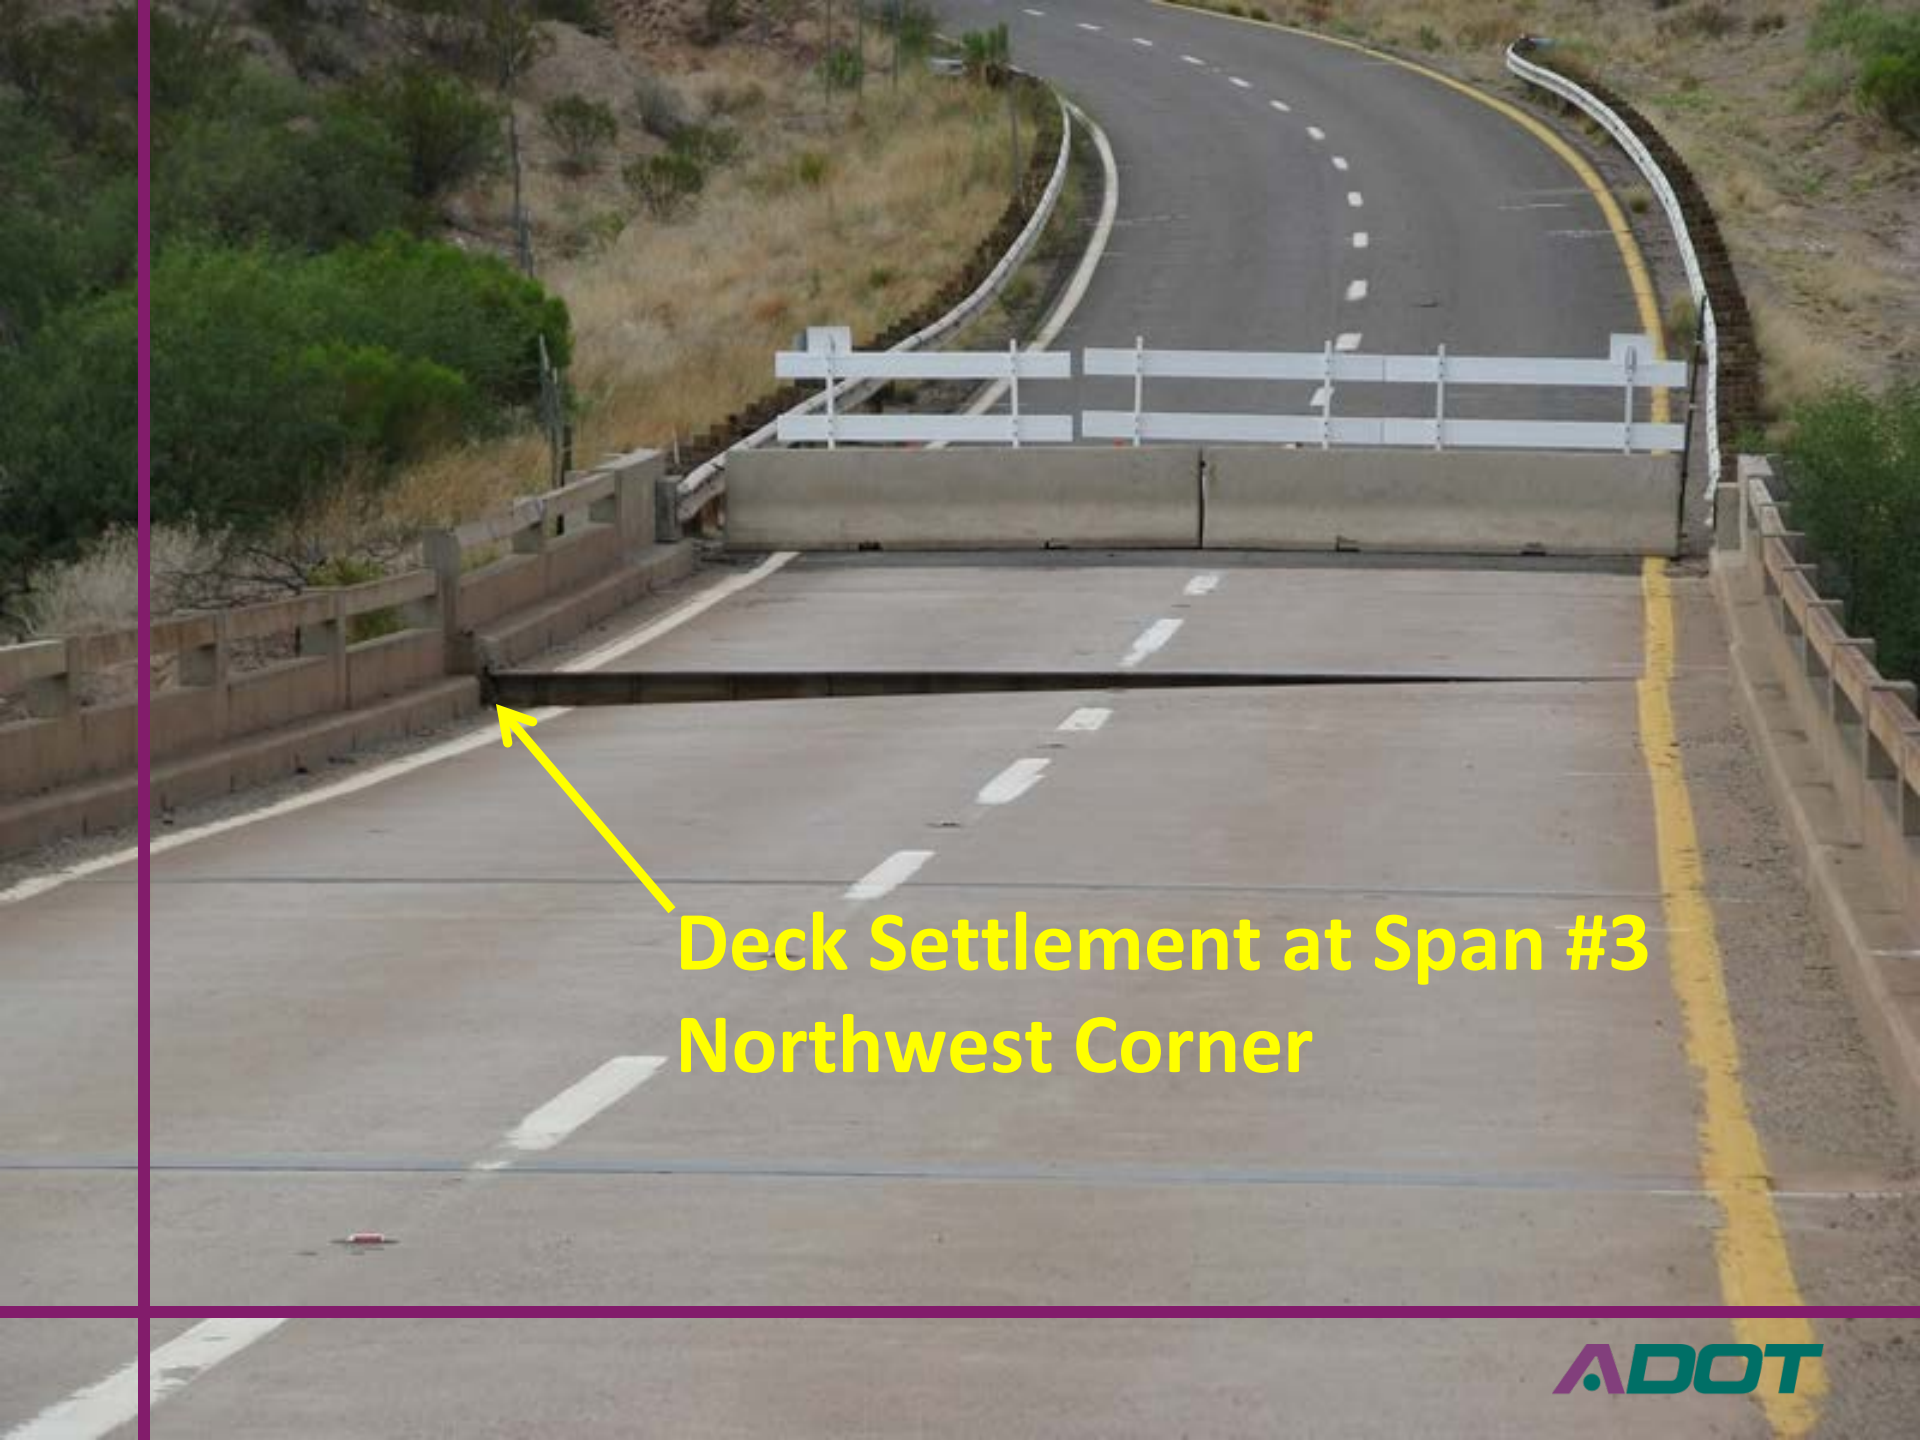
Close-up View of Deck Settlement

**Deck Settlement at Span #3
Northwest Corner**

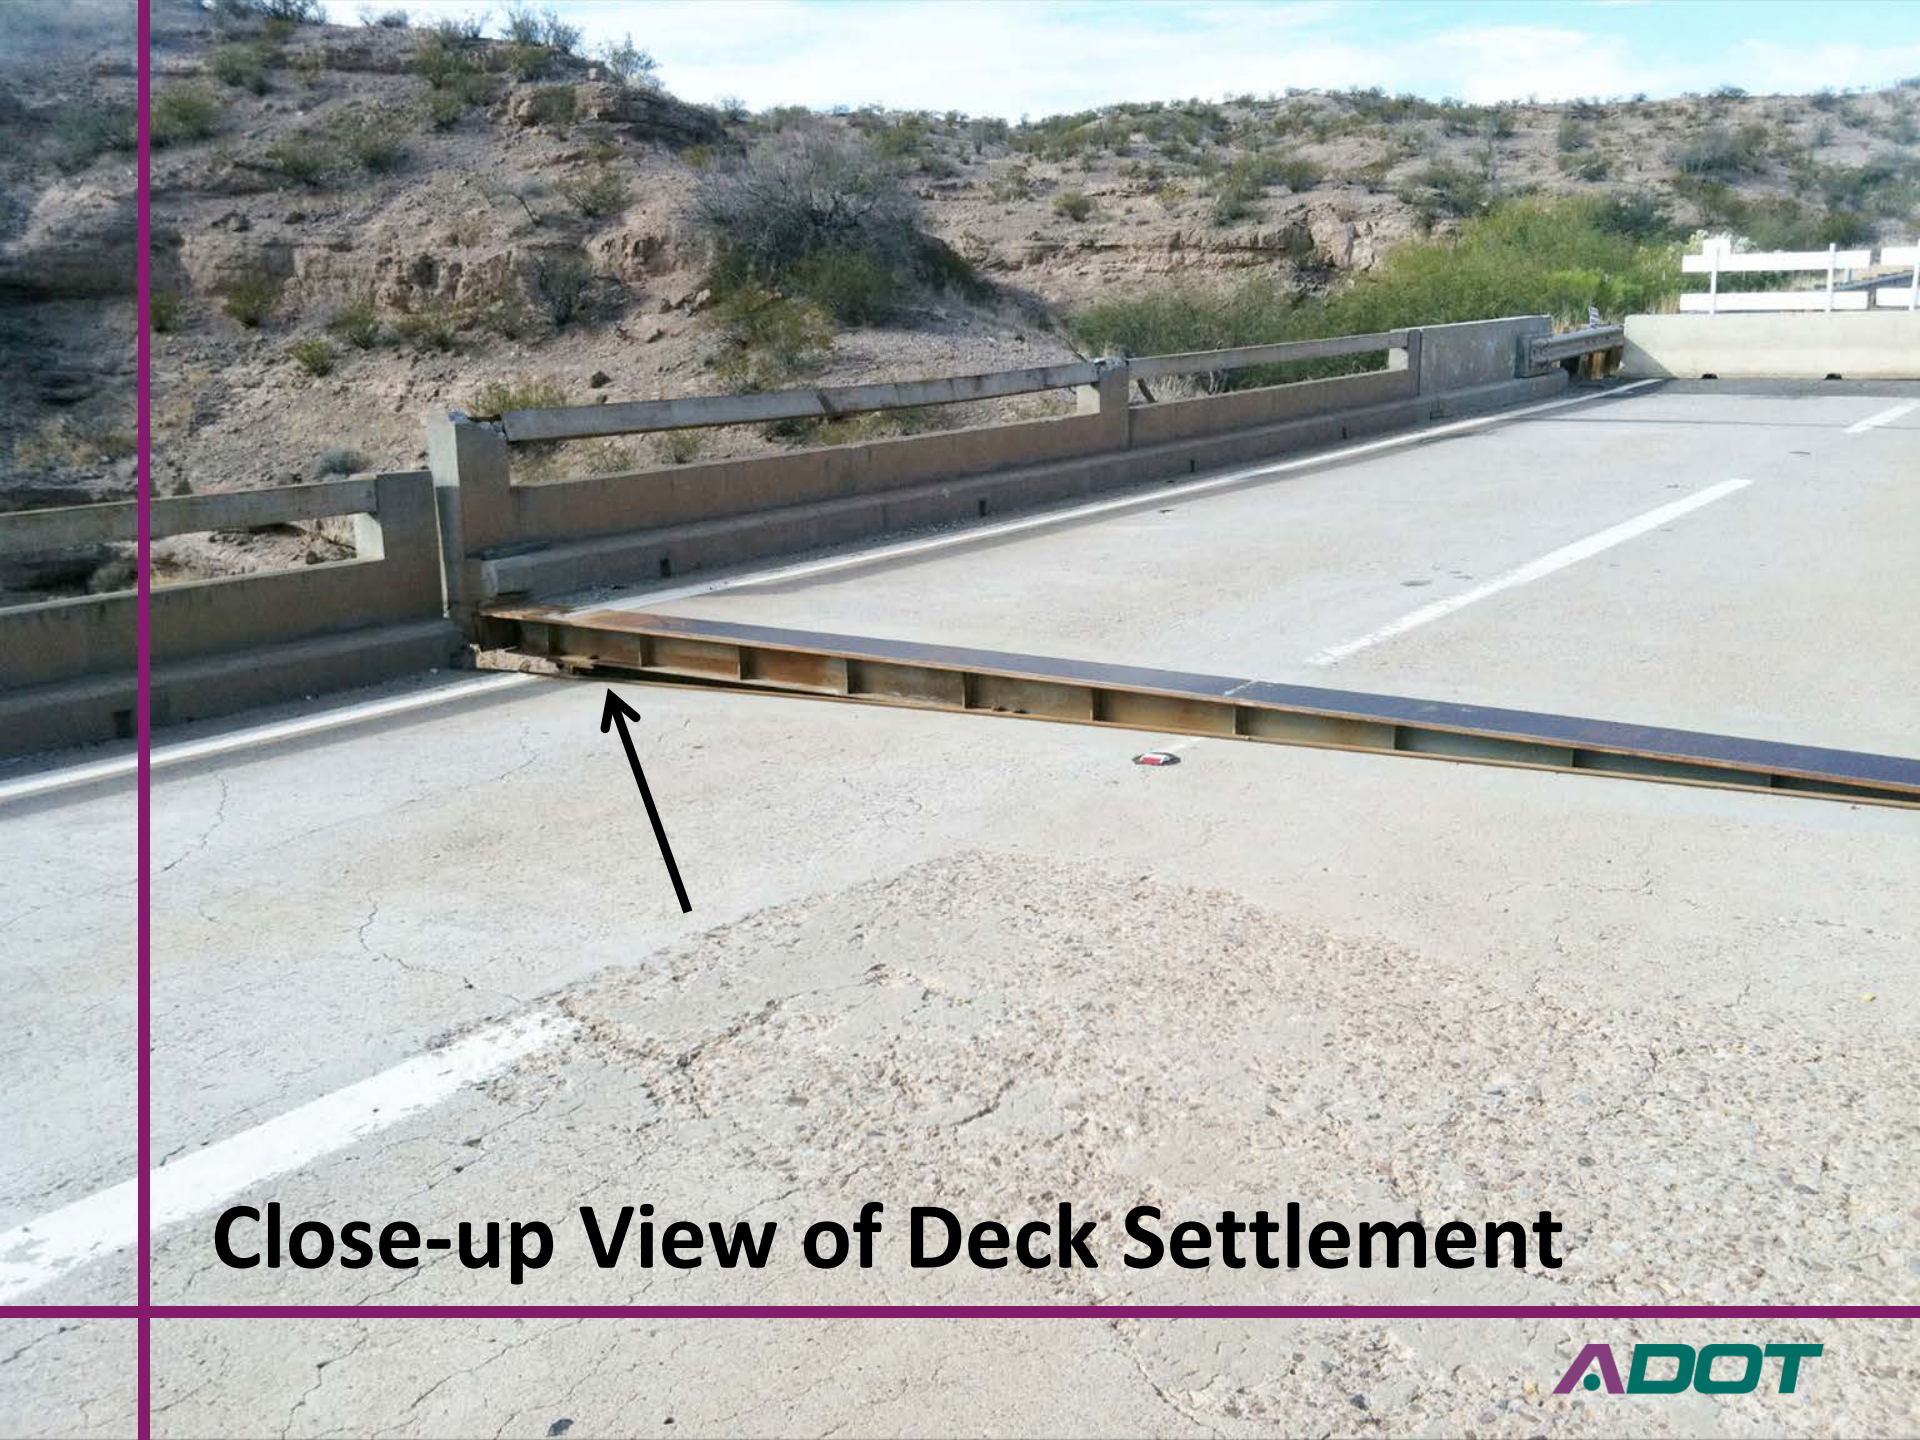
Deck Settlement at NW
Corner of Span #3 (approx 8")

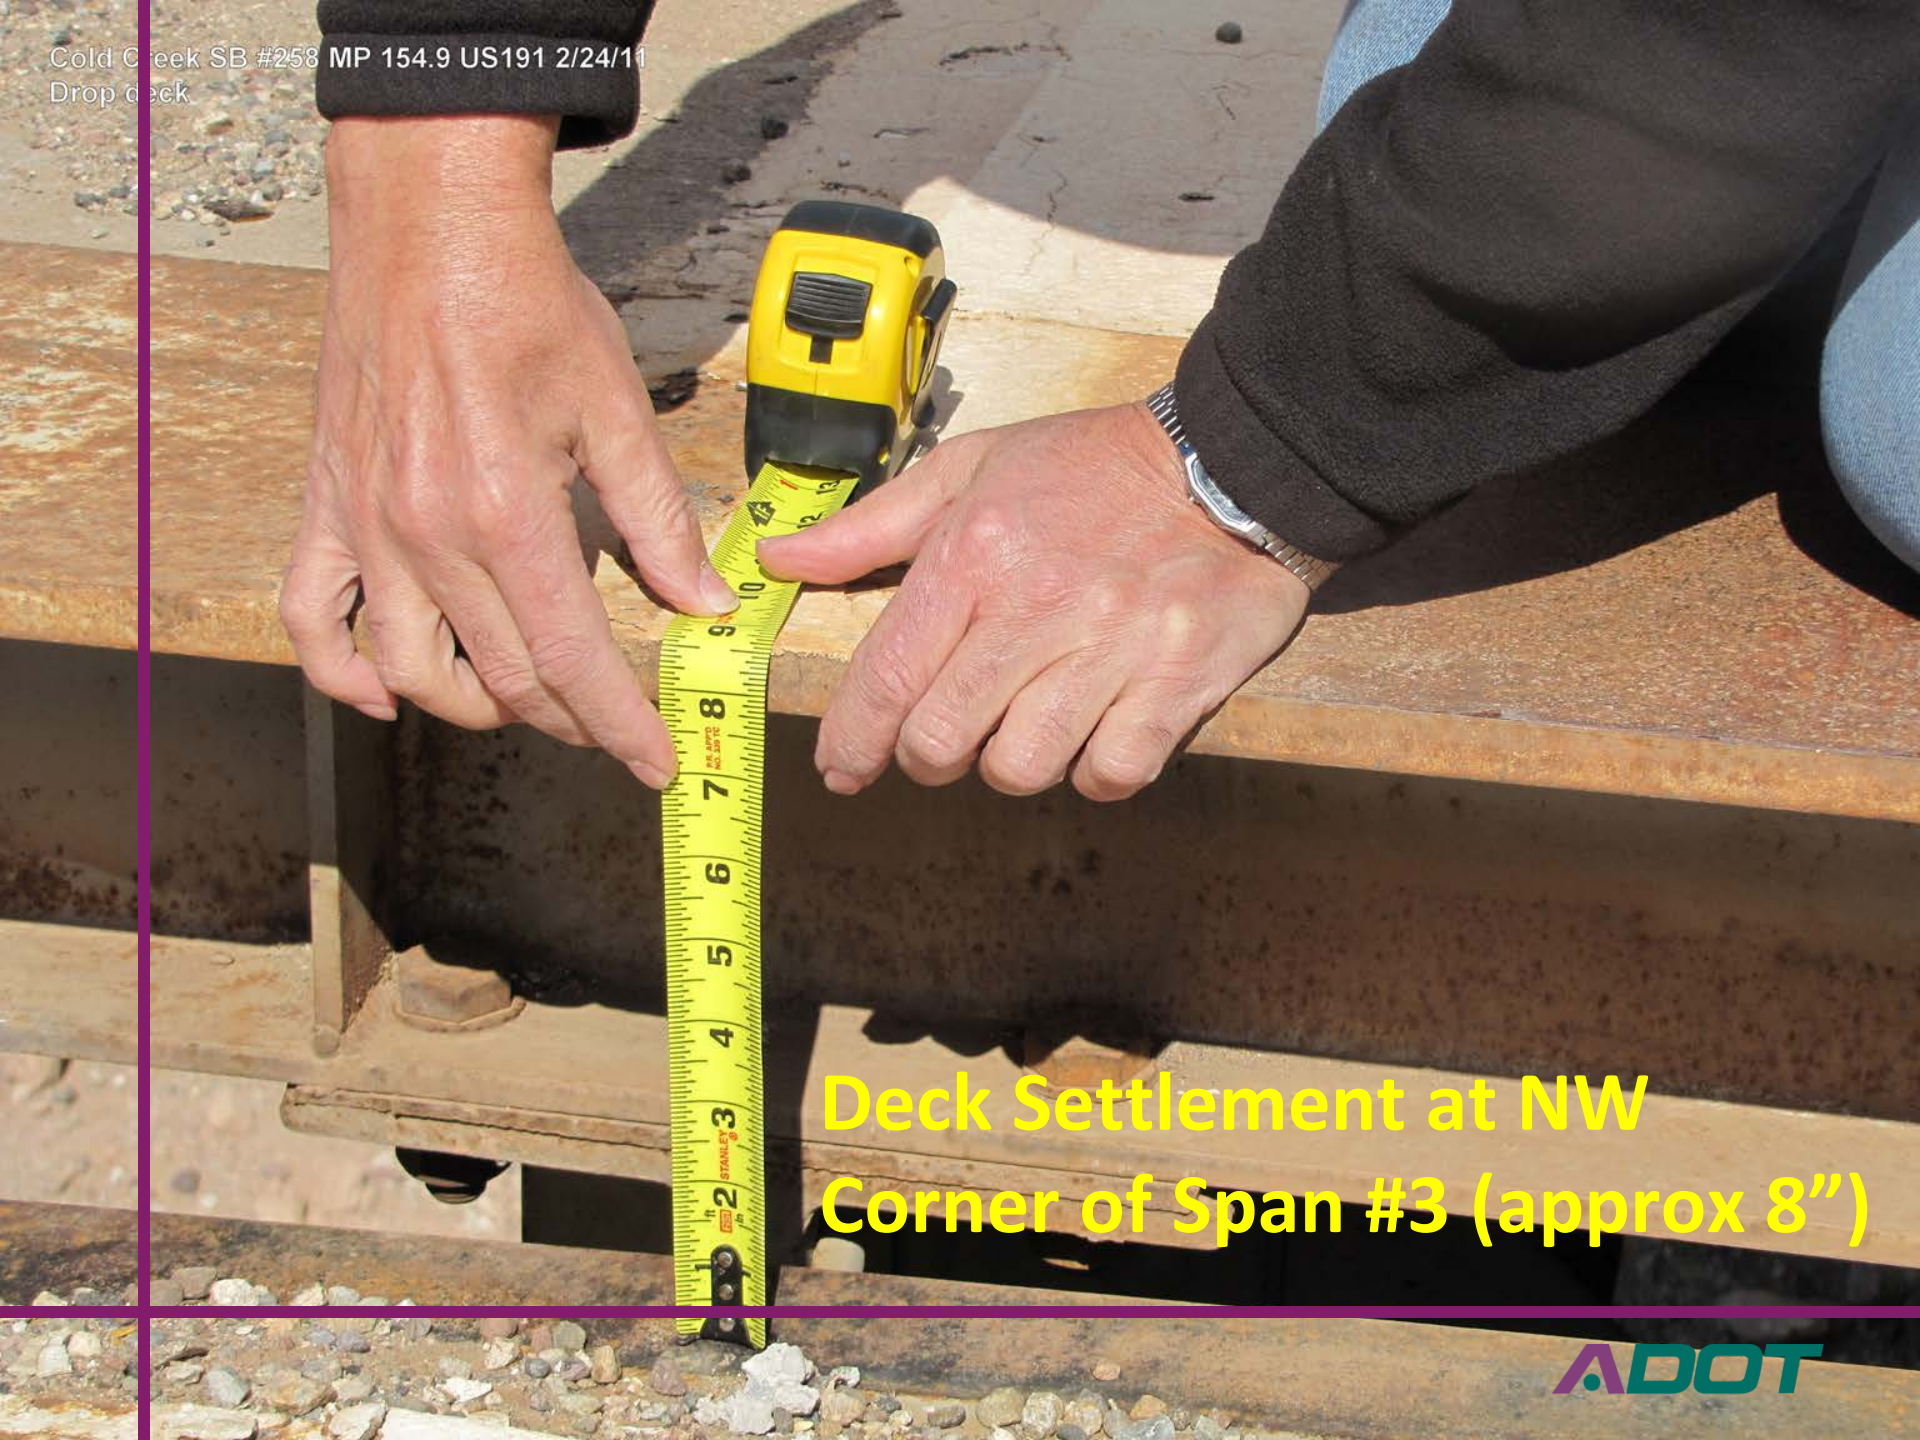
Plate Girder Settlement Looking East

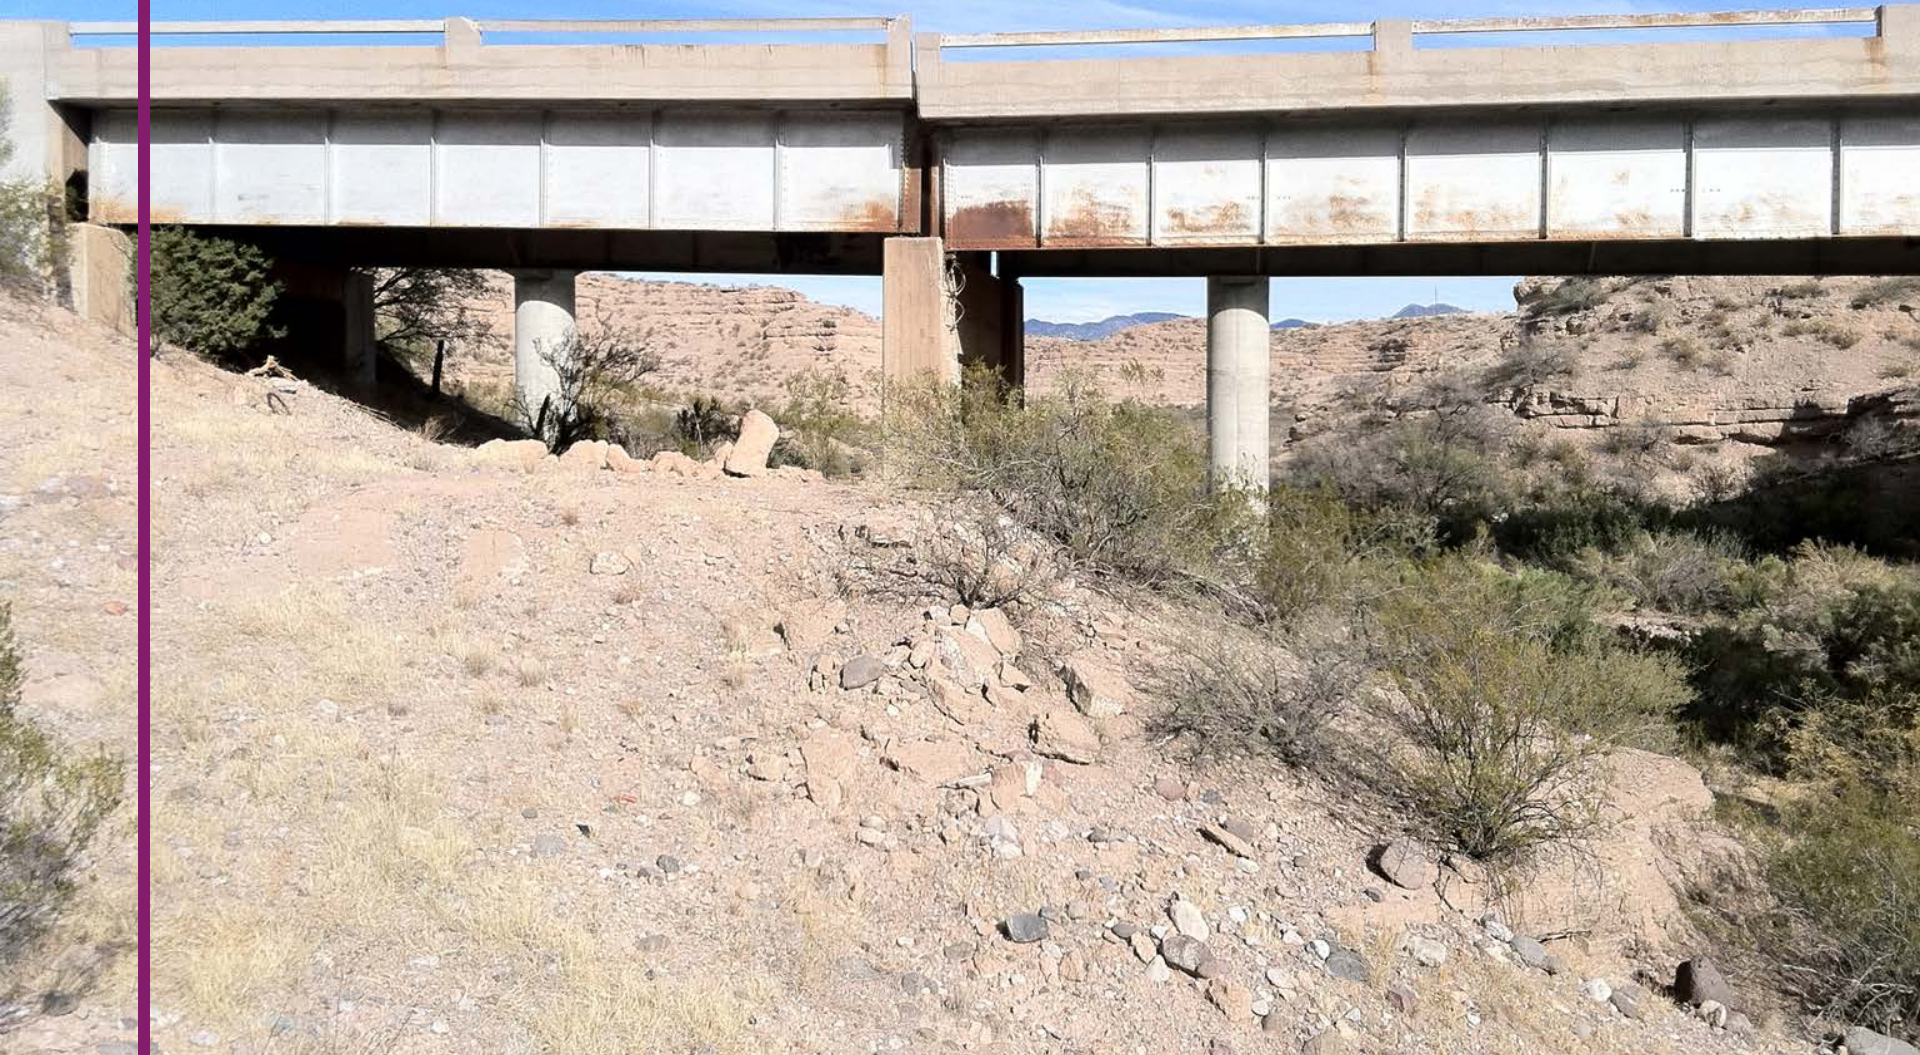
Barrier Settlement Looking East

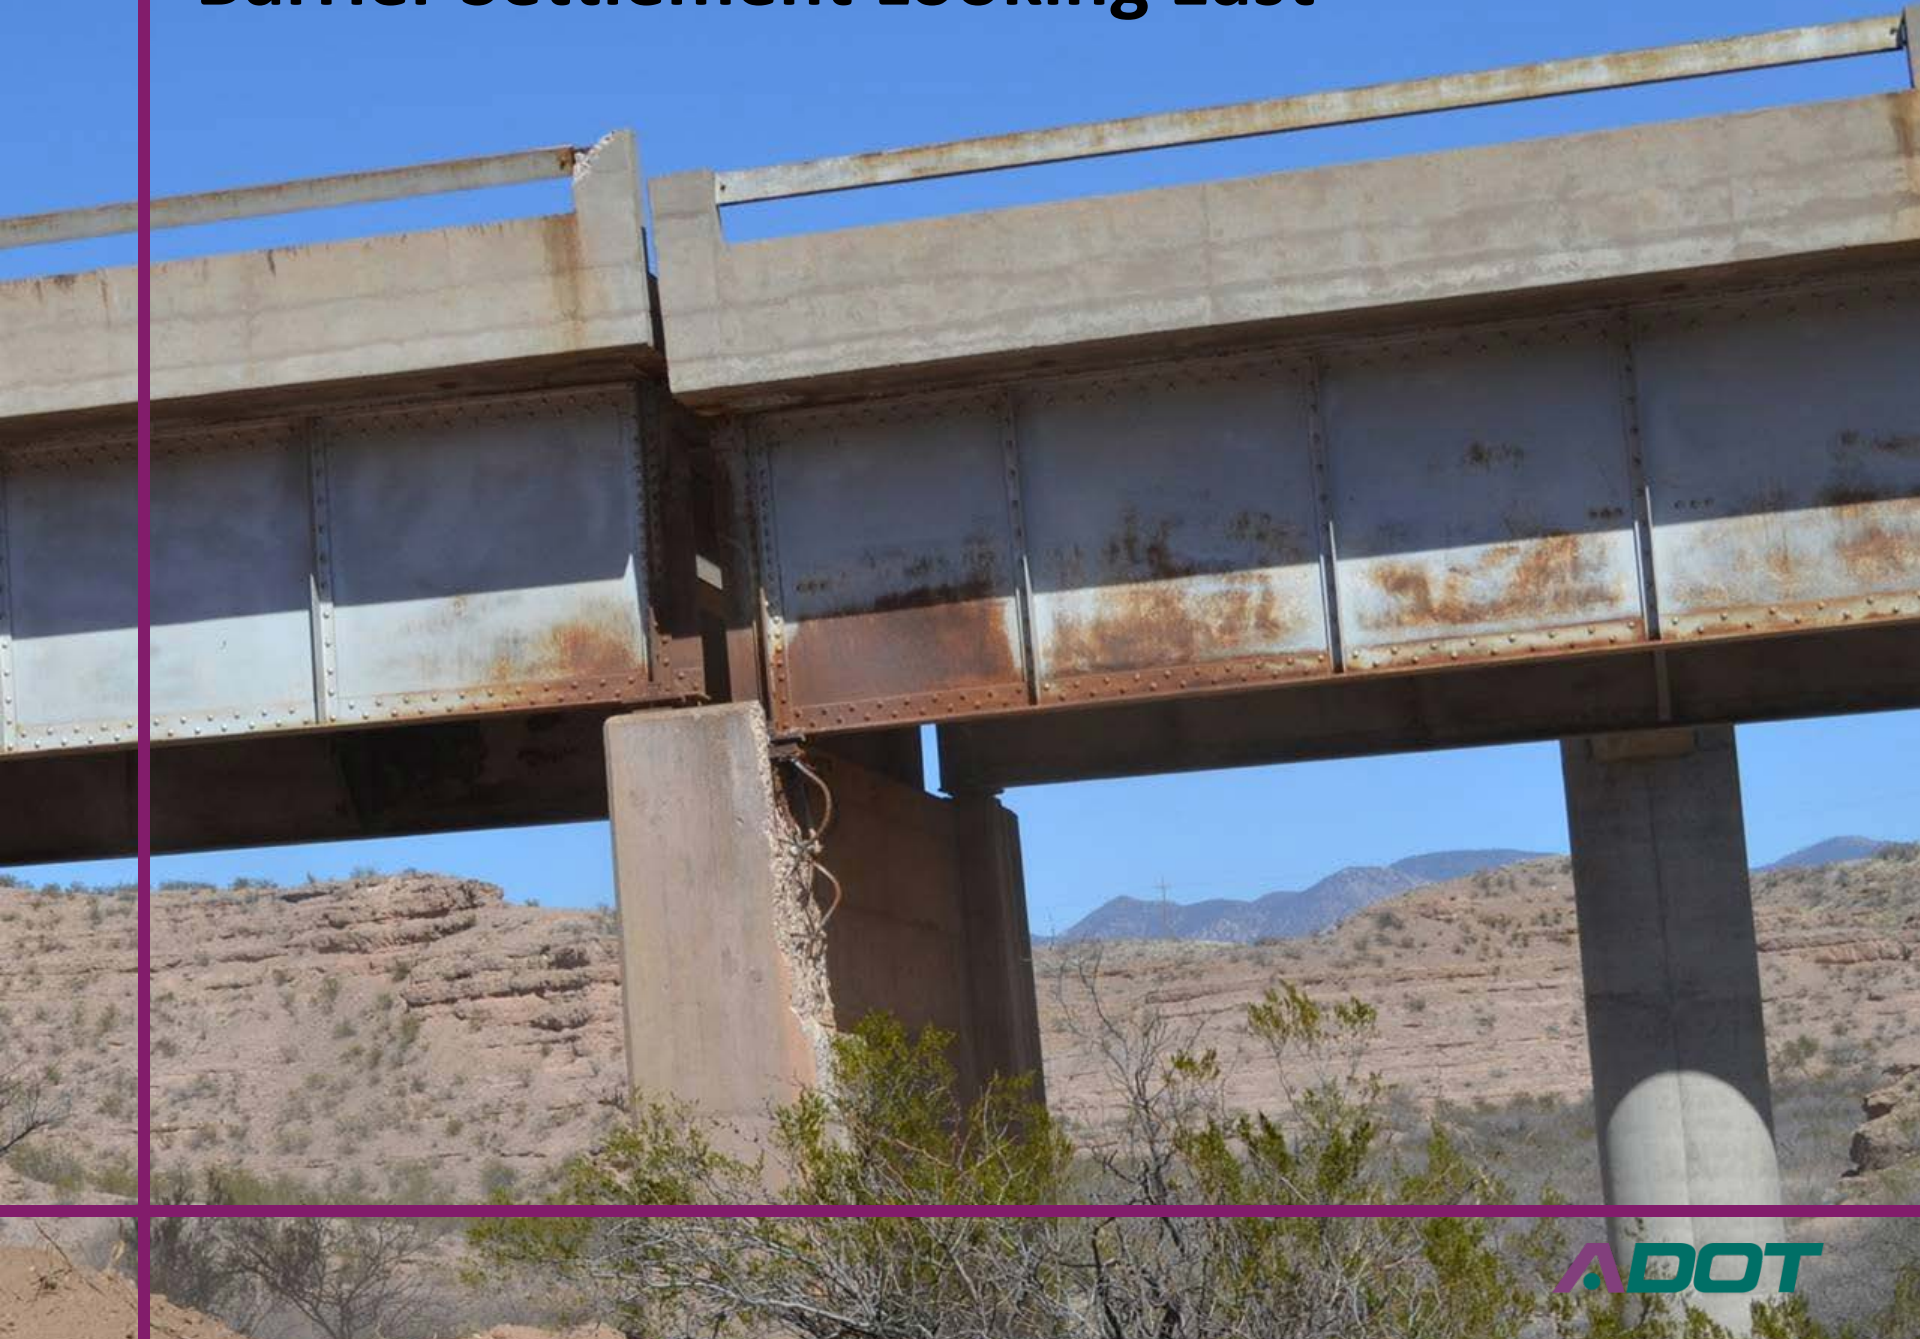
Bearing
separation

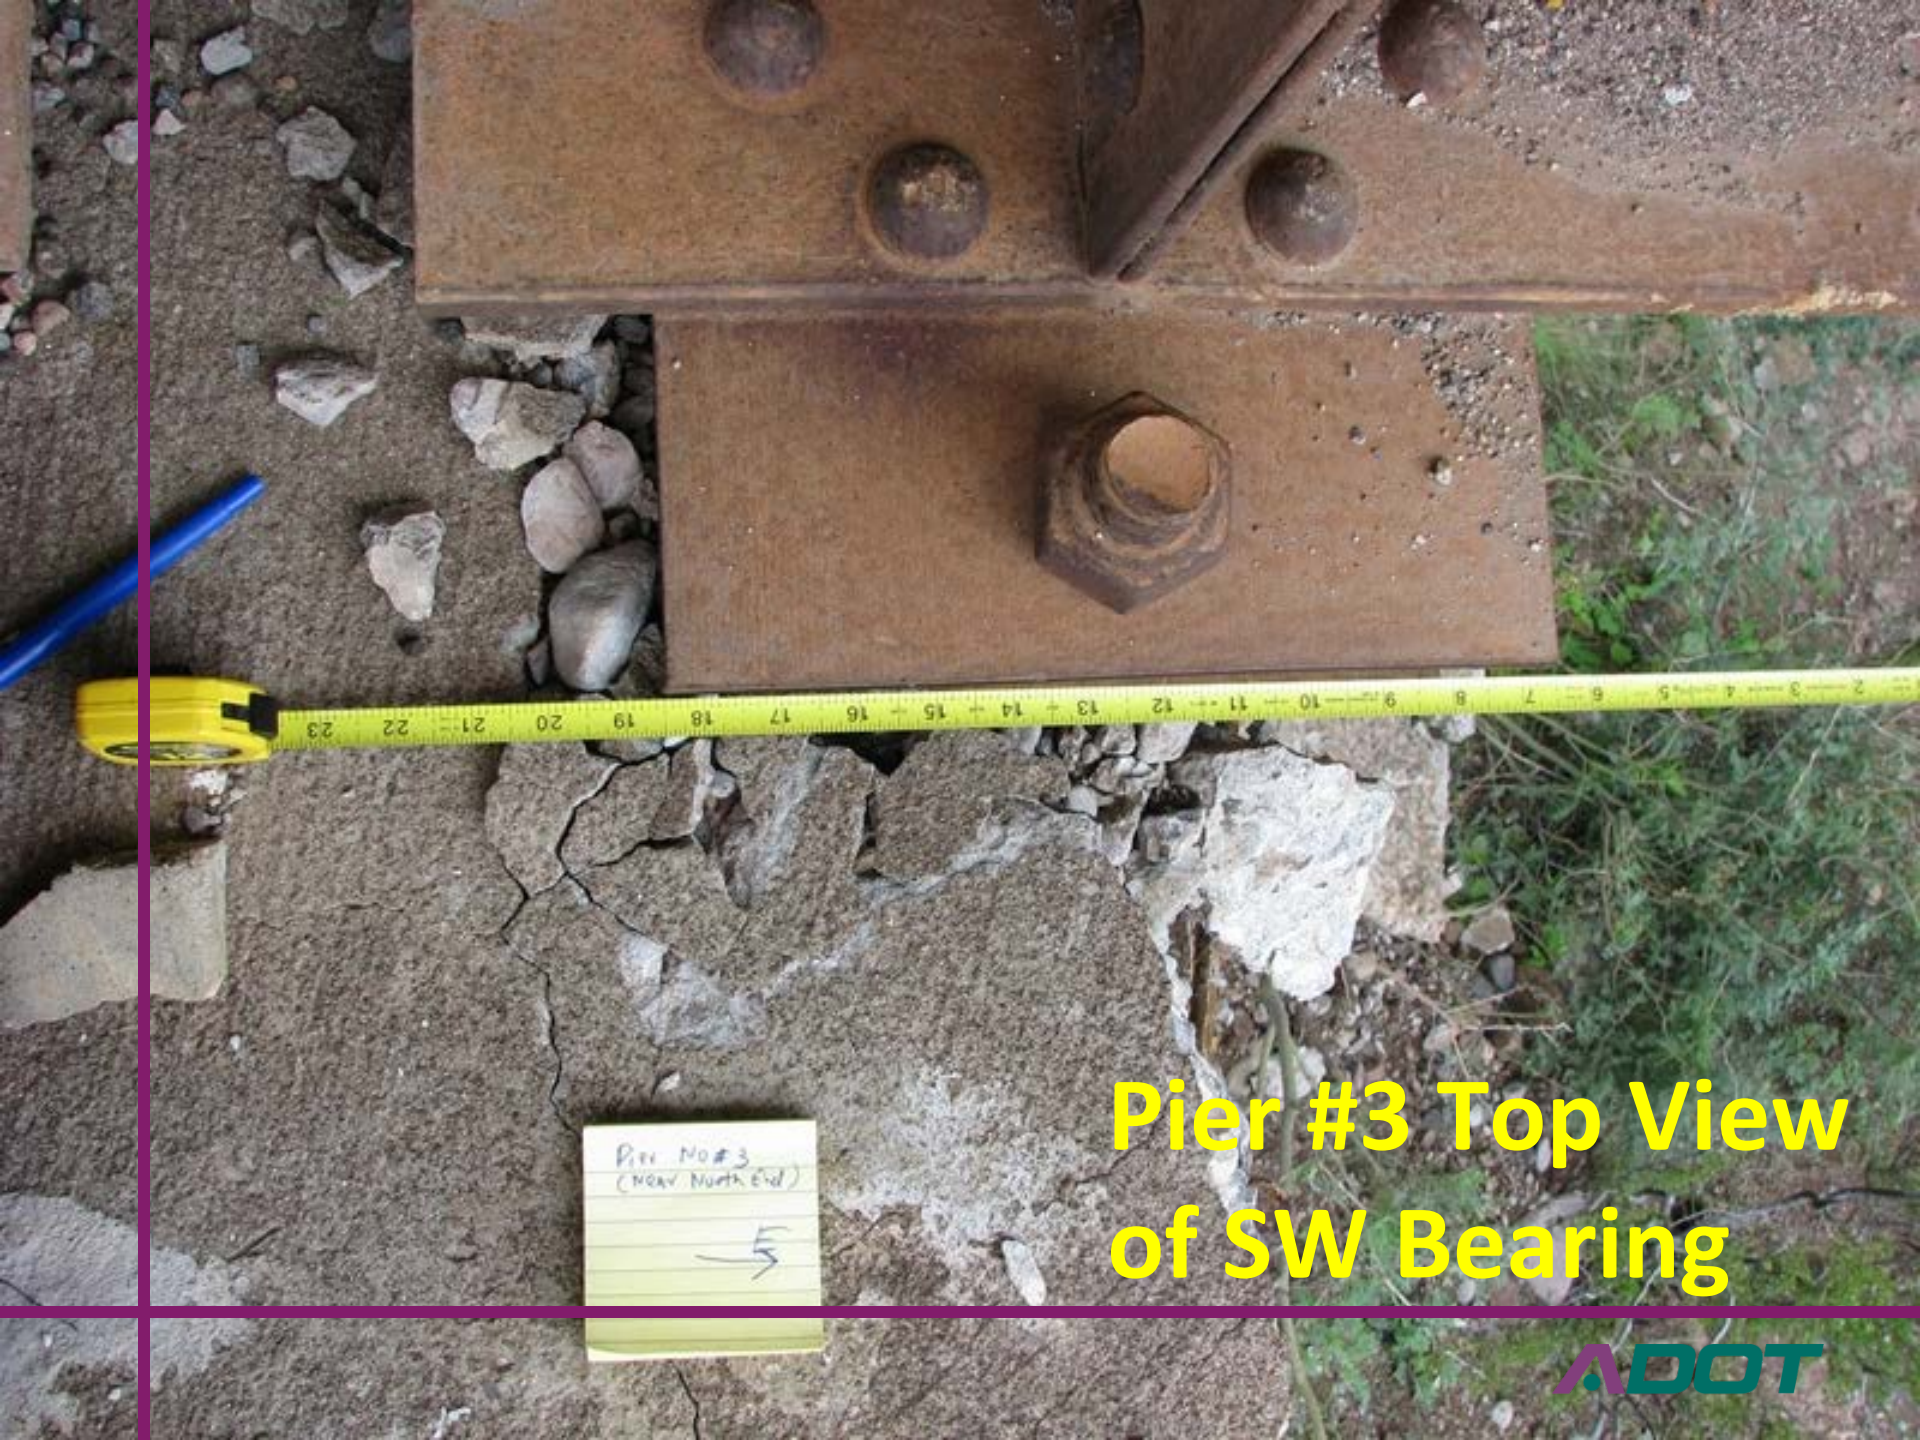
**Spalled Concrete
from Pier #3**

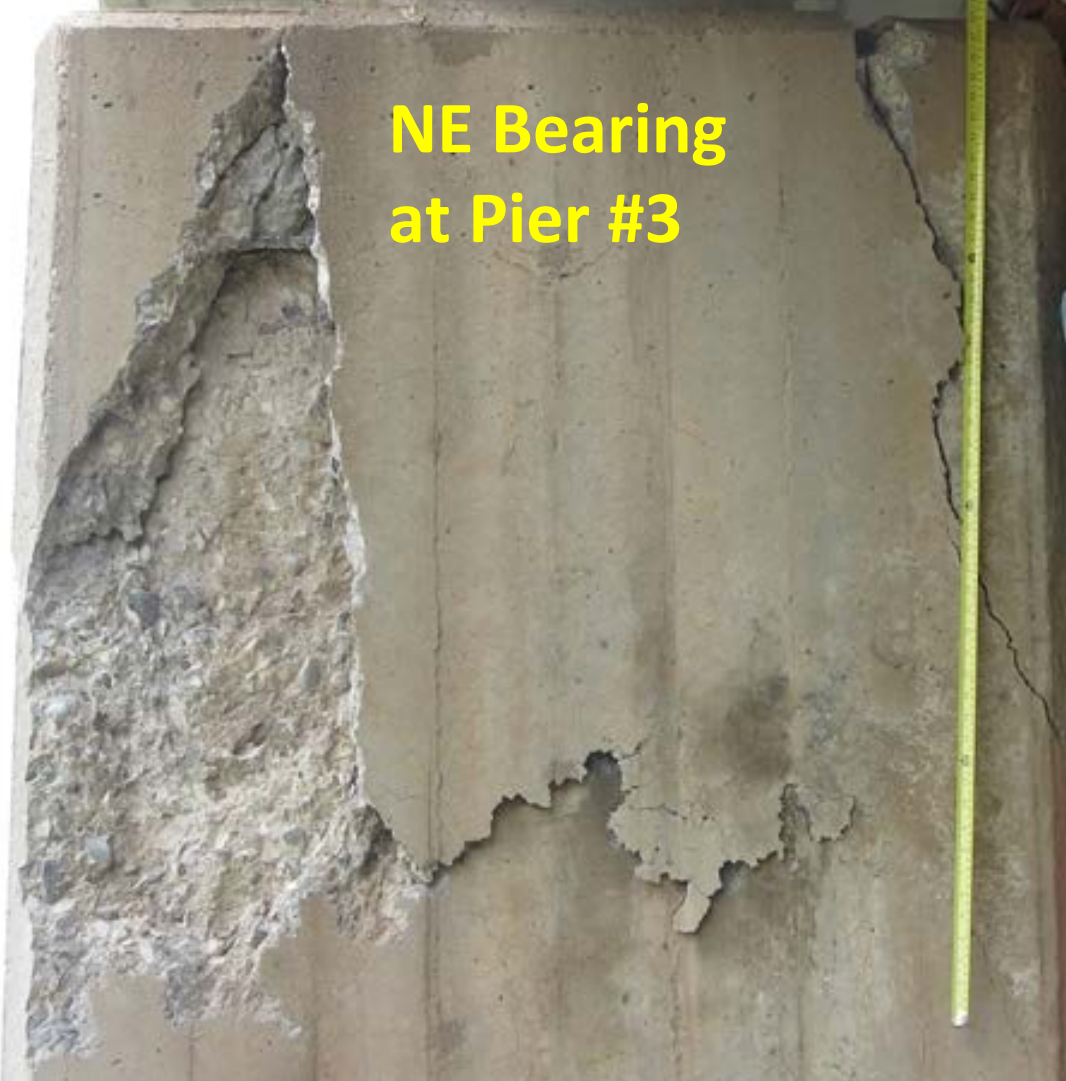
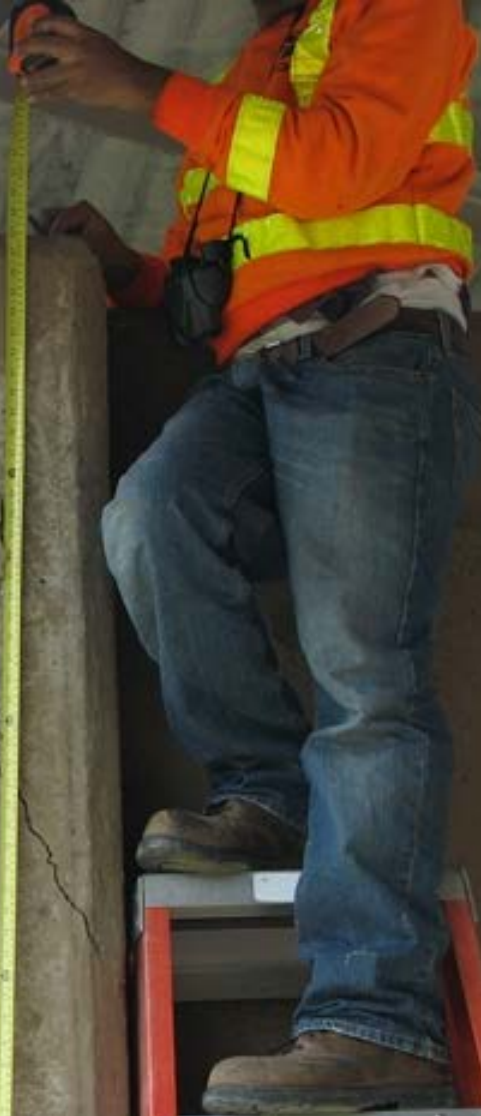
**NE Bearing
at Pier #3**

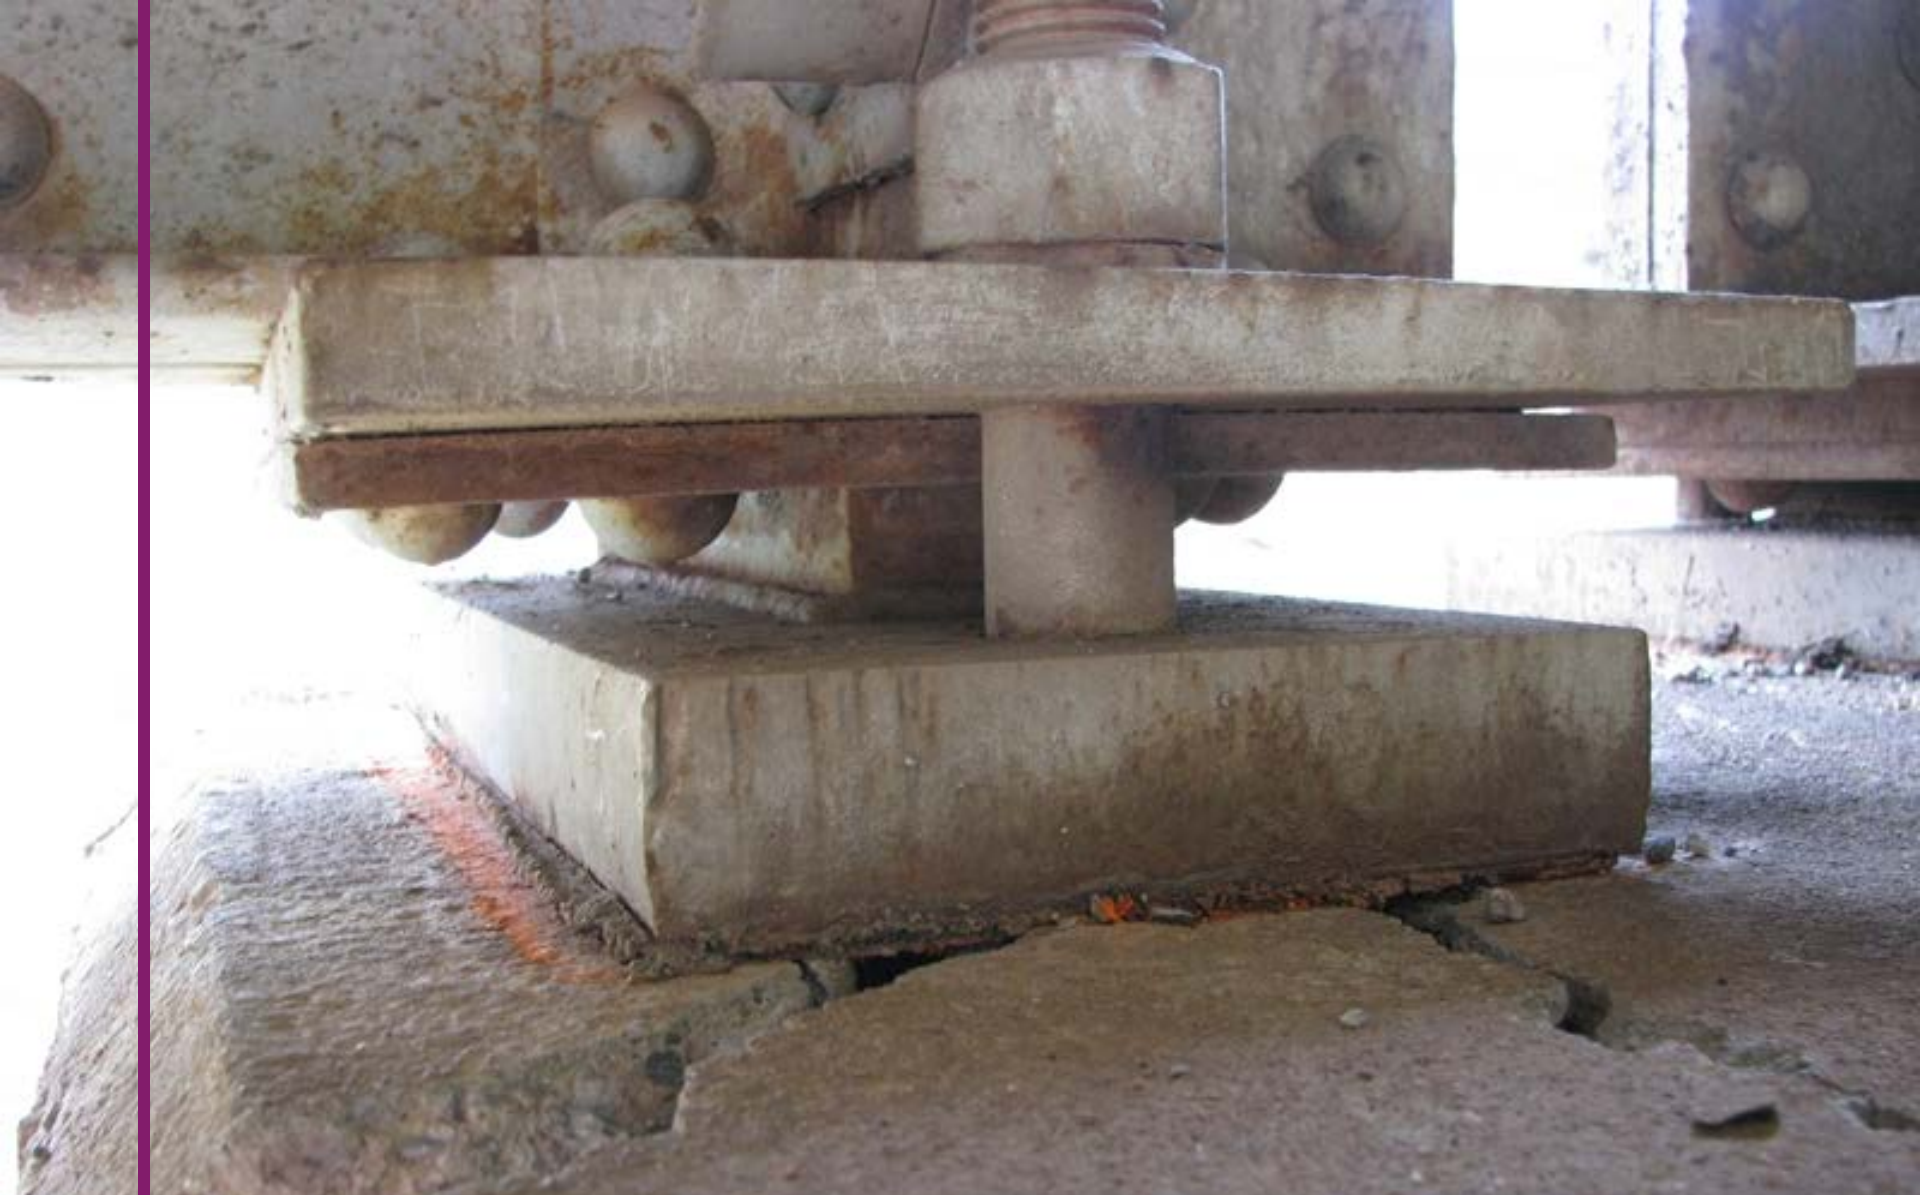
NE Bearing at Pier #3
