Introduction

- Bridge is located in Chicago, Illinois and was built in 1914
- Double leaf bascule of the Chicago type
- 228 feet trunnion to trunnion
- 60 feet wide
- Each leaf weighs approximately 2,000,000 lbs.
- Bridge opens more than 5,000 times per year
- Major structural rehabilitation in the early 1990's
- The mechanical and electrical systems date to original construction

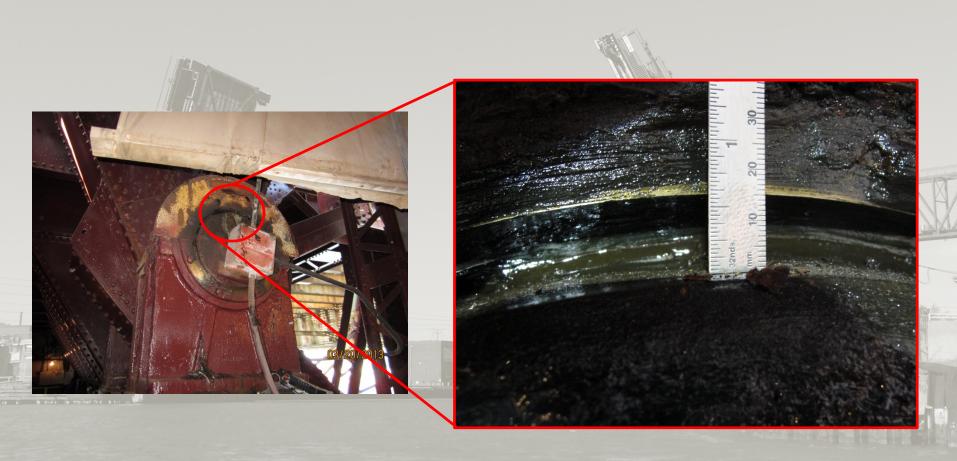
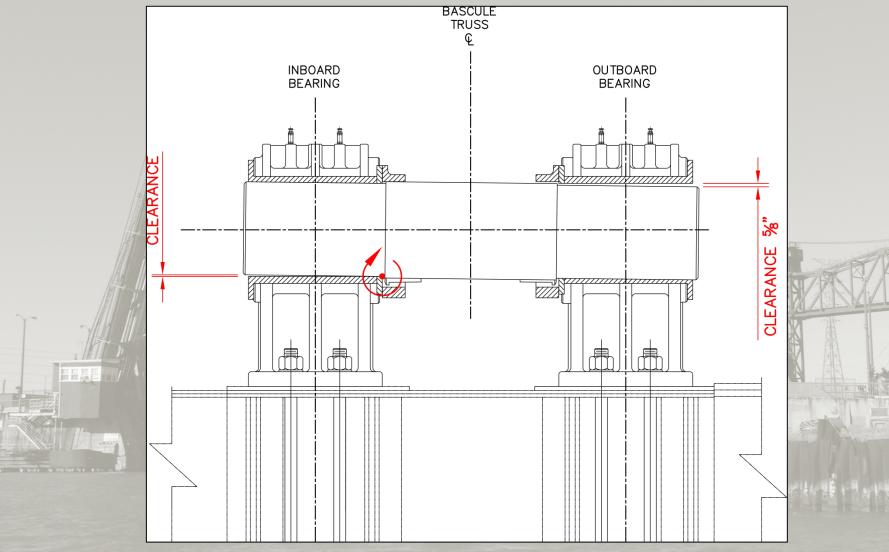
Excess Clearance

- Trunnion bearing is 18" diameter
- Maximum AASHTO clearance (RC6) is 0.018" for 18" diameter bearing
- Northeast outboard trunnion bearing clearance 5/8"
- Other bearings on east leaf within acceptable limits given their age
- Excess clearance at NEOB Trunnion bearing resulted in rotation about the NEIB trunnion bearing
- Hardness measurements were taken of the trunnion shaft and the bronze bushing

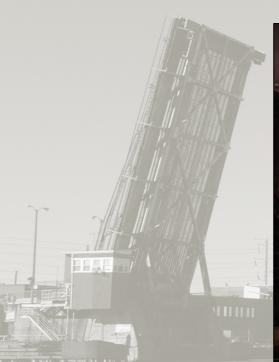
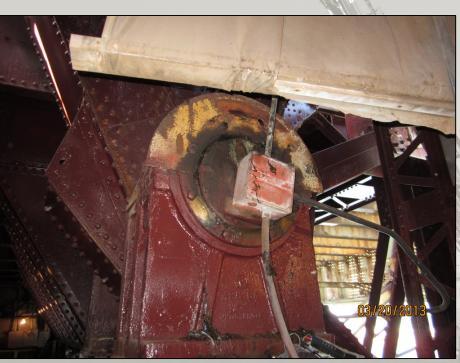
Cause

Lack of lubrication

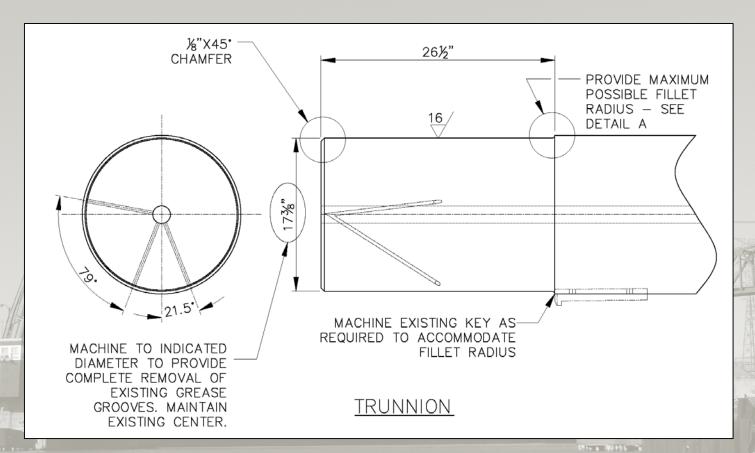
Trunnion with single lube fitting supplying three grease grooves

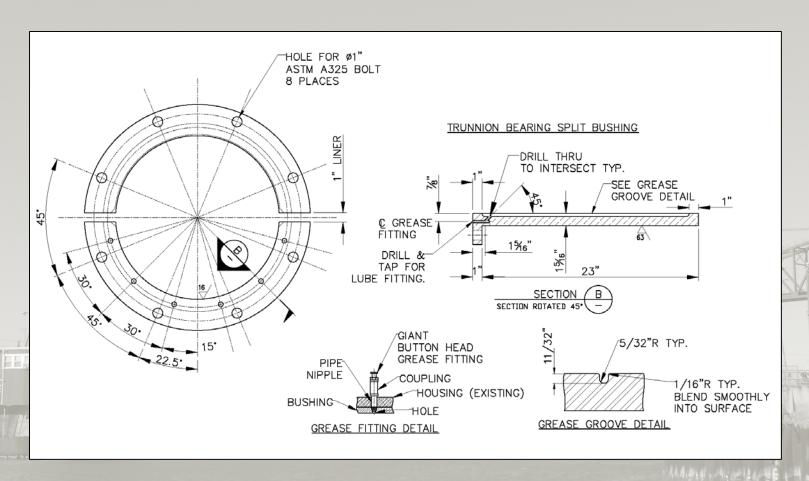
Bushing with six grease grooves, each with a dedicated lube fitting

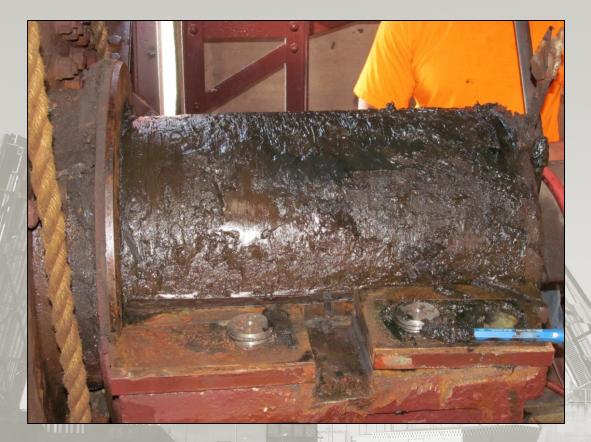
Outboard bearing after cap removal - trunnion journal covered with lubricant

Outboard trunnion journal after removing lubricant – severe corrosion with scaling and pitting

Diameter was measured and ranged from 17.842" on an unworn surface to 17.554" at the inboard end of the trunnion journal.

Taper due to wear and corrosion was 0.288" over length of journal.

- Northeast outboard trunnion bearing
 - Trunnion journal not suitable for continued service
 - Trunnion journal machining required
 - New bushing required
 - New steel collar required
 - Design drawings provide a suitable basis for this work
- Northeast inboard trunnion bearing
 - Trunnion journal is acceptable for continued service
 - Damage at inboard end is due to poor alignment
 - Alignment will be corrected and load redistributed when outboard bearing is rehabilitated

- Rehabilitate northeast outboard bearing based on rehabilitation plans dated
 May 15, 2013
- Take detailed clearance and alignment measurements at northeast inboard bearing as a baseline prior to jacking the bridge
- Remove southeast inboard and outboard bearing caps for inspection of the trunnion journals
- Take detailed clearance and alignment measurement at the southeast inboard and outboard bearings

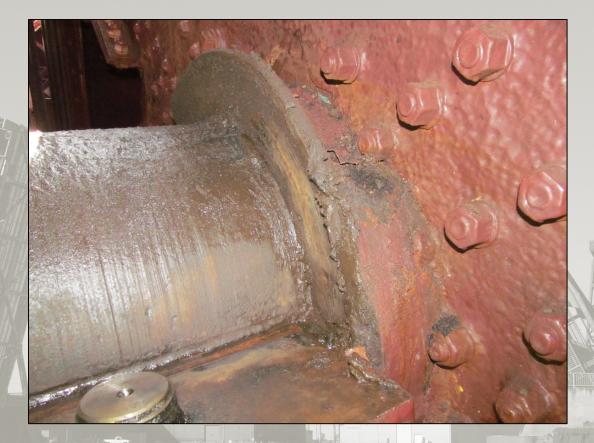
Outboard trunnion journal - grease groove nearly worn away at inboard end

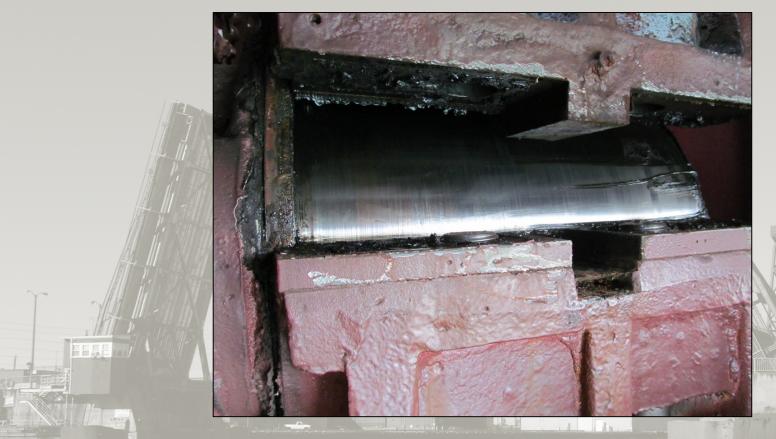
Inboard trunnion journal - generally good to fair condition

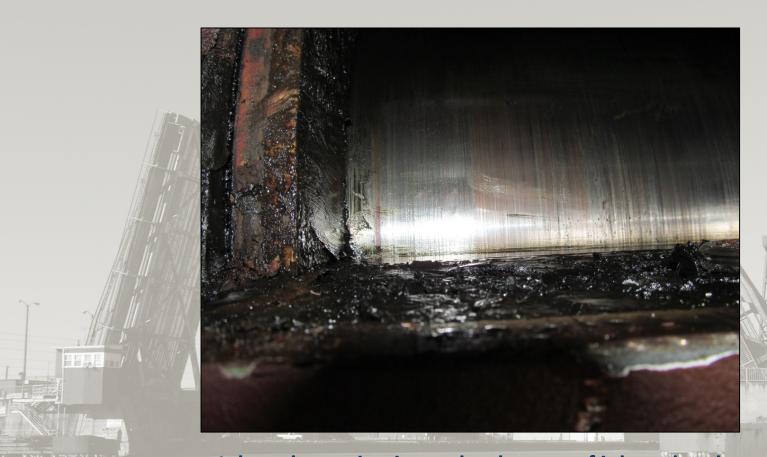
Inboard trunnion journal – close up of inboard end with light scoring and bronze embedment

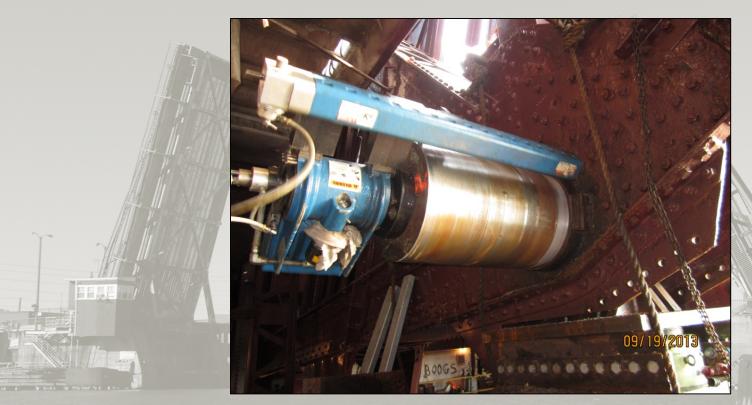
Field Machining - Grease grooves removed, rough cut complete

September 19, 2013 - Grease grooves removed from trunnion journal, rough machining complete

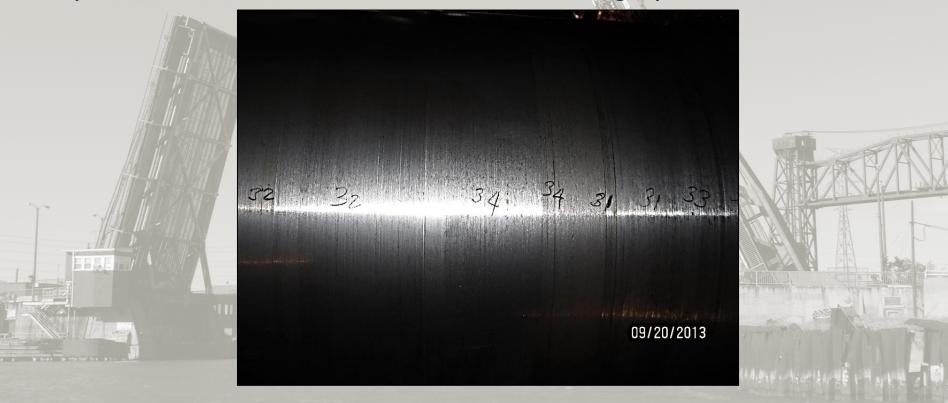
Field machining – Dimensions on shaft

September 20, 2013 - Final trunnion OD determined and bushing ID provided to G&G

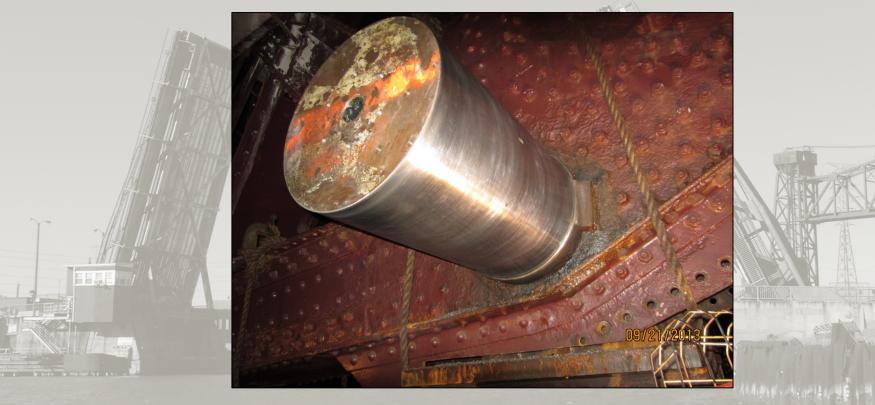
Field machining - Trunnion journal complete

September 21, 2013 - Polishing of trunnion journal completed and Mountain Machine Works demobilizes.

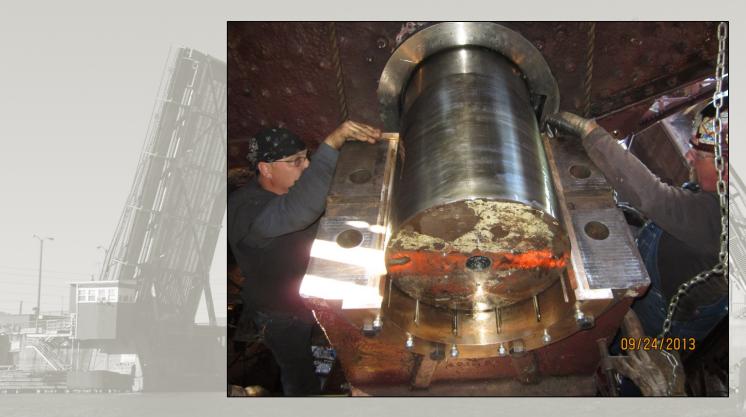
Trunnion bearing base and bushing at installation

September 24, 2013 - Rehabilitated bearing arrives on-site and installed on bridge
