Rehabilitation of Tacoma Avenue S. Bridge, WA

- Kash Nikzad, Ph.D., P.E., TranTech Engineering
- Jim King, SE, TranTech Engineering
- Scott Shih, PE, SE TranTech Engineering

Phung, Ph.D., TranTech
September 9-11, 2015
Engineering

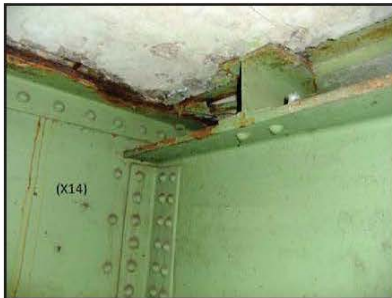
PIER 3 CROSS GIRDER (X14) TOP FLANGE

- Based on in-depth inspection report:
 - Girders have pack rust and section losses due to rusting
 - Crossbeam at bent 5 has substantial reduction in section
 - Roadway is not adequate (deck geometry coded 2)
 - Substructure is damaged (rusted, bent bracing etc.)
 - Seismic settlement Pier/ Abutment 1
