In Service Replacement of Box Girder Bottom Slab

WSDOT Bridge No. 5/537S - Span 11

2015 Western Bridge Engineers' Seminar
Reno, Nevada
September 9-11, 2015

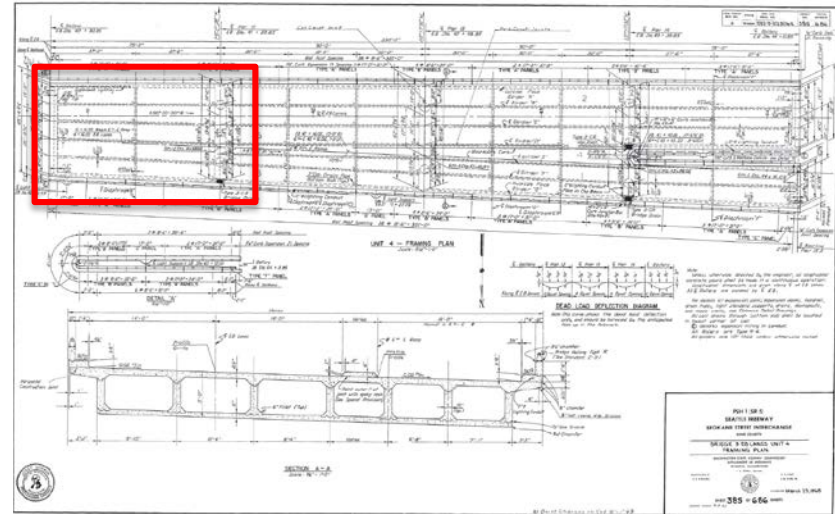
Positive reinforcement to be removed and replaced ((8) #11 bars at each web)

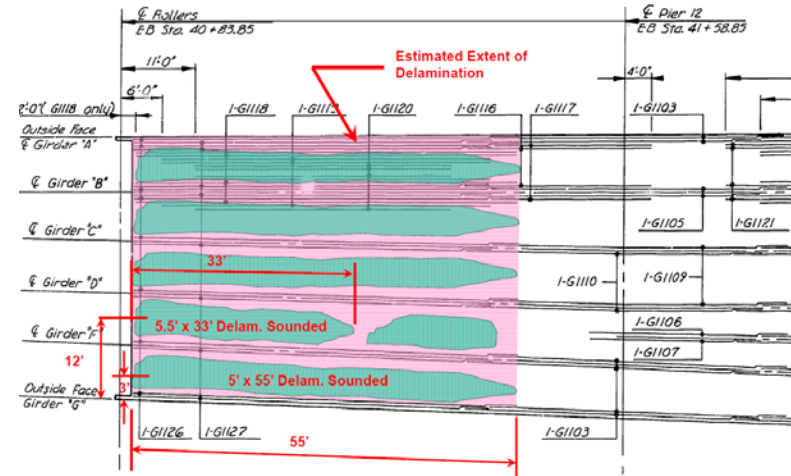
- Sounding of the soffit with a rock hammer found that approximately 70% of the Span 11 bottom surface was delaminated

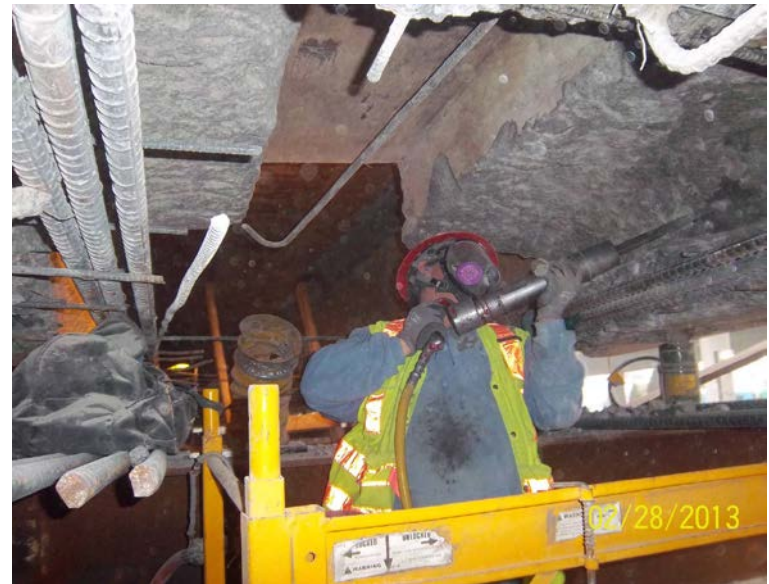
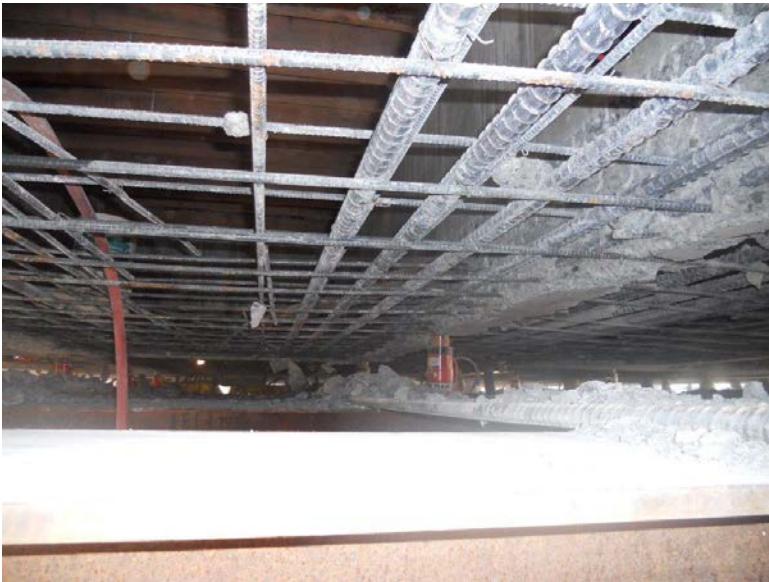
Original reinforcing steel exposed.

Size of equipment used for removal was limited to 30-lb pneumatic hammers, so as to not damage concrete that was to remain

- Contractor chose to remove all concrete with small pneumatic tools
