# GOOD BRIDGES, BAD DETAILS, AND UGLY CRACKS

A STUDY IN TITANIUM ALTERNATIVES TO FIBER REINFORCED POLYMERS

By Paul Strauser, PE

### Str. No. 07626A Mosier WB Conn over Hwy 002

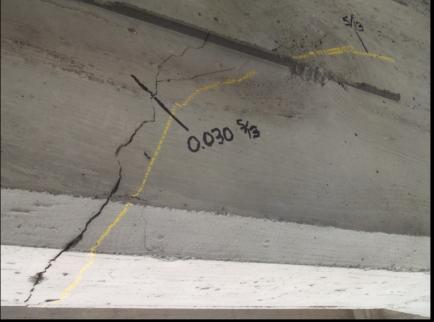
- □ John Adkins, PE R4 Bridge Inspector
  - Span 1 Interior Girders
  - "These cracks seem different from any other cracks I've seen on RCDG structures."
- ODOT Brainstorm
  - Load Rating, HQ, Inspectors
  - Region Notified Salem
    - Updated Load Rating
      - John Milcarek, PE

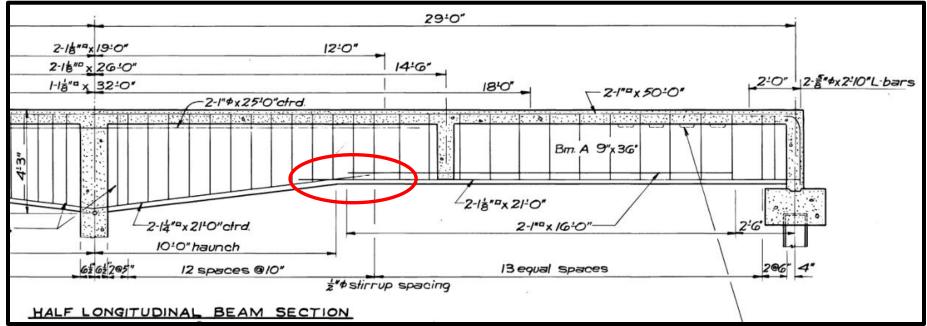
#### Limited Development

- Less than shown
- Vertical Crack Turns Horizontal
  - Anchorage Failure (Not Yield)

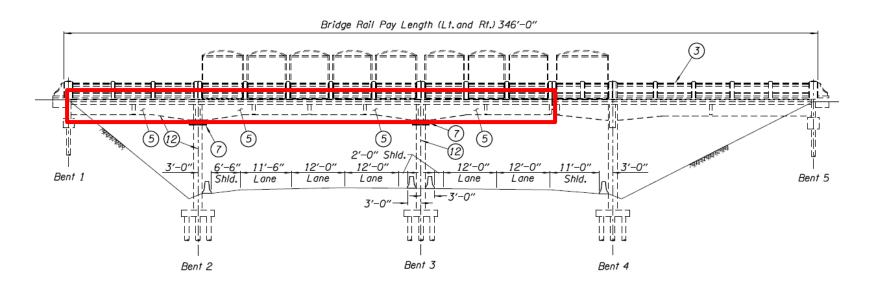
## **Titanium Design**

- Titanium design required 4 bars maximum
- Mid-span deficiencies cause staging issues

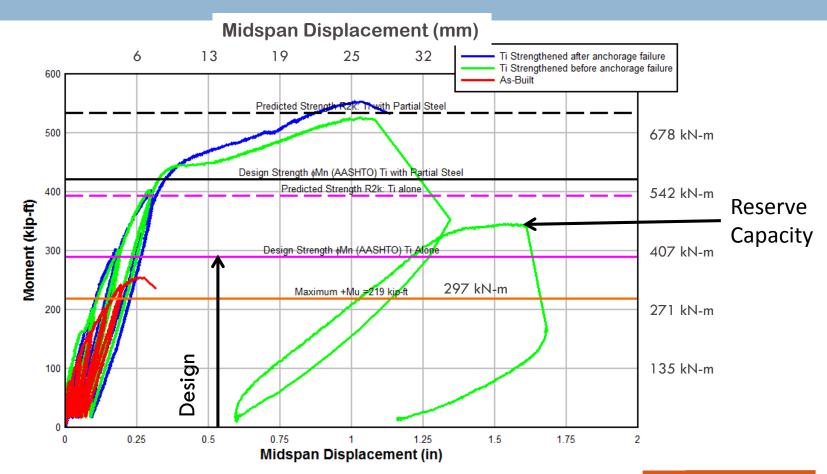
## Analysis

- Reserve strength of Ti girder substantially exceeds factored demands
- Failed anchorage provided similar response as intact

• Design strength of Ti girder exceeds factored demands even with conservative assumptions
