Seismic Retrofit of Ogden Siphon Pipe Suspension Bridge

Western
Bridge
Engineers'
Seminar

Mark L. Reno, P.E.
September 11, 2015

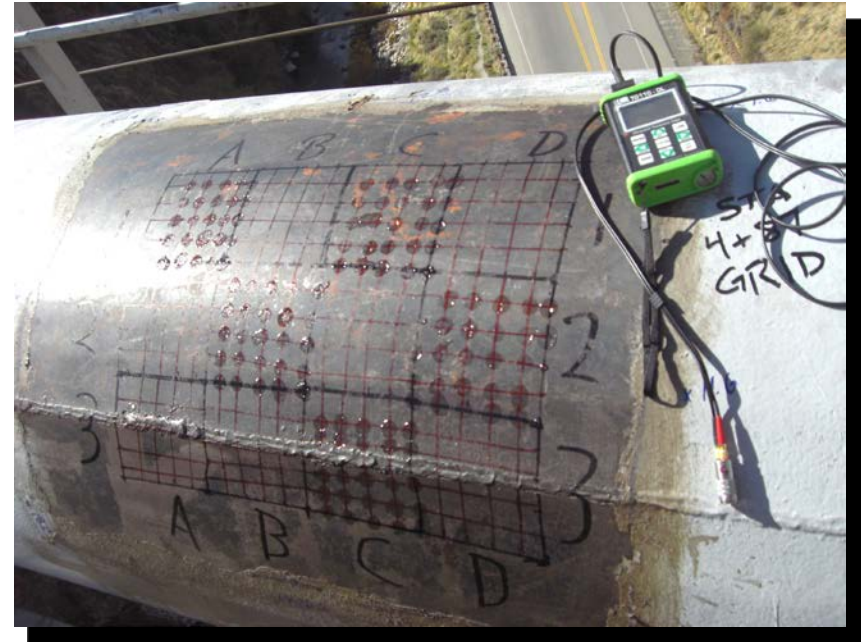
- Pipe condition evaluated by MWH
- Found active corrosion and loss of metal thickness
- Recommended relining and recoating

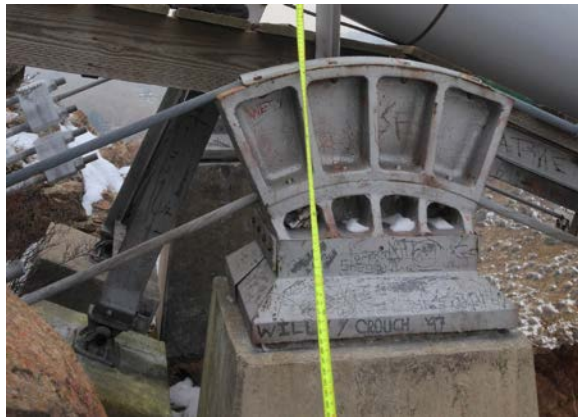
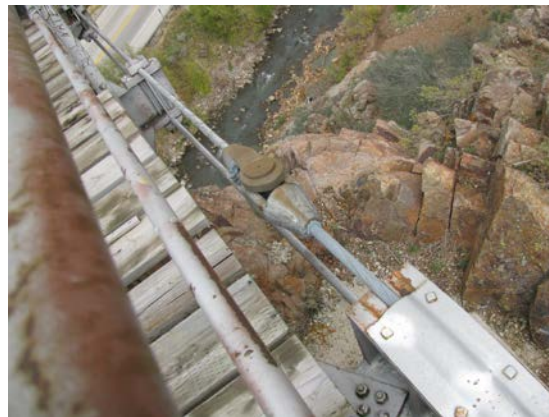
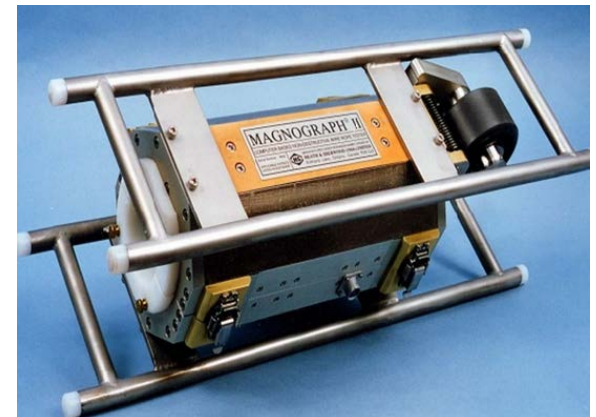
Cable Inspection by Acuren

- Electromagnetic NDT found 5% loss of metallic area
- Portions of main cable require replacement similar to replacement recommended in 1991
- Recommended lifting of upper part of saddle saddles to inspect lower cables
- Cables require cleaning and painting

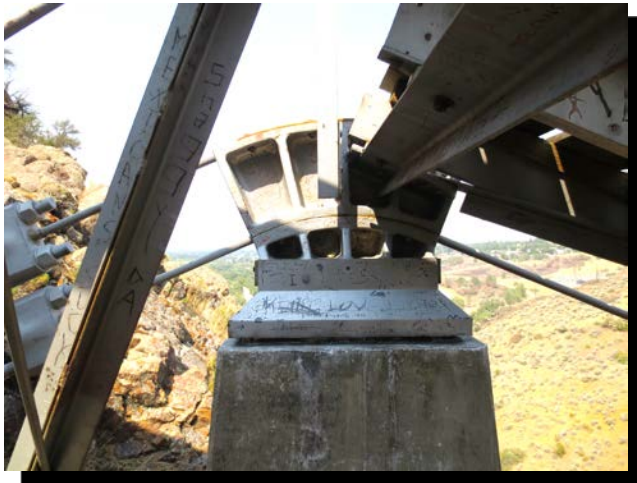
MAIN CABLE

Element	Condition	Retrofit	Replacement
Upper NW & SW	Loss of Area	<ul style="list-style-type: none">• Replace upper NW & SW cable• Inspect all lower cables at saddles and possibly replace	Install New Cables
Galvanizing	Loss of Corrosion Protection	Clean and Paint Cable	Install New Cables

Replacement option changed cable size from 1.50 inch to 1.625 inch to improve factor of safety

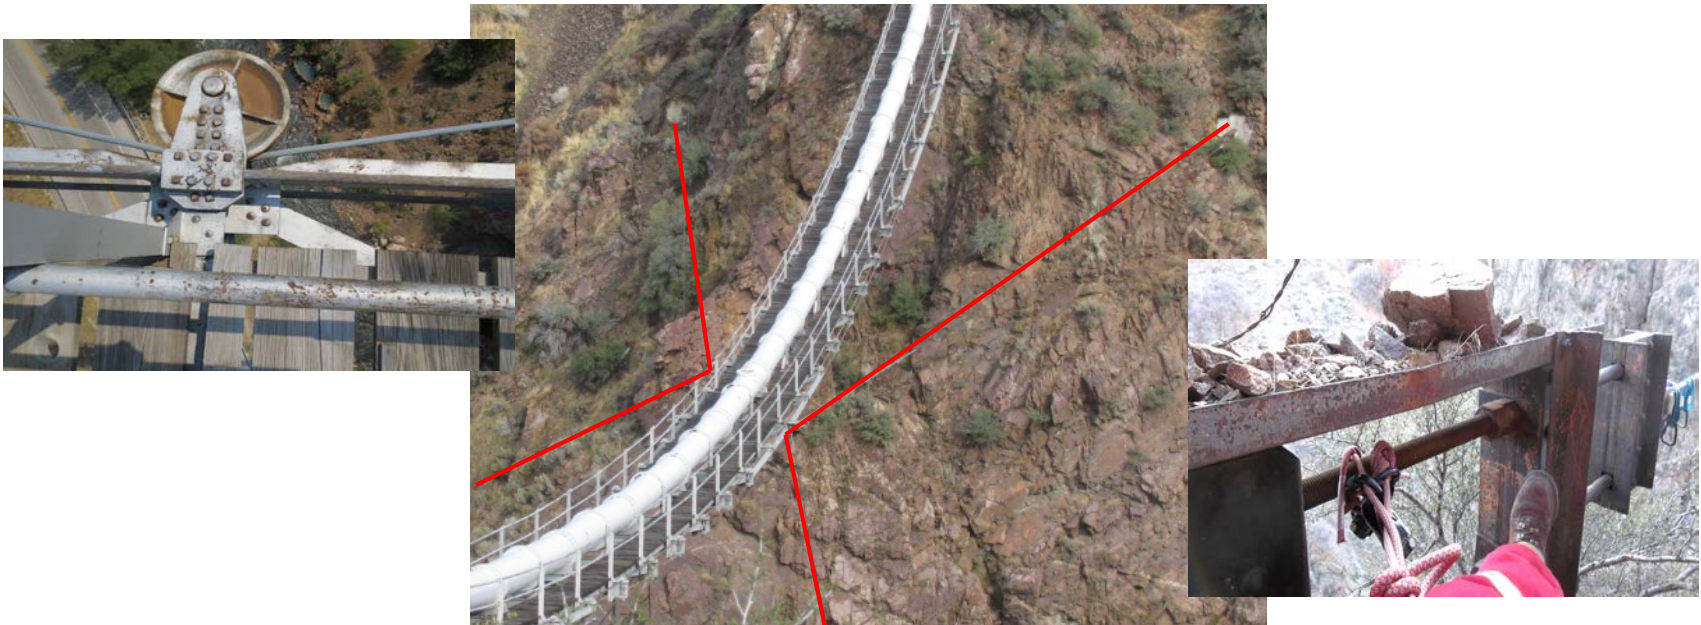
WIND CABLE

Element	Condition	Retrofit
Wind Cable	Inadequate Strength	Install new larger 1.25" dia cable
Wind Sheave Pin	Inadequate Strength	Install new with $F_y = 70$ ksi
Anchorage	Damaged by rock falls	Clean, paint and reinforce w/plates

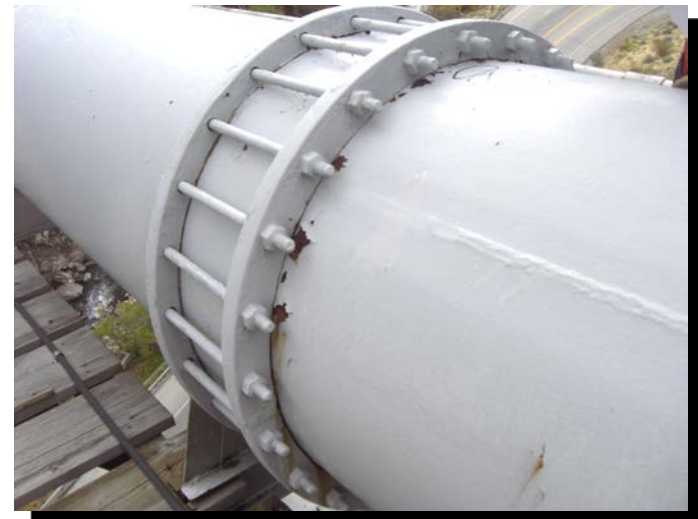
Element	Condition	Retrofit
Couplers	Rotation pipe geometry and from Wind and Seismic Motion produces rotation of existing couplers beyond capacity	Install coupler with greater rotation capacity

Rotational Capacity

Existing 2.5 deg

Retrofit 5.5 deg

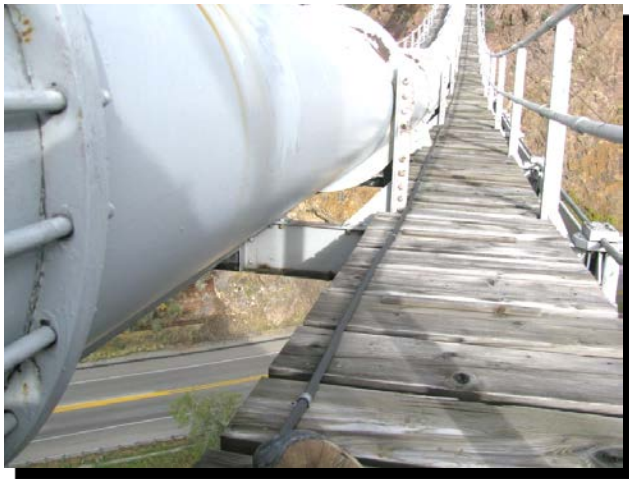
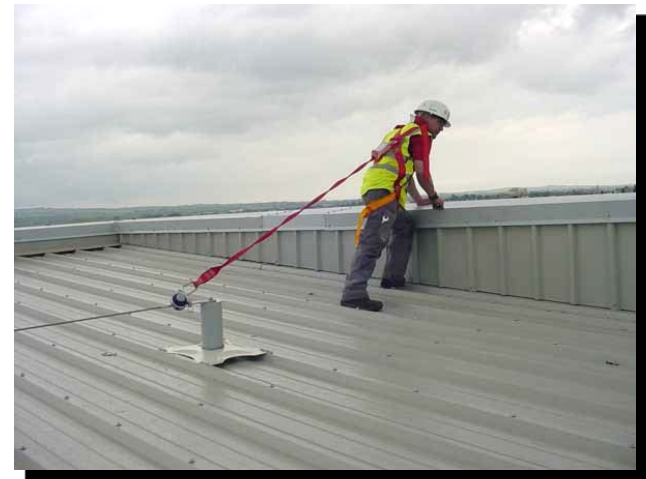
Element	Condition	Retrofit
Wood Deck	Poor Condition	Replace with grating
Wood Deck	Objects can fall	Add toe kick
Rail Posts	Inadequate strength	Strengthen
Worker Safety	No provisions	Add fall protection system

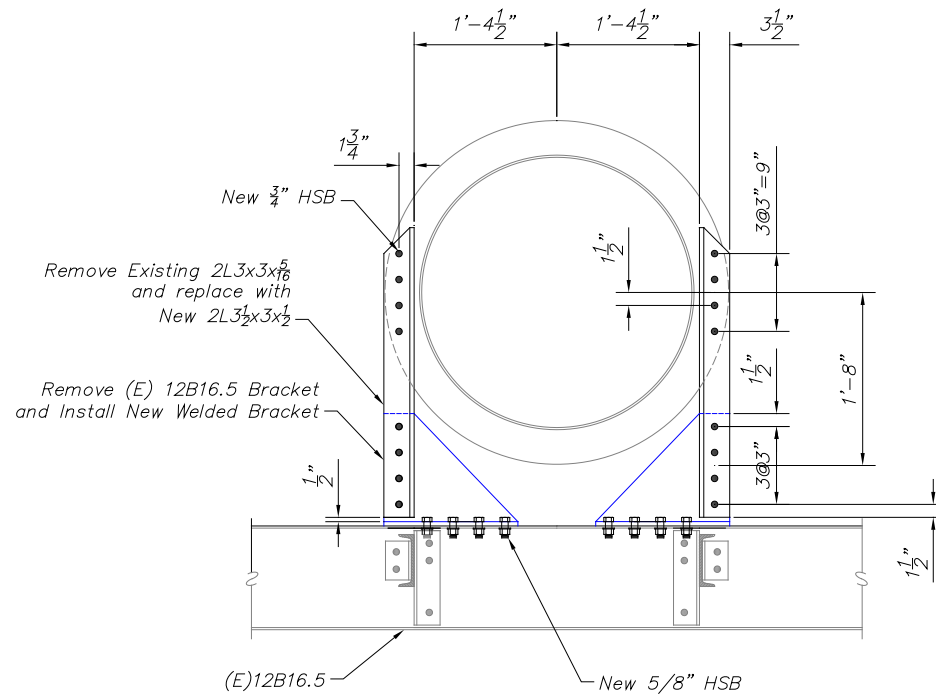
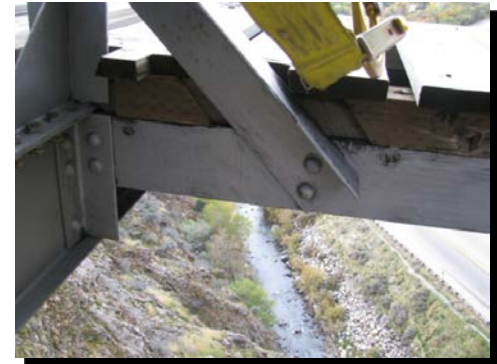
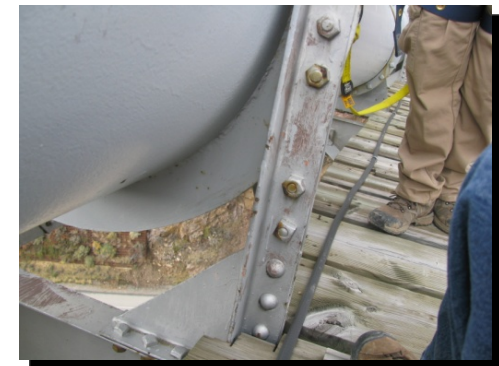
PIPE SUPPORTS

Element	Condition	Retrofit
Pipe Supports	Overstressed	Increase angle depth and thickness. Use $F_y = 50$ ksi
Support Bracing	Overstressed	Install brace on two sides. Use $F_y = 50$ ksi

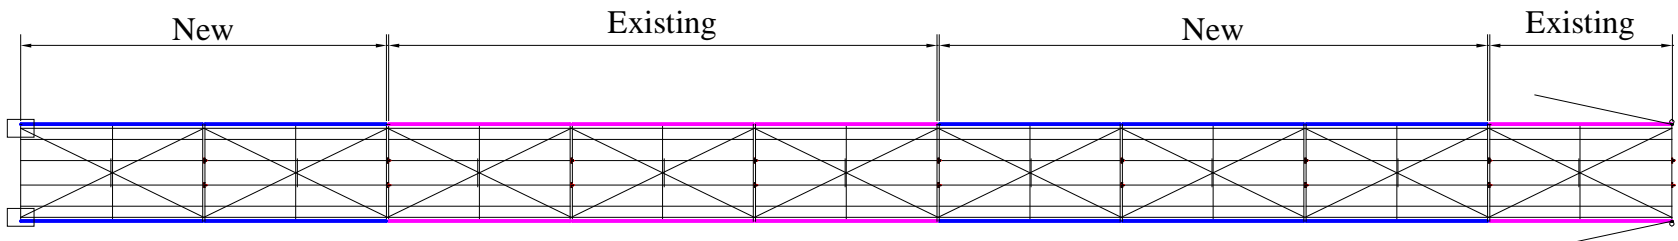
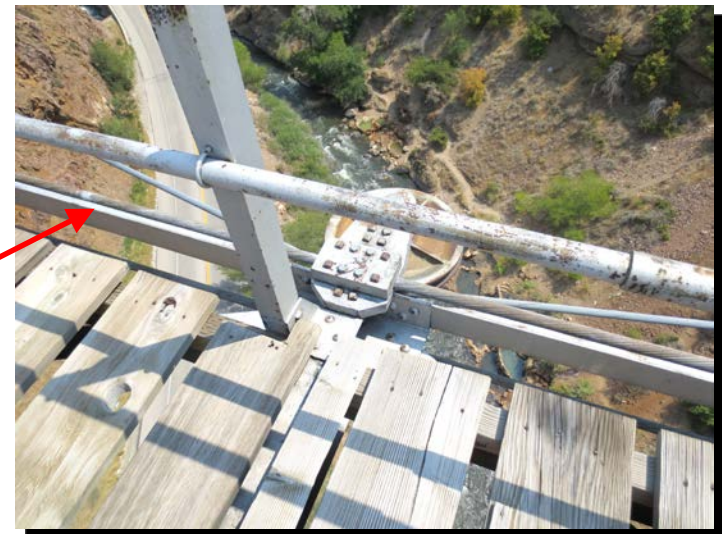
Edge Angle

Element	Condition	Retrofit
Edge Angles	Inadequate strength	Strengthen Existing and Install New Elements

Use slotted holes and tighten HS Bolts after pipe installed to limit tension in members

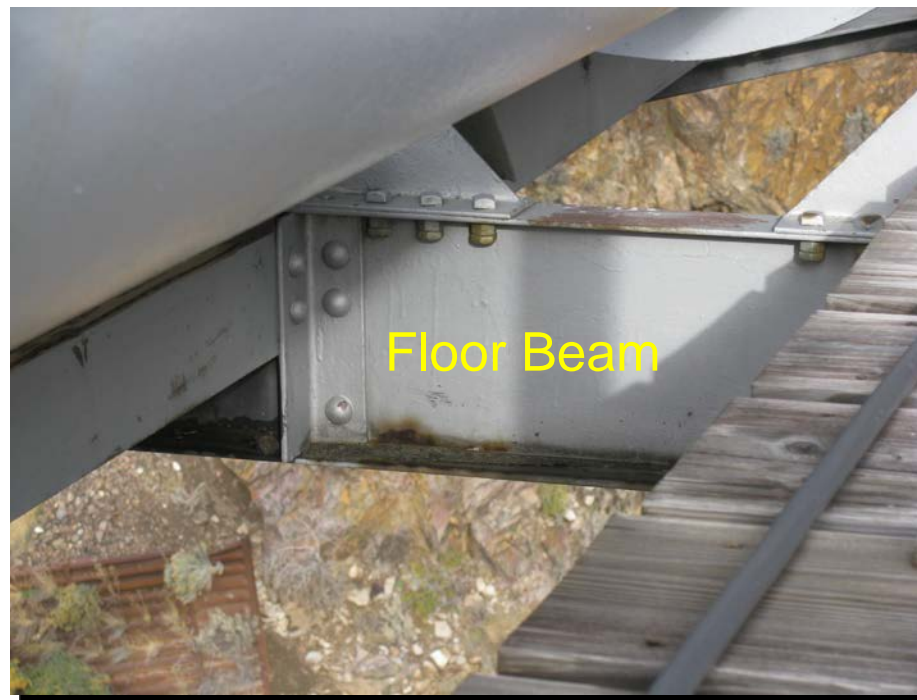
FLOOR BEAMS

Element	Condition	Retrofit Option	Replacement Option
Floor Beam	Overstressed	Add Reinforcing Plates	Use larger size and $F_y = 50$ ksi

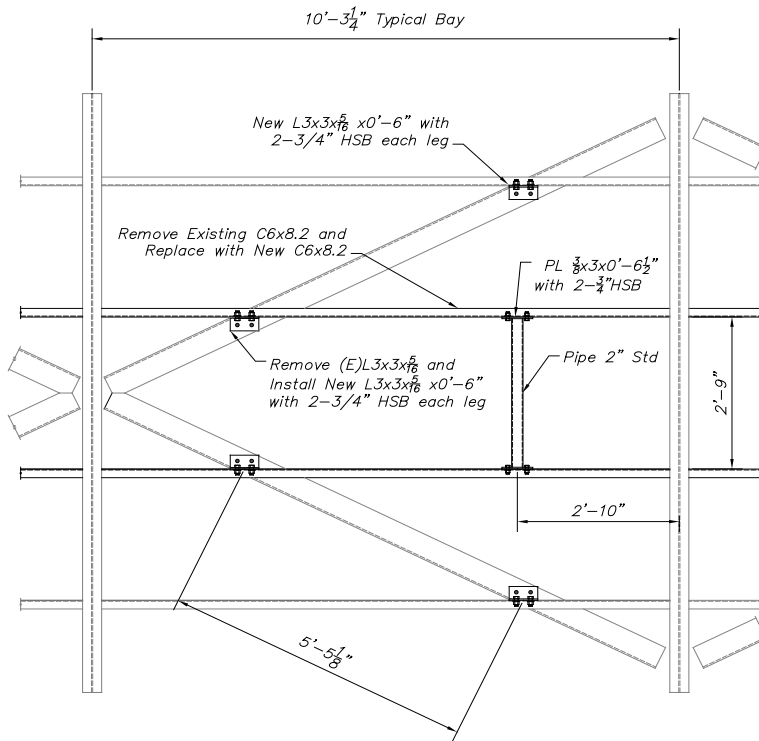
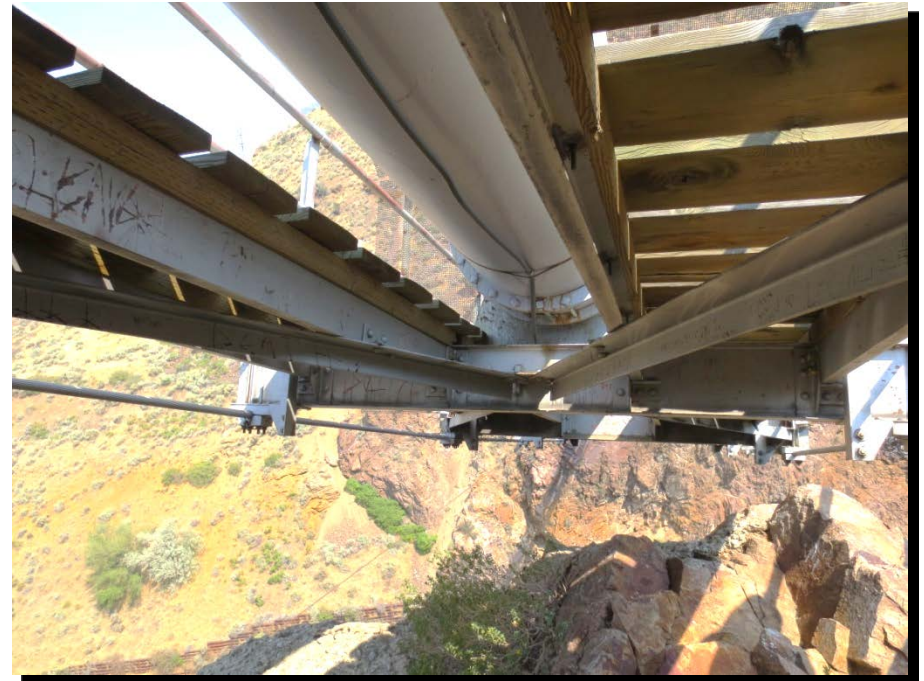
DIAGONAL BRACING

Element	Condition	Retrofit Option	Replacement Option
Diagonal Brace	Overstressed	Reduce Buckling Length	Use $F_y = 50$ ksi

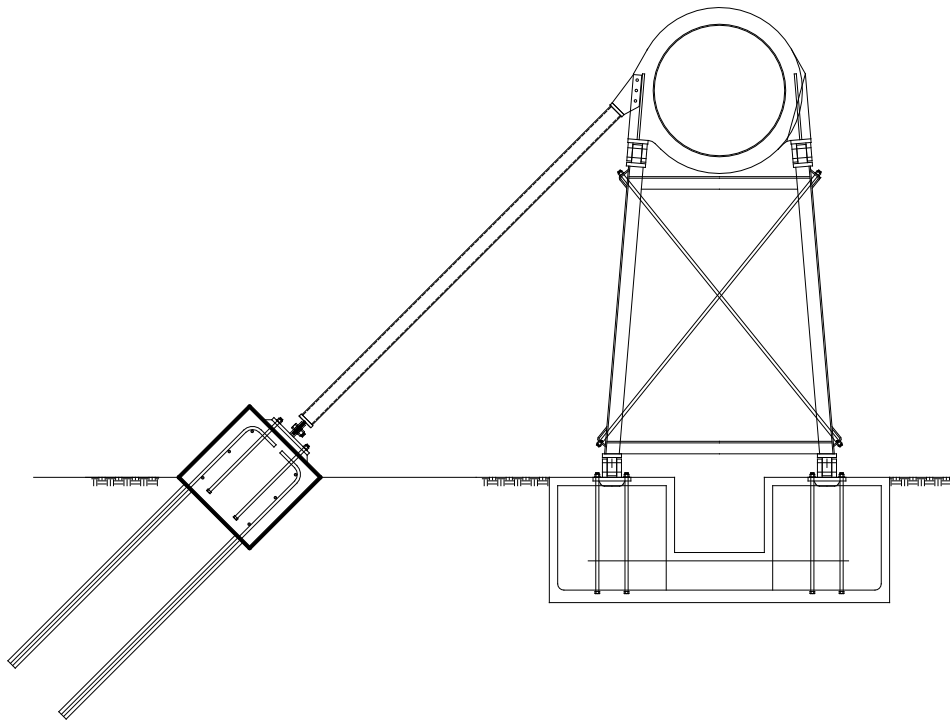
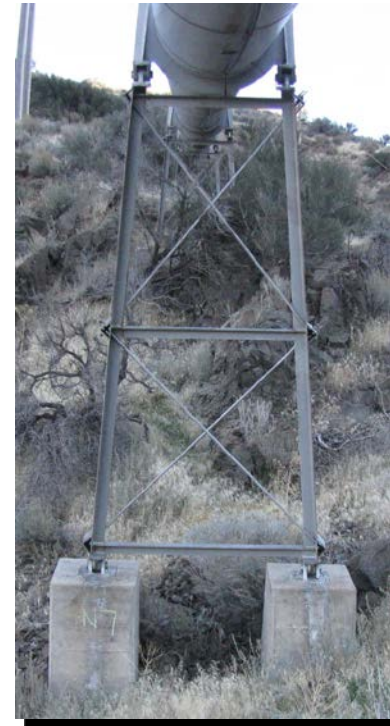
LAND TOWERS

Element	Condition	Retrofit
Rod Bracing	Overstressed	Install external bracing
Foundations	Overstressed	Install external bracing foundation

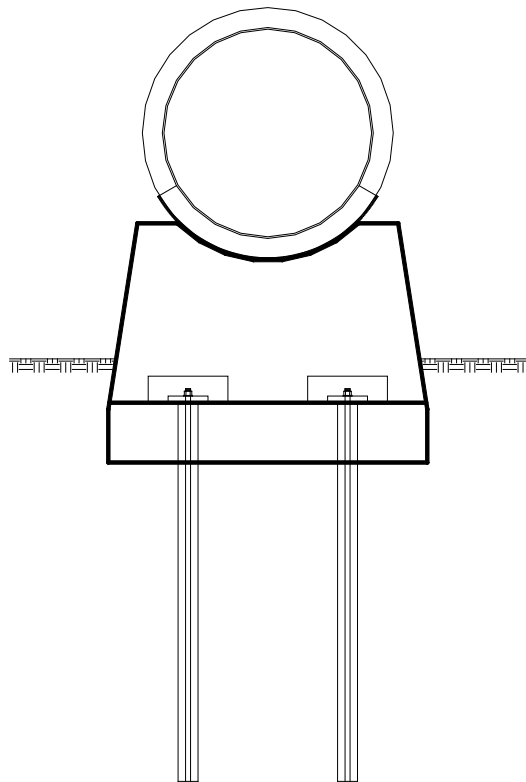
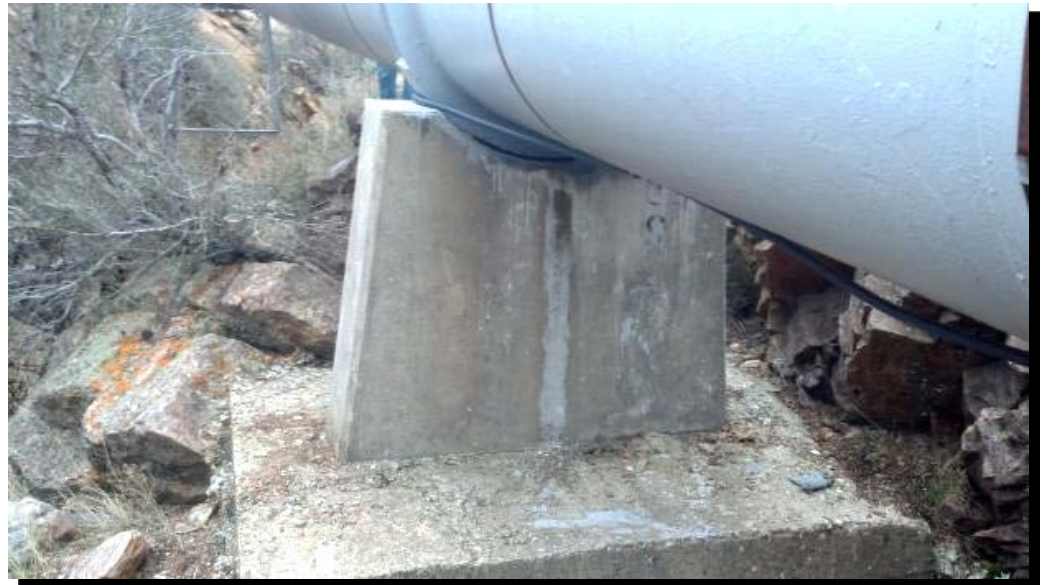
LAND PIERS

Element	Condition	Retrofit
Land Pier Foundation	Subject to Overturning	Add Rock Anchors

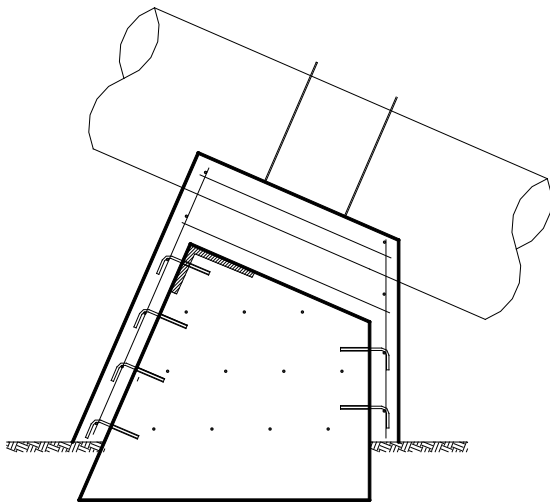
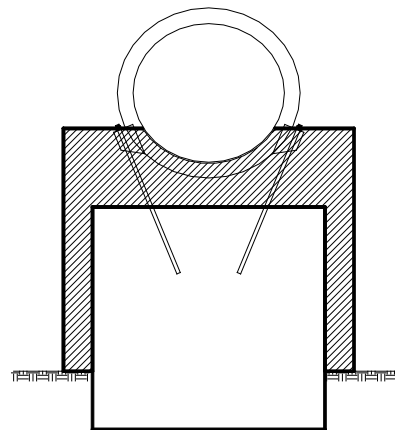
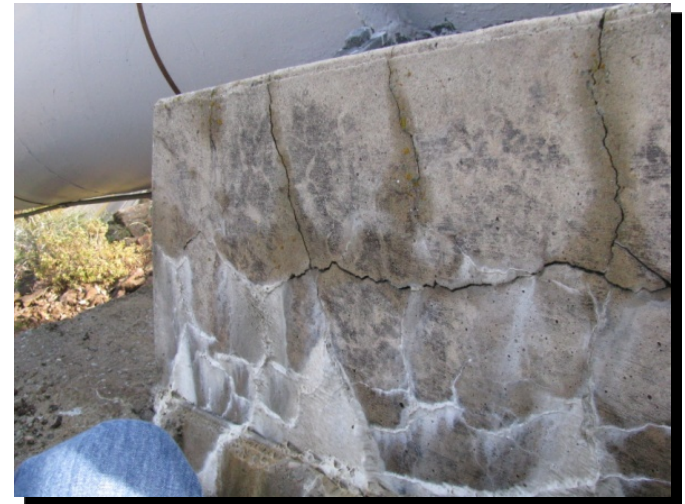
ANCHOR FOUNDATIONS

Element	Condition	Retrofit
Anchor Foundations	Cracked and Spalled Concrete	Remove unsound concrete and add new concrete cover

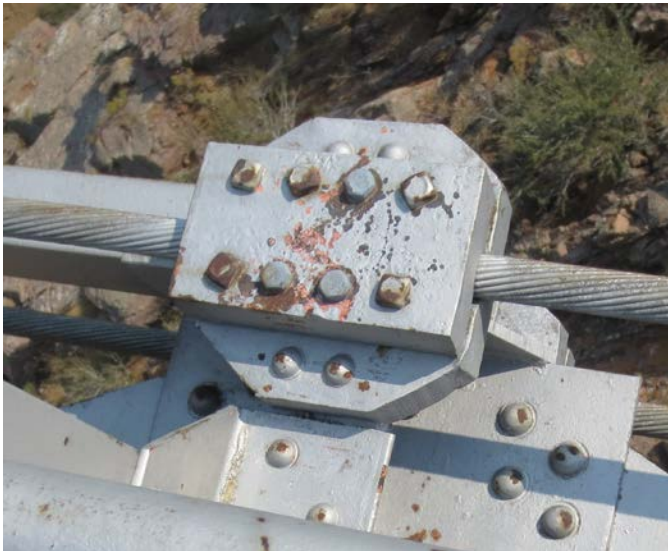
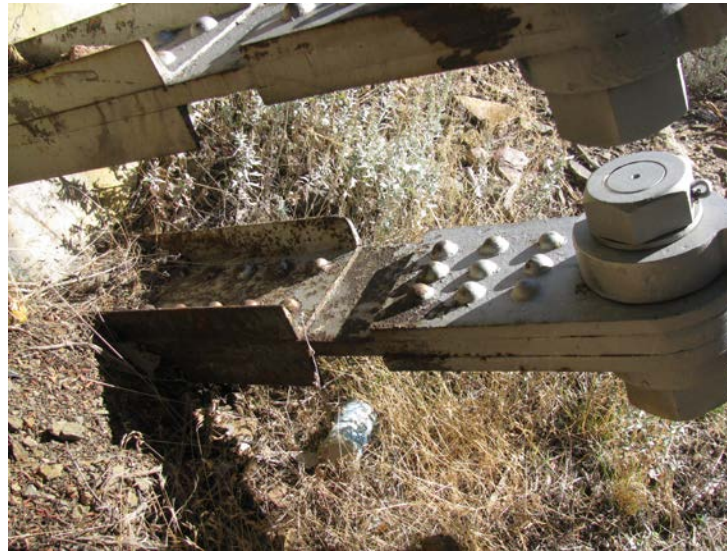
Element	Condition	Retrofit
Paint System	Failed at some locations	Clean and Paint

Existing Paint System contains lead
