UNDERWATER INSPECTION OF THE GOLDEN GATE BRIDGE: THE IMAGE OF AN ICON

COLLINS
ENGINEERSZDaniel G. Stromberg, S.E., P.E.
Project Manager
Chief Structural Engineer/Diver

South and North Tower Piers Underwater Bridge Inspection Services

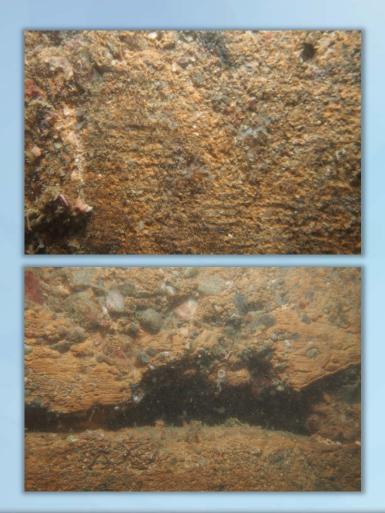
South Tower Pier-Findings

- Generally remarkably good concrete surfaces
- Minimal loss of original section
- Structurally insignificant section loss along construction joints
- Up to 26 ft. of sediment in moat

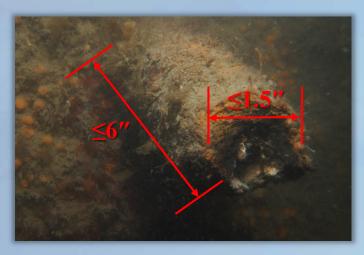
South Tower Pier-Findings

- Random vertical cracks around perimeter of shaft
- Random steel protrusions at base of shaft

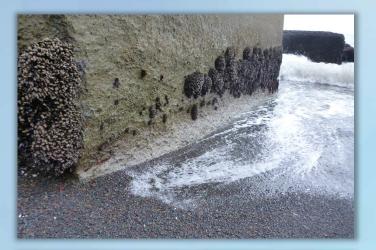
North Tower Pier-Findings

- Generally remarkably good concrete surfaces
- Minimal loss of original section
- Erosion-related section loss
- Sound shaft-bedrock interface
