3 WESTERN BRIDGE SEMINAR 2017 INNOVATIVE LARGE SHAFT REPAIR

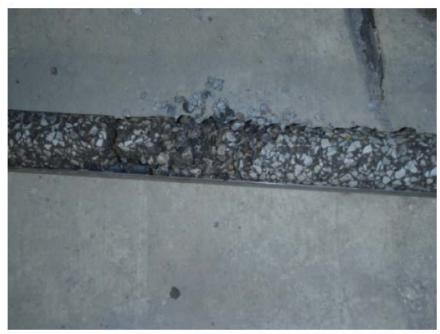
Photo 16 3R-2 Center Boring Closeup 123.6' to 124.5' Box ? of ?

- > Coring samples
- > 1.7ksi average f'c in bottom part of the shaft

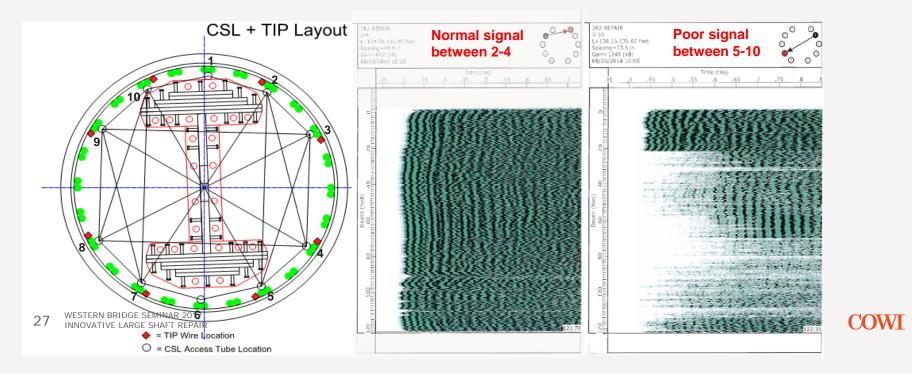
- Crosshole Sonic Logging (CSL) on the new shaft.
- Thick flanges blocked sonic signals being transmitted between 1-6, 2-7, 5-10, etc.
- CSL: Inclusive results in those paths intersected by flanges.

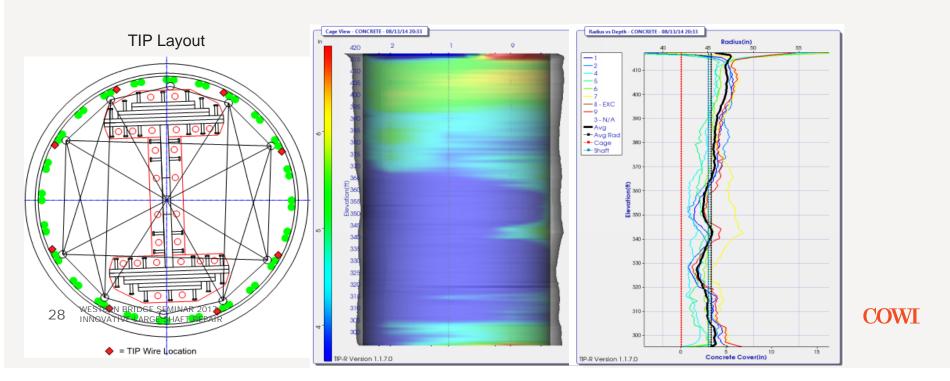
- Thermal Integrity Profiling (TIP) was pre-planned and carried out on the new shaft.
- TIP thermal wire measurements were monitored during concrete pour and over the next 35-hour period.
- TIP: Concrete cure was normal; Detected slight cage tilting; No concerns.
