**Technical Presentation**

# Willow Creek Bridge No. 5 (I-40)

**ADOT Structure No. 1768**

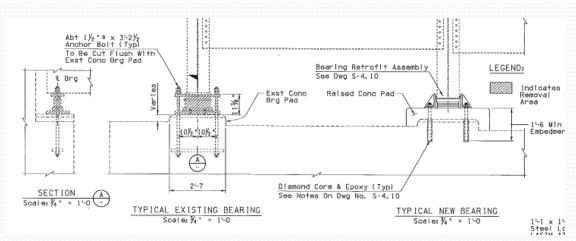
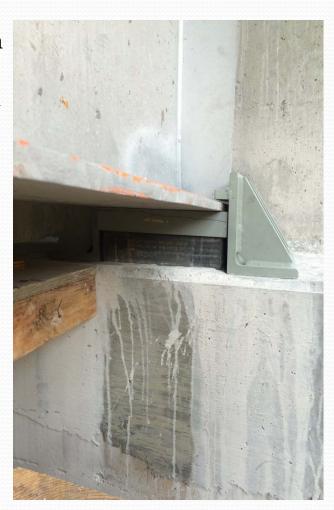
## **Abutment Bearing Replacement**

- Rocker bearings replaced with raised concrete pedestals, elastomeric bearing pads, and steel angles to restrain girder movement.
- Work was accomplished with temporary hydraulic jack supports.

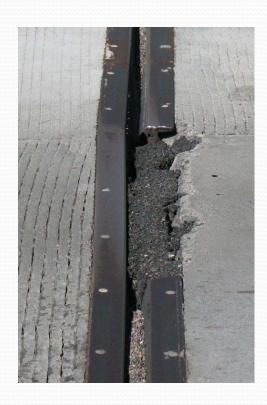
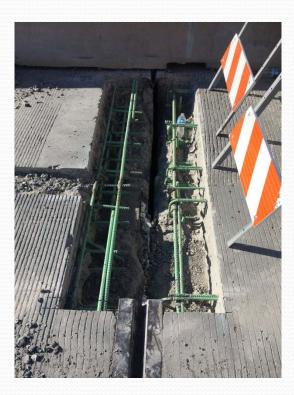
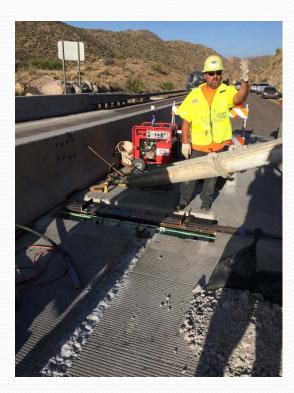
# Bridge No. 1 (Str # 1592)

• Transverse Joint Repair

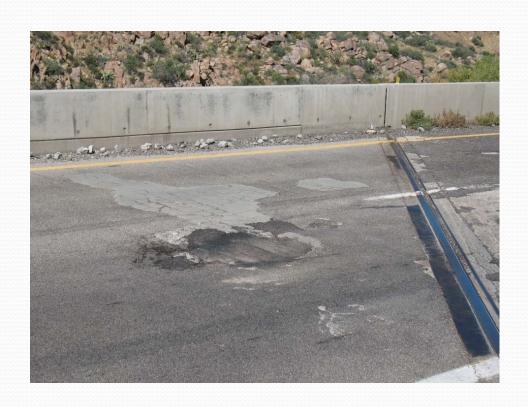
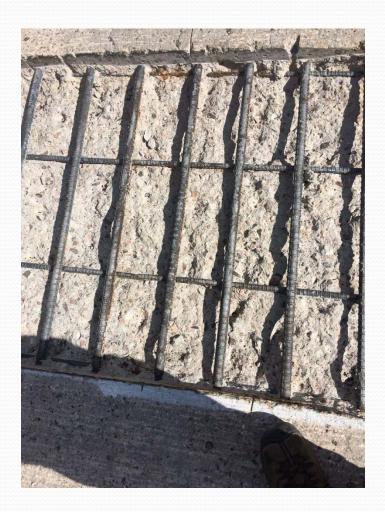
# Bridge No. 3 (Str # 1594)

Bridge Deck Overlay

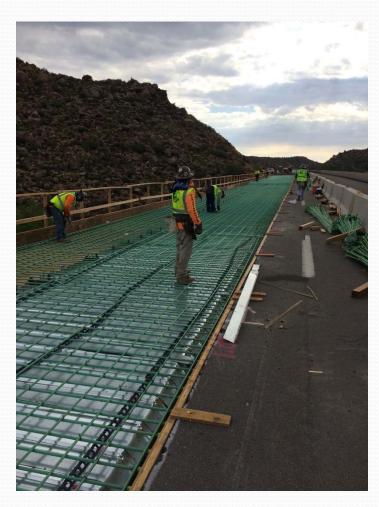
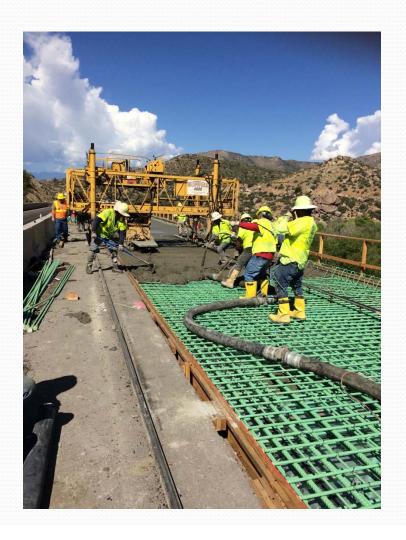
# Bridge No. 4 (Str # 1595)

Deck Replacement

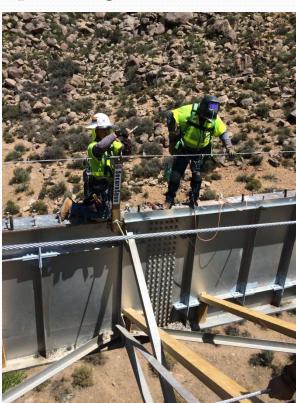
## Bridge No. 4 (Str # 1595)

- Girder Repairs -
  - New Bearing Stiffeners
  - Repair Longitudinal Stiffeners

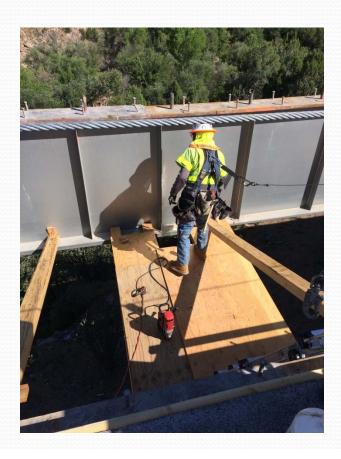
New Bottom Flange Cover Plate

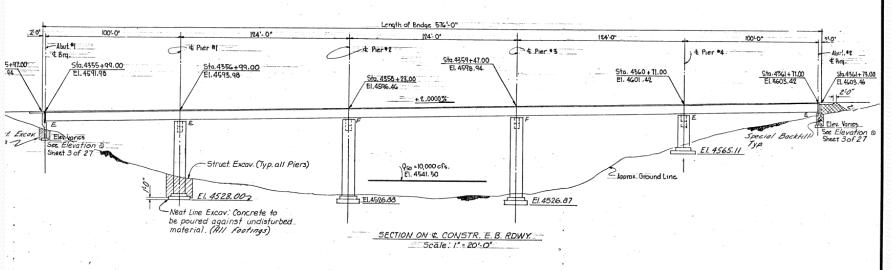
## Bridge No. 5 (Str # 1768)

• Willow Creek Bridge No. 5 consisted of a 5-span steel girder bridge with a composite cast-in-place concrete deck built in the late 1960's. The concrete deck was experiencing severe corrosion due to deicing salt usage.

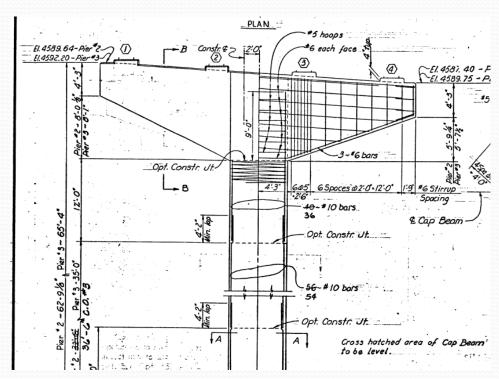
- Existing pier columns on Bridge No.5:
  - Single-column piers, large cantilevers (16'-9" pier overhangs)
  - Maximum height of 65'-4" (top of pier to bottom of footing) with a diameter of 7'-6"
  - 2500 psi concrete
  - Grade 40 steel

- Existing pier columns on Bridge No.5:
  - Not conducive to phased deck replacement!!

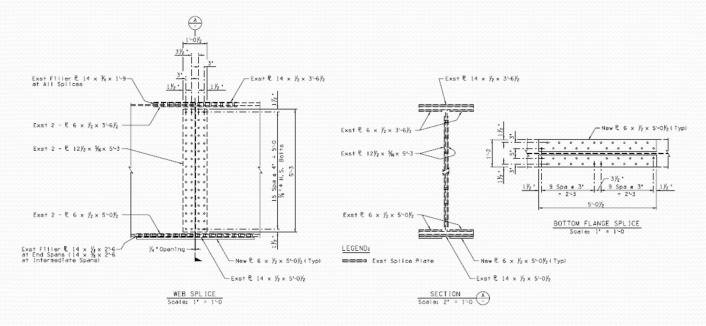
## Bridge No. 5 (Str # 1768)

- Girder Repairs -
  - Bottom Flange Splice Plate Repair
  - New Bottom Flange Cover Plate
  - New Intermediate Cross Bracing
