# Healdsburg Avenue Bridge – Reviving a Piece of History

**Mark A. Weaver, PE, SE**

**Cornerstone Structural Engineering Group**

Western Bridge  
Engineers' Seminar  
September 6-8, 2017

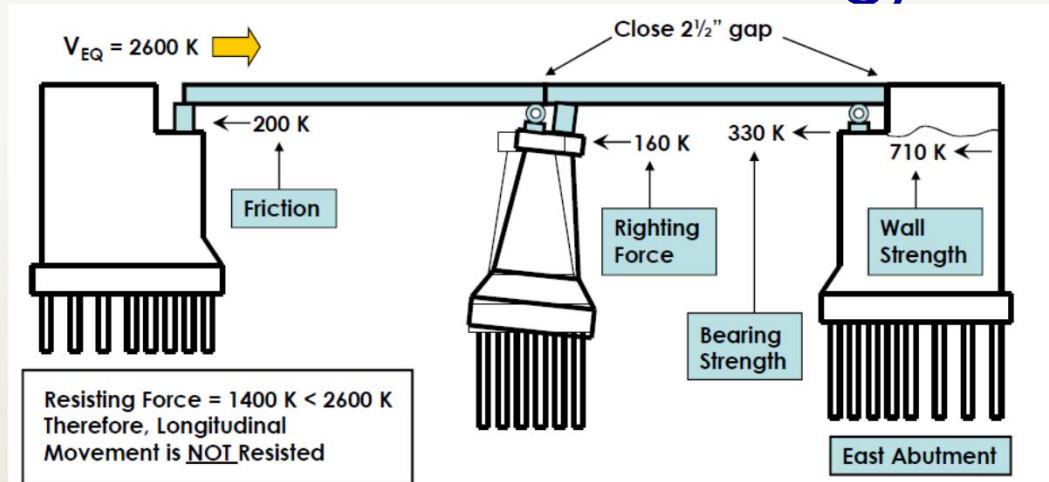
| LONGITUDINAL PUSH TOWARDS EAST ABUTMENT | | | | COMMENTS |
|---|---|---|---|---|
| Peak Inertial Force (k) | 2600 | | | Abut walls FAIL. Long. movement is unrestrained. |
| Abut walls | 1910 | 710 | 2.7 | |
| Abut walls | 2070 | 710 | 2.9 | |

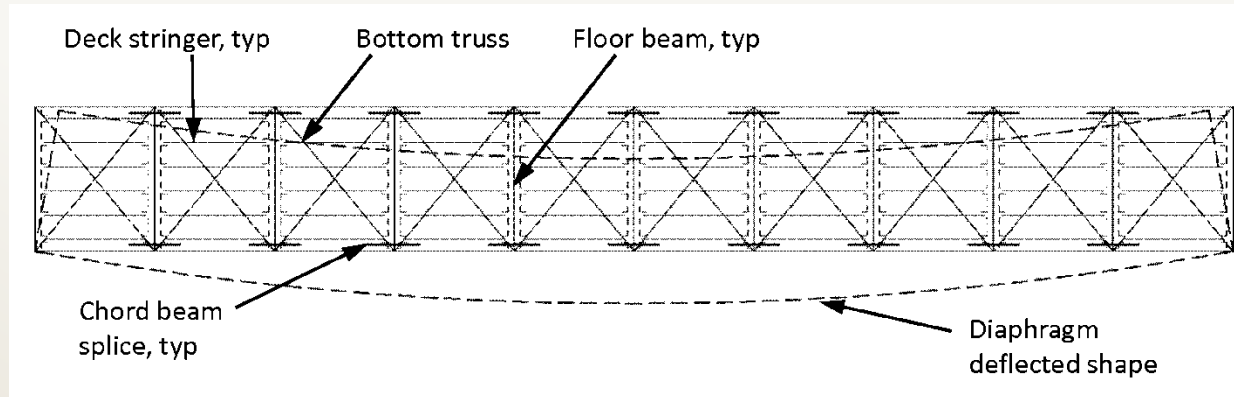
| MODE | TRANSVERSE RESPONSE | | | COMMENTS | |
|---|---|---|---|---|---|
| | | Shear Connectors | 0 | <b>NG</b> | No mechanism for shear transfer between deck & end floor beams. |
| Tension (k) | 1040 | Stringer | 490 | <b>2.12</b> | Stringer YIELDS, resulting in loss of support for deck. |
| | | Stringer-to-floor beam Connection | 130 | <b>8.00</b> | Connection FAILS, resulting in loss of stringer. |

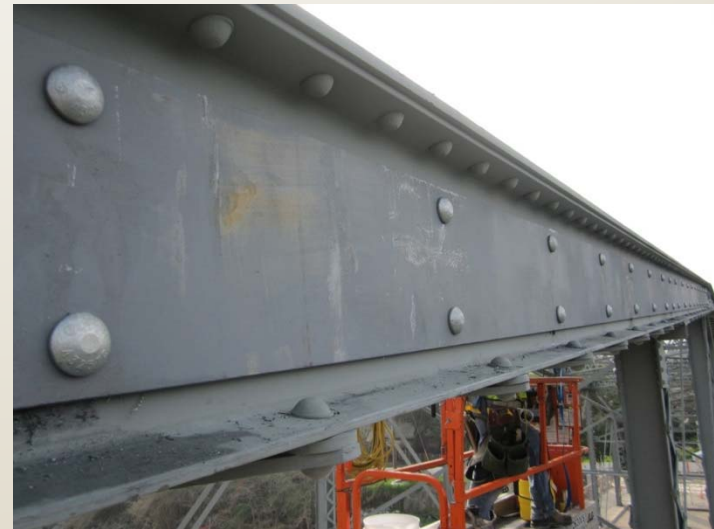
Always Check Truss Pin  
Eccentricity

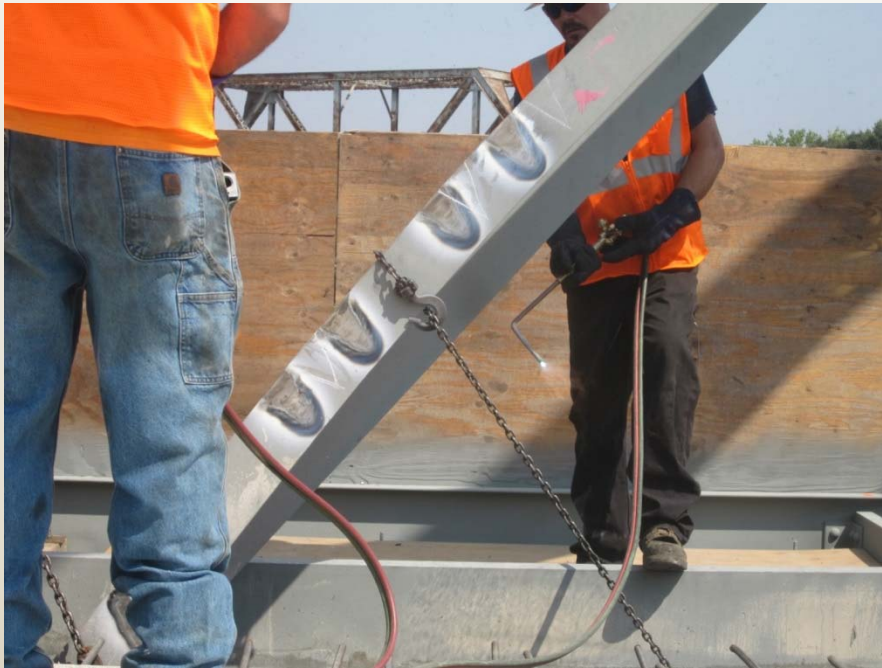
Before Heat Straightening

- Highly Effective
- Completed in Only a Few Days
- Web Members Tuned to Balance Load

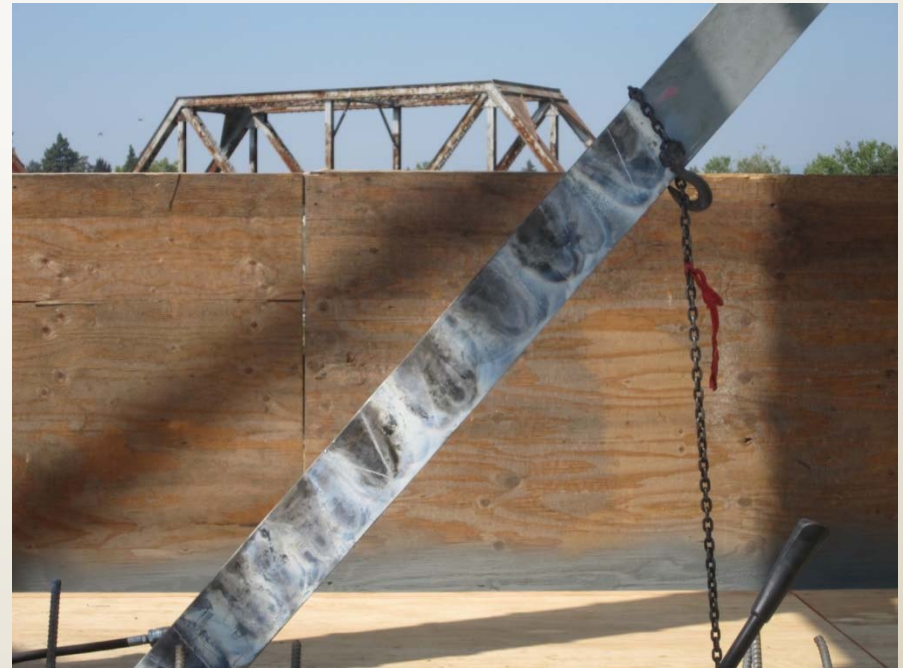
After Heat Straightening

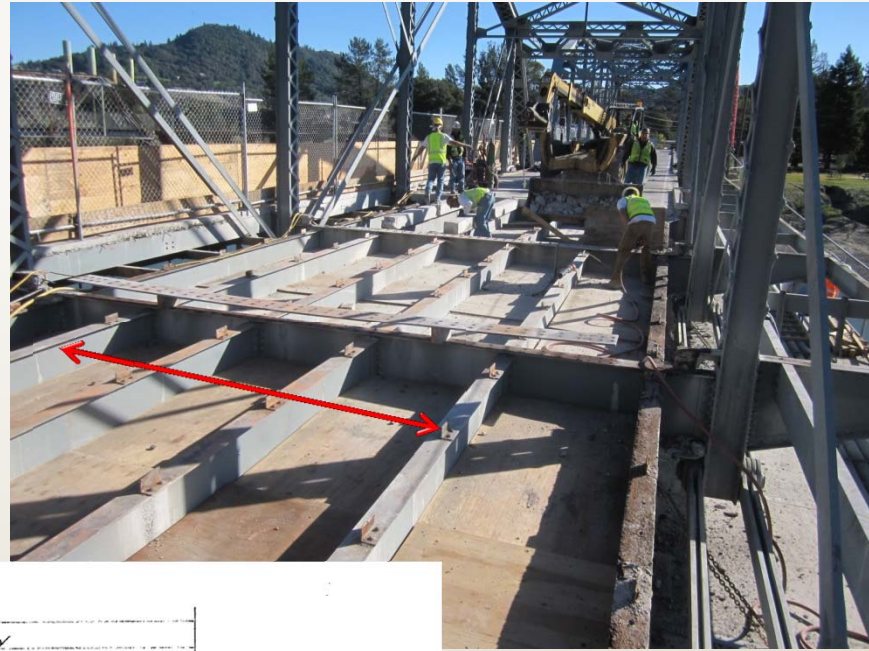
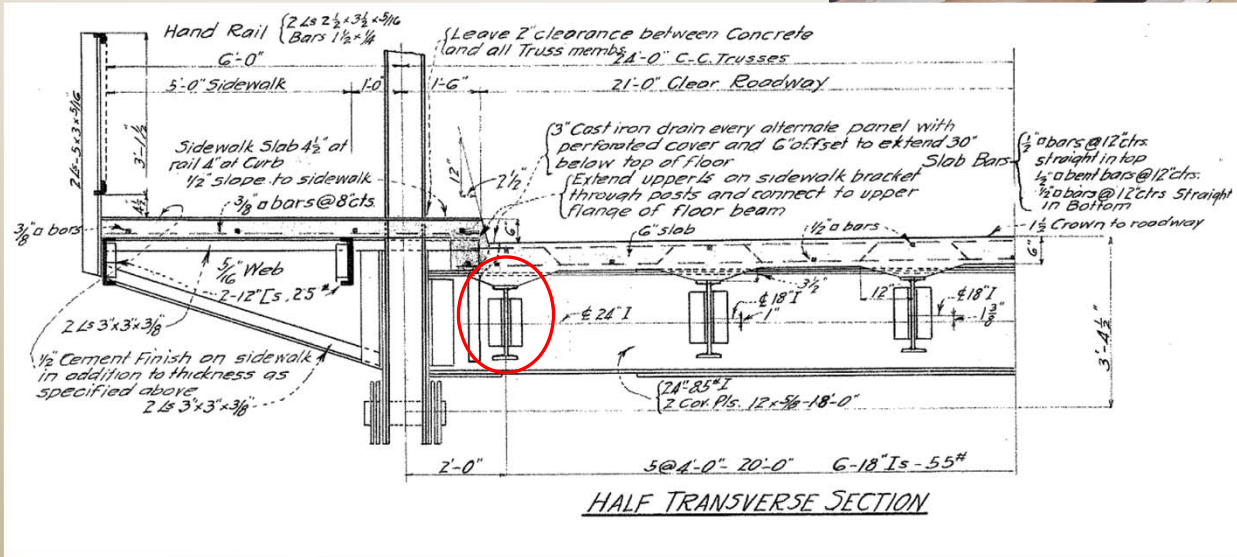
- Severe Pack Rust on Exterior Stringers
- Interior Stringers Minor Surface Rust
- Maintaining Deck Drainage is Not a Minor Concern For Steel Bridges

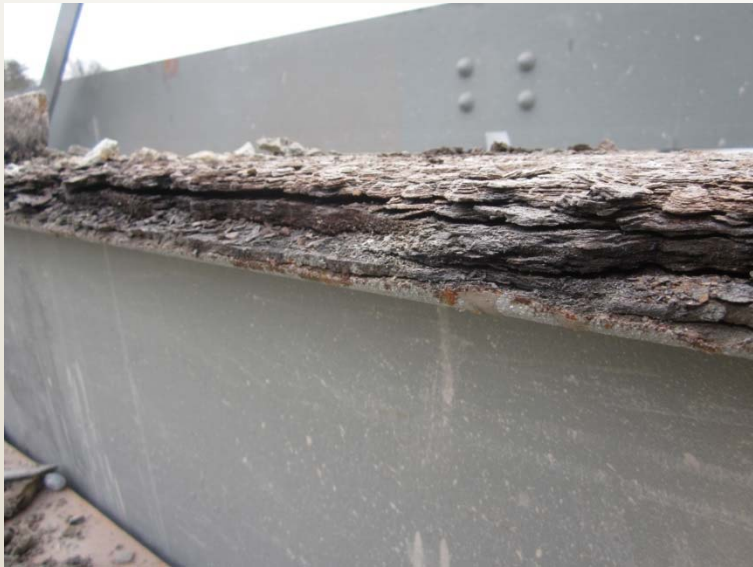
Before Cleaning Stringer

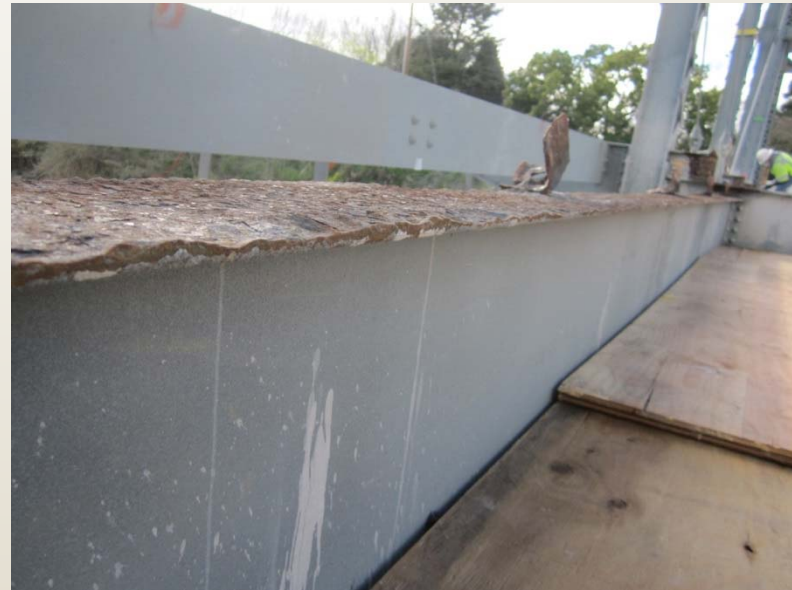
After Cleaning Stringer

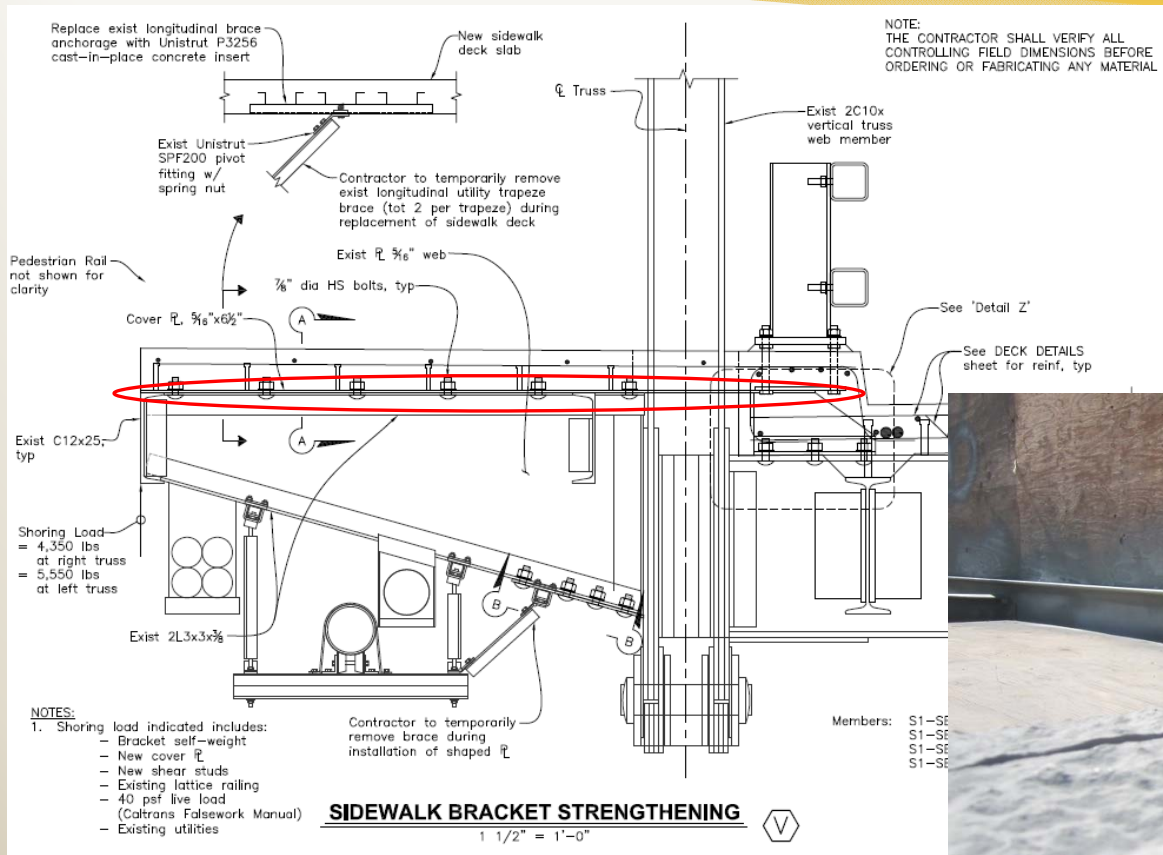
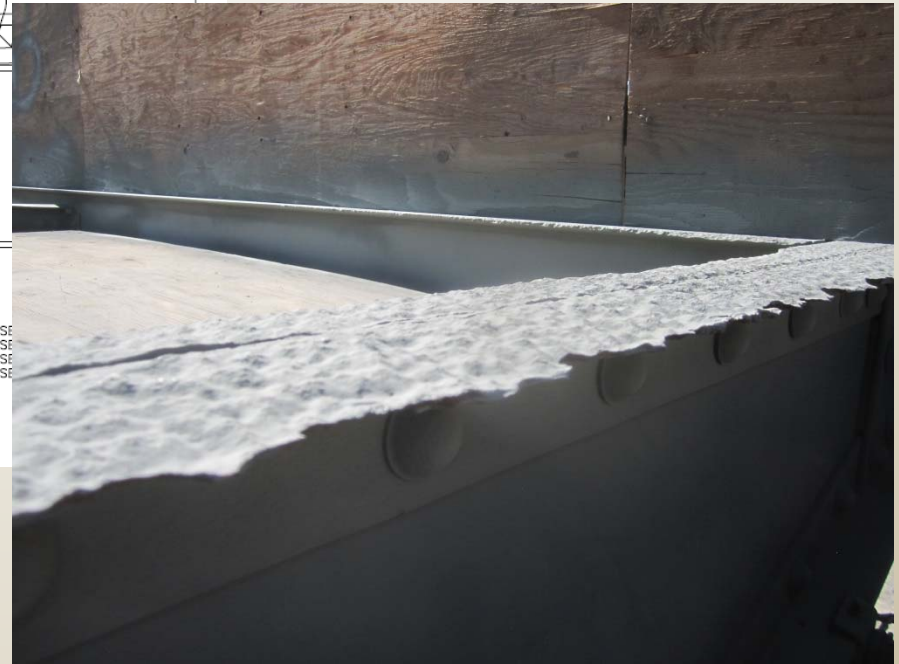
- Primary Sidewalk Support Member Almost Entirely Gone
- Double Angles Replaced
