Boeing Access Road Bridge Seismic Retrofit & Rehabilitation

**Western
Bridge
Engineers'
Seminar**

Kevin Kim, PE, SE, P.Eng.
Hana D'Acci, PE

Portland, OR
September 6, 2017

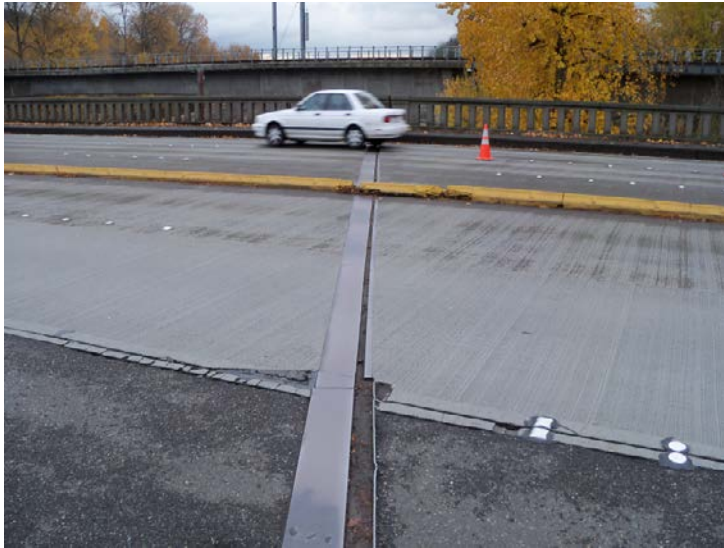
Expansion Joints –
Transverse & Long.

- Solution:**
- Repair or replace transverse expansion joint to meet current standards.
 - Seal longitudinal joint to minimize future maintenance.

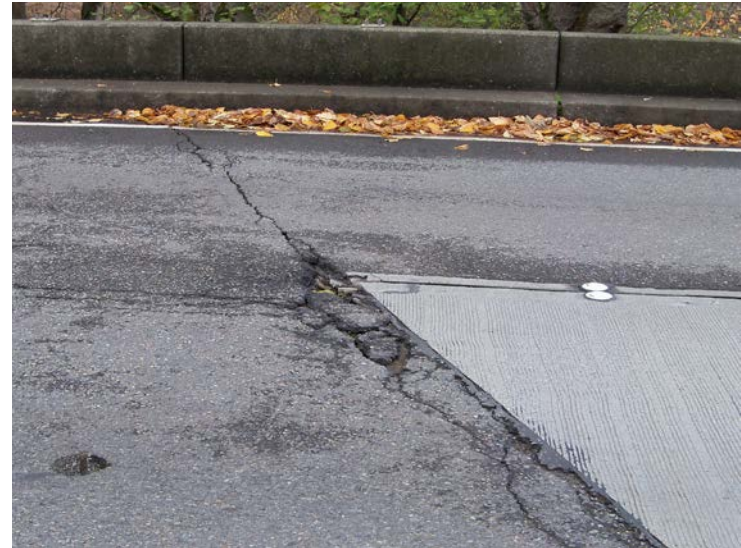
Joints in Pavement

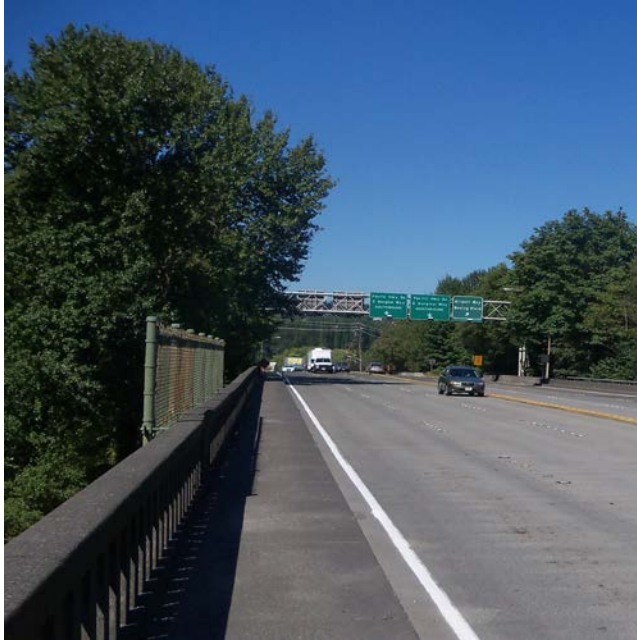
Narrow Sidewalk

- Solution:**
- Narrow 4 of the 6 existing lanes to establish a new traffic barrier at the existing southern curb line.
 - Replace barrier on south side with 10-foot pedestrian/bicycle path and railing.

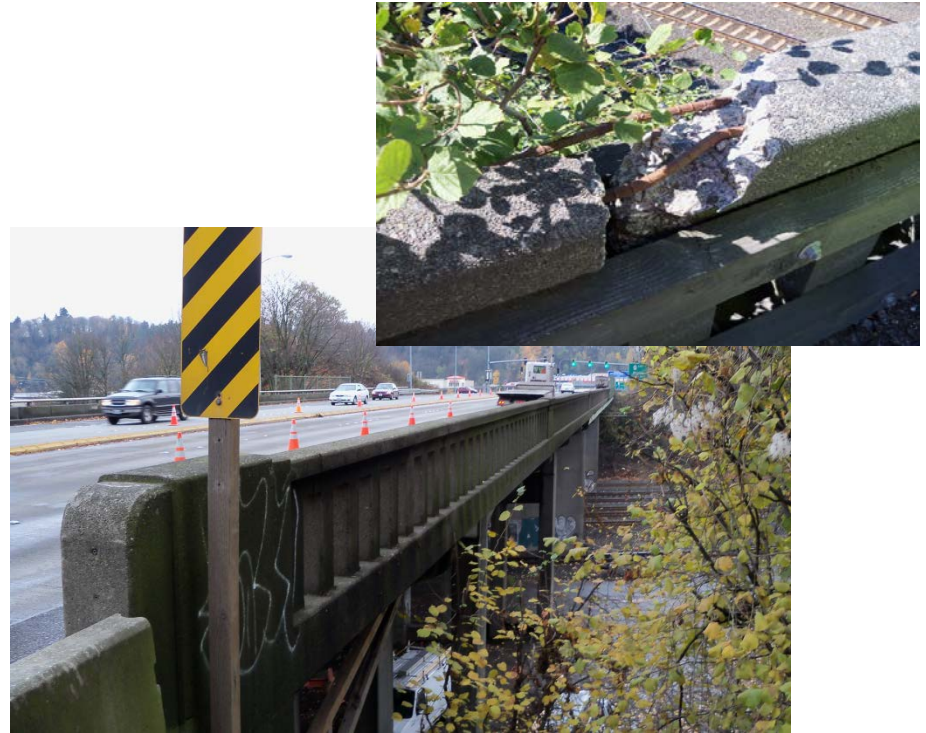
Concrete Barrier

- Solution:**
- Repair with appropriate materials to increase barrier longevity.
 - Replace traffic barrier as part of the bridge widening, if necessary.

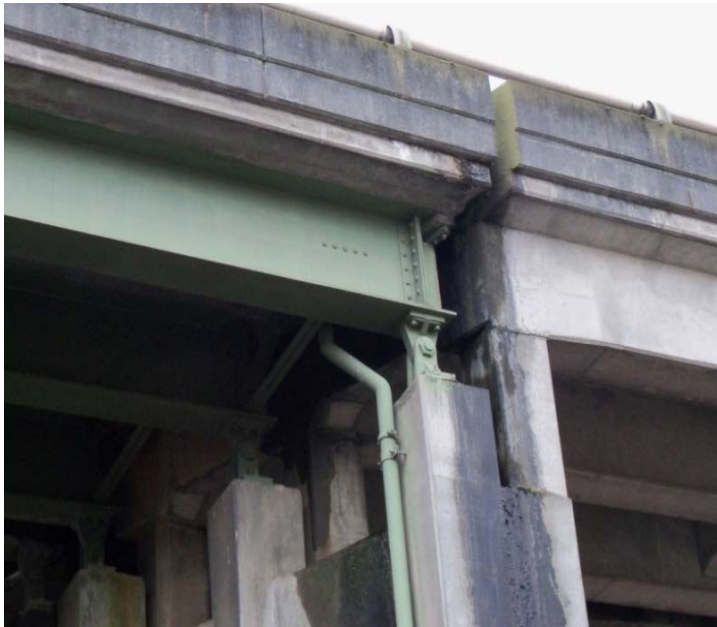
Transverse joint at Pier 4

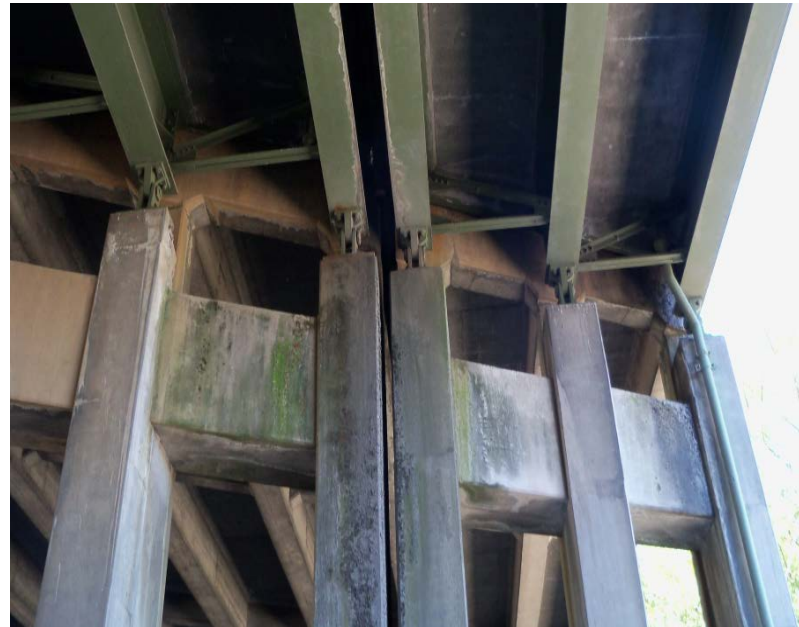
Longitudinal joint

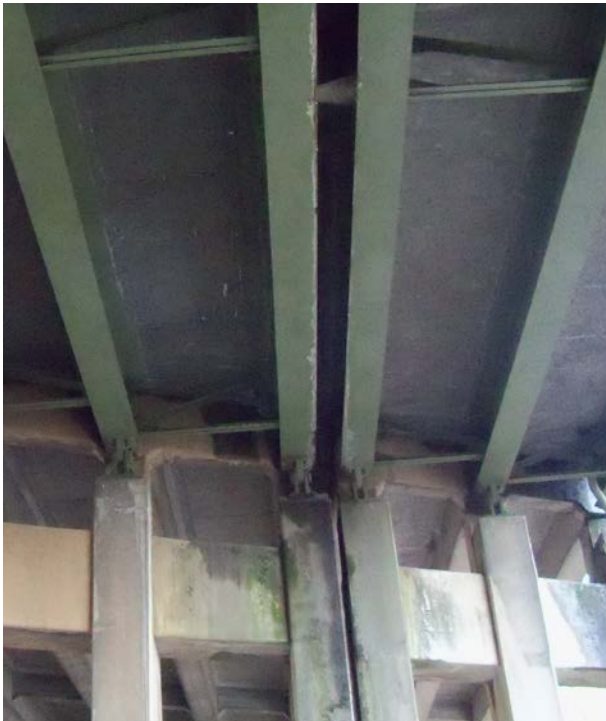
Corroded Steel Girders

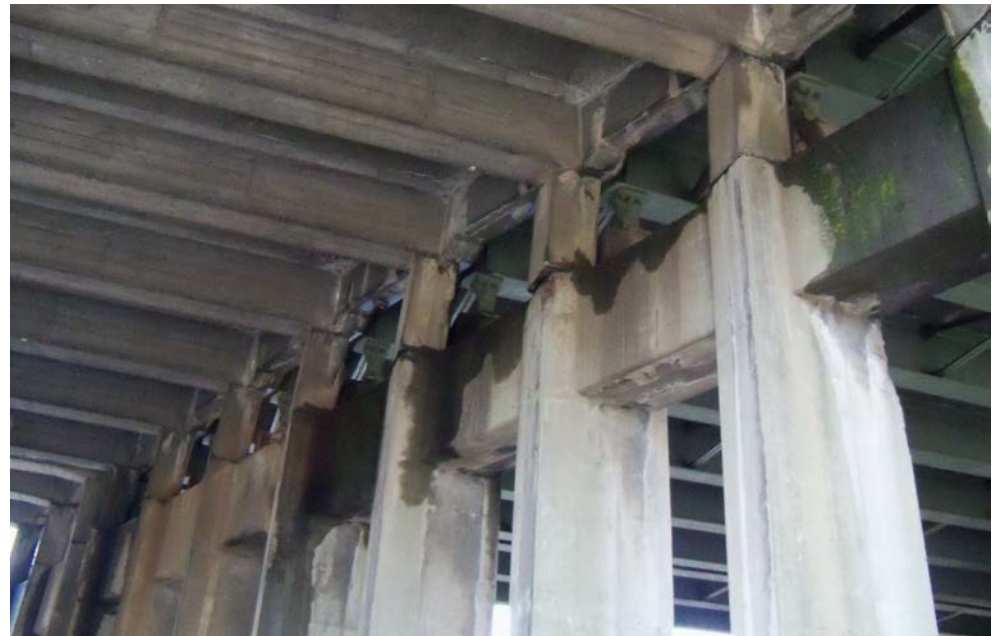
Concrete Spalls

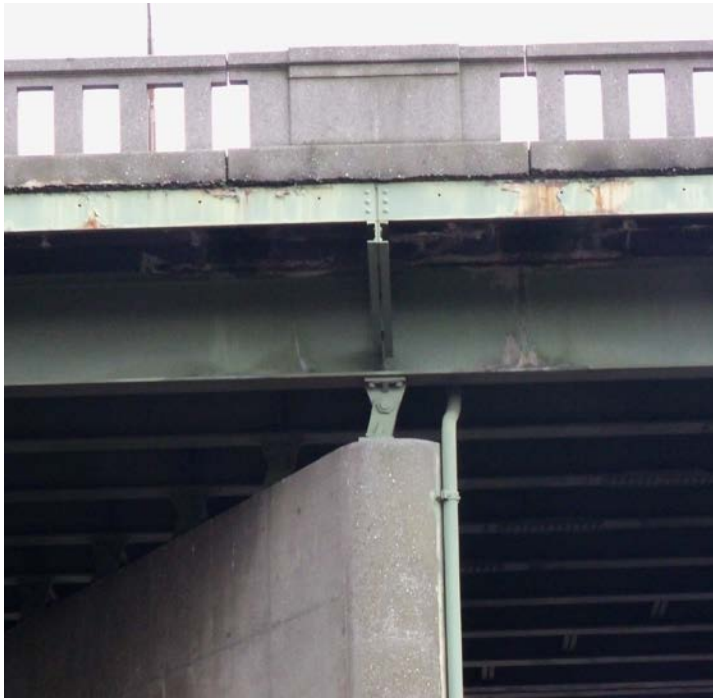
Wall Pier with Steel Bearing

- Solution:**
- Upgrade concrete pedestals, rocker bearings, steel end diaphragms, longitudinal seismic restrainers, and seat extensions.

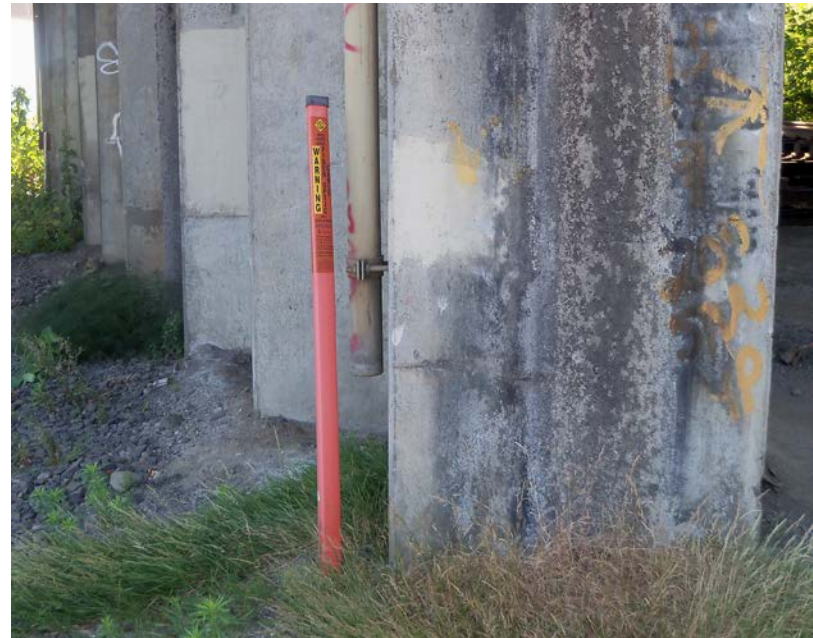
Buried Existing Utilities

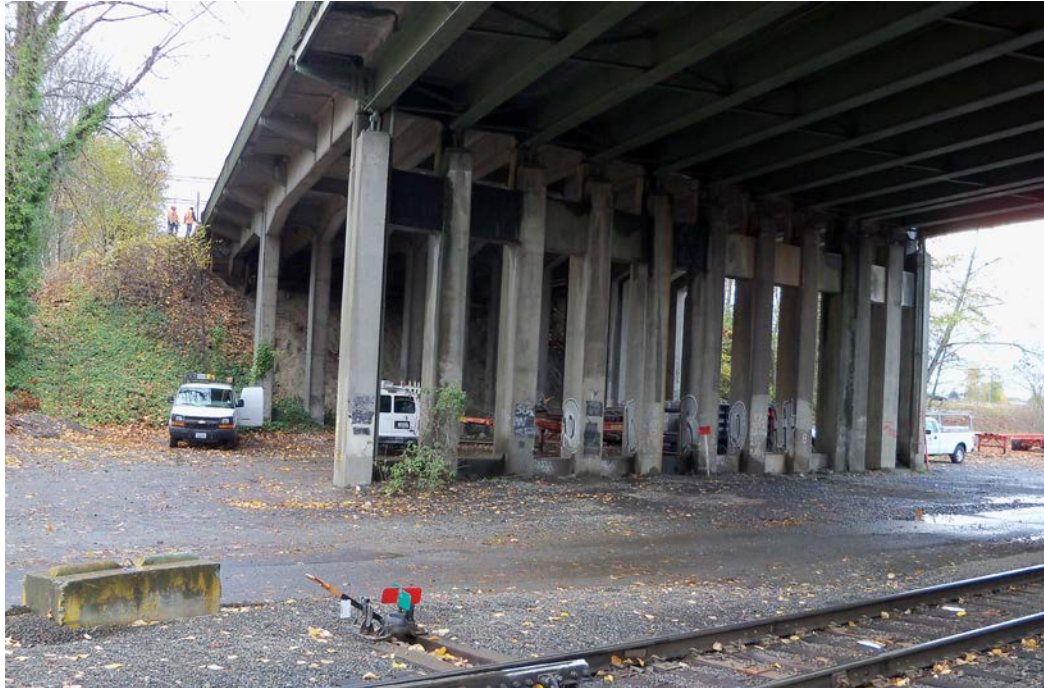
Steep slope with Liquefiable Soils near Pier 5

- Solution:**
- Assess foundation lateral and vertical capacity and need for structural upgrades.
 - Investigate ground improvements as an alternative for structural upgrade.
