Repair of A Large Diameter Non-Redundant Drilled Shaft

2017 Western Bridge Engineers' Seminar

September 7, 2017

Alan Marchman, PE and Kuan Go, PE, SE

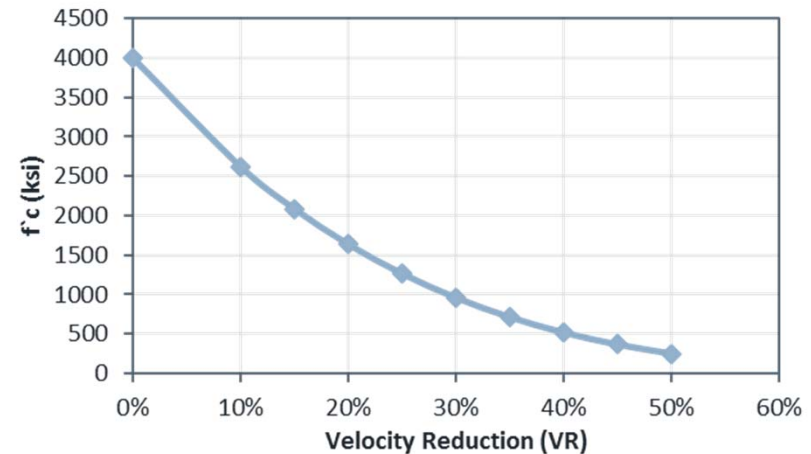
- CSL Reported Velocity Reductions >50% In Critical Regions About 13.5 Feet Deep

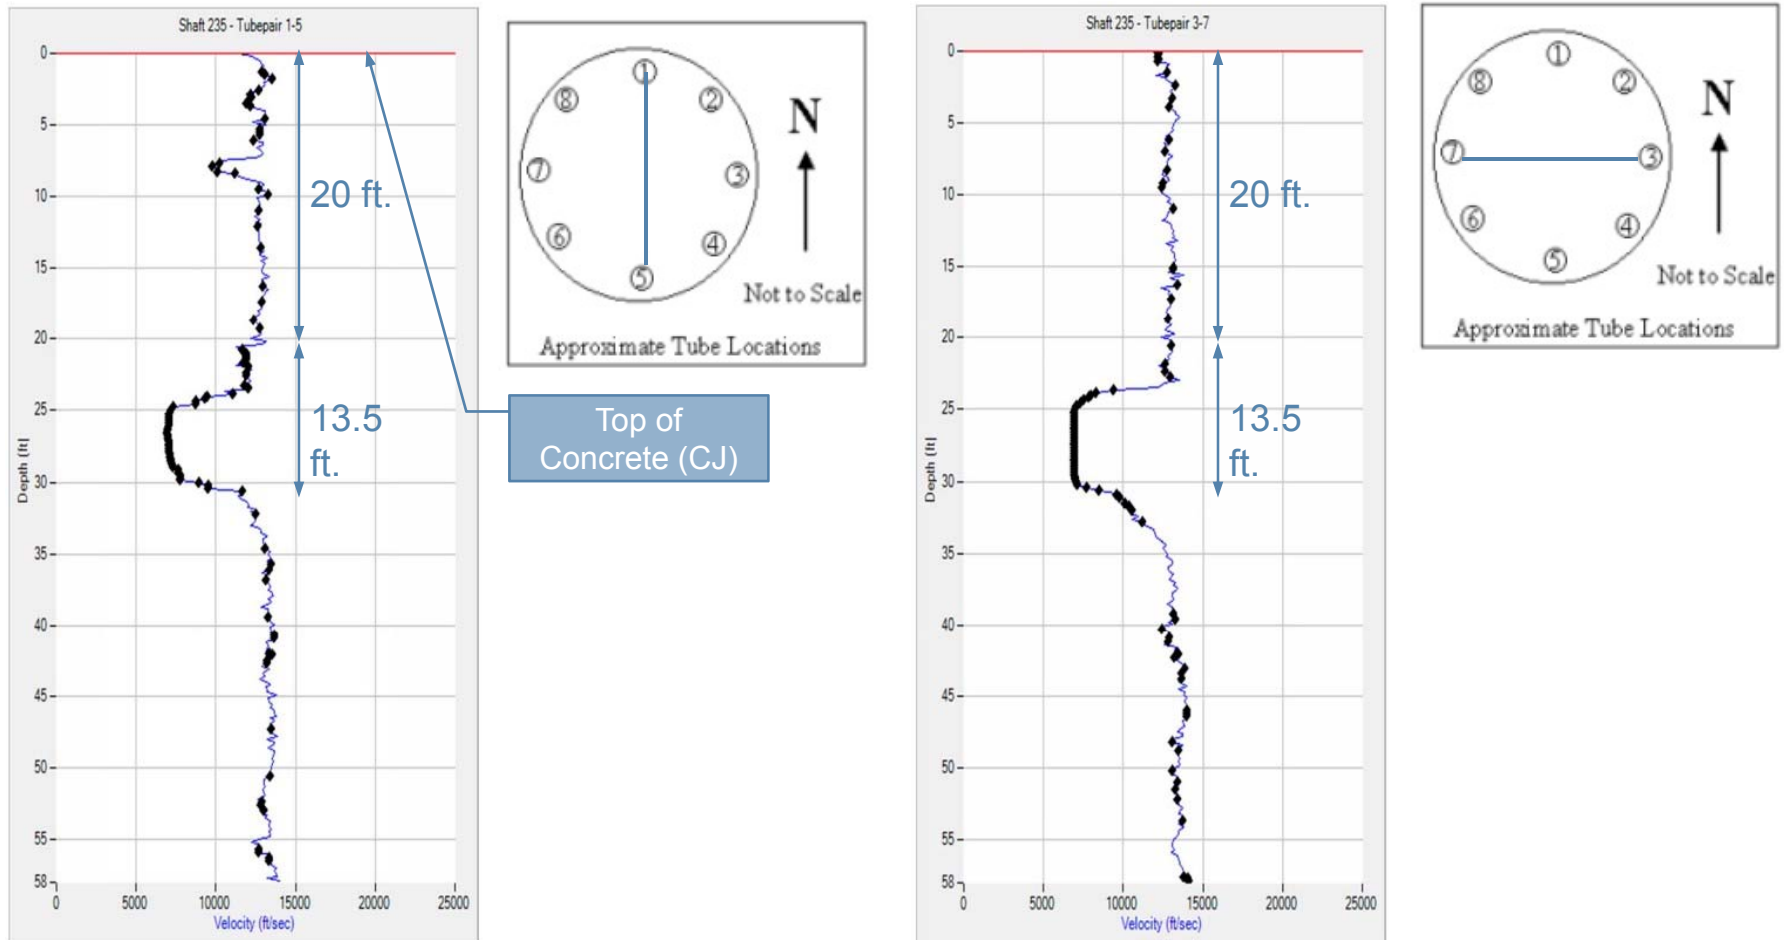
- Cored Anomalous Areas Showed Non-homogenous Concrete

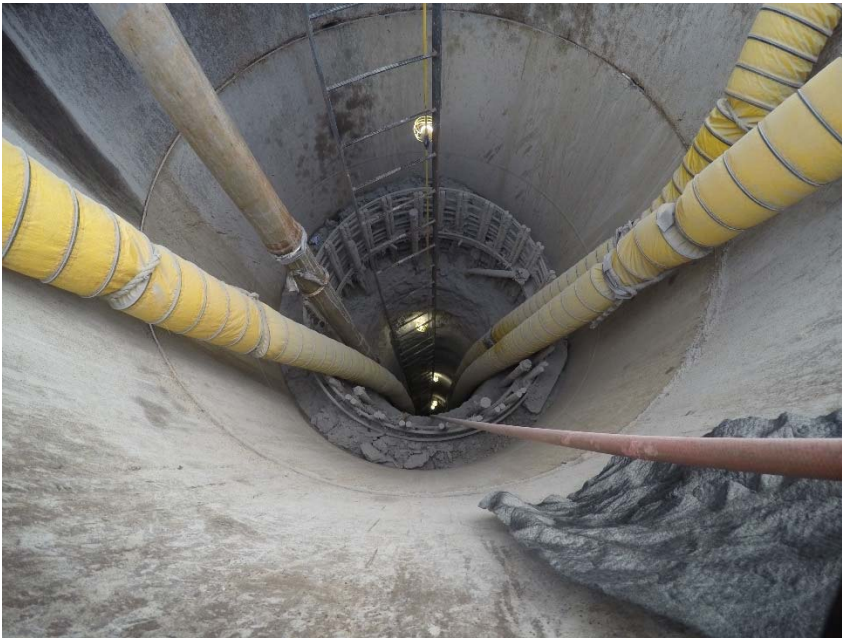
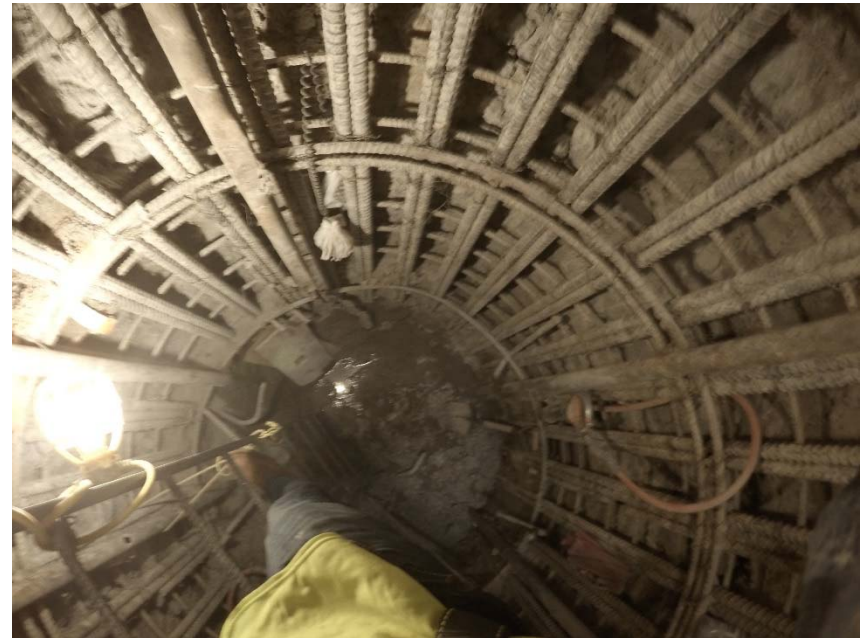
- Inspection

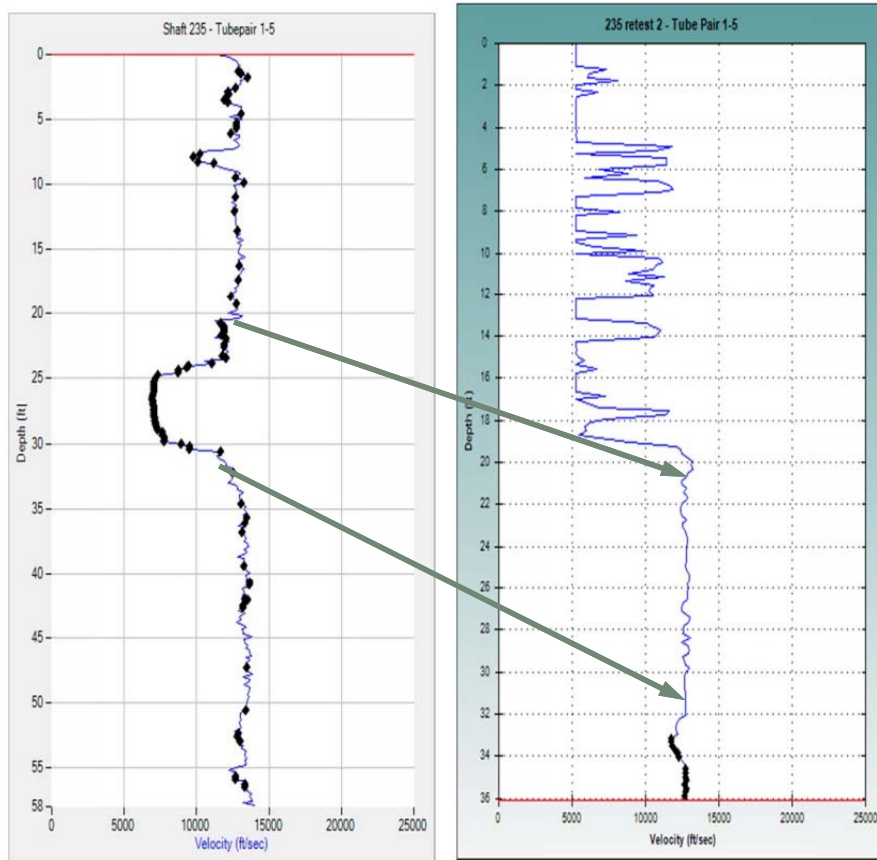
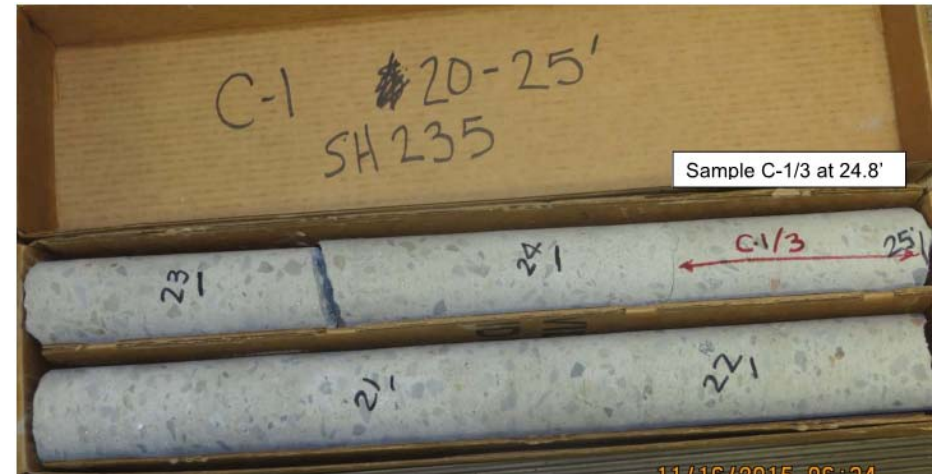
- CSL Re-testing & Verification Coring
 - Damaged CSL Tubes

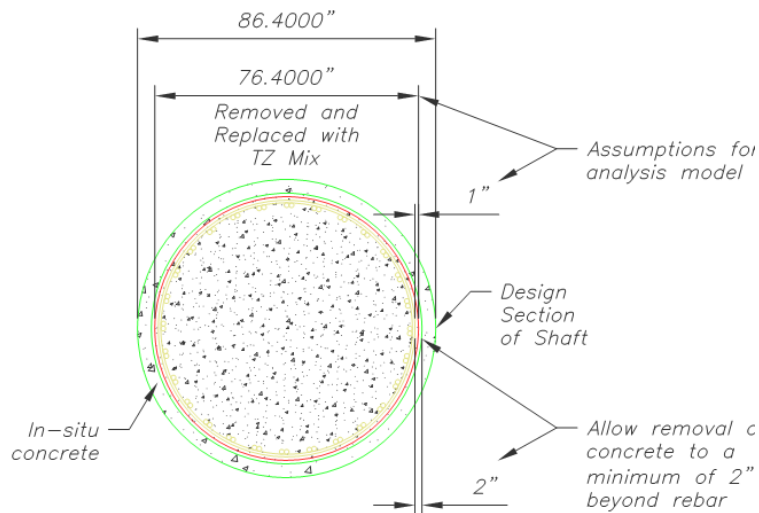
Typical Section Through 13.5'-Deep Anomalous Region

- As-built Analysis Via Fb-pier
 - Verify Force Distribution
 - Confirm Capacity
