DAVID EVANS
AND ASSOCIATES INC.

Finding the Right Solution for Two Different Bridges

Presented by
Travis Kinney

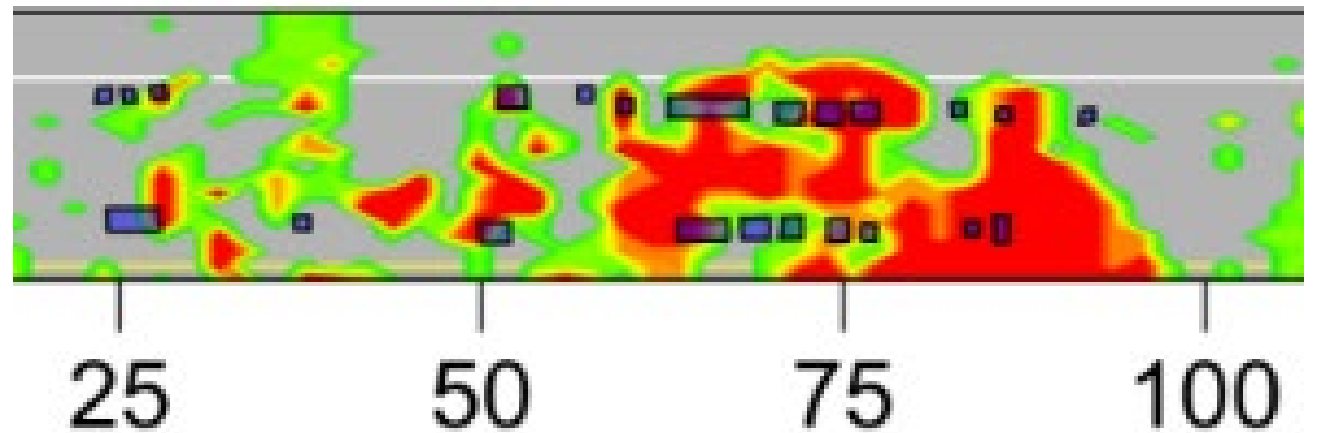
Acoustic Sounding: Capitol

Condition Summary		
Condition	s.f.	%
Severe	243.8	4.7
Poor	347.5	6.7
Fair	1015.8	19.4
Intact	3617.9	69.2

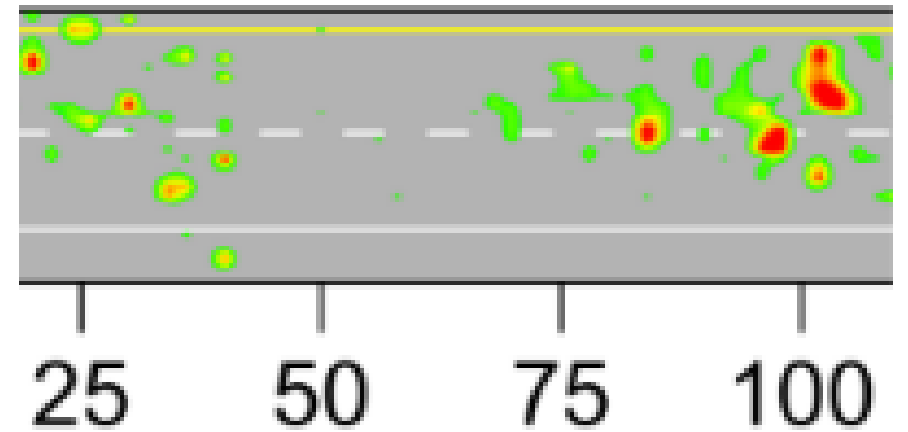
Acoustic Sounding: Multnomah

Condition Summary		
Condition	s.f.	%
Severe	36.5	0.3
Poor	98.4	0.9
Fair	1057.2	9.2
Intact	10293.5	89.6

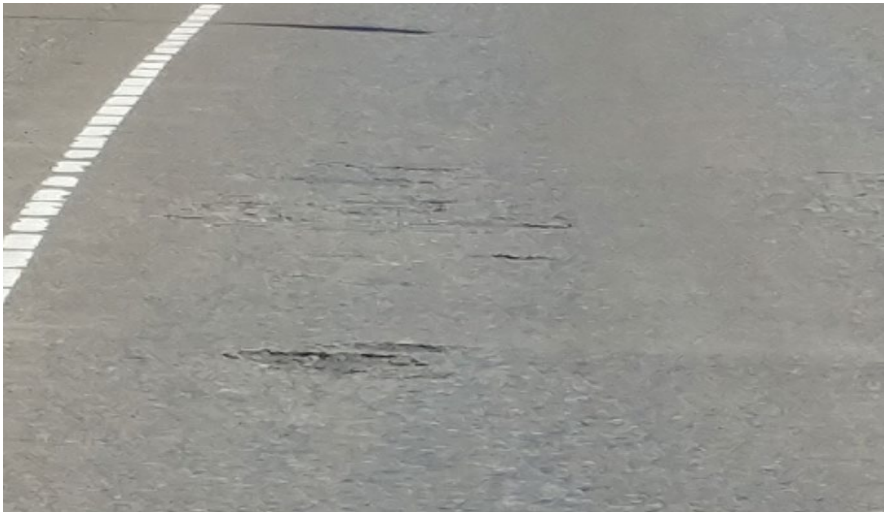
Capitol Hwy

- High Chloride Levels
- ~11% of Deck Delaminated
- Significant Deck Cracking

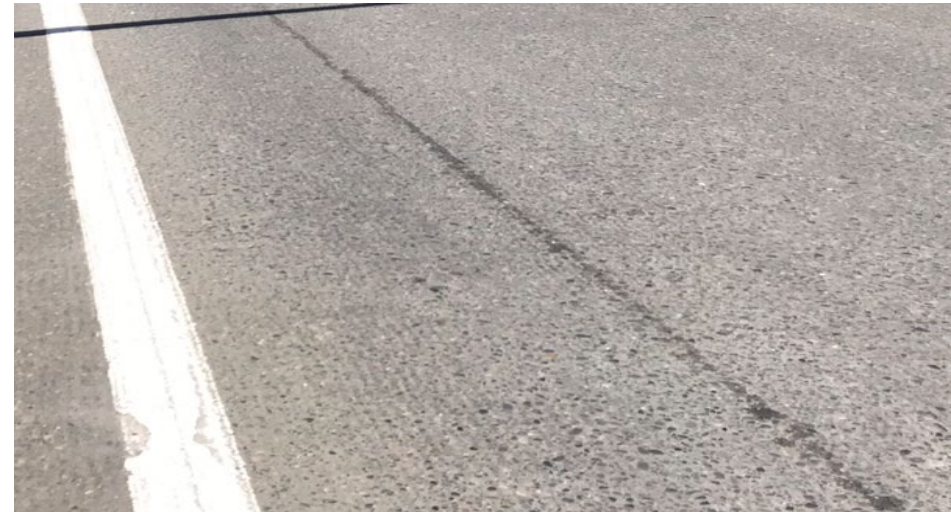
Multnomah

- Acceptable Chloride Levels
- ~1% of Deck Delaminated
- Significant Deck Cracking
