# Clarence L. Gosse Memorial Bridge Rehabilitation

Christopher R. Dyck, M.Sc., P.Eng.  
Senior Bridge Specialist

Western Bridge Engineers Seminar, Phoenix AZ, December 5-8, 2023

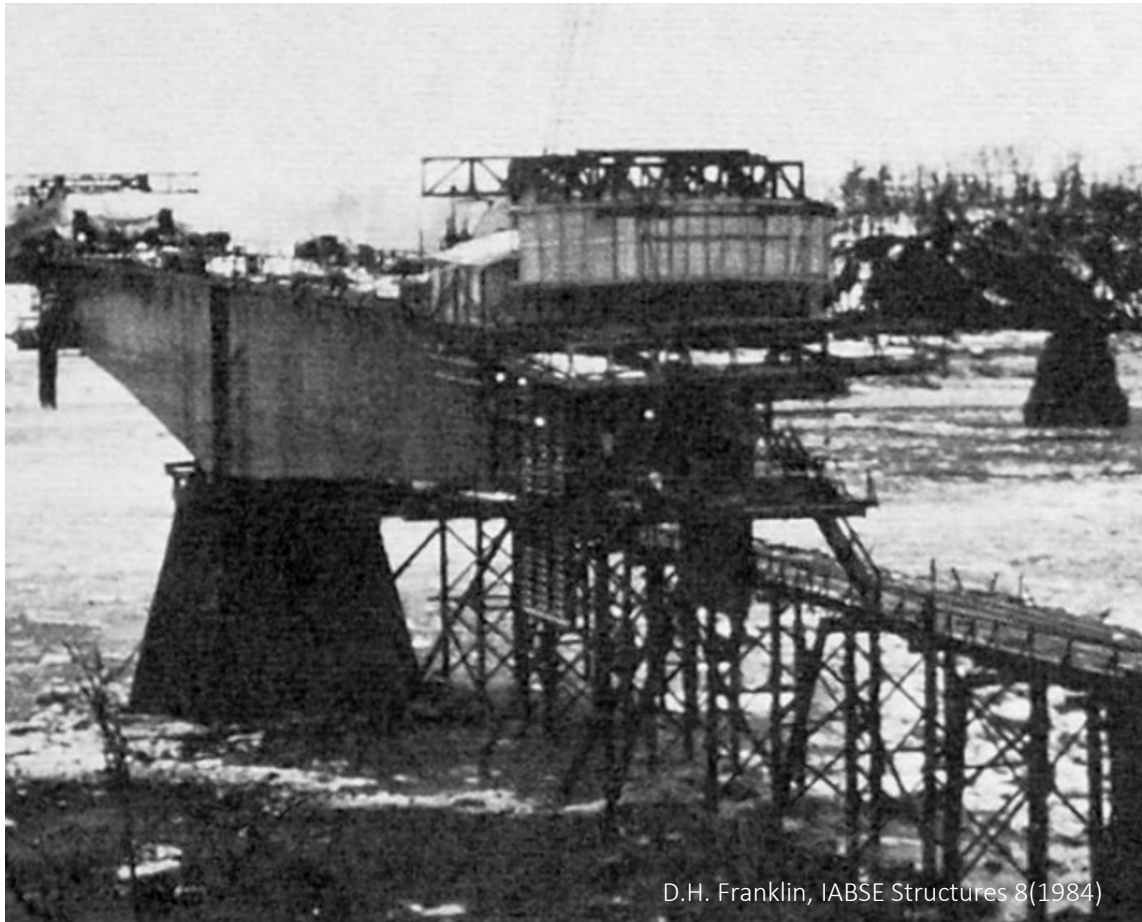
East Span – Note Icy Winter Conditions

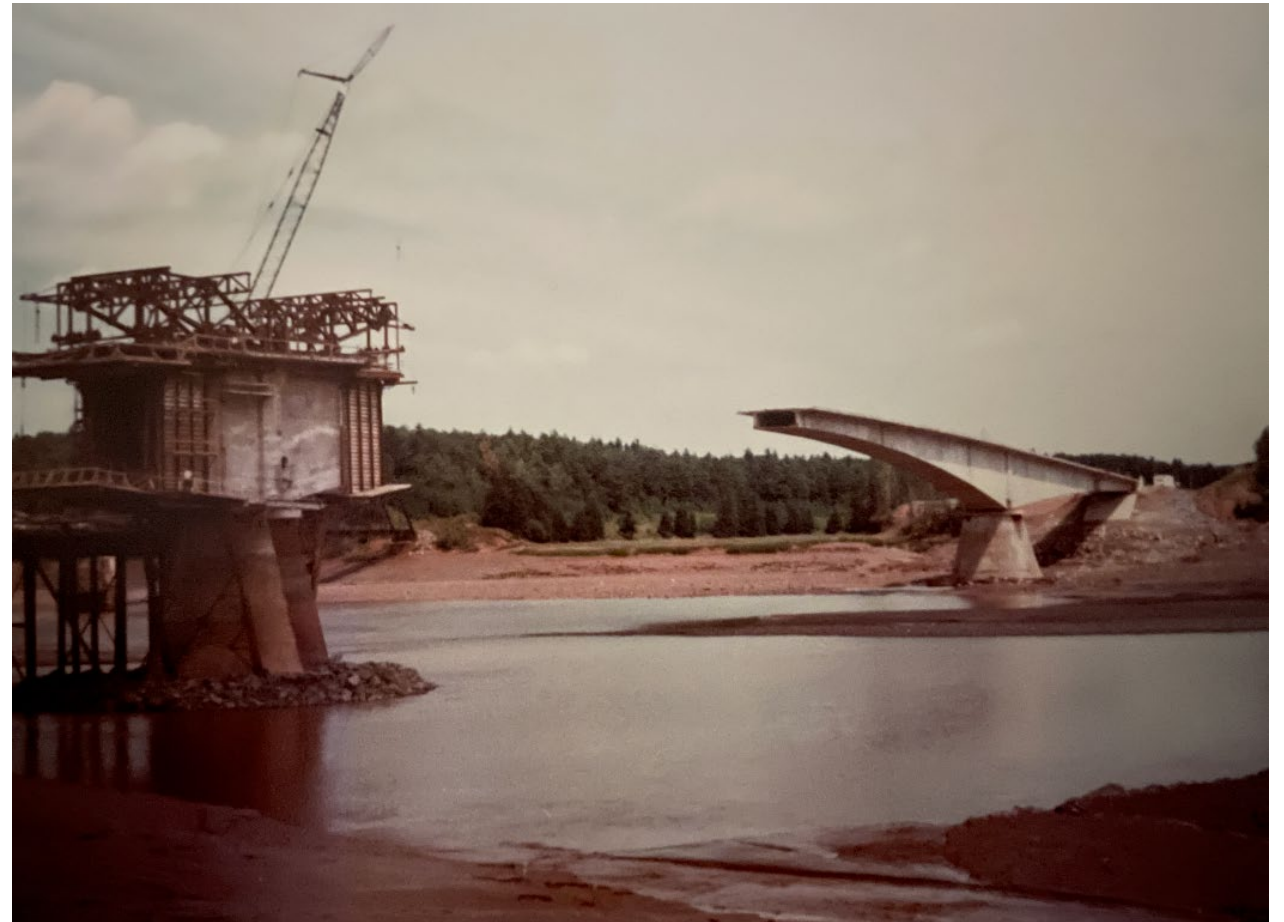
West Span – Summer construction

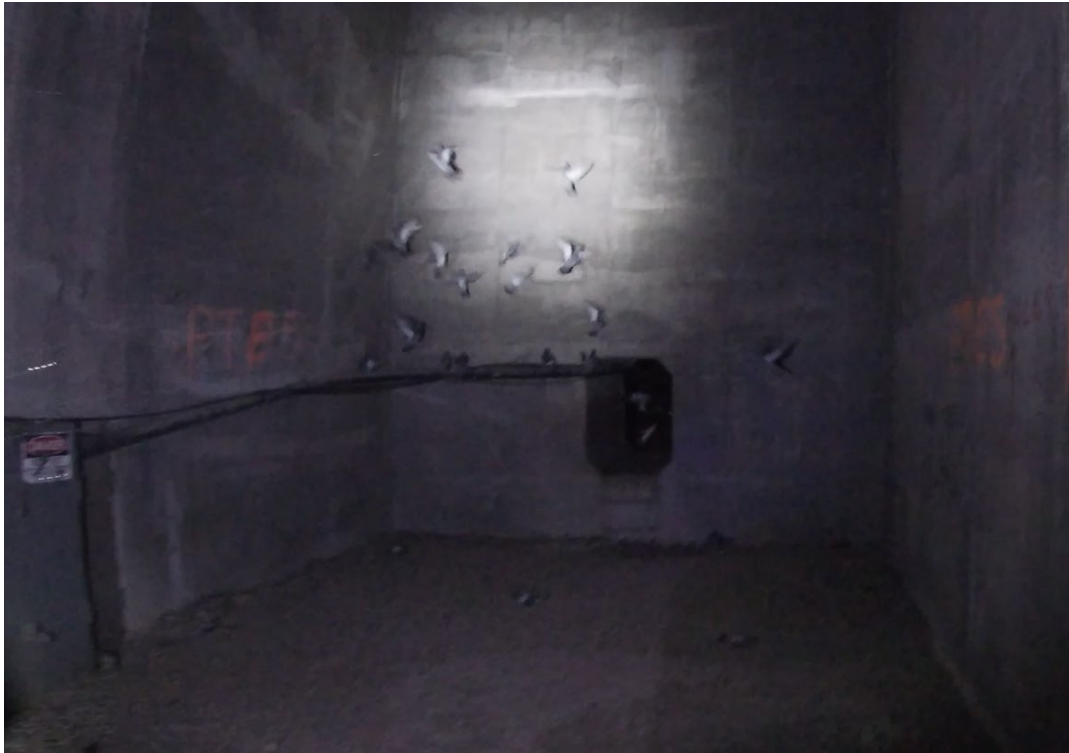
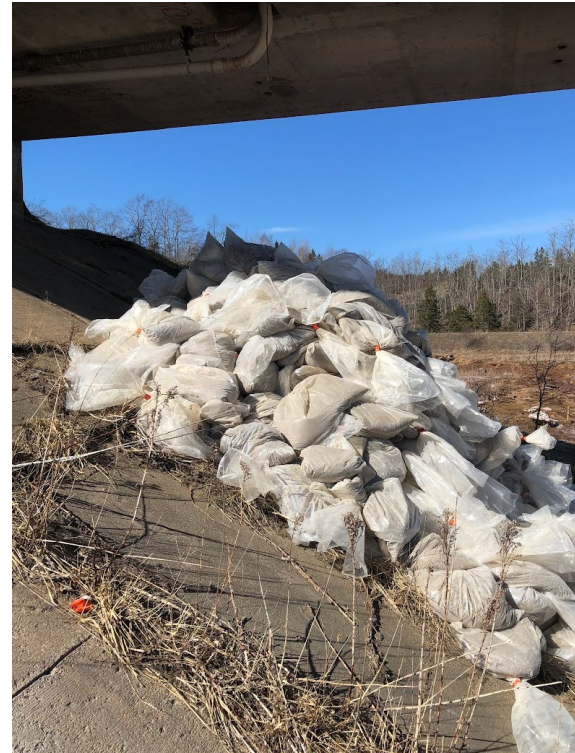
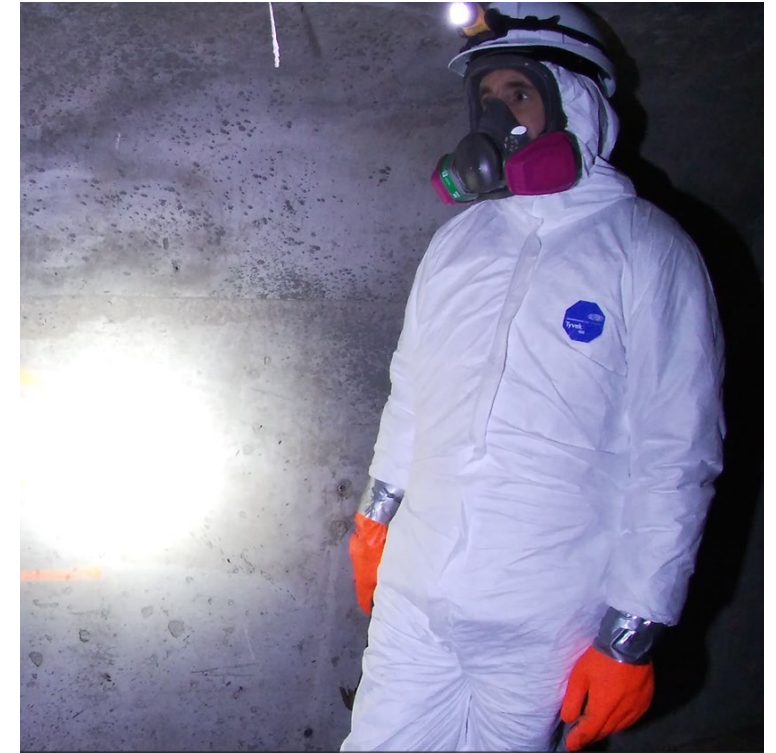
- Vandalism resulted in serious bird infestation
- Heavy steel covers installed to prevent vandalism and bird damage

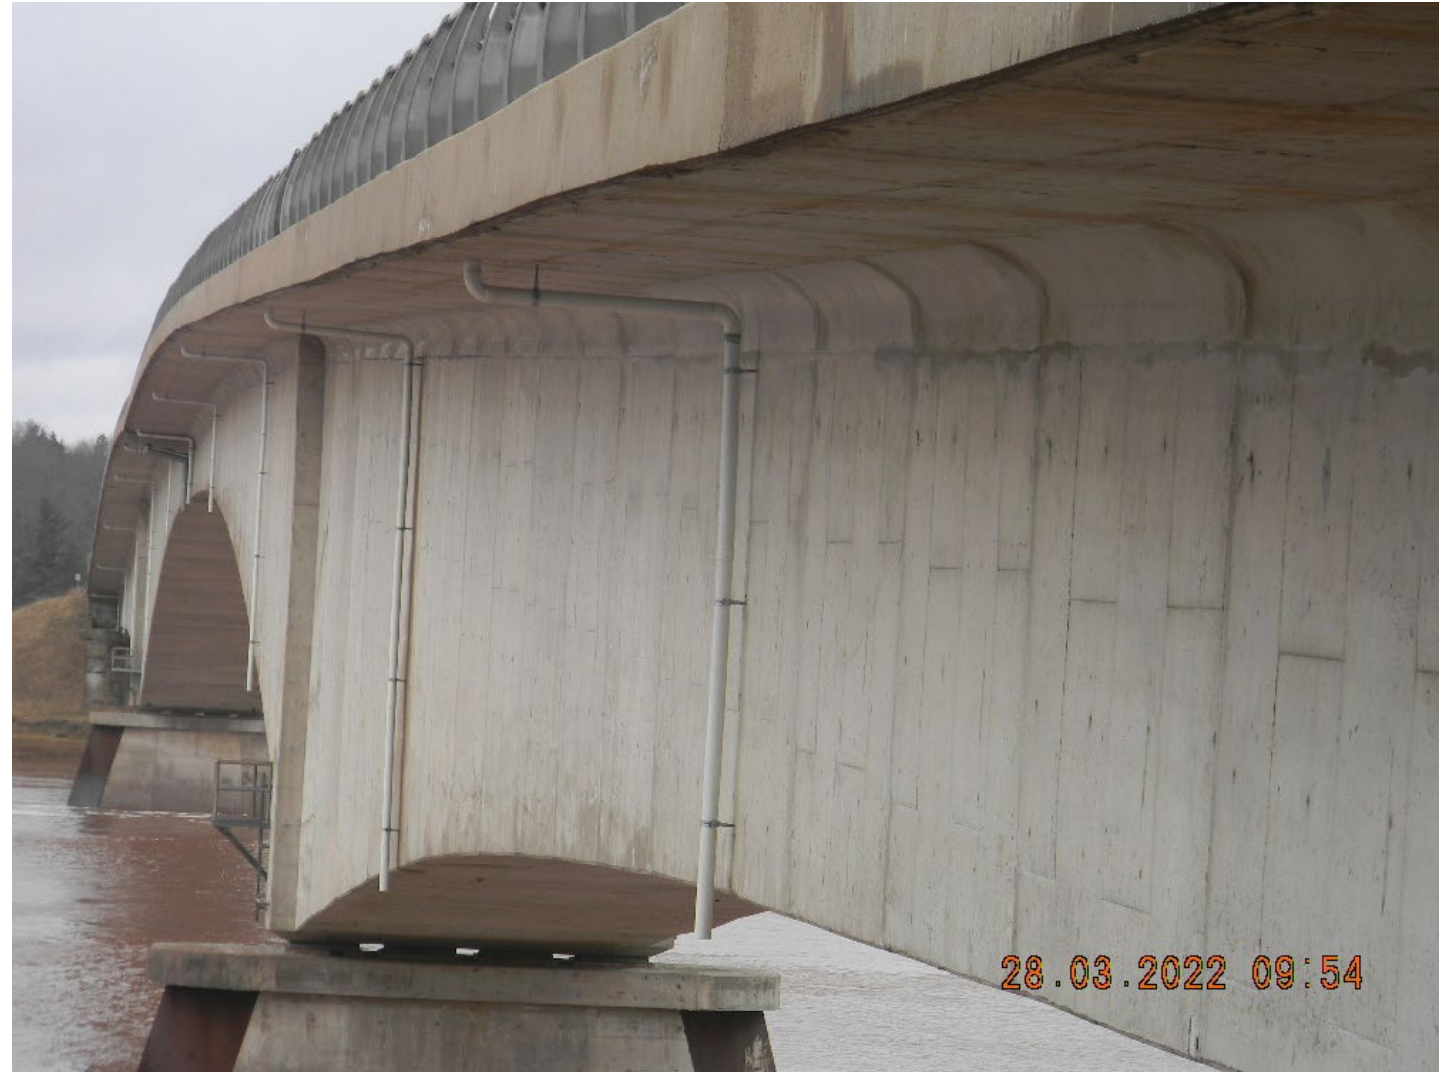
- Deck drain reinstatements
- Extension below girder soffit

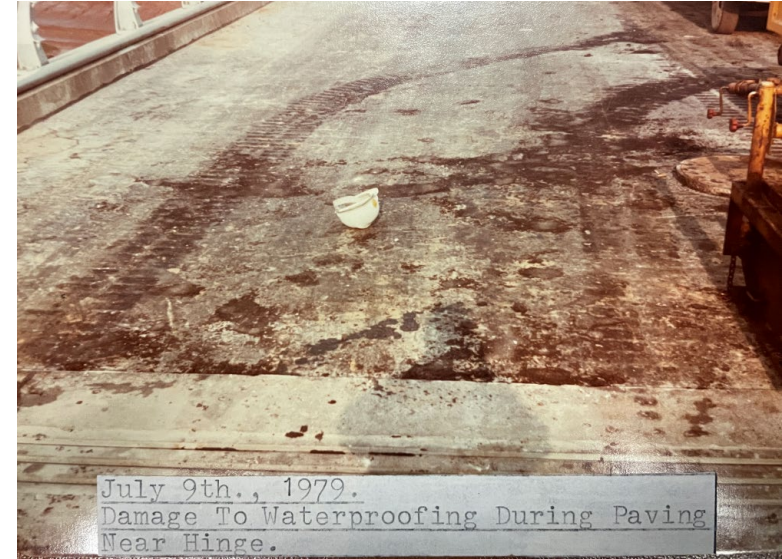
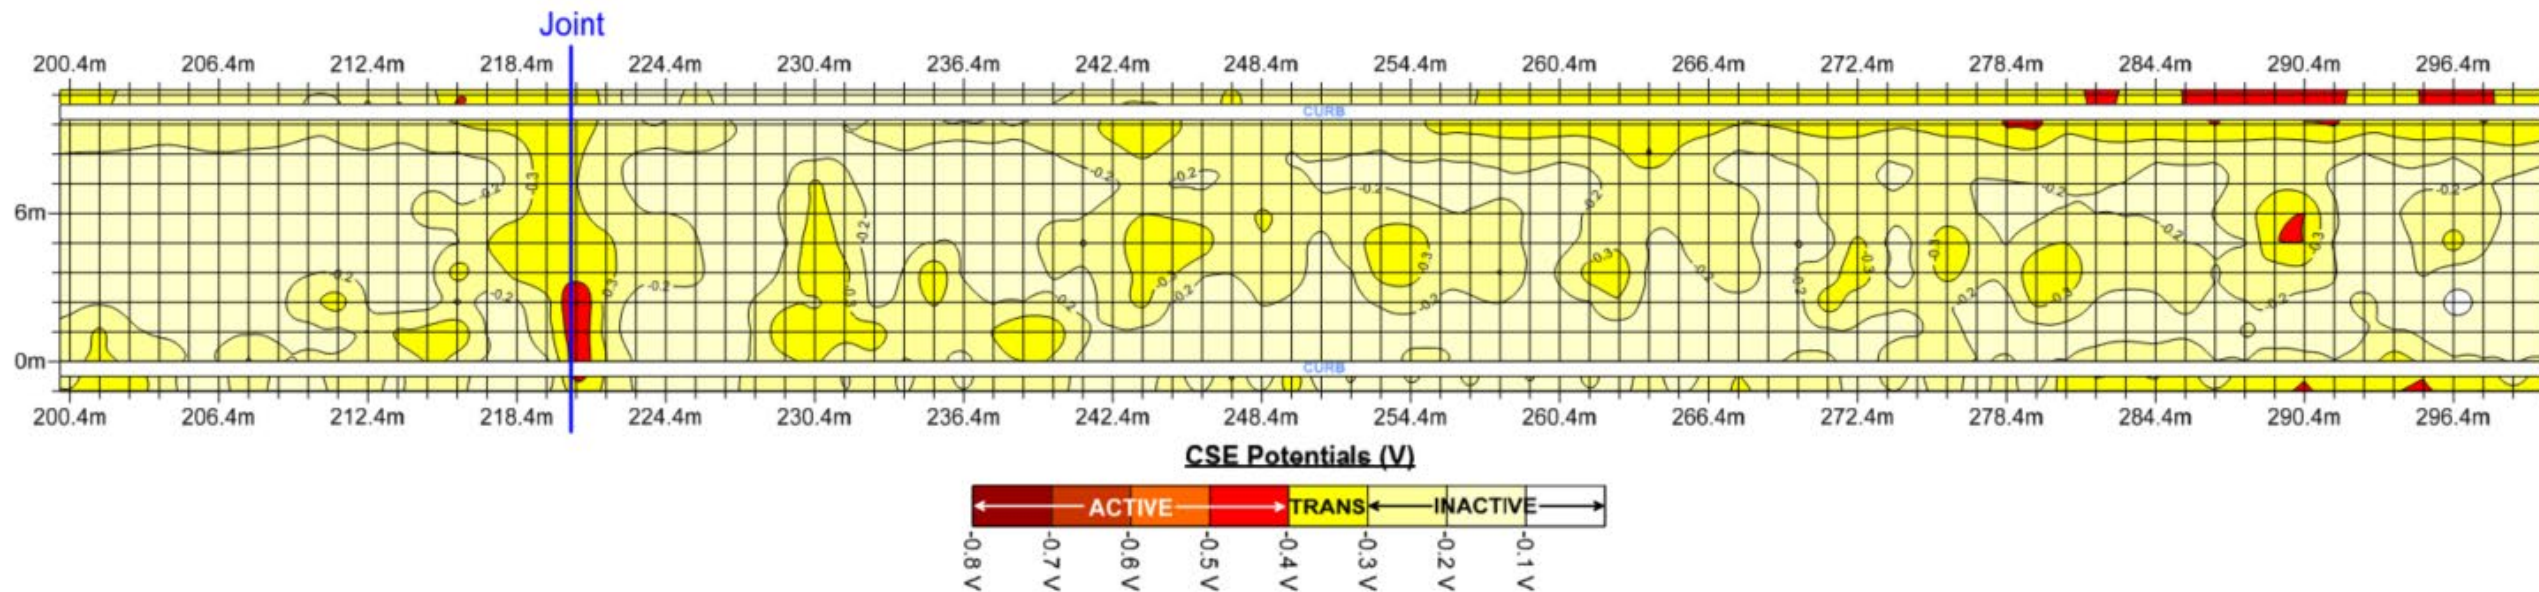
- Copper Sulphate Electrode (CSE) potential testing
  - Active and transition potential maps
    - Total Active + Transition Area = 4000 Sq.ft.
    - Actual Repair Area of Deck = 3700 Sq.ft.

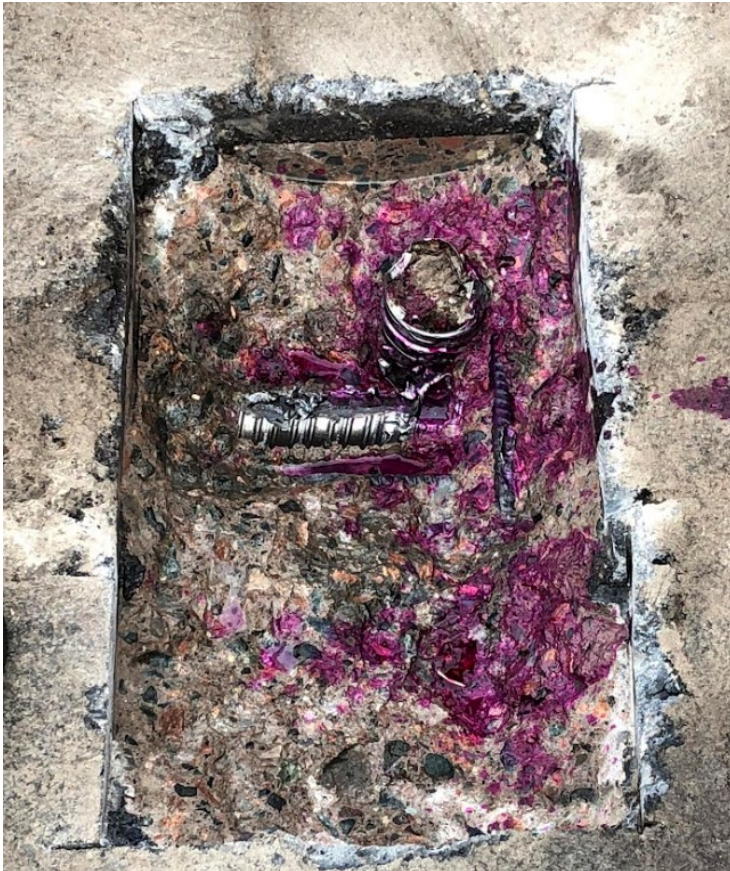
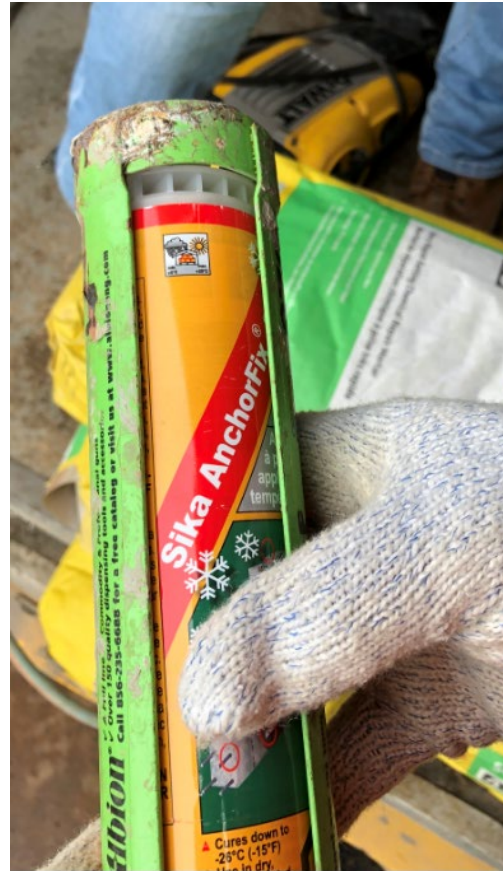
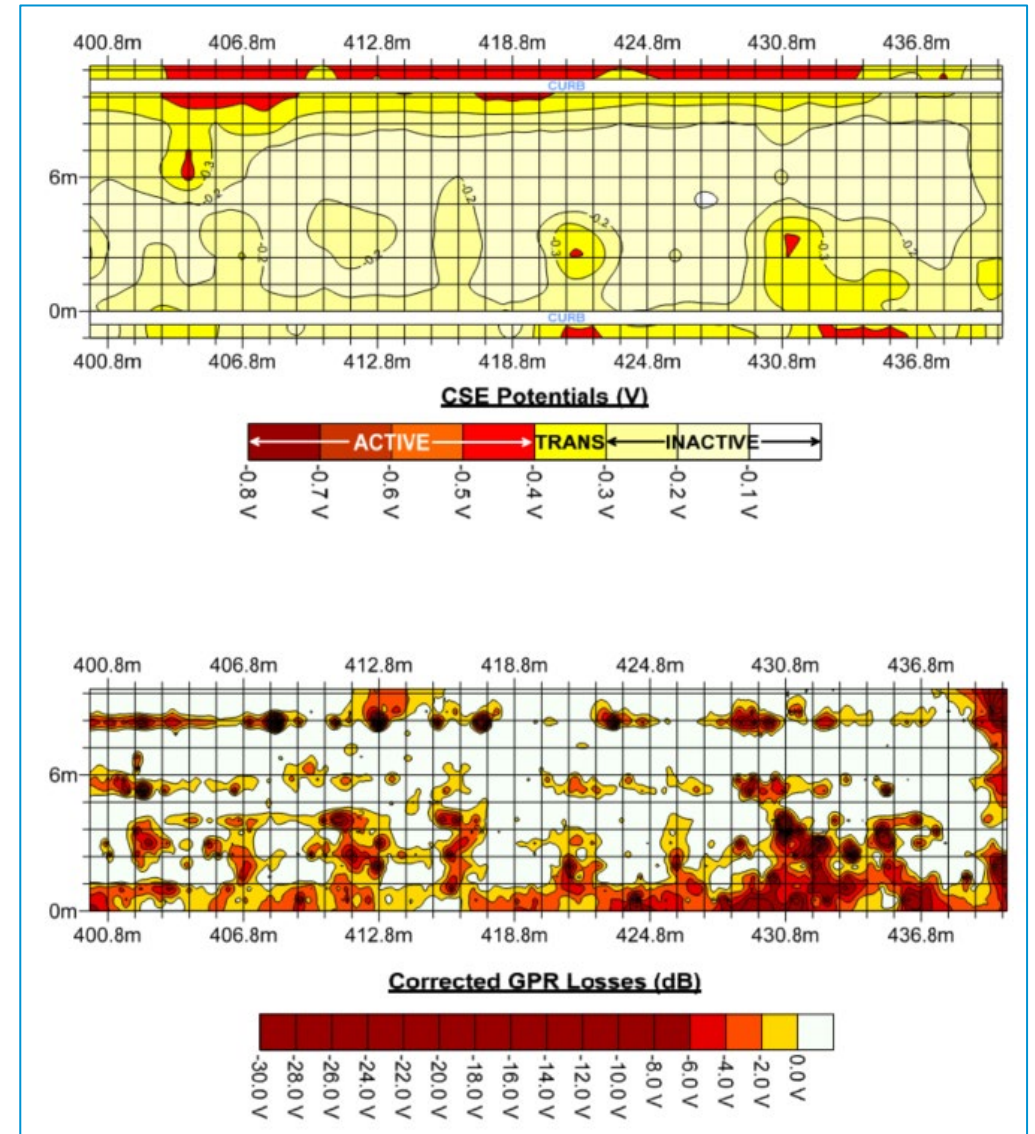
- Ground Penetrating Radar (GPR)
- Tendon Investigation

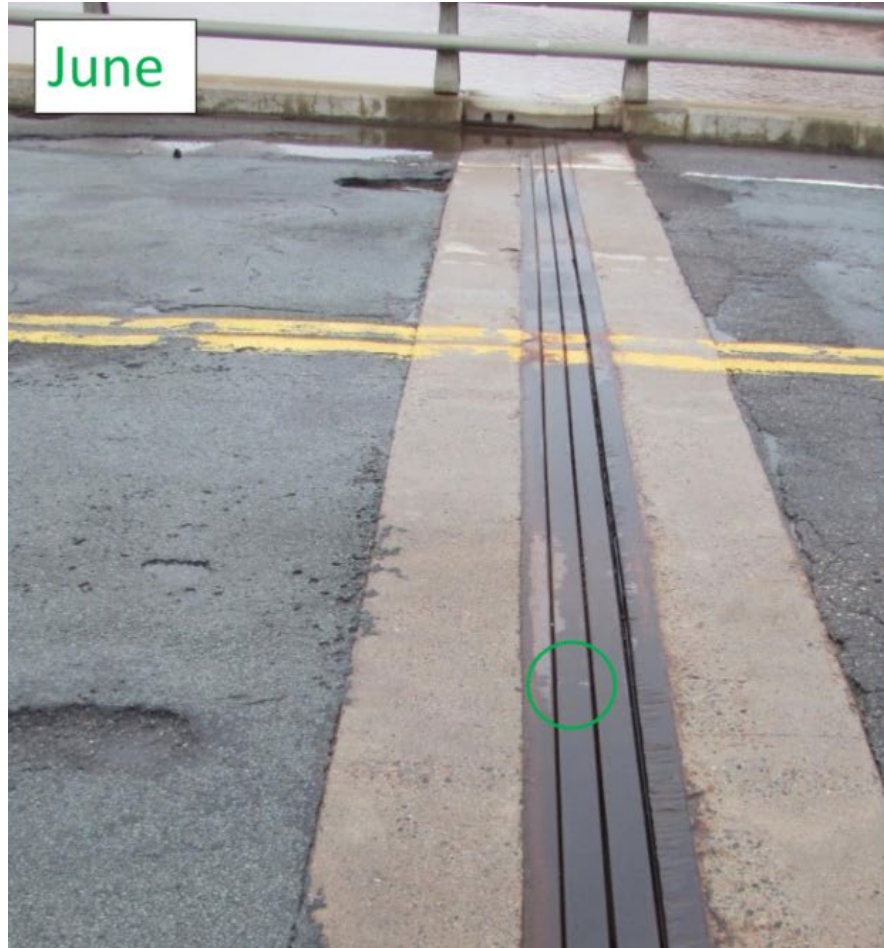
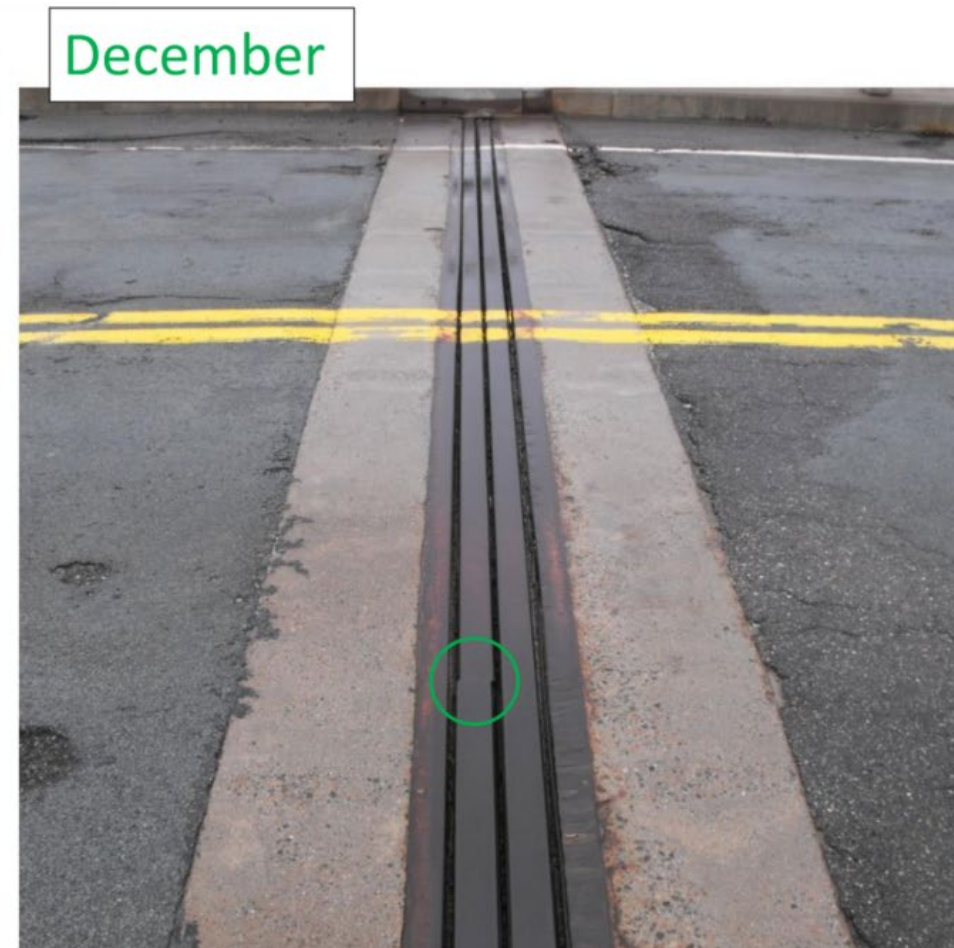
- Expansion Joint Replacements – Midspan joint assessment 2018-2019

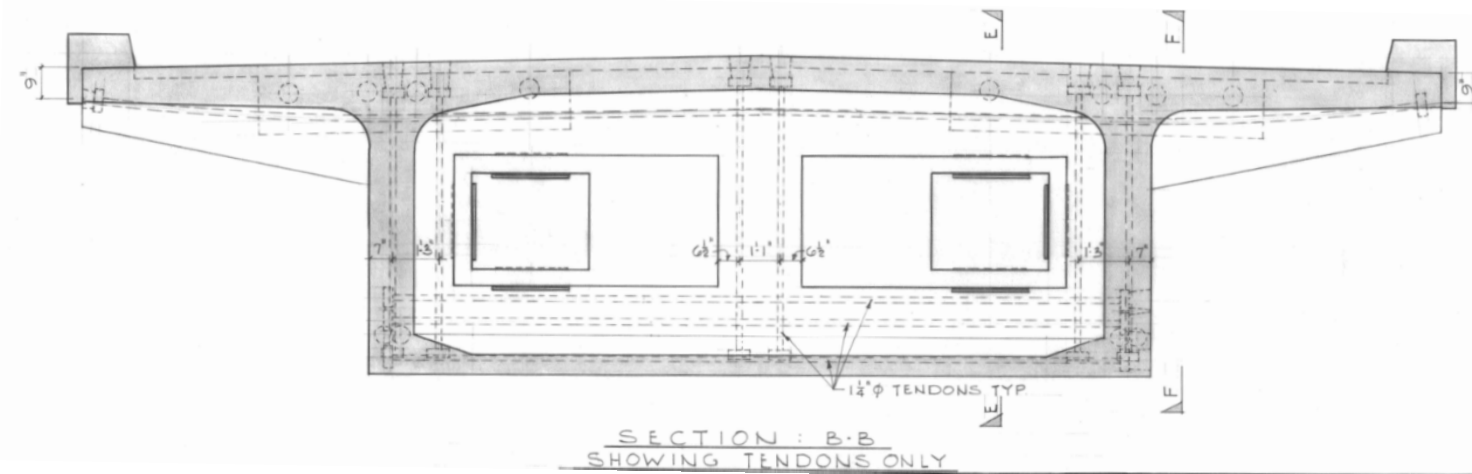
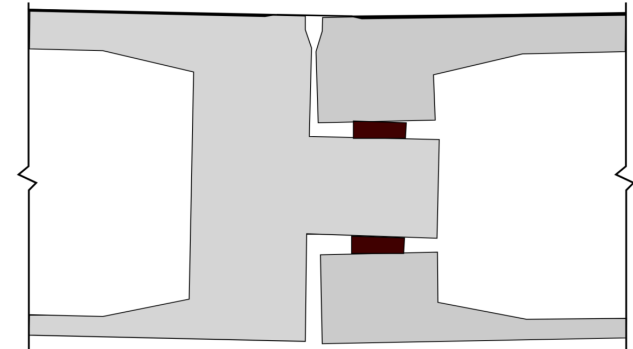
- Midspan sag created challenges for removal of the bearing blocks
