ITD's Mores Creek Bridge Asset Management Plan Case Study

Brian Leshko, PE
September 2023

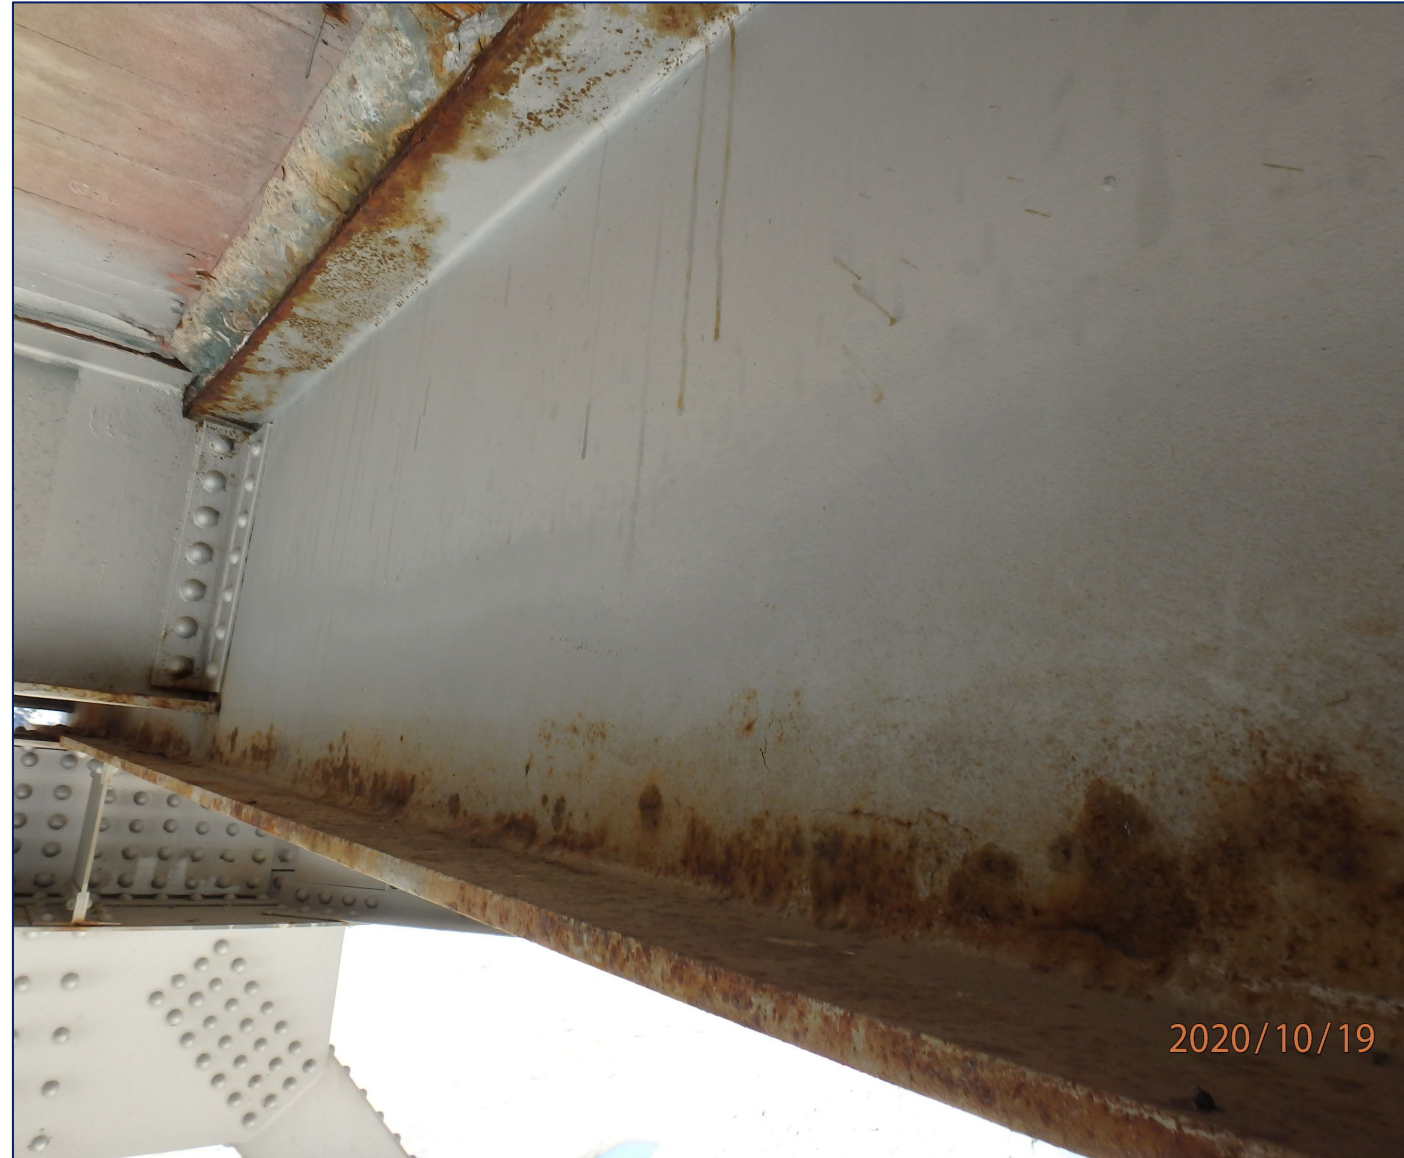
Key Finding 1:

The worst-case corrosion is located along the floor beams at the deck joints.

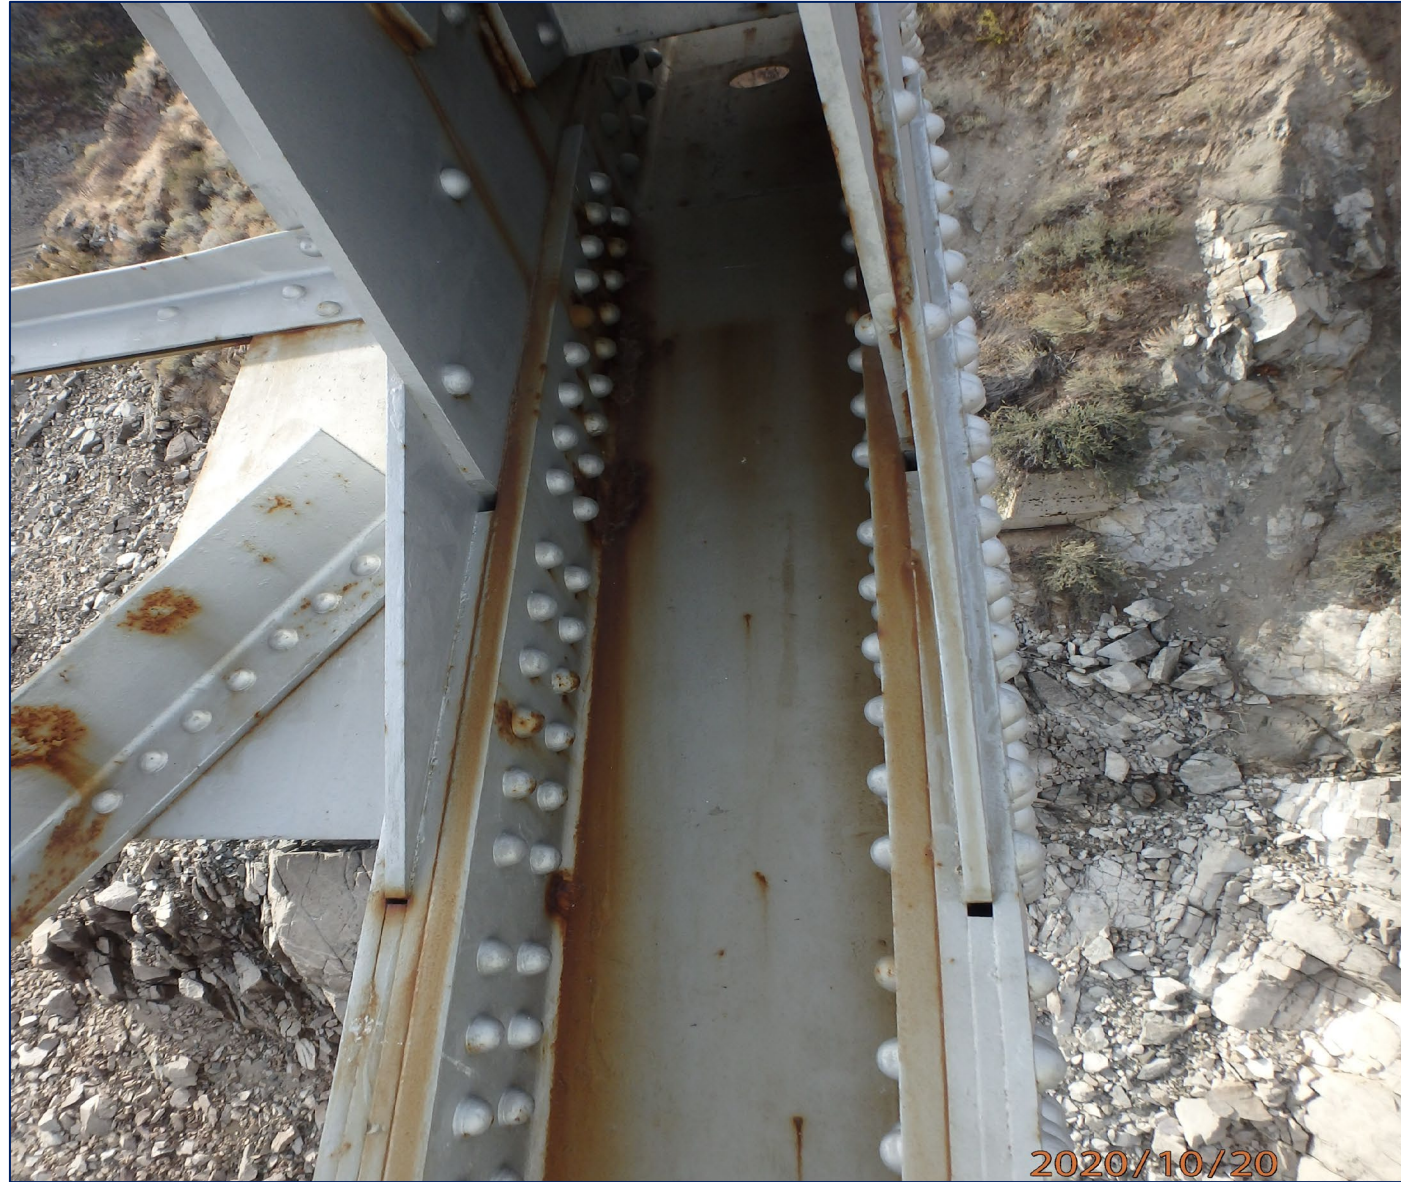
Key Finding 2:

Pack rust formed between many riveted built-up FCM/NSTM members.

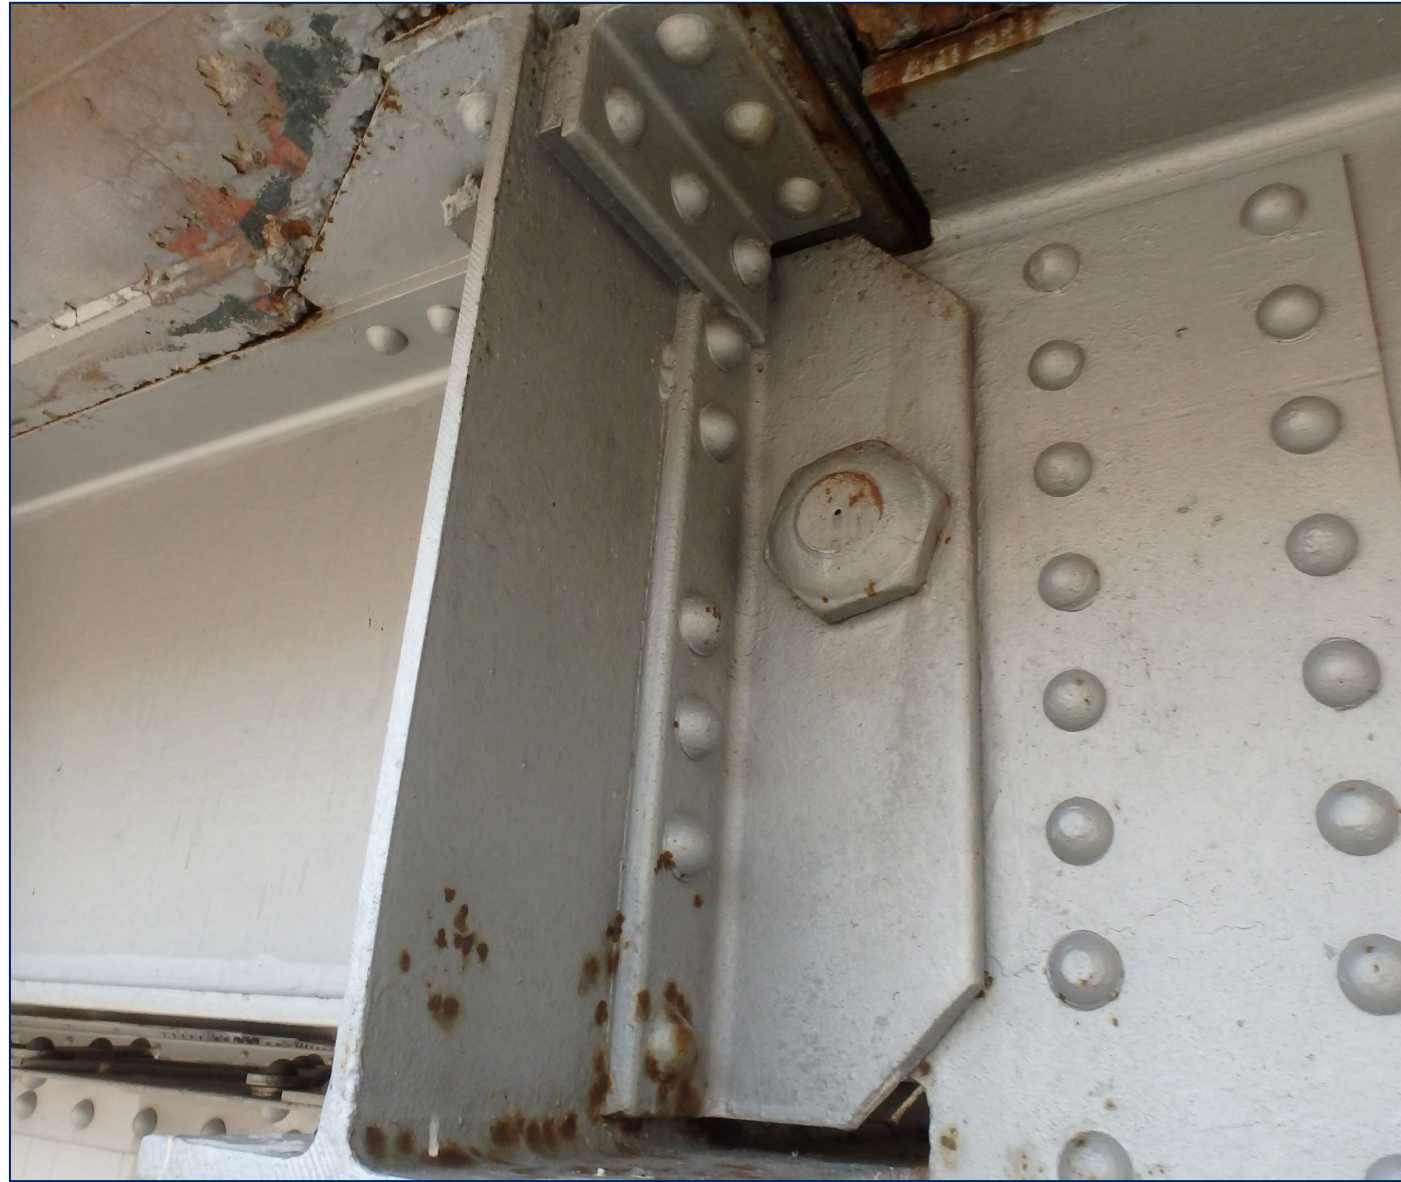
Key Finding 3:

More than 20 deck joints exhibit leakage over the floor beams.

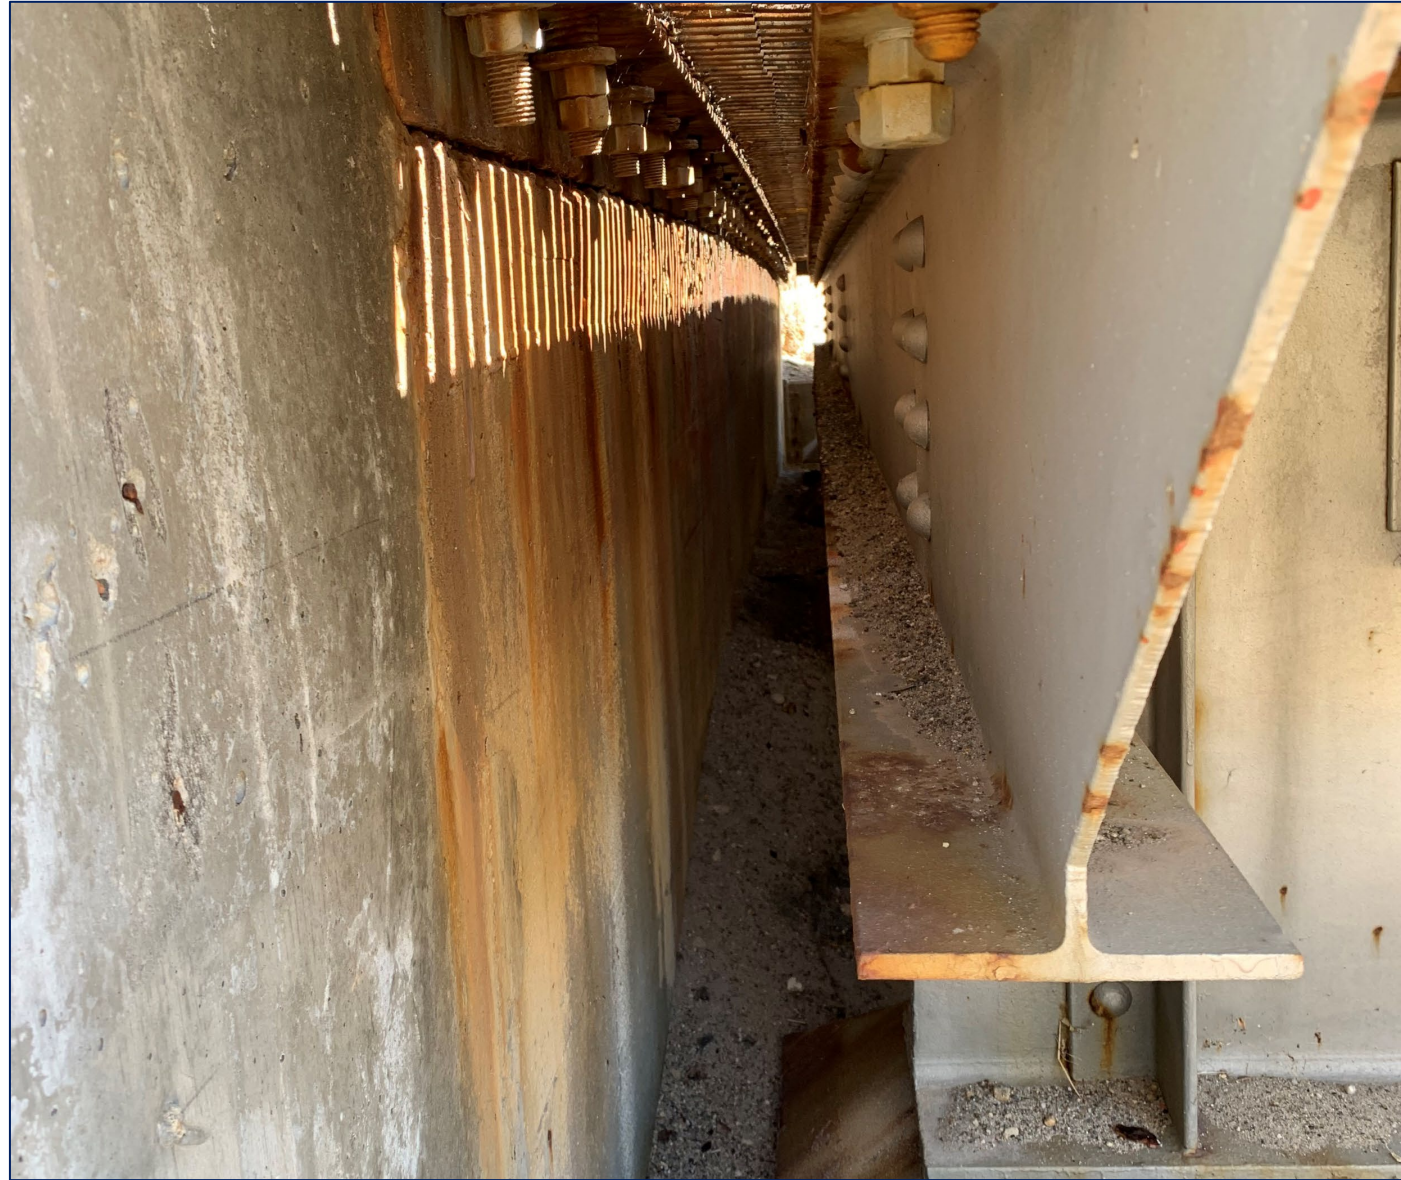
Key Finding 4:

Install the missing neoprene trough below the finger joint assembly at Abutment 2.
