# Cloverdale Bridge Replacement

Mike Johnson, Idaho Transportation Department, Bridge Section

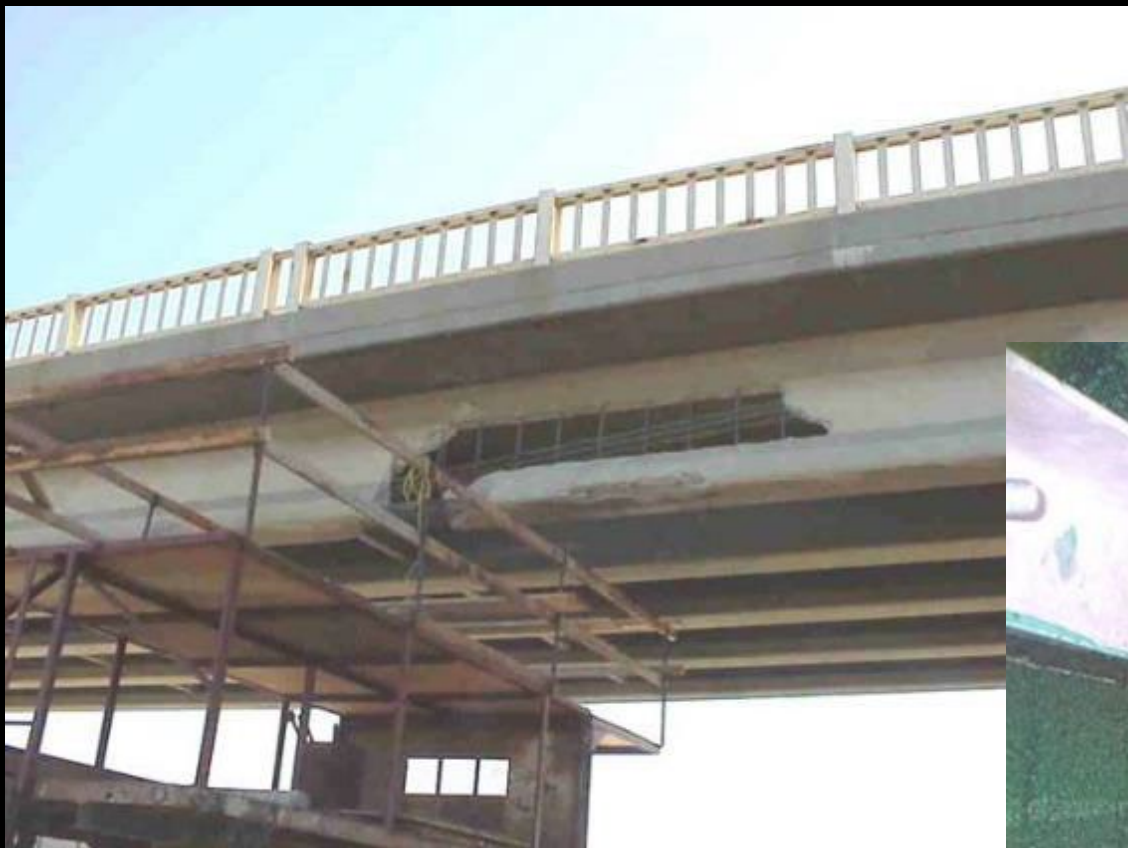
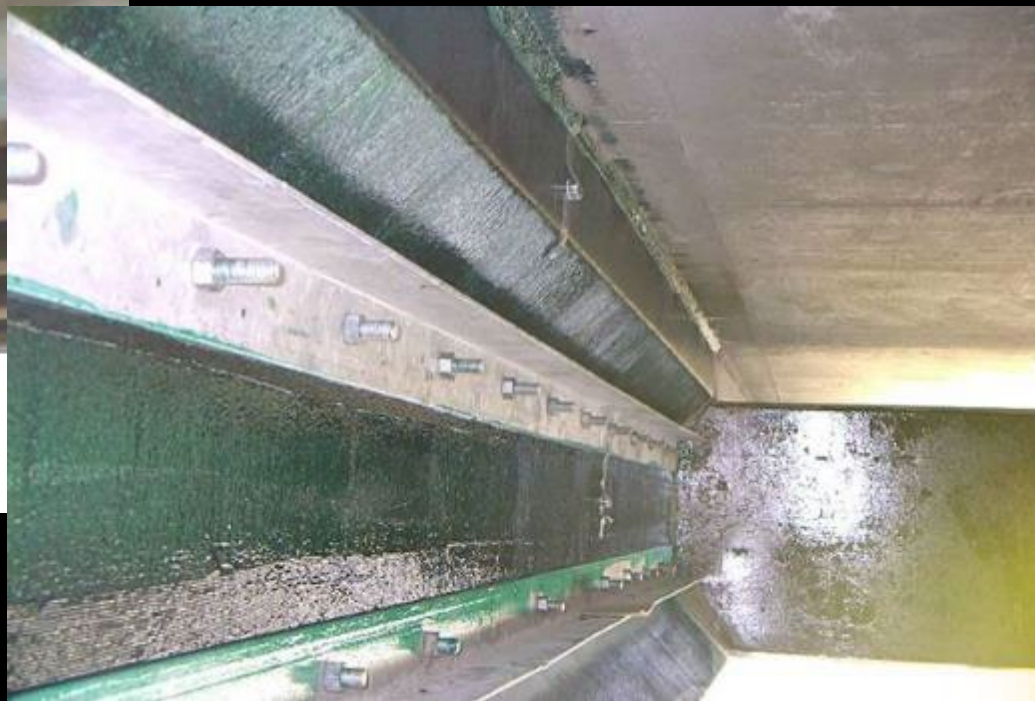
# Overheight Load Damage - 2002

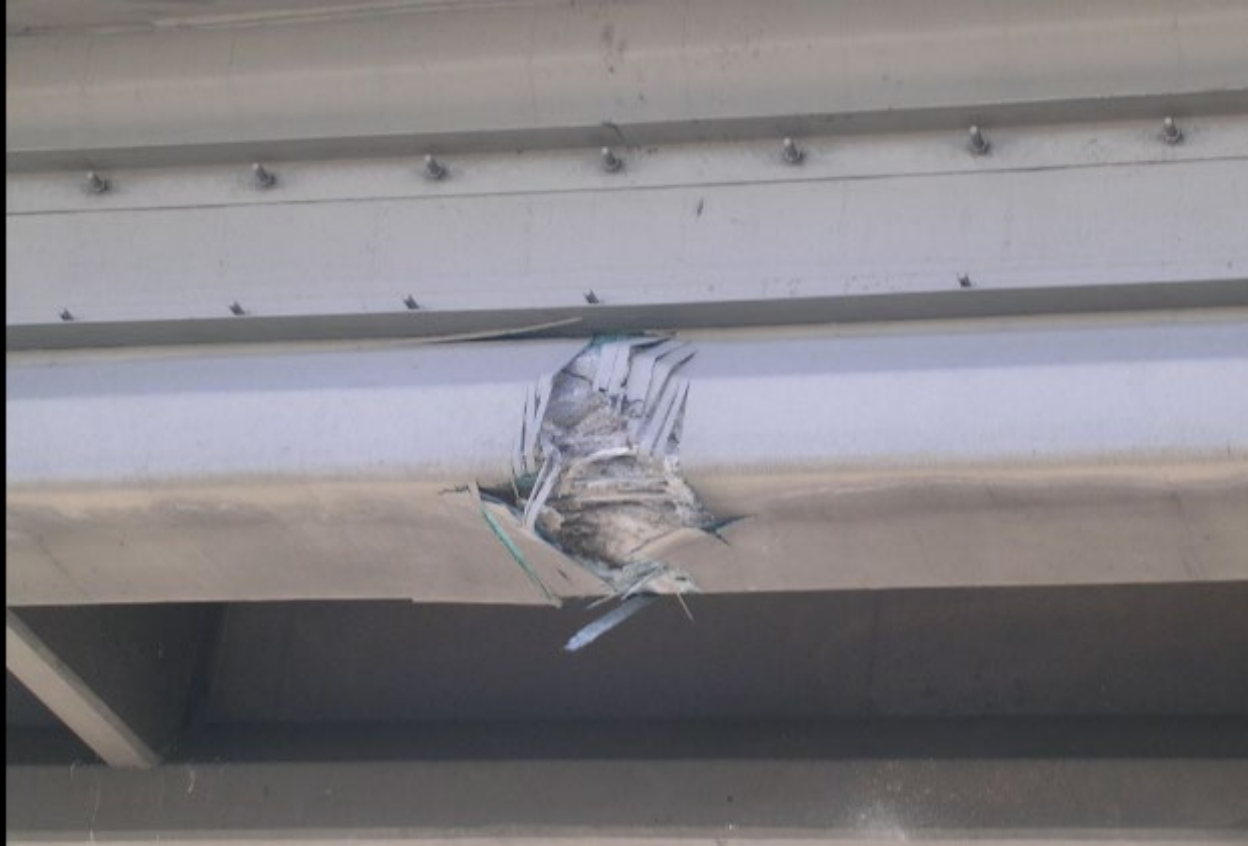
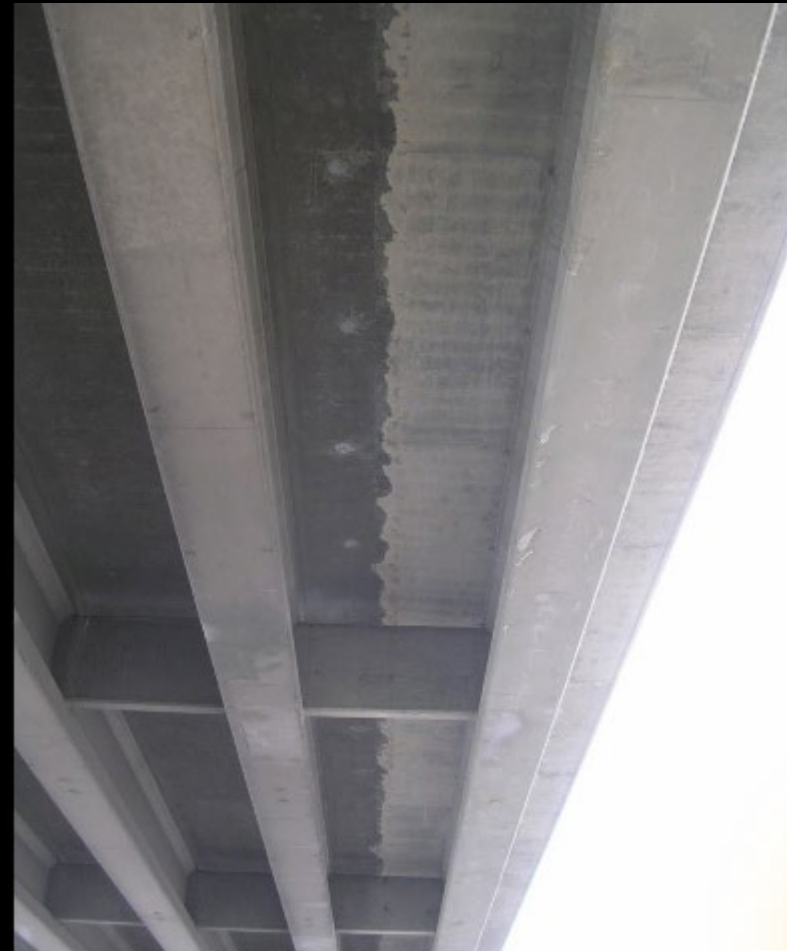
# Overheight Load Damage - 2006

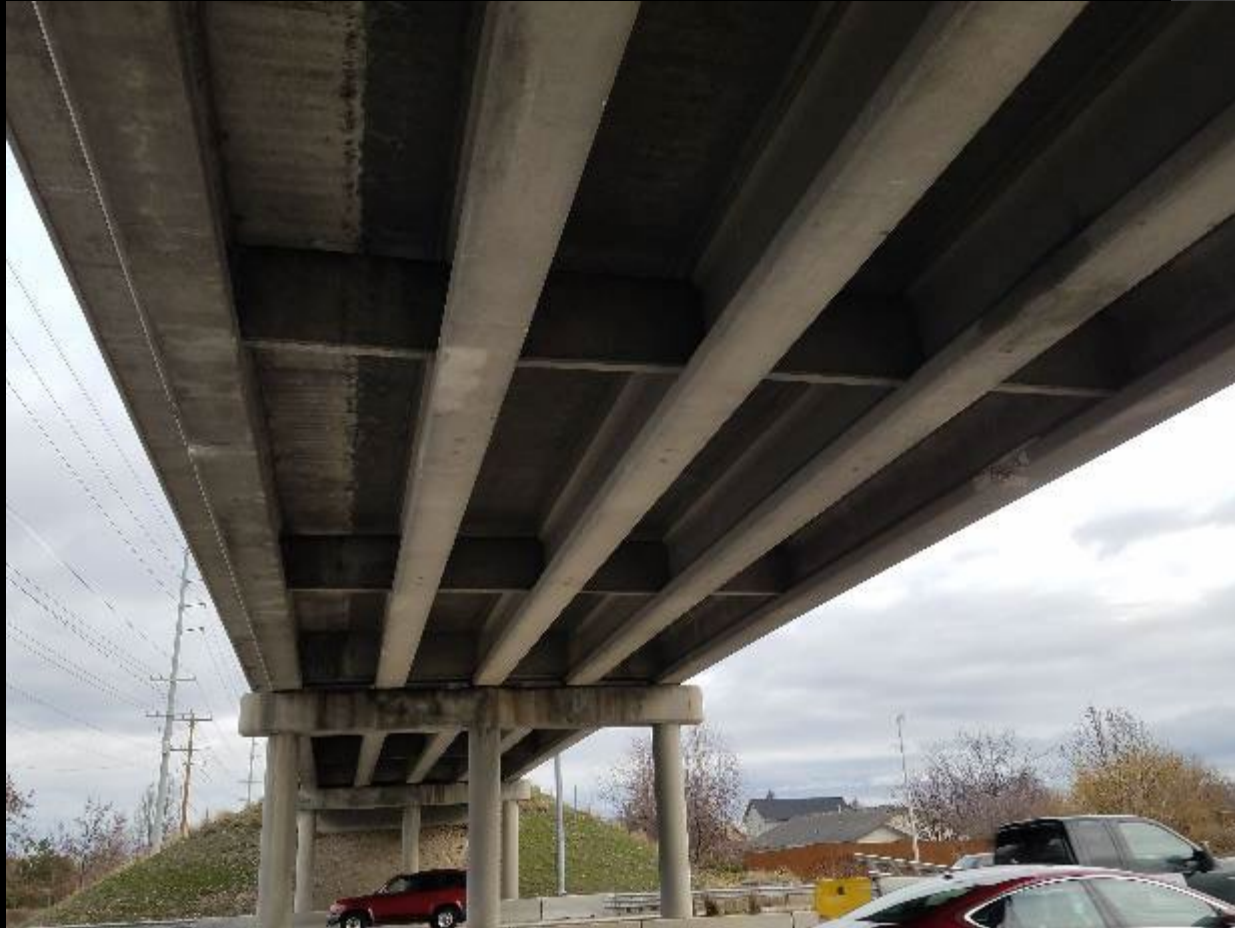
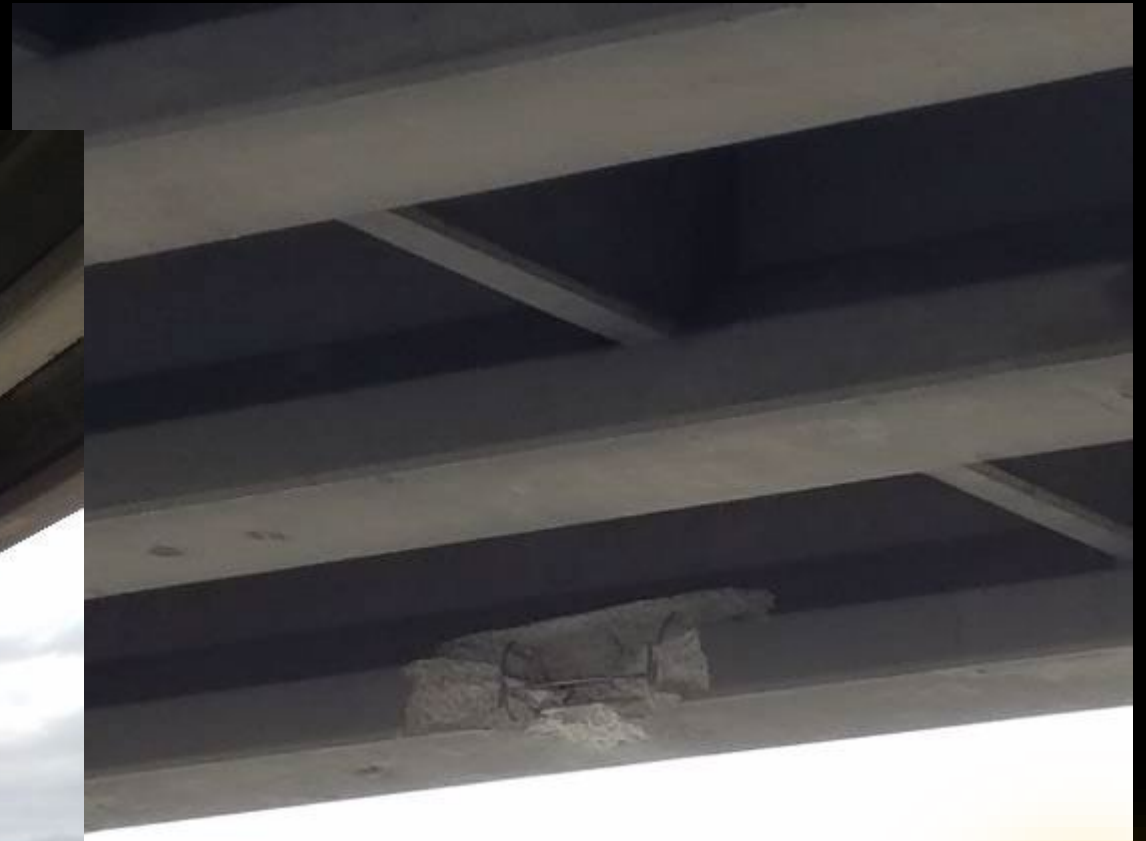
# Overheight Load Damage - 2016

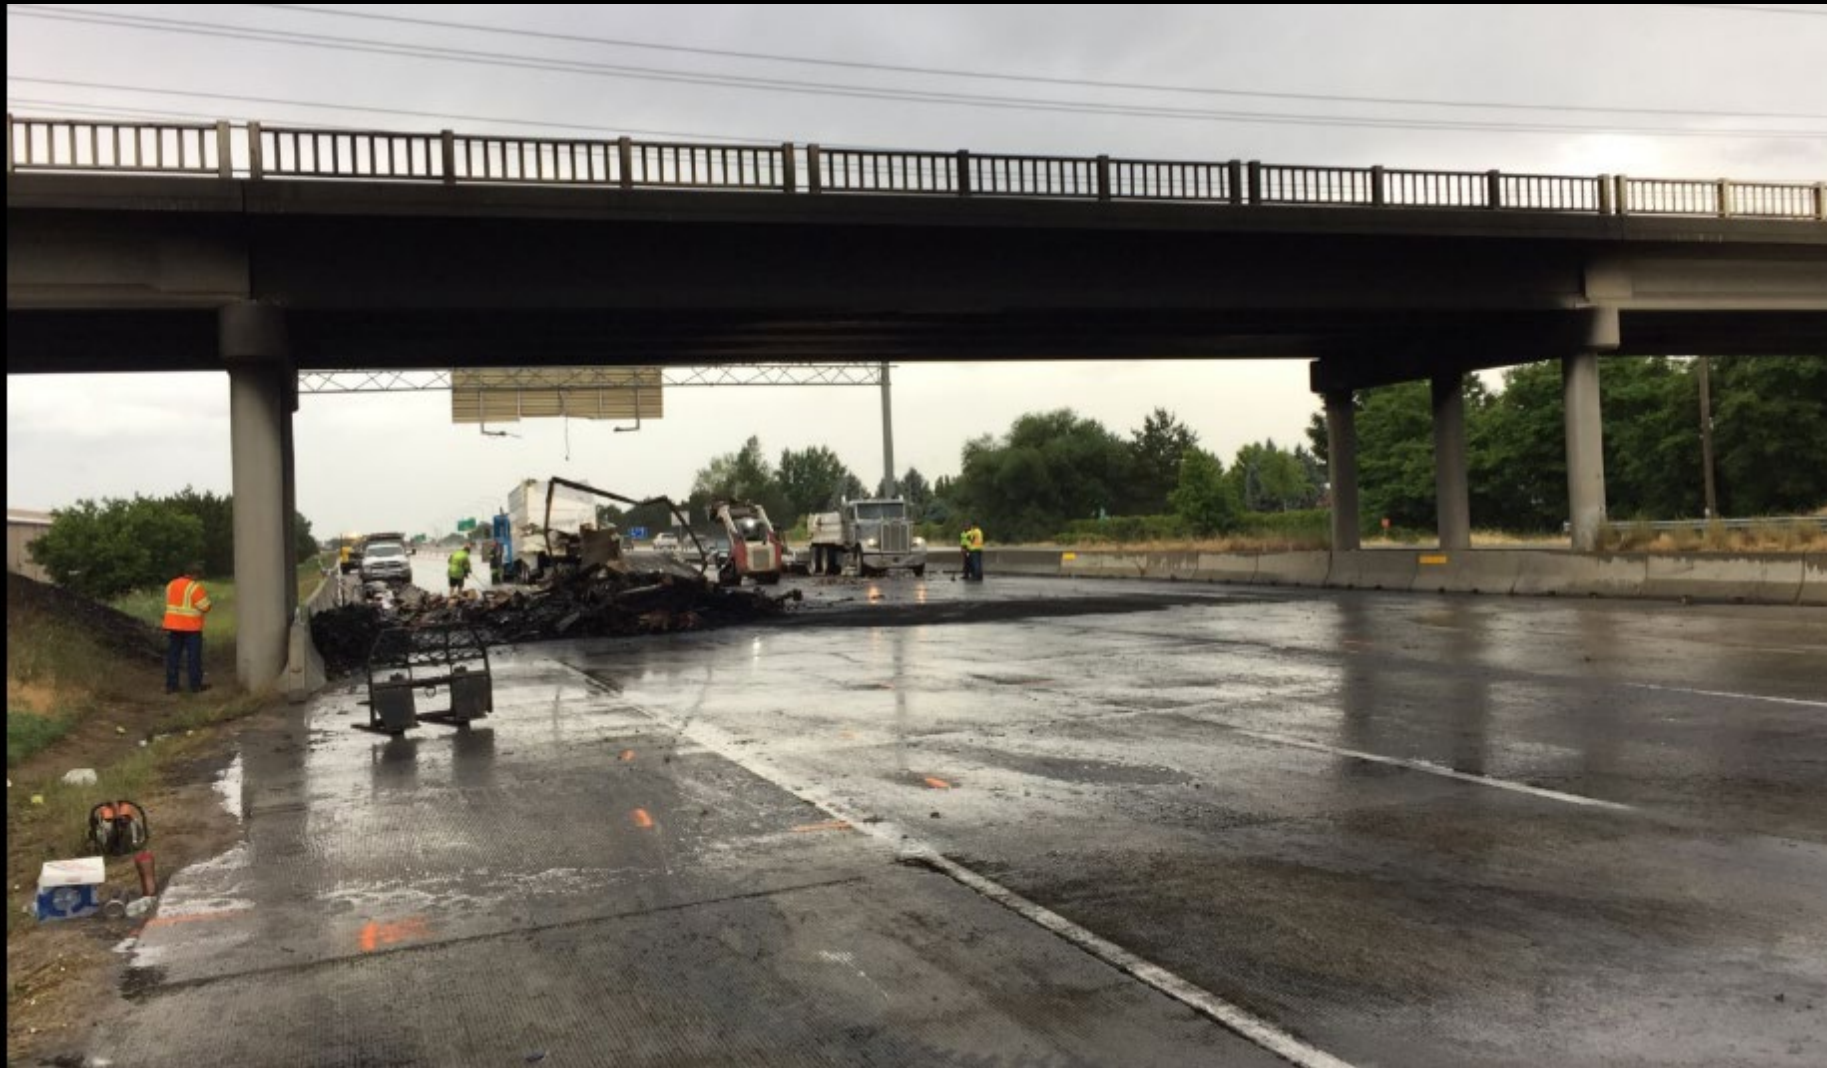
# The Damage

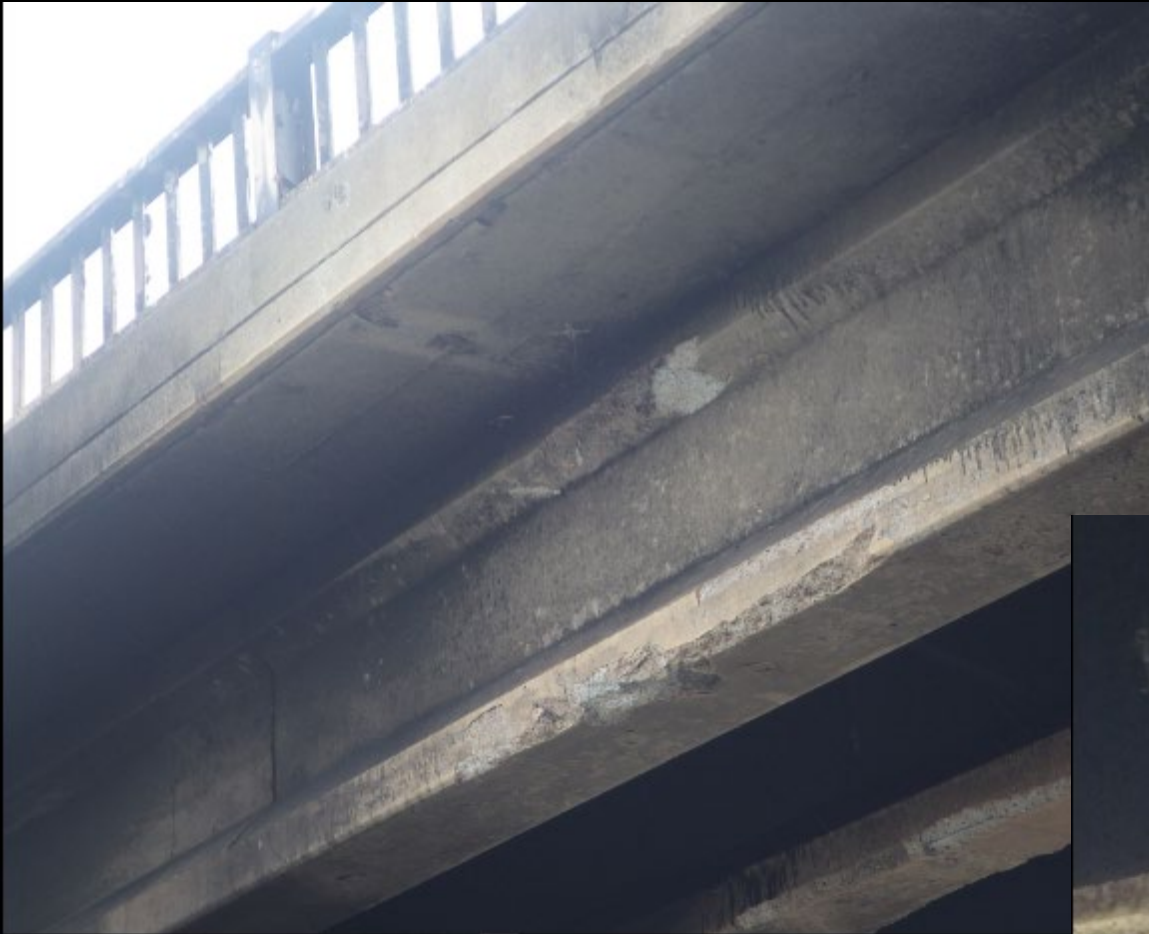
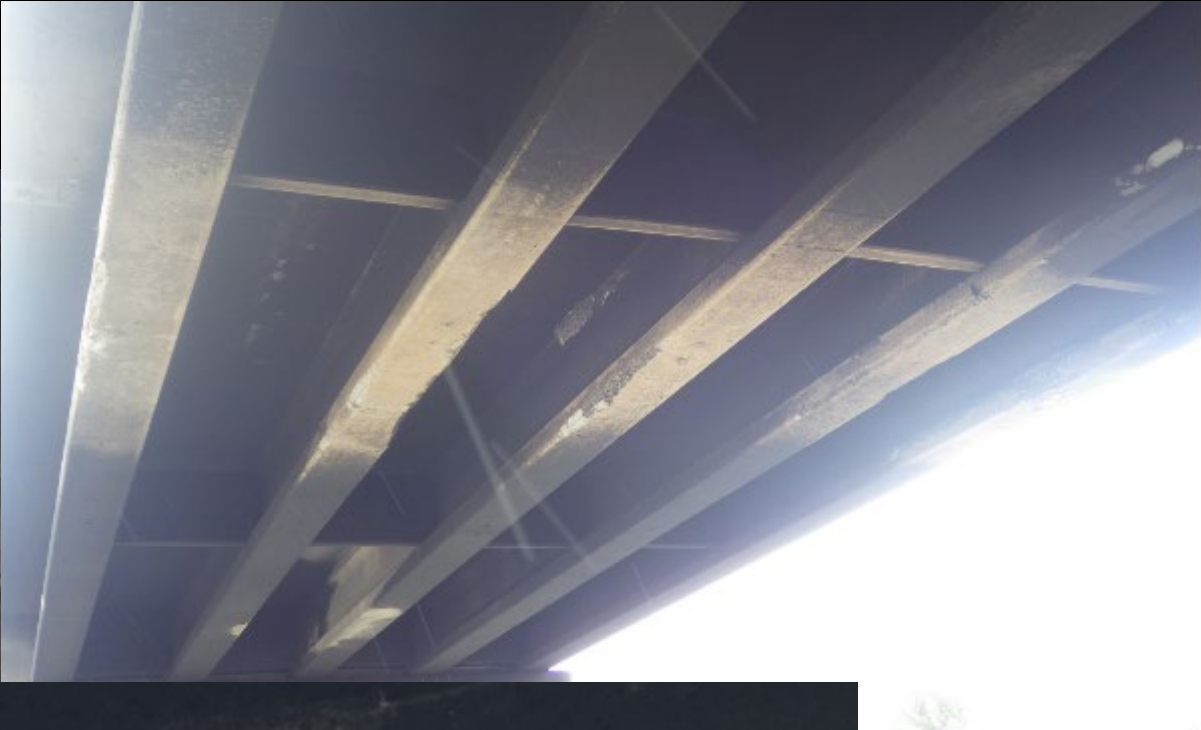
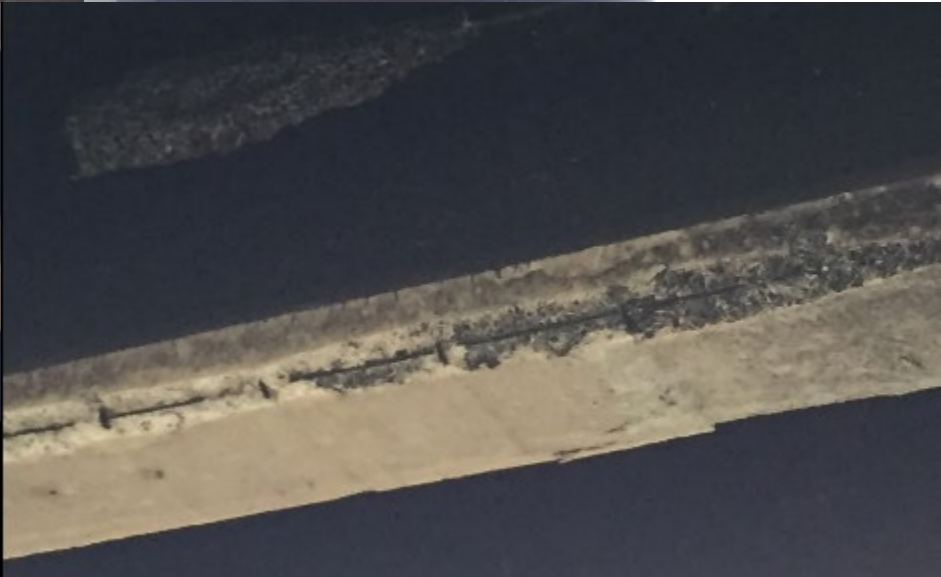
# Condition Assessment

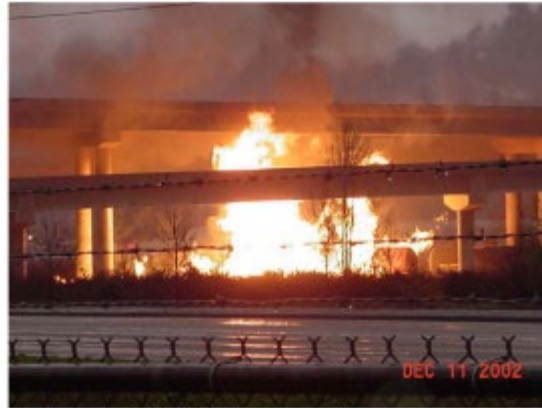
Photo 1. Puyallup River Bridge Railroad Tanker Fire

On December 11, 2002, at approximately 4:00 pm, a railroad tanker collision caused a fire under a prestressed girder bridge that consumed 30,000 gallons of methanol, (photo 1). This section of the bridge was a relatively new continuous three span frame constructed in 1997. The girders had a span length of 146 feet, a 28 day concrete strength of 7000 psi, and 0.5" diameter 270 ksi steel strands. The bridge deck and columns were constructed using 5000 psi concrete and 60 ksi mild steel. Confinement reinforcement in the columns was provided by tightly wound spiral cages.

The fire engulfed Span 8 and maintained a high flame temperature for approximately one hour. The interstate freeway was immediately closed to traffic and remained closed pending an all night structural inspection. The bridge displayed no unusual deflections or misalignments and was reopened to commuter traffic and legal weight trucks on the morning of December 12<sup>th</sup>. Over weight trucks were prohibited and routed to I-5.
