SR 99: ALASKAN WAY VIADUCT & SEAWALL REPLACEMENT PROGRAM

Hazardous Materials Technical Memorandum S. Holgate Street to S. King Street Viaduct Replacement Project Environmental Assessment

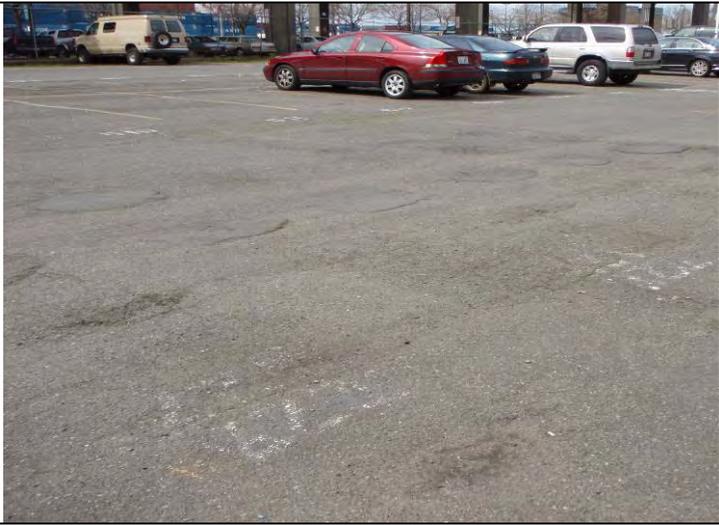
BLOCK NO. 370.1	Bounding Streets: S. Dearborn Street, First Avenue S., S. Royal Brougham Way, Alaskan Way S.

Property Description: Formerly known as the WOSCA and Gerry Sportswear sites. Unpaved and paved parking areas are located on the west side and middle portion of the block. Three buildings are located along the east side of the block and parallel First Avenue S. Storm drains that trend north-south are located in the parking area west of the buildings. Monitoring wells for the Project are located in the parking area. A monitoring well that did not appear to be associated with the Project was located about 50 feet west of the WOSCA warehouse, approximately midblock. Asphalt patches trend north-south and appear to be a result of subsidence along a utility line. Rail lines that trend north-south were located on the west edge, middle, and east edge of the property. A fenced area approximately midblock, along the western edge of the property, is used to store investigation-derived waste from the Project geotechnical exploration program.

Photo Description: Looking northwest at asphalt patches.

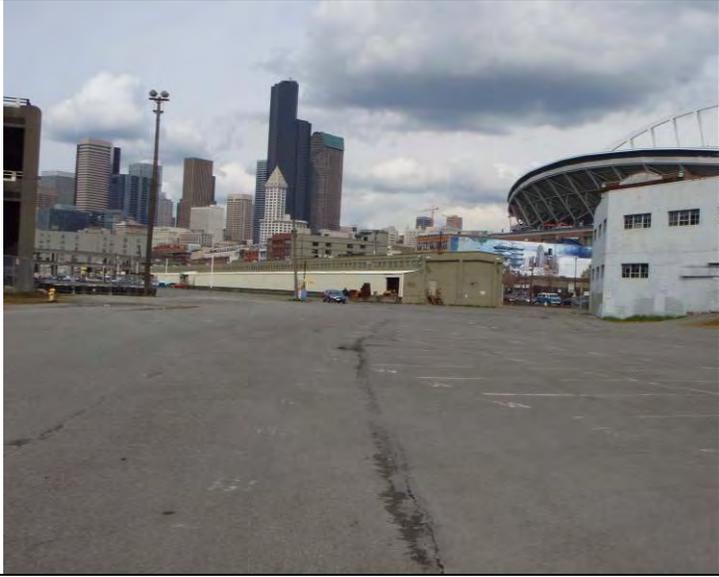
Acquisition Plan: Full. WSDOT has acquired the property for the Project. Phase I and Phase II ESAs were conducted prior to acquisition. Localized petroleum contamination has been documented at the northwest end of the Gerry Sportswear Building (see Section 3.6, Environmental Site Assessment Conducted for the Project).
Photo Description: Looking northeast at area of known petroleum contamination.

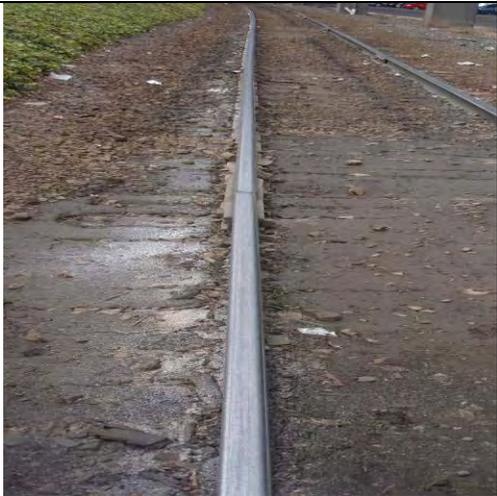
<p>BLOCK NO. 370.1-380.2 (WEST SIDE OF BLOCKS)</p>	<p>Bounding Streets: S. Dearborn Street, First Avenue S., S. Atlantic Street, and Alaskan Way S.</p>

<p>Property Description: A bike path is located directly east of Alaskan Way S.; farther east is a rail line. Dark stained soils are located between the rails. Three observation wells for the Alaskan Way Viaduct and Seawall Replacement Program are located along the bike path. Storm drains are located on the west side of Alaskan Way S. located beneath the viaduct, which is elevated through this section of the project footprint. The area underneath the viaduct is used for parking, and numerous small stains were observed, most likely associated with oil dripping from parked cars. Storm water drain pipes from the upper roadway are attached to support columns and penetrate the ground surface. It is assumed that they connect with the stormwater drainage system.</p> <p><u>Acquisition Plan:</u> Right-of-way owned by WSDOT and/or the City.</p>

<p>Photo Description: Looking north at oil staining between the rails.</p>

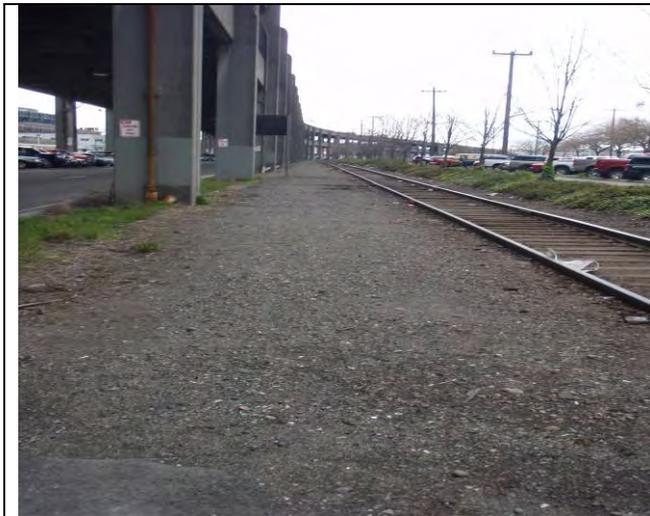
Photo Description: Looking south at unpaved area under the viaduct, adjacent to the west rail line.

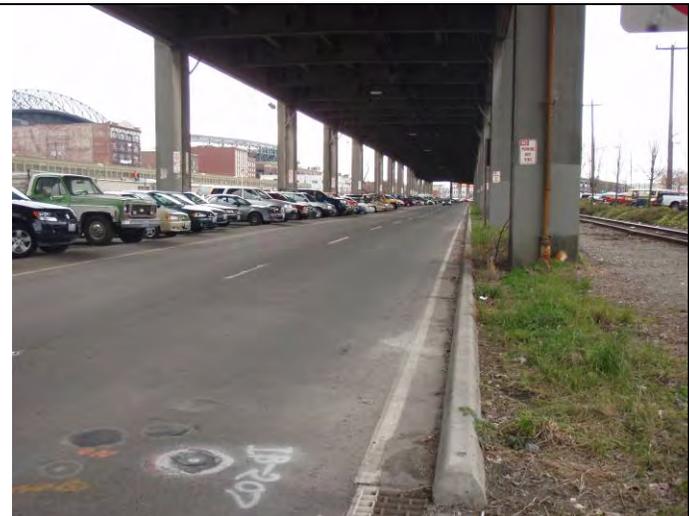
Photo Description: Looking south at paved area under the viaduct, adjacent to the west rail line. Project observation well and storm drain grate in foreground.

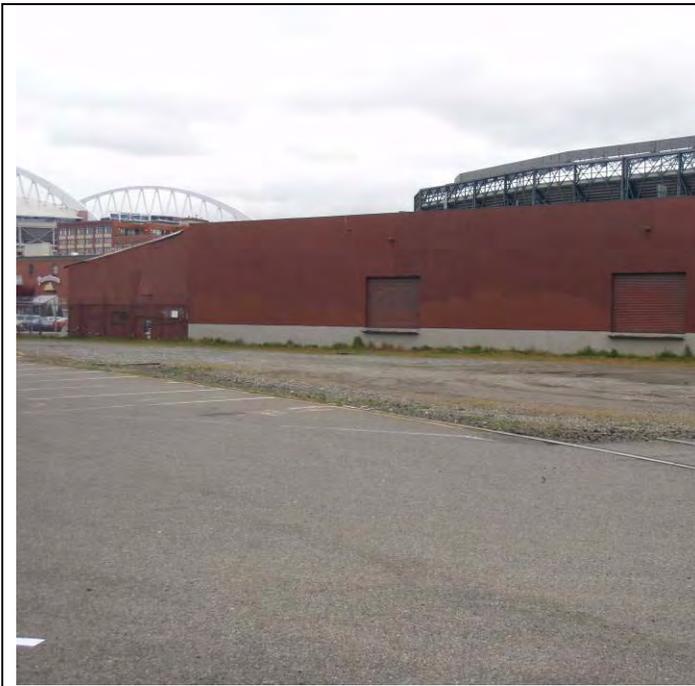
<p>BLOCK NOS. 380.2 AND 380.3</p>	<p>Bounding Streets: S. Royal Brougham Way, First Avenue S., S. Atlantic Street, and railroad tracks.</p>
--	--

Photo Description: Looking northeast at red warehouse and unpaved loading area.

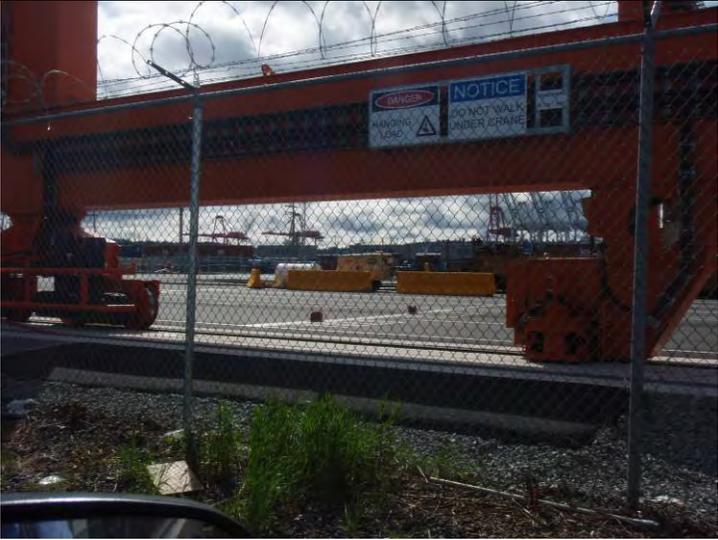
BLOCK NO. 410.3	<p>Bounding Streets: S. Holgate Street, Utah Avenue S., railroad tracks (S. Walker Street), and railroad tracks.</p>

<p>Property Description: The property is a container loading terminal where containers are transferred from trucks to rail (continued south from Block 400.3). The railyard is paved. An above-ground storage tank (AST) was observed within the railyard. A crushed 55-gallon drum was observed outside the east fence. <u>Acquisition Plan:</u> No, Block 410.3 is located one block east of the project footprint.</p>
<p>Photo Description: Looking west at an AST located within the SIG Railyard.</p>

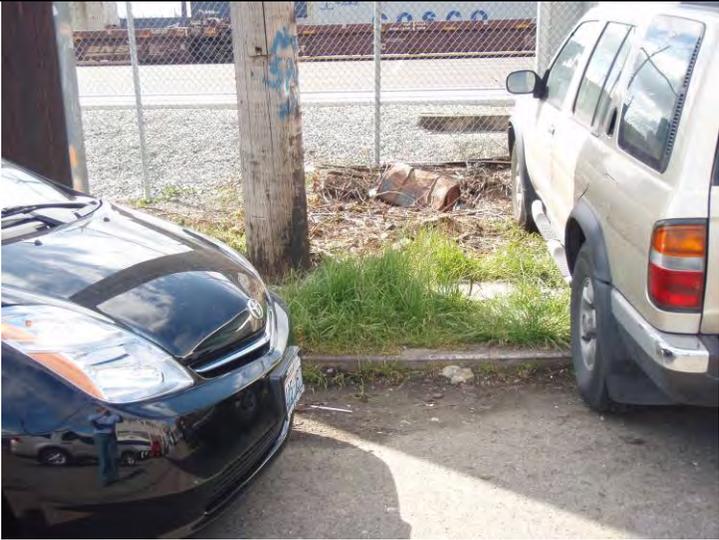
<p align="center">BLOCK NO. 410.3</p>	<p>Bounding Streets: S. Holgate Street, Utah Avenue S., railroad tracks (S. Walker Street), and railroad tracks.</p>

<p>Photo Description: Looking west at a crushed drum located east of the SIG Railyard fence.</p>

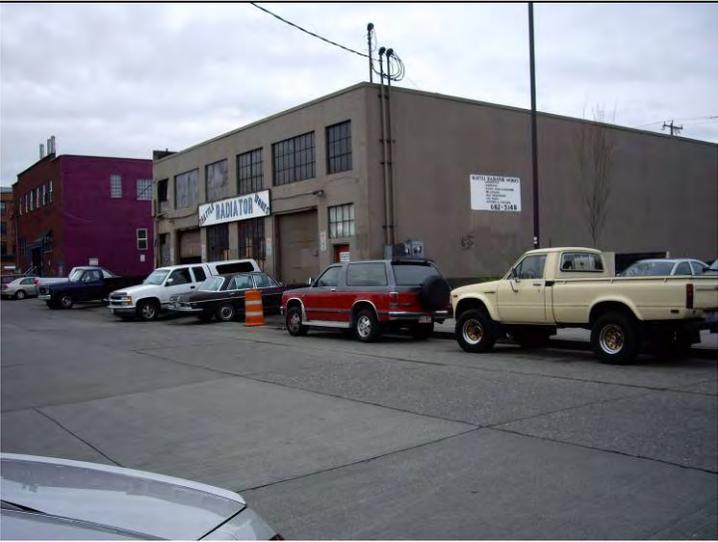
<p>Property Description: Older retail, warehouse buildings, and parking lots were observed. Dumpsters were located on Occidental Avenue S. Good housekeeping practices were observed outside of the buildings.</p> <p>Acquisition Plan: No, the block is located four blocks east of the project footprint.</p>
<p>Photo Description: Looking northwest at Radiator Business located approximately midblock.</p>
