Re: Woodland State Airport Hangar Review

**Woodland State Airport Hangar Review
Washington State Department of Transportation**

**Attachment B
Structural Examination of
Woodland State Airport Letter Report**

RE: Structural Examination of Woodland State Airport

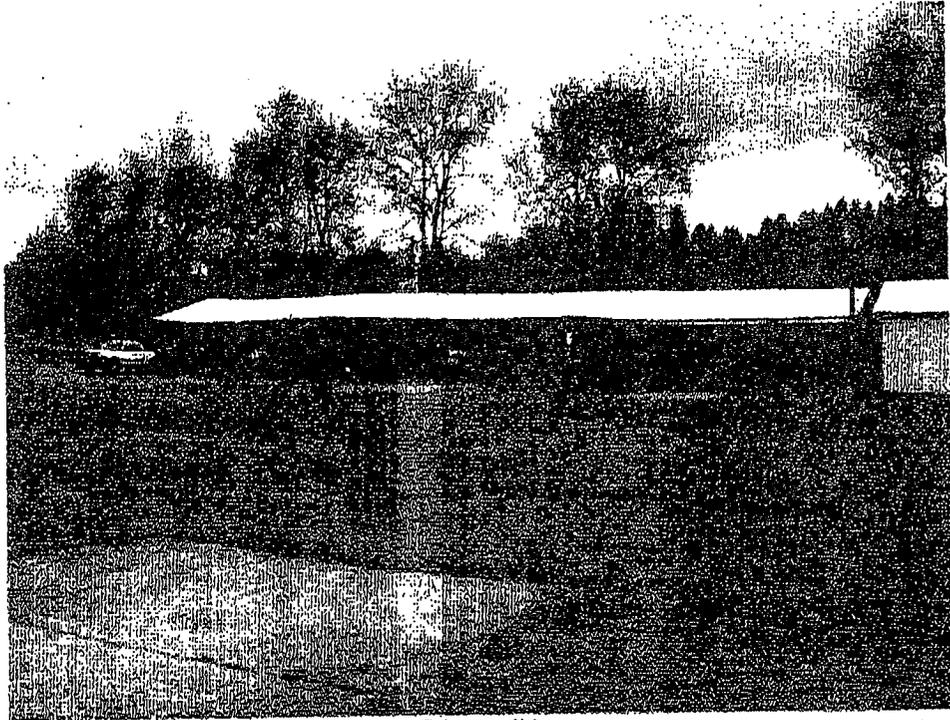
supported at the center as well as the front and rear post lines. Roof purlins consist of 2x6 members at 2' to 2'-6" on center single spanned up to 20' with a galvanized corrugated metal roof. The exterior posts generally consist of creosote treated double 3x6 members and interior posts consist of pressure treated 6x6 members. The posts are embedded into the ground and are situated at an alternating 10' and 20' on center spacing with the exterior post lines enclosed by galvanized corrugated metal siding. (See Photos #1 and #2)

Photo #1
Building A, Hangars 1 Thru 3

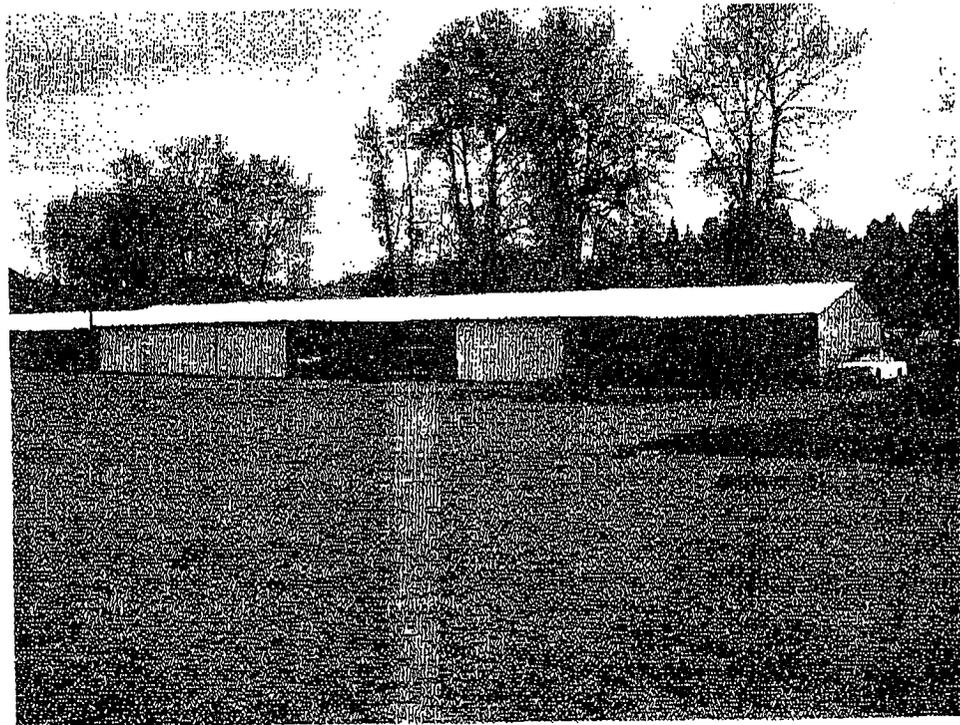
Photo #2
Building B, Hangars 4 Thru 8

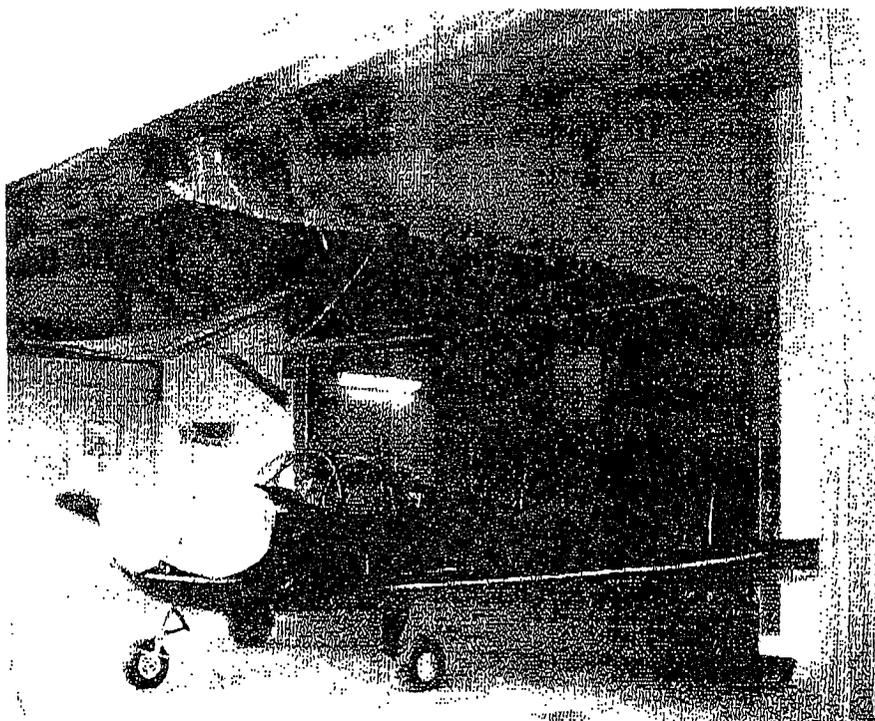
Buildings A and B have been typically modified at the hangar bay openings by removing exterior supporting posts to accommodate the required bay openings. A few of the hangar bay openings have door systems of different construction installed and many others are open to the elements. In some locations, replacement 4x4 posts were installed with hinges at the exterior truss bearing point to apparently allow the post to be moved up out of the way and then returned to a supporting position. However, each of the posts installed in this manner have been tied up in the open position and provide no support. In a few locations, the original posts have been cut off above the ground and spliced to replacement posts. In building A, all of the hangar openings and missing posts are located along the west wall line. In building B, the hangar openings and missing posts are alternated between the west and east wall lines. (See Photo #4)

Photo #4
Cantilevered Framing Typical, Hangar 8

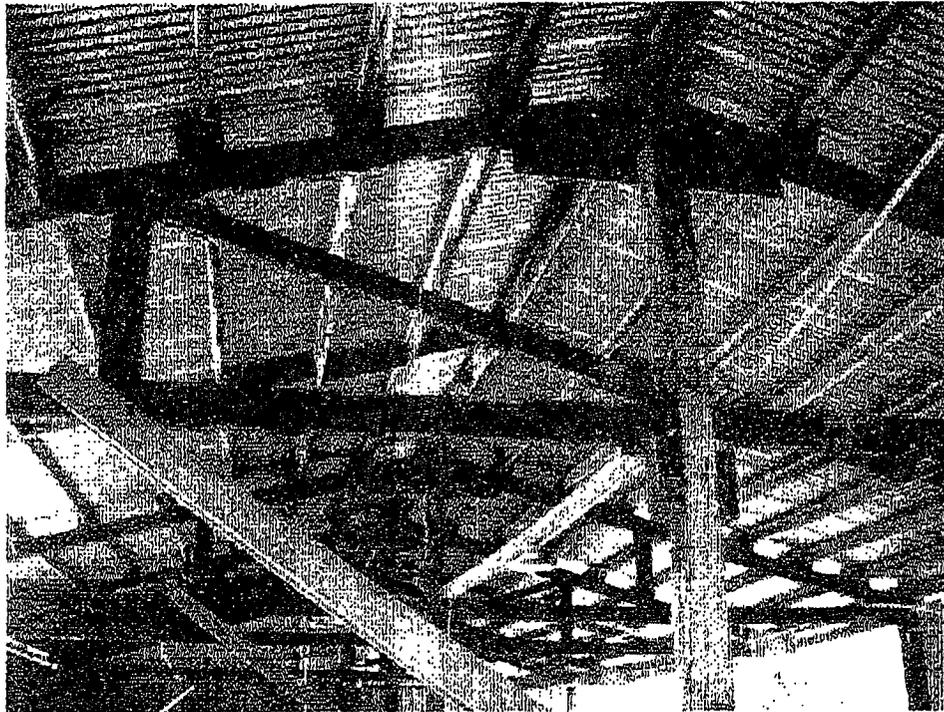
The gabled, wood framework supporting the roof joists generally consist of creosote treated 3x6 wood members framed into the interior bearing post from each side and connected at the eaves to form a truss type configuration. At locations where the exterior post was removed or modified, the tails of the truss-type framework is cantilevered out 16' with a 16' back span. An intermediate vertical member is present at each side near mid-span and a diagonal member is typically installed on the cantilevered side. Connections at the tails and panel points vary, but generally consist of plywood gusset plates at one or both sides with 3/8"-1/2" through bolts and varied nailing patterns. Many interior panel connection points for the vertical and diagonal members have no gusset plates or obvious connection. (See Photo #5)

The gable truss-type framework supporting the roof joists are not supported or constructed as true trusses. Typical truss design for hand built trusses requires careful attention to connections at the joined members. The observed geometry and existing connections do not even closely appear to be adequate. This is evident in the necessity of the numerous additional supporting knee braces, tie rods and scabs that have been installed to the framework over time. The design and connections of which are also not entirely sufficient as several are failing. As a result, the roof framing is deflected and sagging in many areas under dead load alone. Increased or full required design vertical loading could be expected to cause full or partial collapse in many areas.

Photo #5
Truss Type Framing Support. Buildings A and B

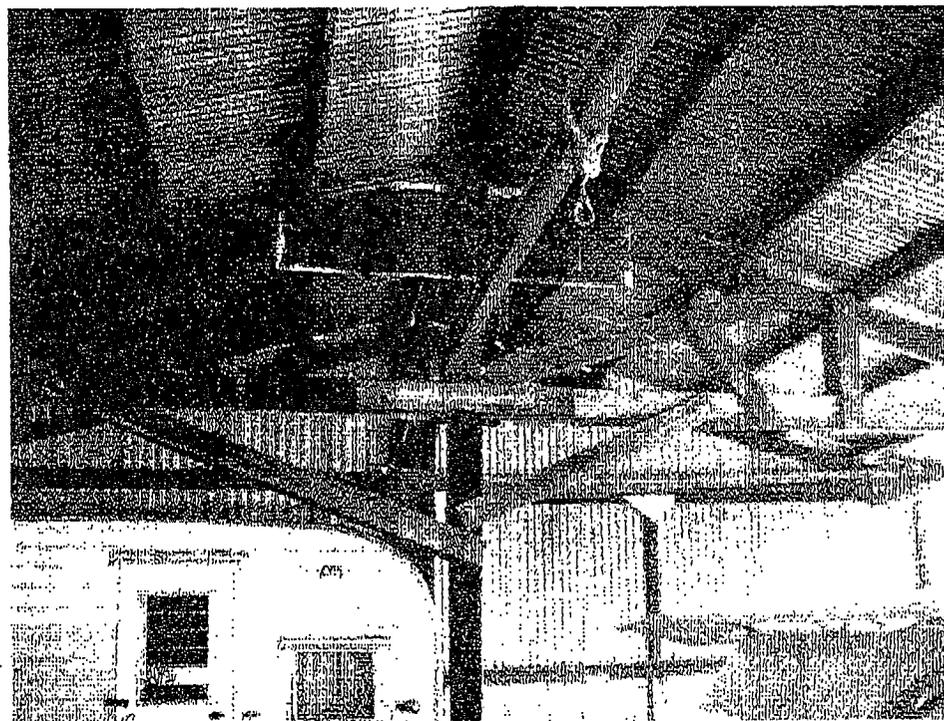
In several areas the truss type frame work has been modified further with additional vertical and diagonal scab members and or strapping in various configurations to provide additional rigidity. On the cantilevered end side of the framework, additional diagonal knee braces have been installed in various configurations. These braces typically consist of single or double 2x6's attached to the interior post and out to near mid span of the framing. These connections also vary with through bolts in some locations and minimal nailing in others. Many of the installed knee braces are buckling out of plane up to 1" or more and several nailed connections are beginning to separate. At a few locations, 1/2" steel tie rods with angle clips, between the top and bottom chords, were installed in place of knee braces. The angle clips are bending slightly and crushing at the back of the through bolt connection. (See Photos #5 and #6)

Photo #6
Multiple Band-Aids

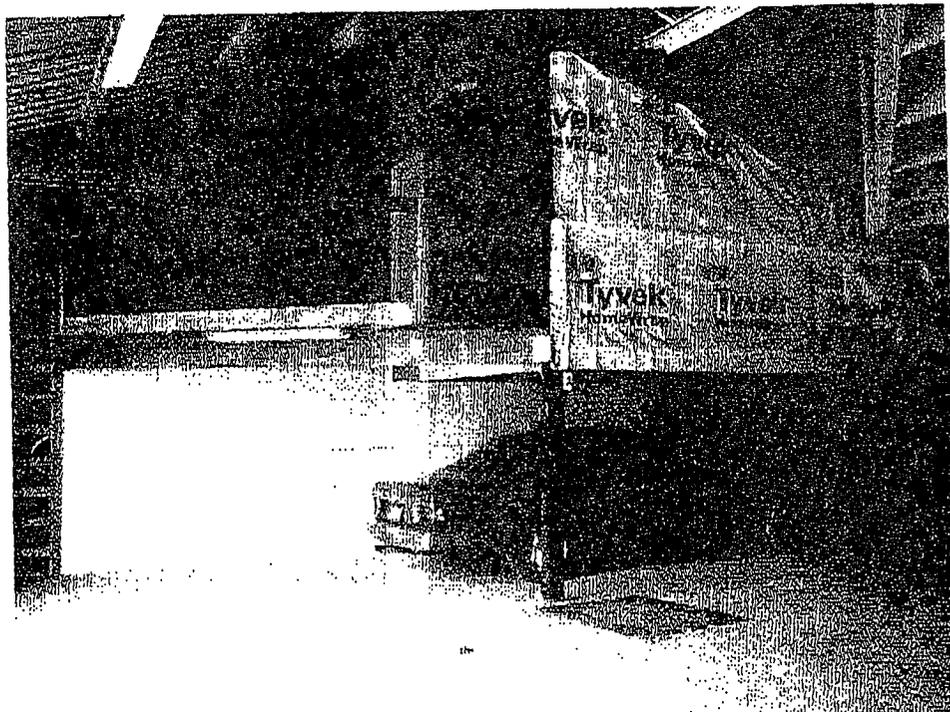
Photo #10
Mezzanine With Enclosed Storage Space, Hangar 13
