Unfunded Preservation Needs

Adams County

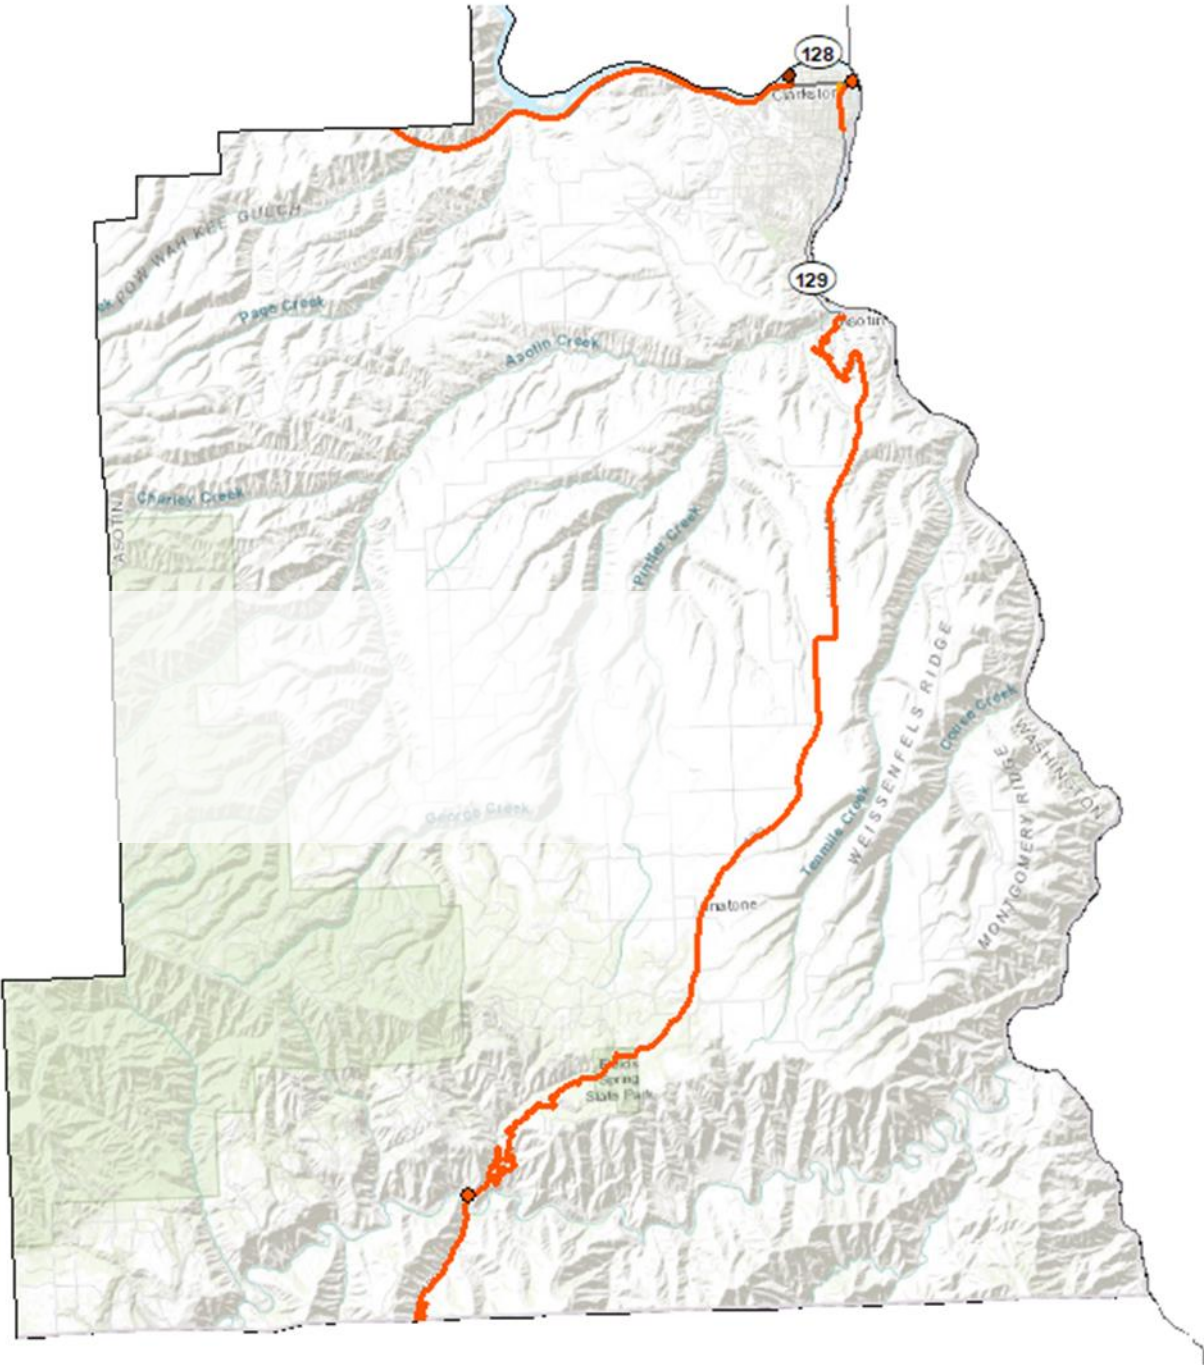
WSDOT has been cost-effectively managing this corridor for 70 years through chip seal surfacing. The first ten miles are rougher than WSDOT standards. Not chip sealing and repairing rough sections during the next ten years makes it very likely much of this route will need major rehabilitation or reconstruction.

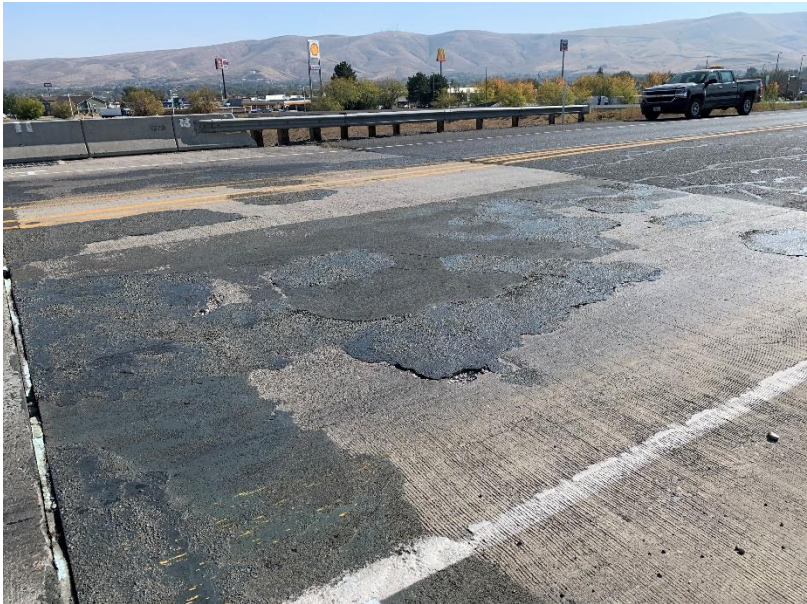
Severe deterioration on a bridge approach at the I-82/Gap Rd interchange in Prosser. Nearly all ramp preservation needs are currently unfunded. Interchanges currently in fair condition (minor cracking and patching) will look like this in ten years. Those currently in this condition will see failed bridge crossings and pavements in need of reconstruction.

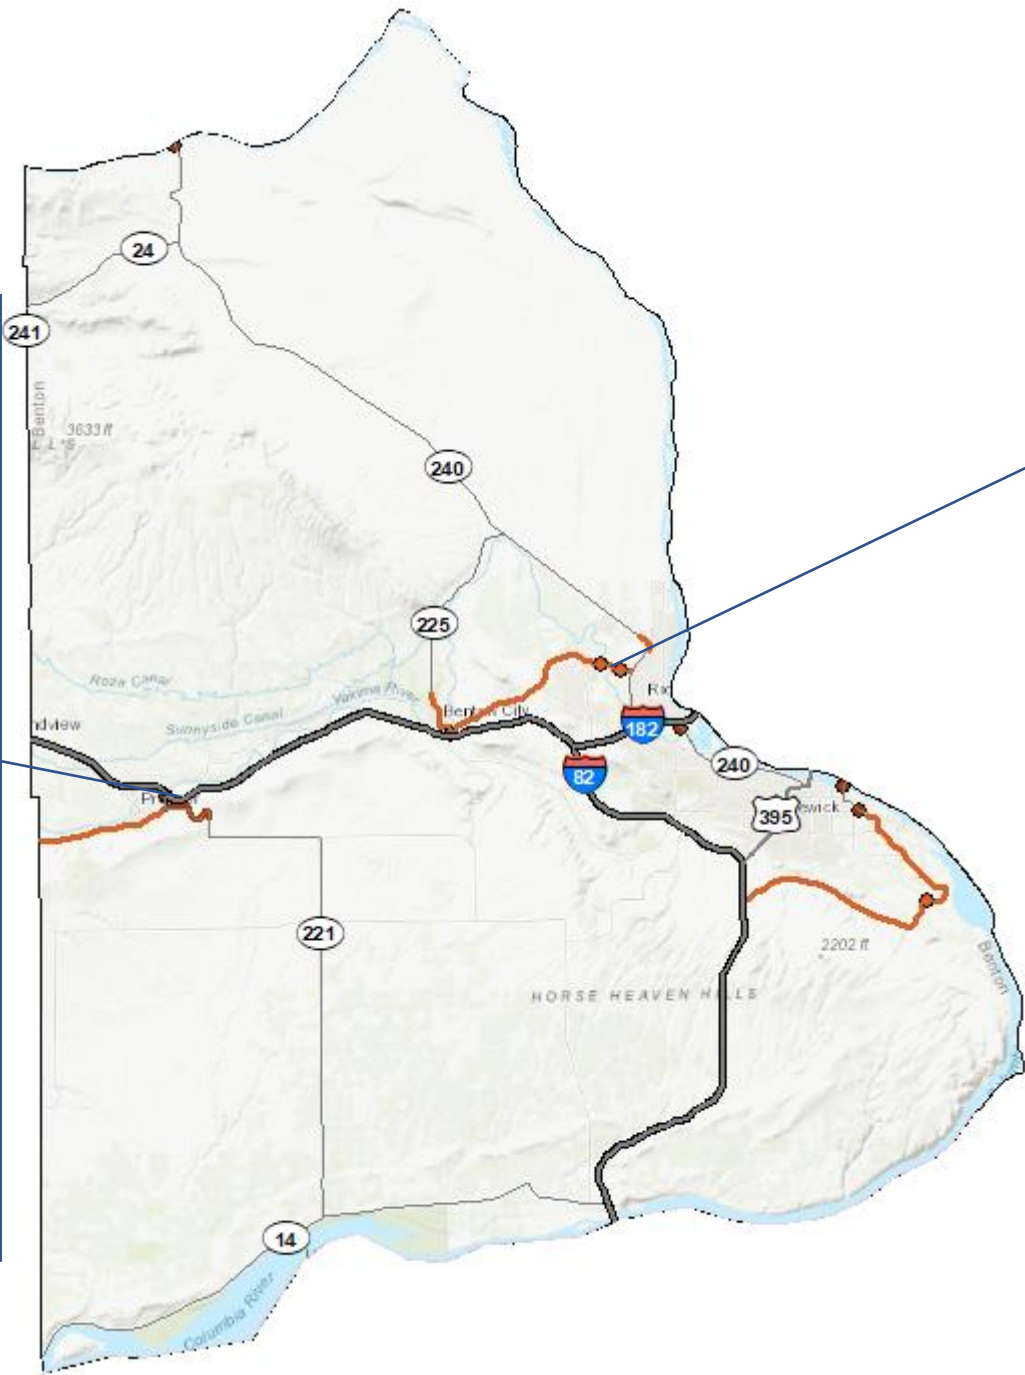
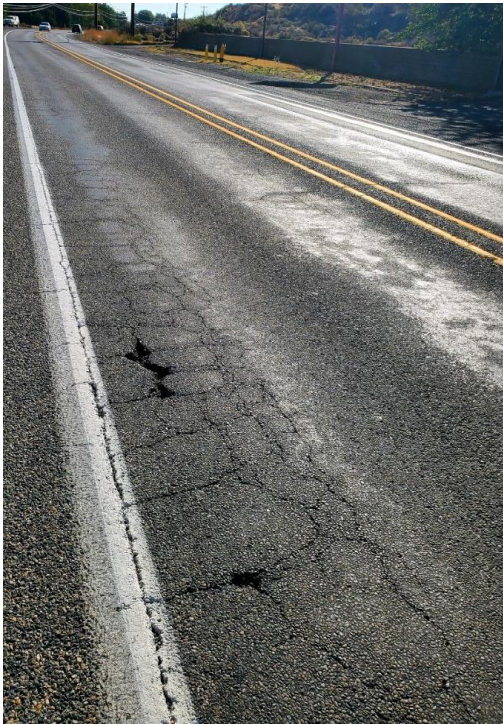
Severe alligator cracking and spalling on SR 224 in West Richland.

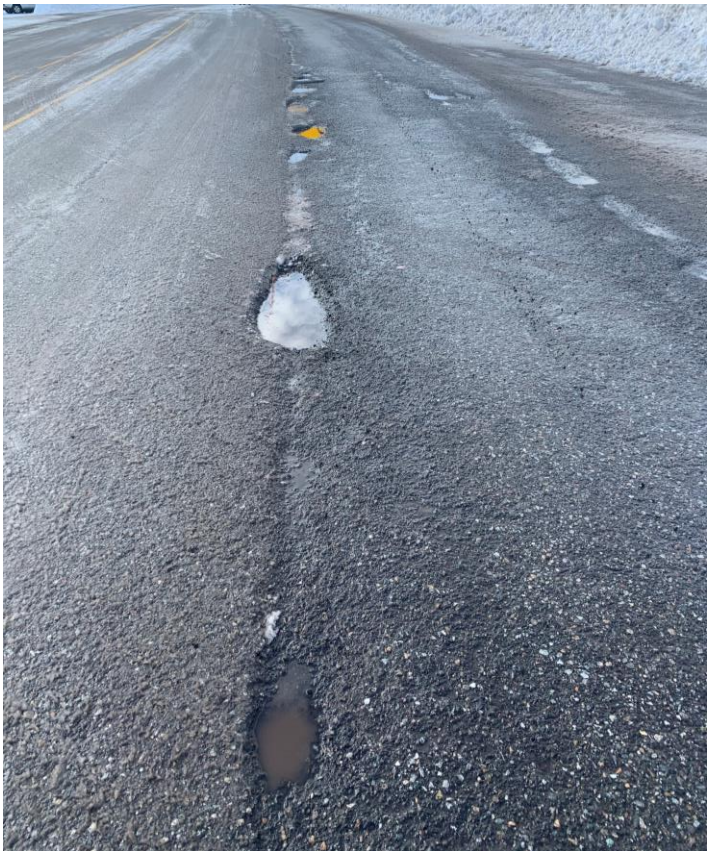
US 2 – Stevens Pass: Cracking, rutting, potholing and delamination is developing on the roadway surface, less the 5 years after resurfacing. Extensive patching is planned for this summer, but a full resurfacing is needed.

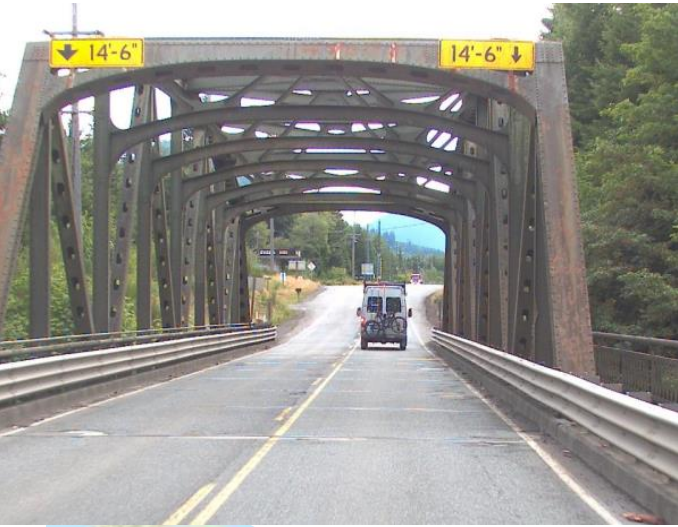
US 101 Bridge over the Sol Duc River. Rust blooms throughout the truss. Bridge has extensive patching, some of which has reflected through the asphalt.

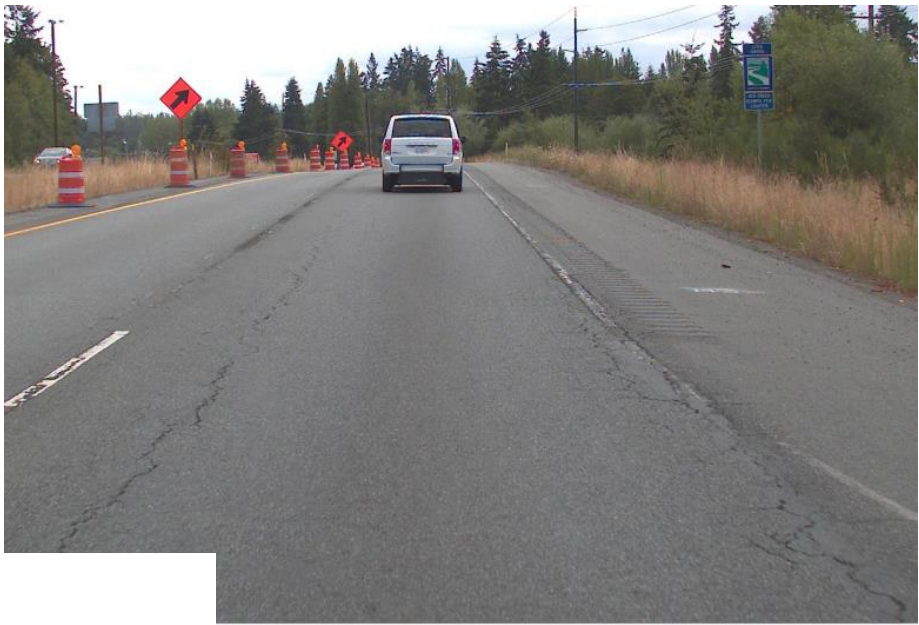
Cracking throughout US 101 outside of Port Angeles, including distresses at the recessed pavement markers and rumble strips. In addition to preserving the pavement, preservation projects preserve safety features like rumble strips and pavement markers. These features also cannot be preserved on the same roads that do not having funding for bridge and pavement preservation.

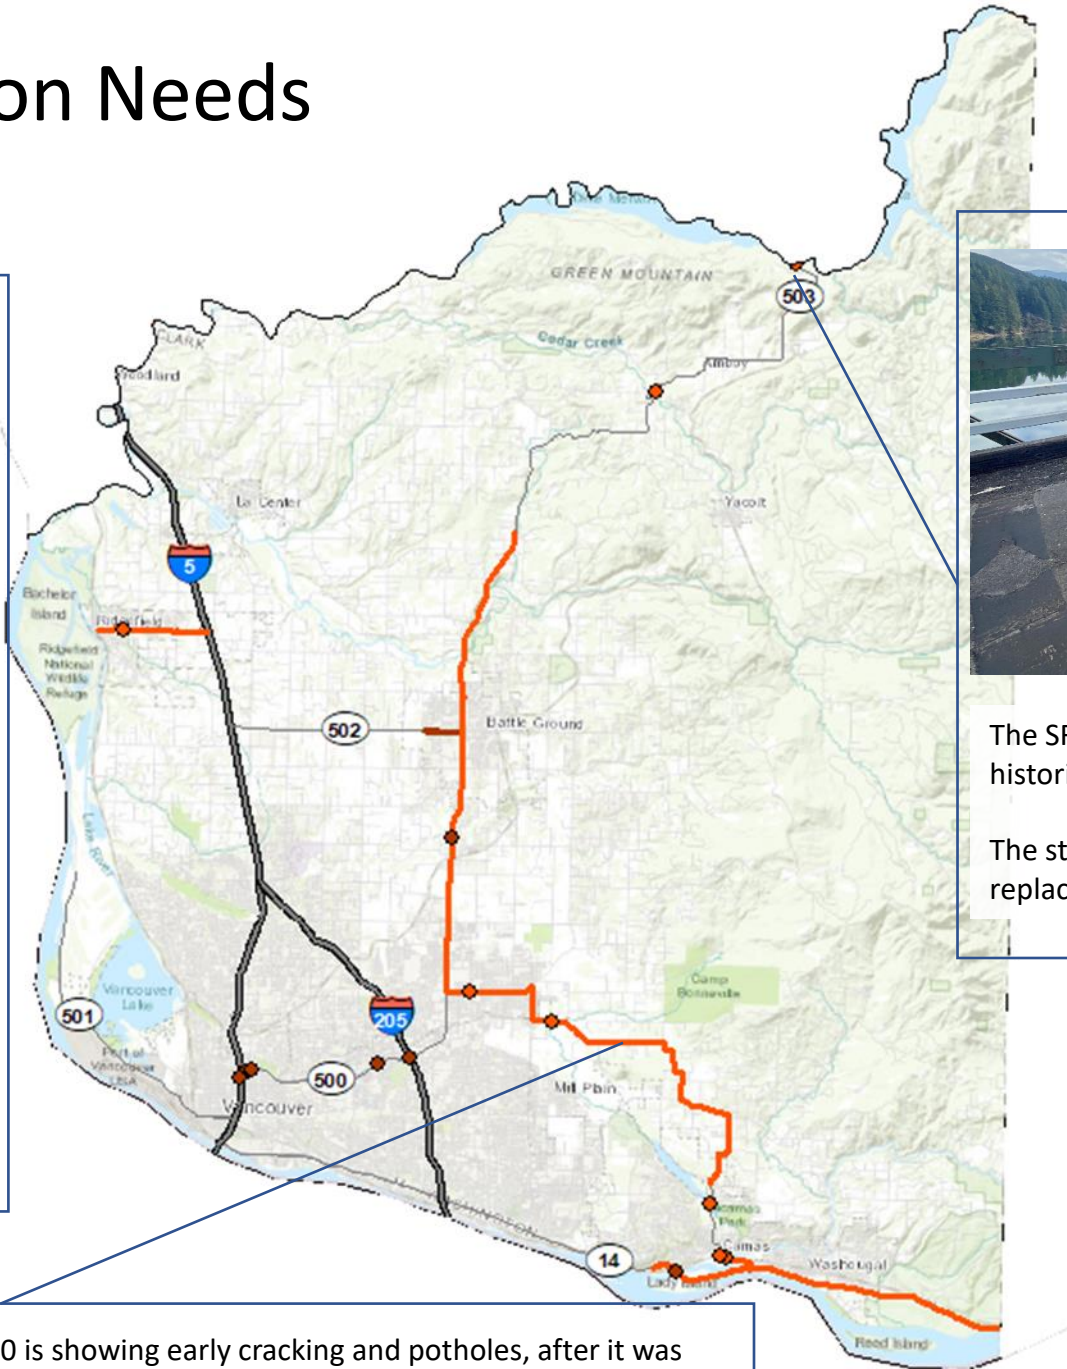
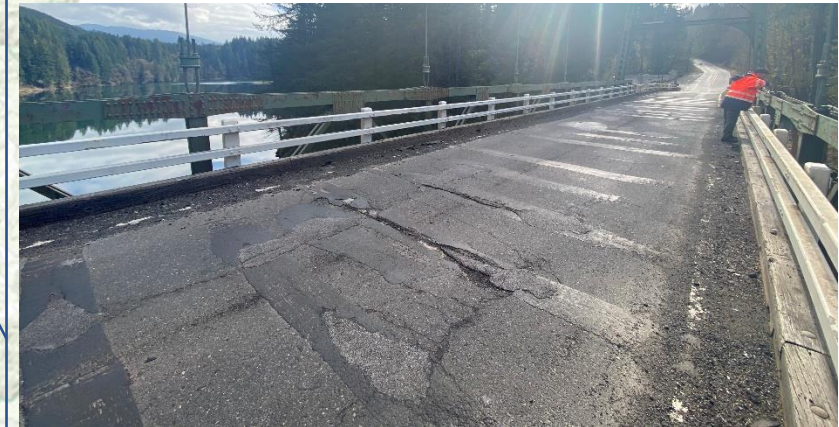
The SR 503 Lewis River Yale bridge is a narrow, one lane, historical bridge with eagles that nest in its towers.

The structure is in need of both steel painting and deck replacement and could be a candidate for replacement.

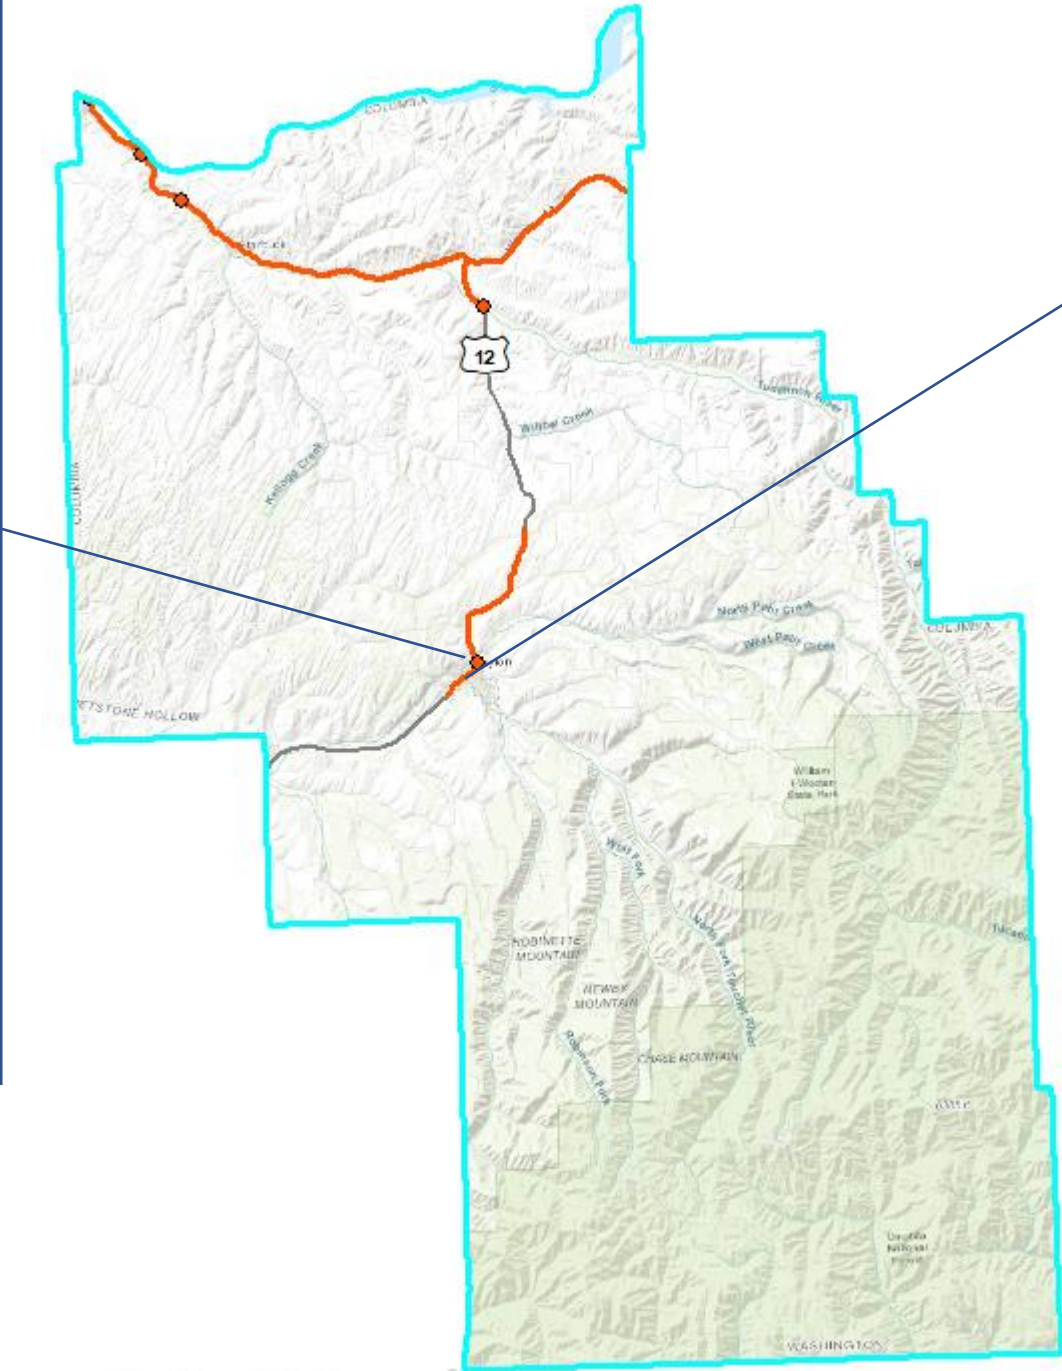
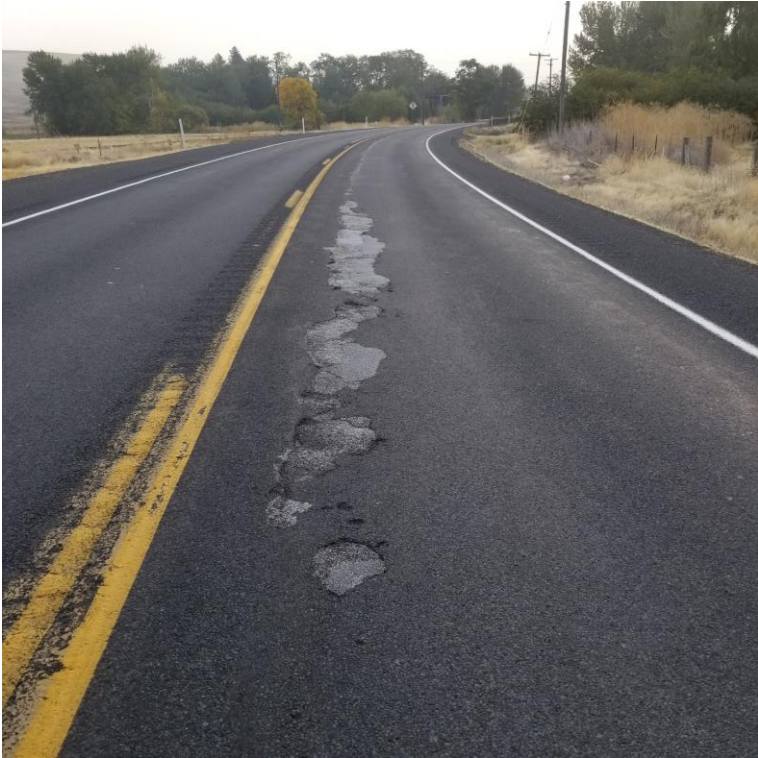
Potholes and delamination on US 12 southeast of Dayton. This section is in need of a chip seal now for optimal, cost-effective preservation, and to prevent it from further deterioration over the next ten years.

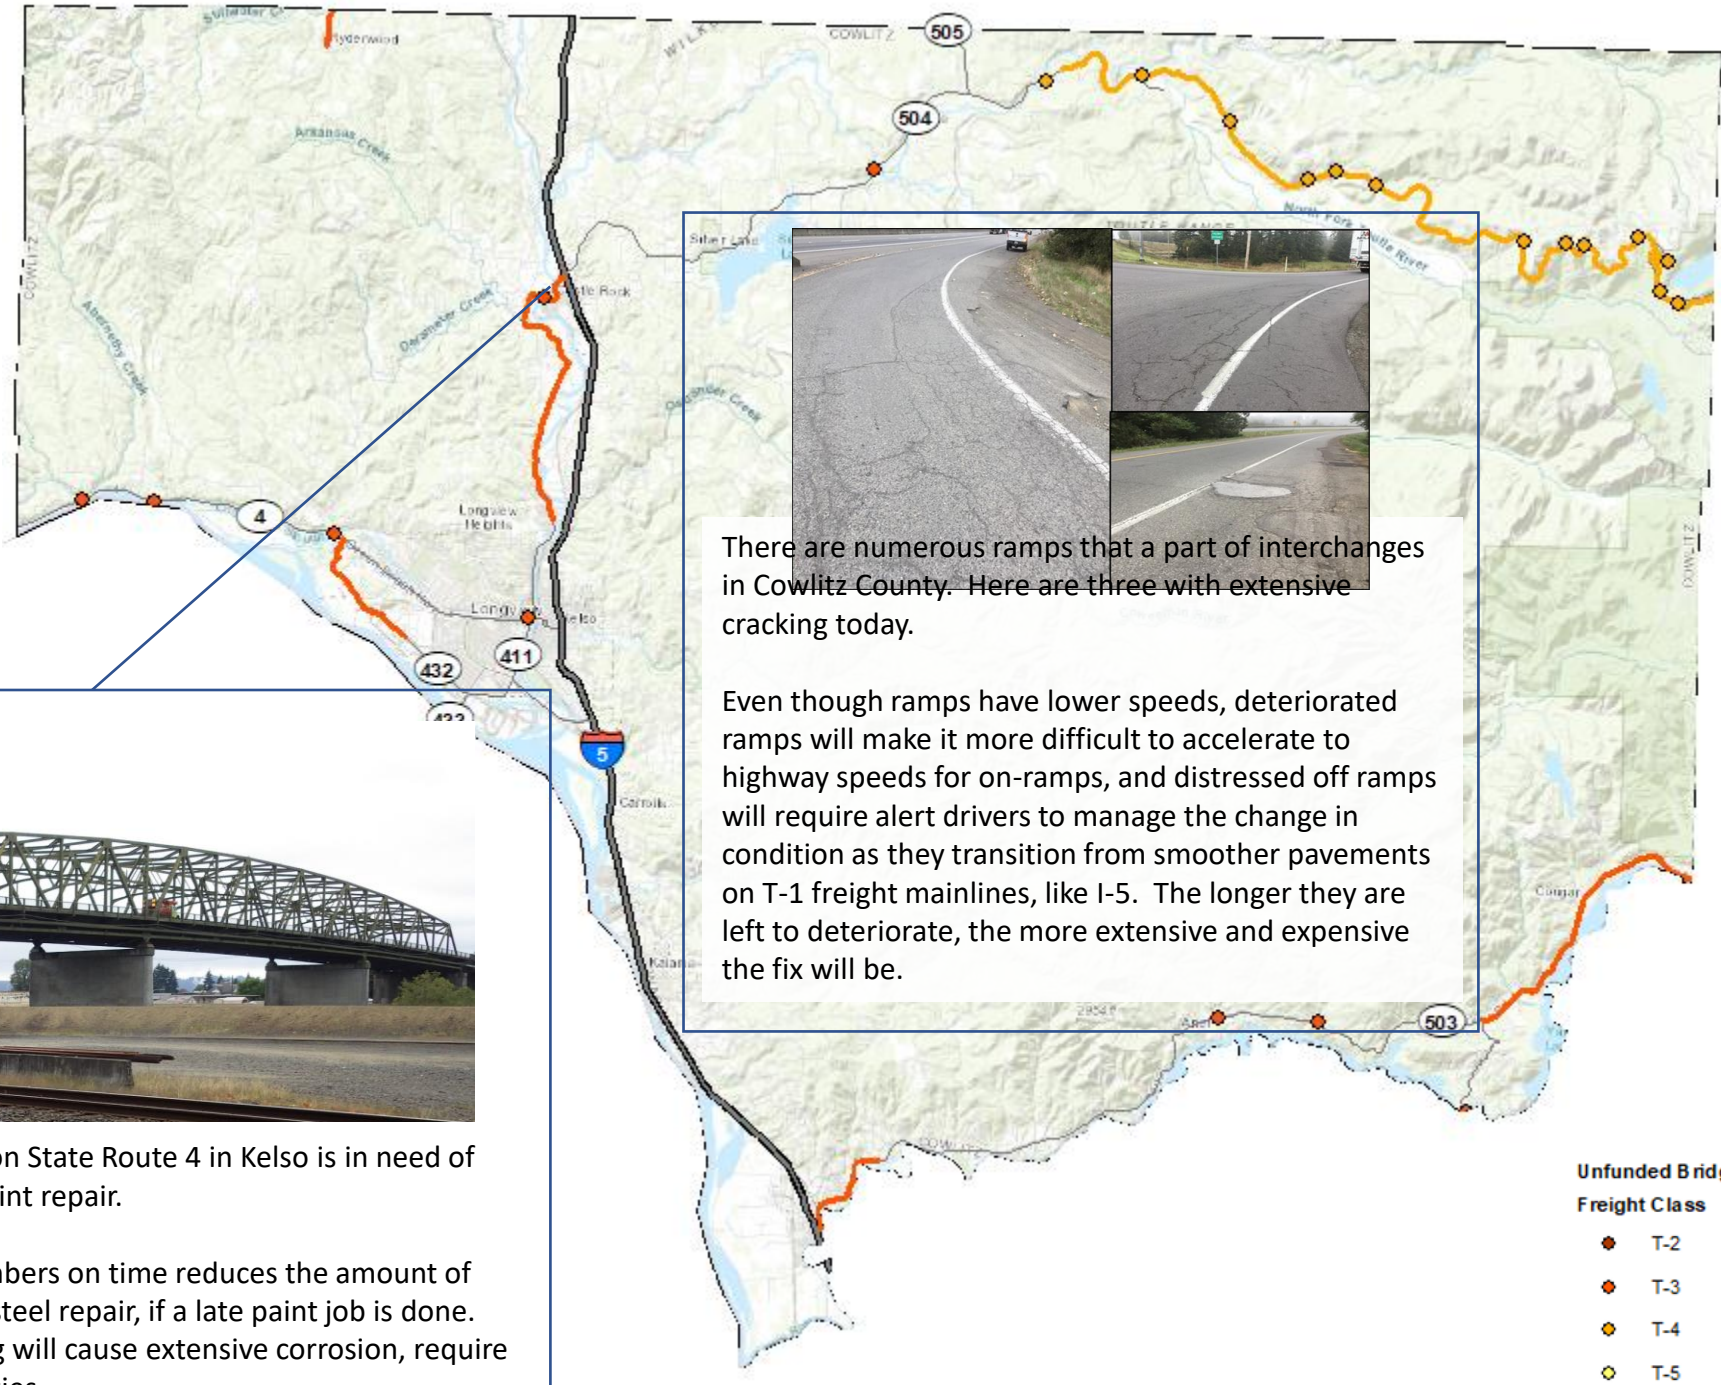
The Cowlitz River bridge on State Route 4 in Kelso is in need of painting and expansion joint repair.

Painting steel bridge members on time reduces the amount of corrosion, and therefore steel repair, if a late paint job is done. Delaying painting too long will cause extensive corrosion, require major replacement activities.

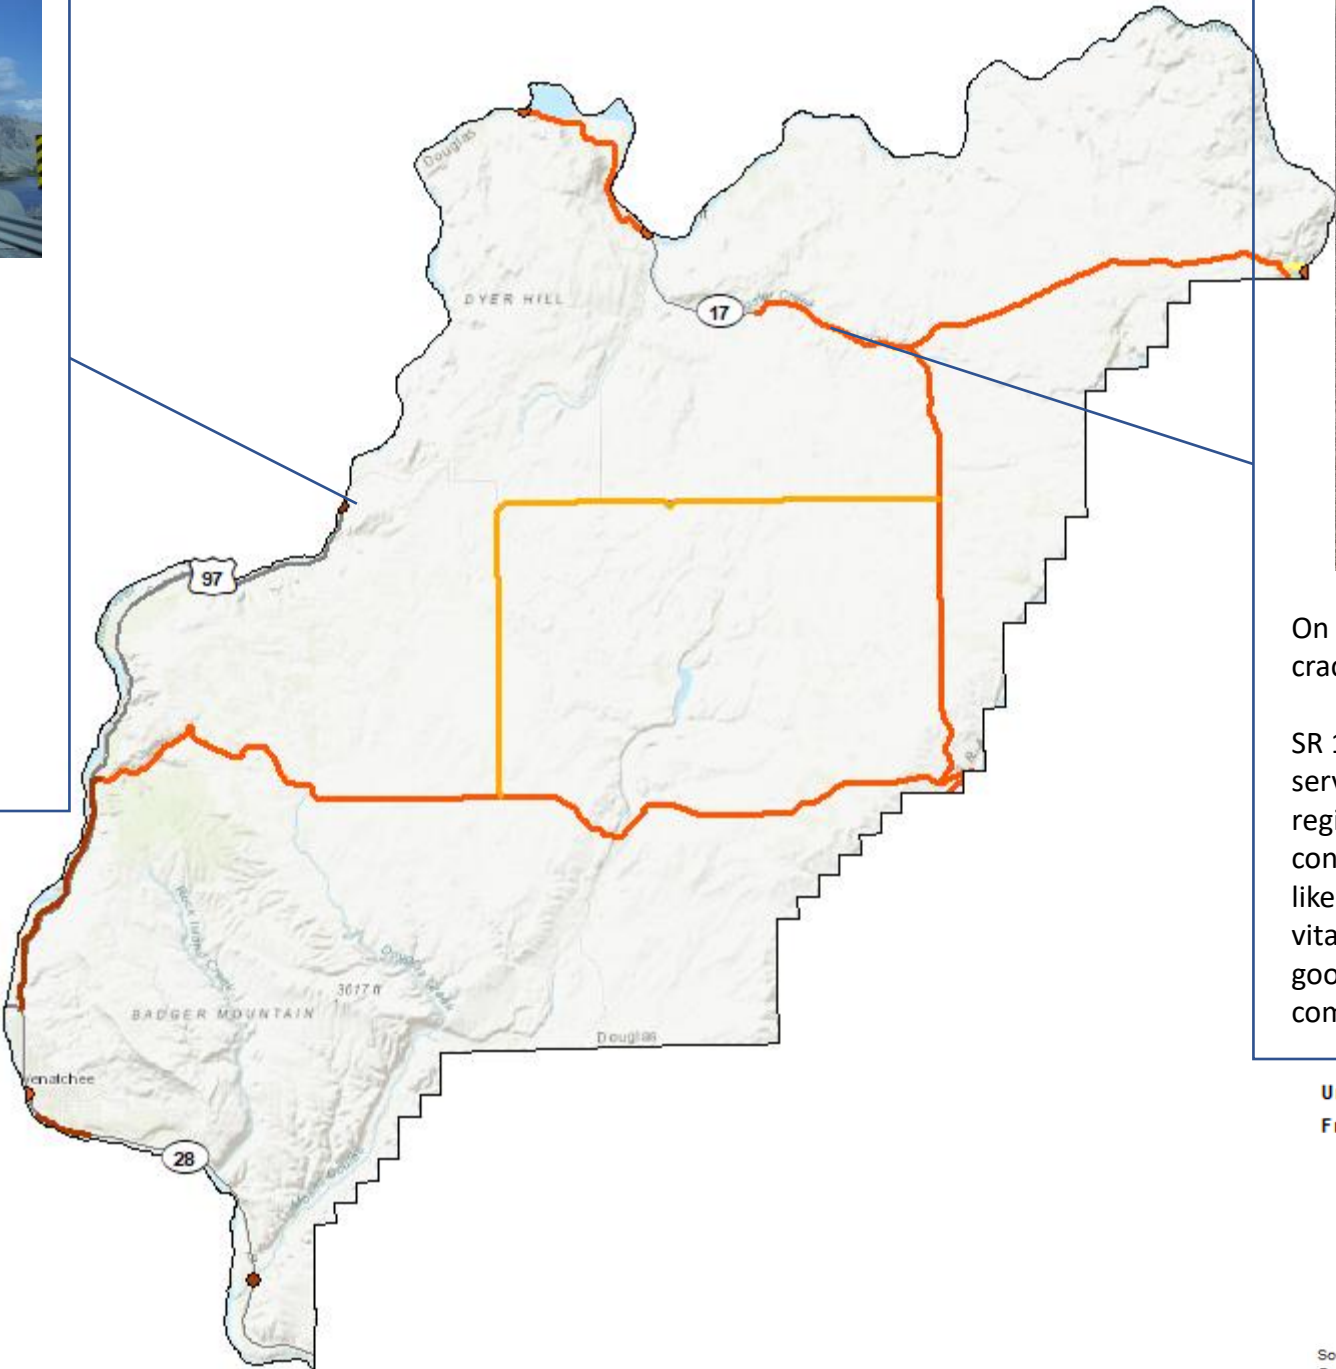
On State Route 17 Leahy West, the pavement is cracked and rutted.

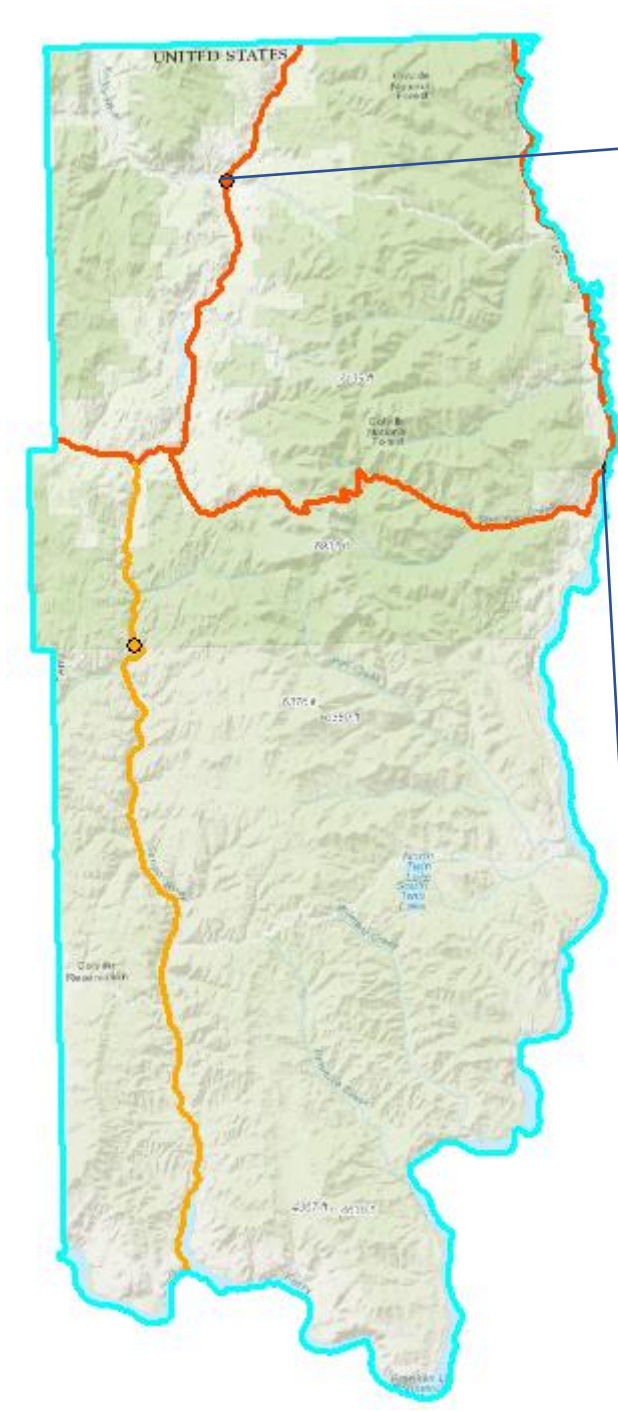
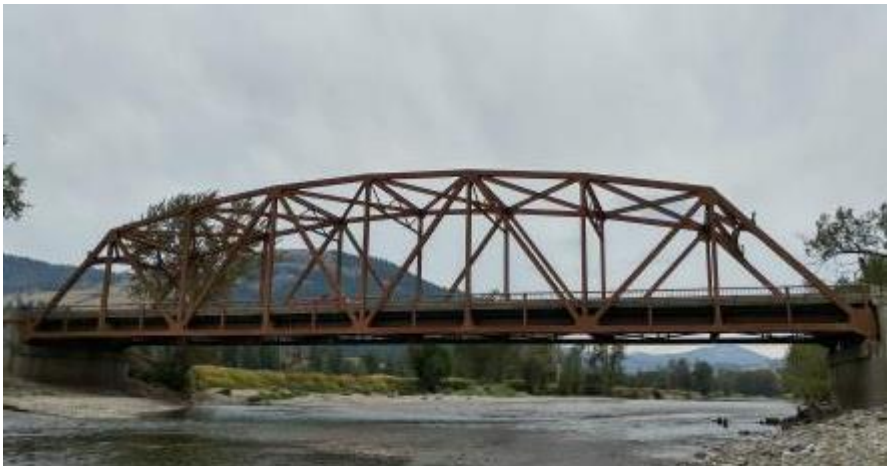
The Kettle River Bridge on State Route 21 has extensive rust on its structural members, due to being overdue for painting. It also has expansion joints that need to be replaced. When painting is missed, the steel rusts and corrodes, making the next paint job much more costly. If not painted after some years, the corrosion will require all the steel structure to be replaced.

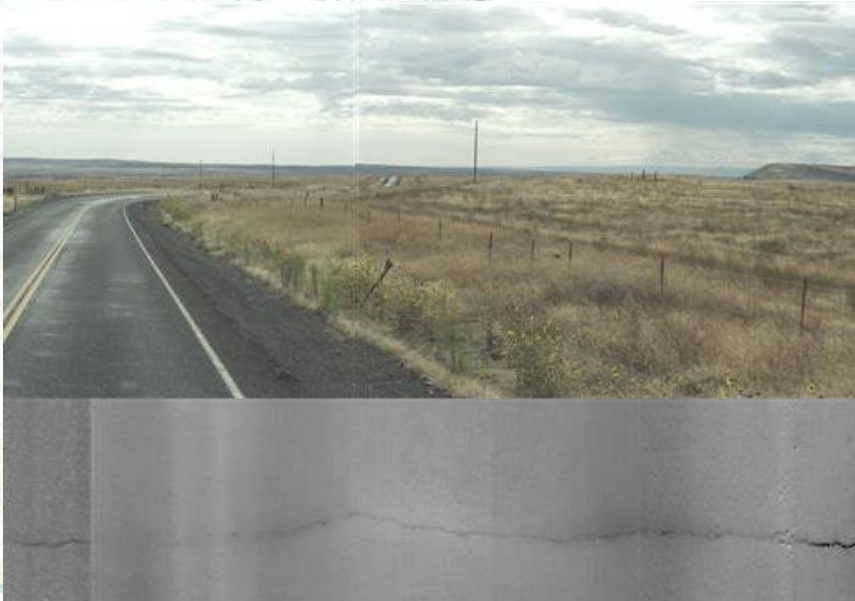
Rutting, roughness and intermittent cracking on State Route 261. Most of this section is rough. However, WSDOT has had to continue to use chip seal resurfacing to protect the pavement from further distress. Even a chip seal no longer prioritizes in the Preservation budget.

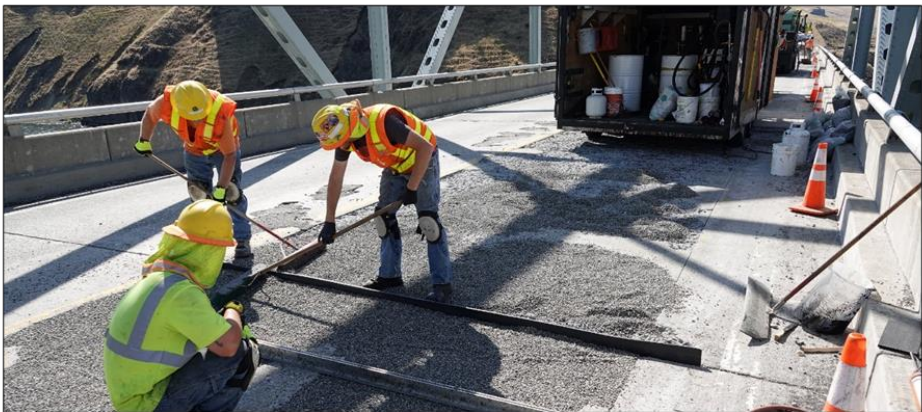
The Elmer C. Huntley Bridge on State Route 127 deck is deteriorating requiring frequent repairs by maintenance to fill holes. The steel portions of the bridge are also rusting and need to be painted.

In 2019, WSDOT made a temporary fix to try and extend the life of the bridge until the bridge deck can be replaced, however new issues develop every day. At current funding levels, it will not be replaced.

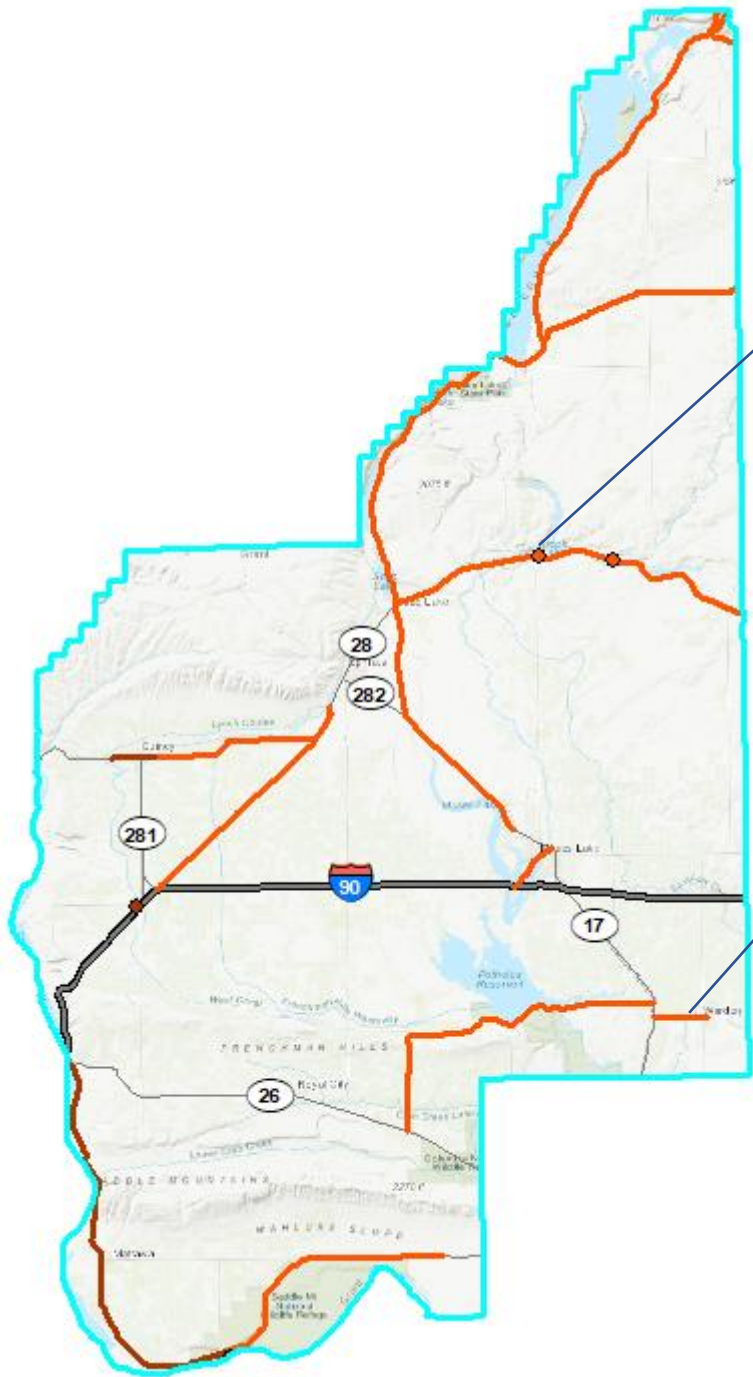
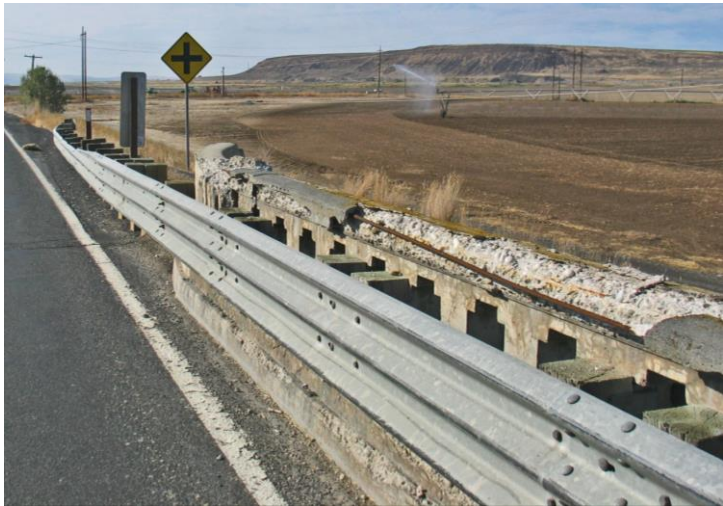
State Route 28 Crab Creek Bridge shows deteriorated concrete with exposed rebar and need to be replaced.

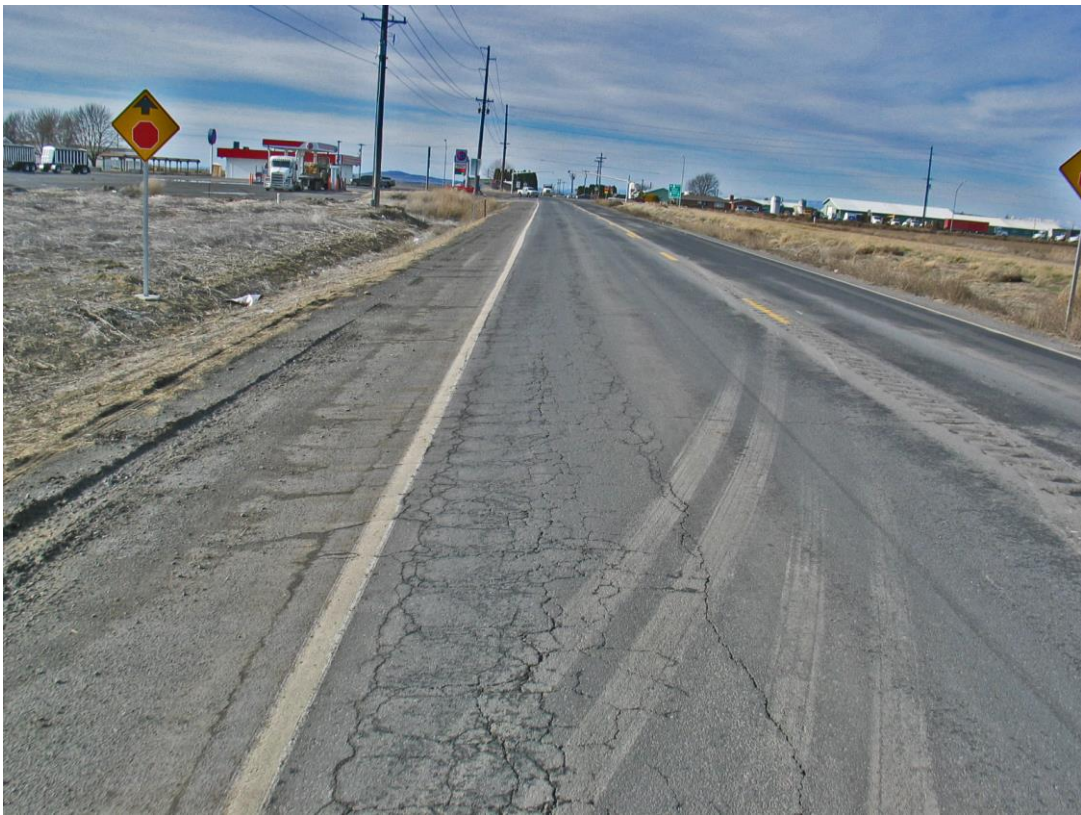
State Route 170 pavement is severely cracked, rutted and rough. Road surface is very rough to traveling public and impacts agricultural hauling.

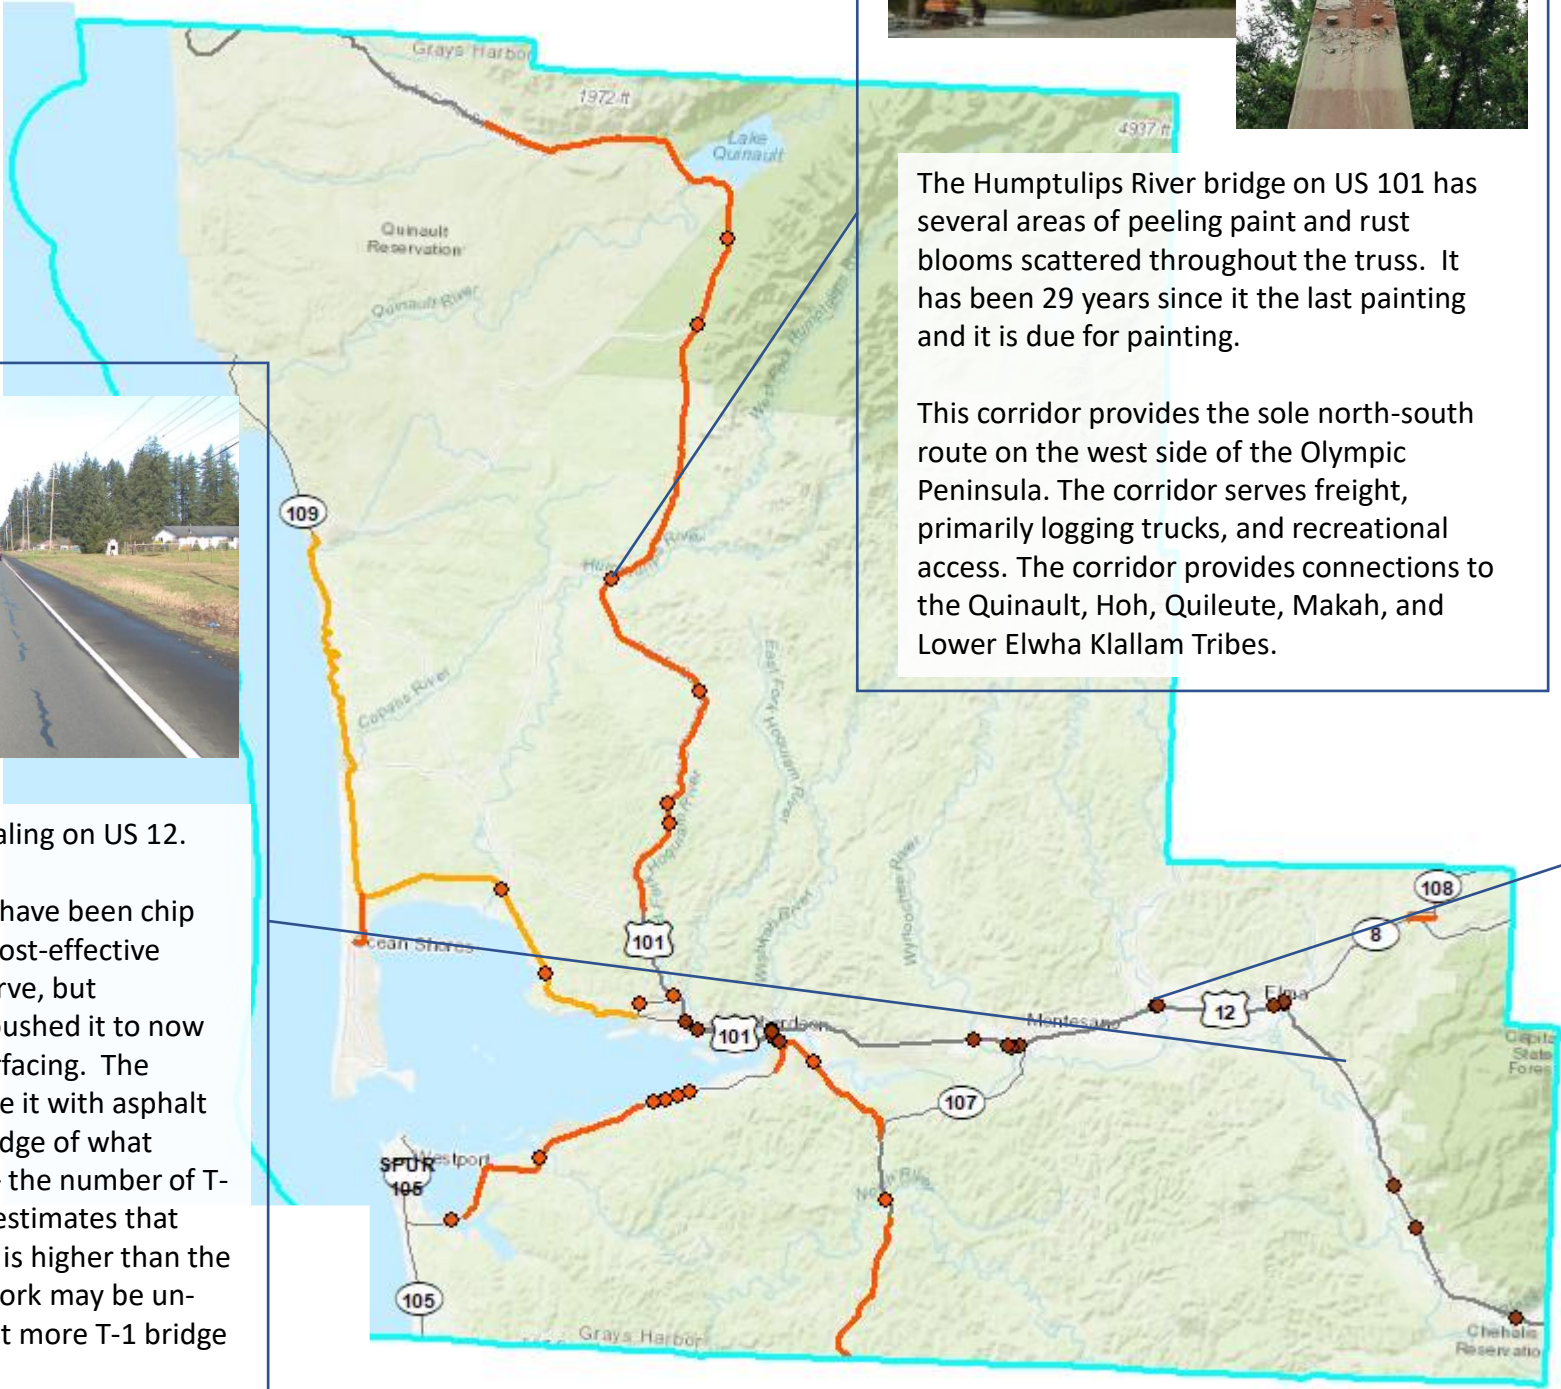
The Humptulips River bridge on US 101 has several areas of peeling paint and rust blooms scattered throughout the truss. It has been 29 years since it the last painting and it is due for painting.

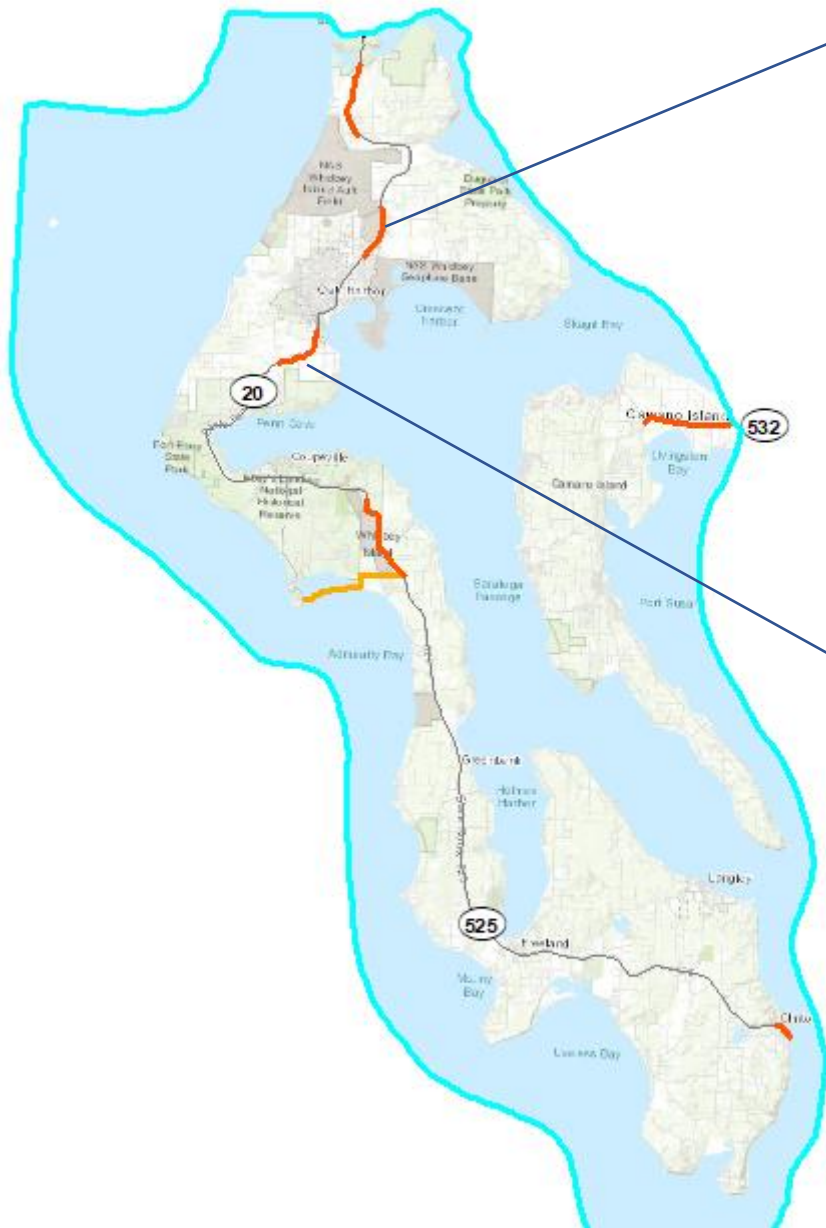
Last paved 20 years ago, the pavement is distressed and deteriorated south of Oak Harbor. Crack sealing has been applied.

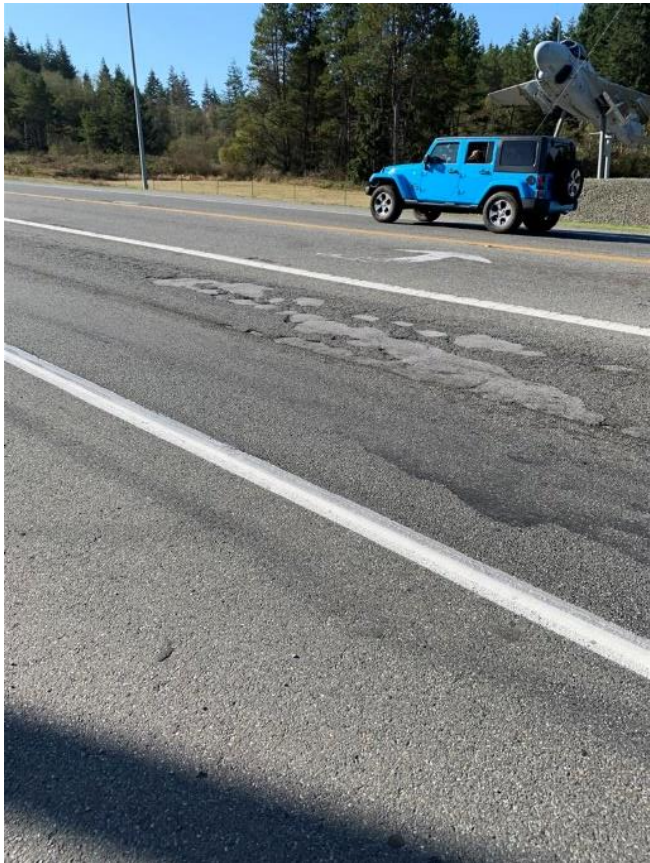
Last paved around 2000, this section of pavement on State Route 20 north of Oak Harbor shows distress and deterioration in varying degrees of severity. Maintenance crews have applied crack seal and conducted pothole repair throughout these limits. The picture shows failed maintenance patching.
