Unfunded Preservation Needs

Adams County

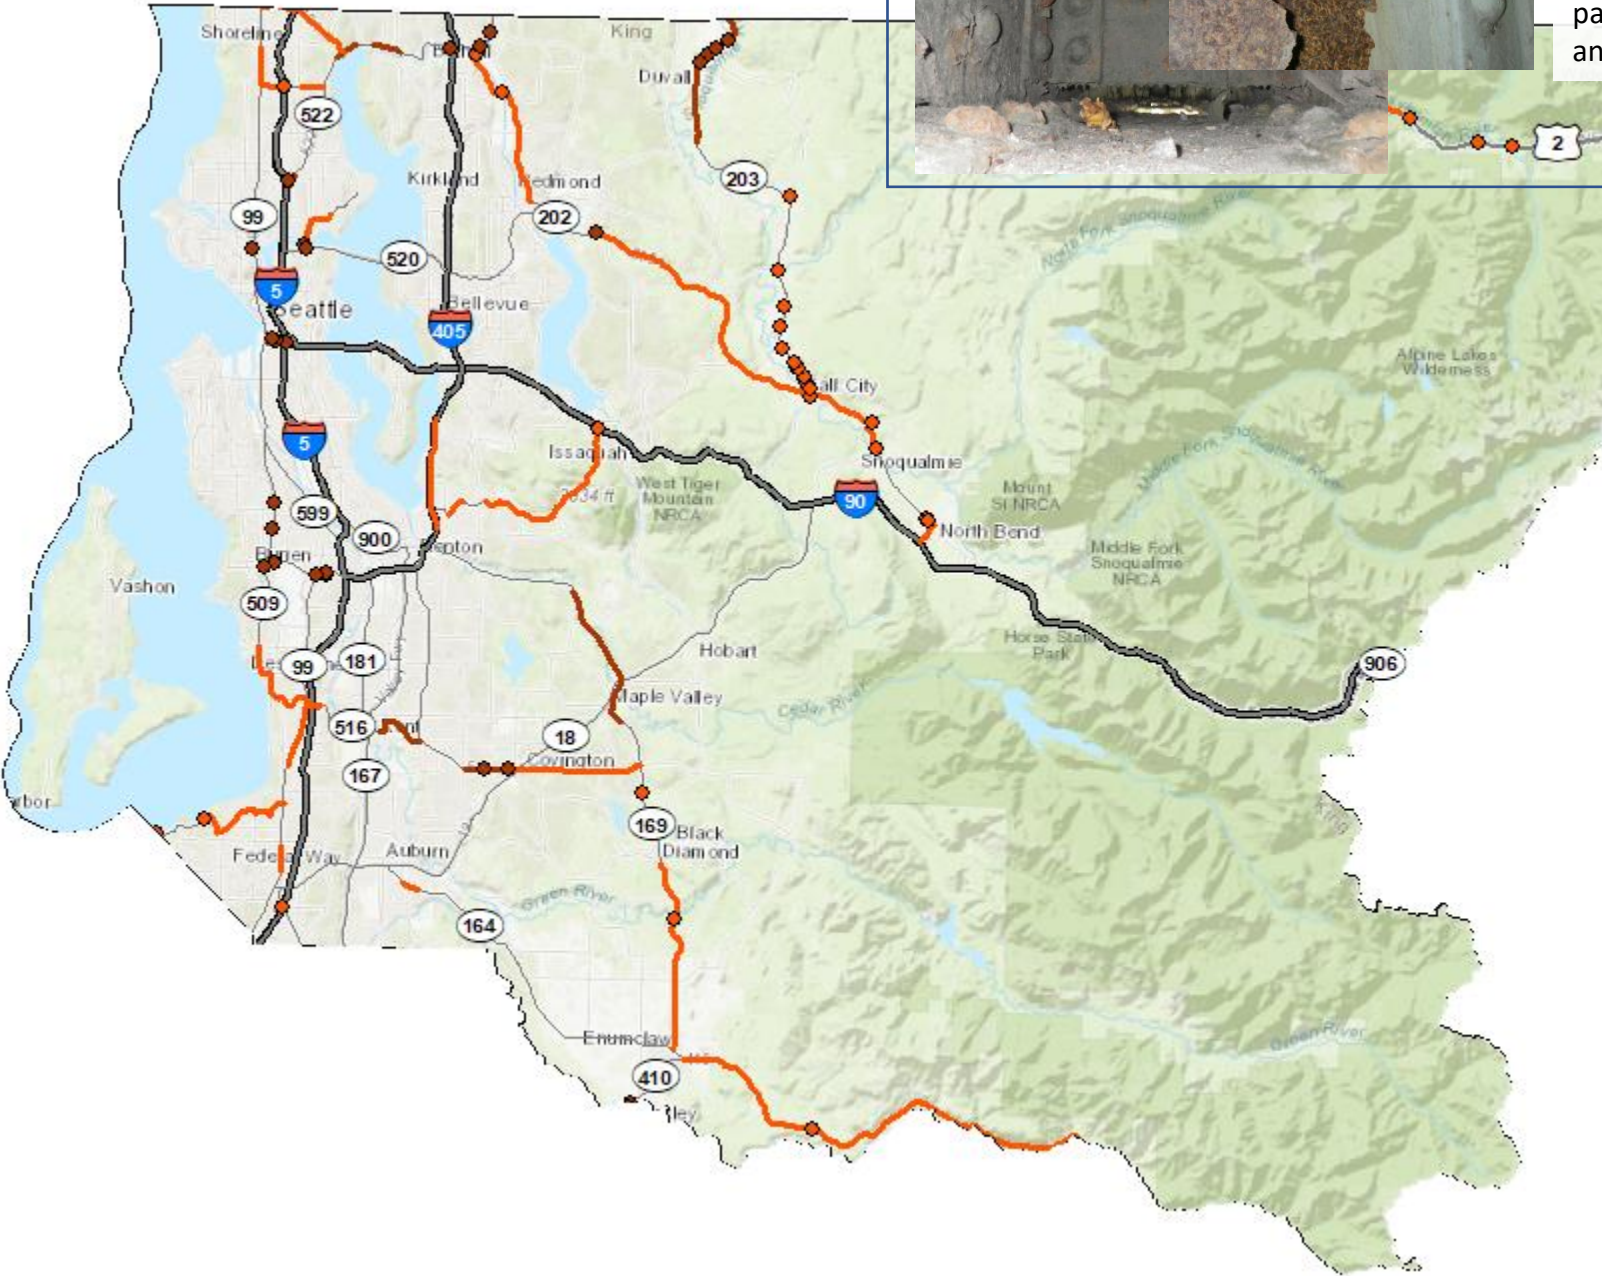
The bridges on State Route 202 over the Snoqualmie and South Fork Snoqualmie need steel painting. Paint is peeled and cracked throughout and there are rust in steel members.

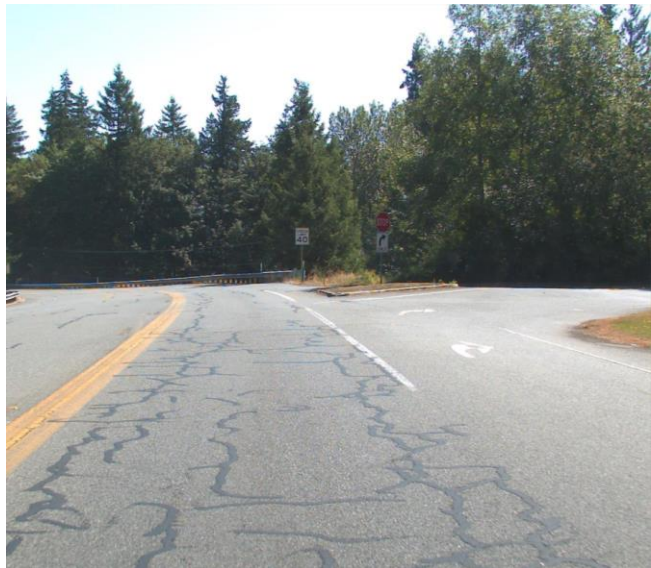
Extensive crack sealing on State Route 308. WSDOT uses a preventive approach to maximize Preservation dollars, and crack sealing is a very cost-effective way to get a few more years before a resurfacing is needed. However, this section of SR 308 will need resurfacing in the next few years or it will deteriorate to a point where major rehabilitation or reconstruction will be needed.

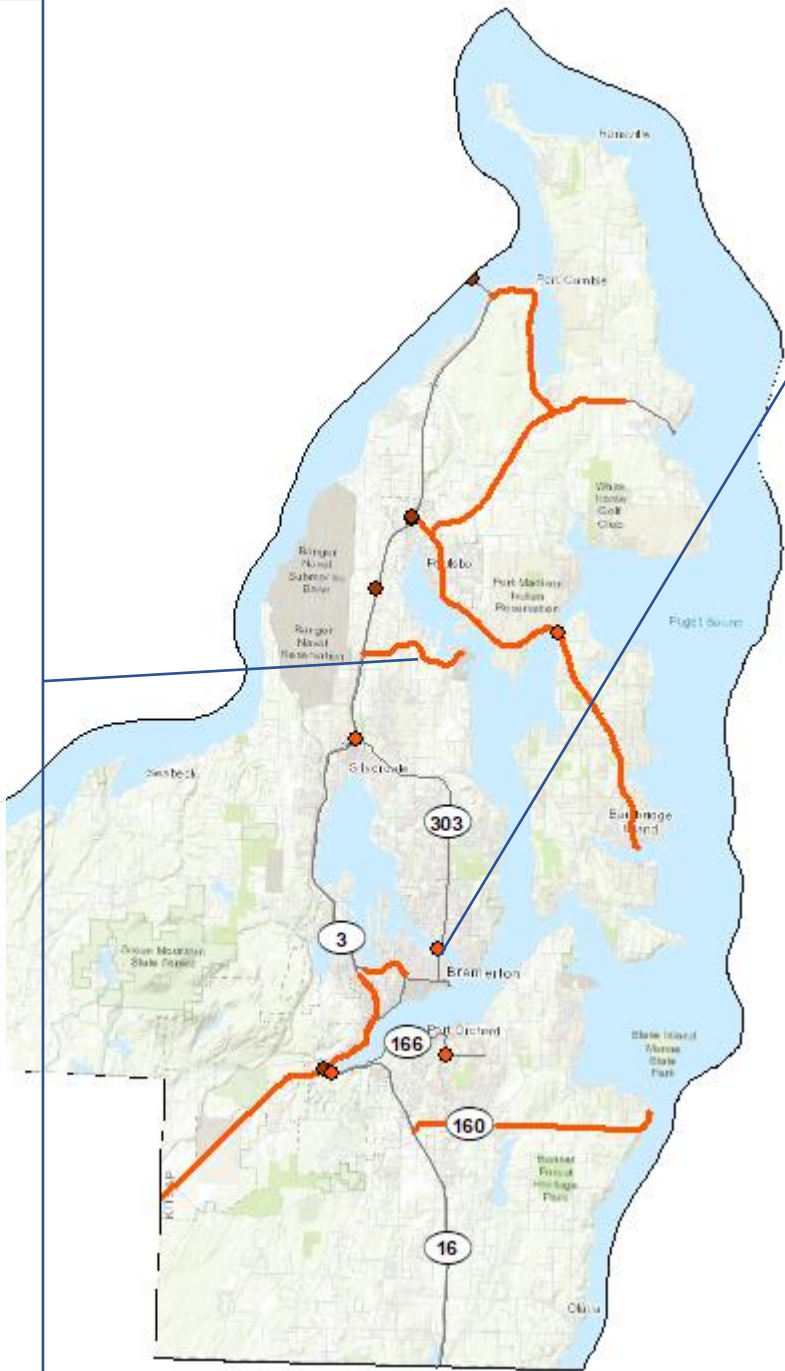
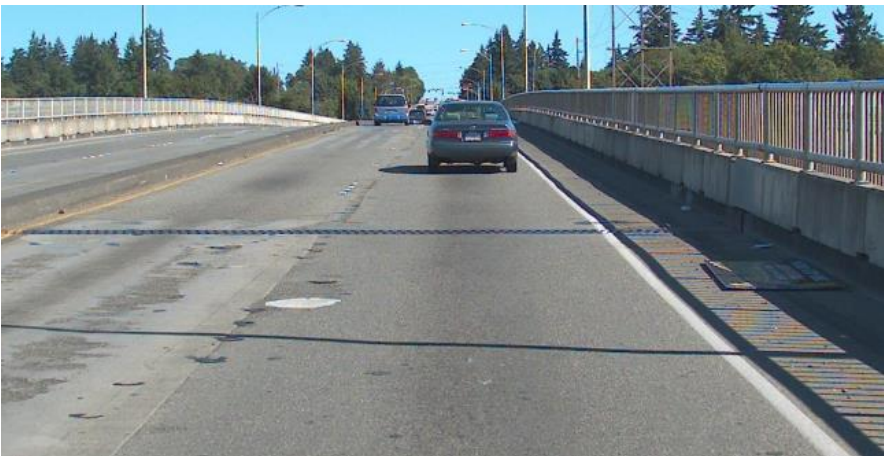
The Port Washington bridge on State Route 303 is an example of a bridge deck in Fair condition with some aged patching but needs resurfacing now in order to avoid further patching and exposure of the deck to weathering and deterioration, which leads to the entire deck needing replacement.

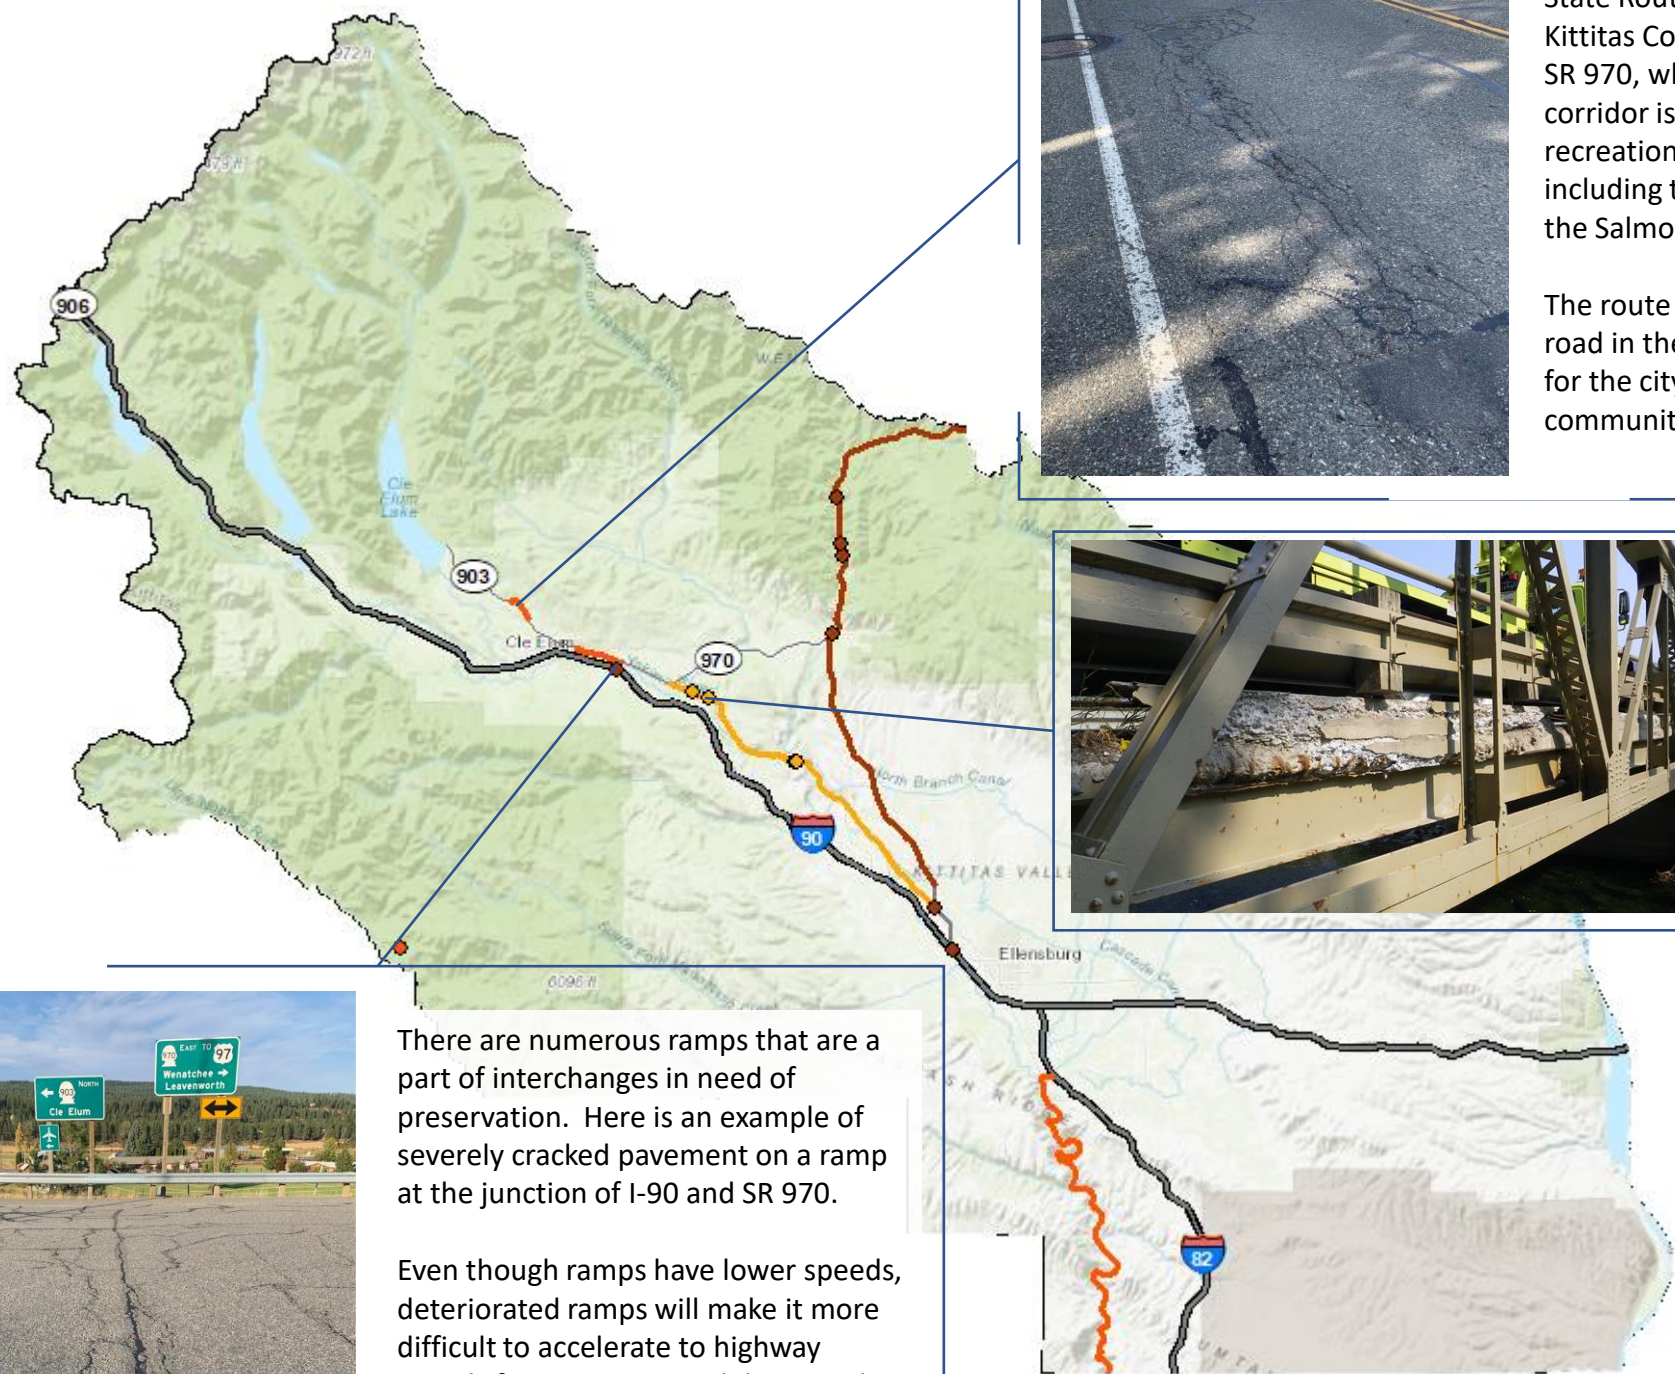
Extensive alligator cracking with some patching and crack sealing on SR 903 in Roslyn.

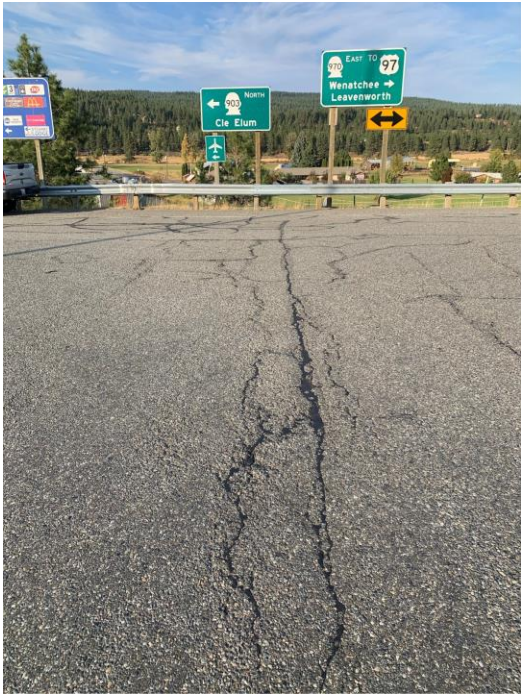
There are numerous ramps that are a part of interchanges in need of preservation. Here is an example of severely cracked pavement on a ramp at the junction of I-90 and SR 970.

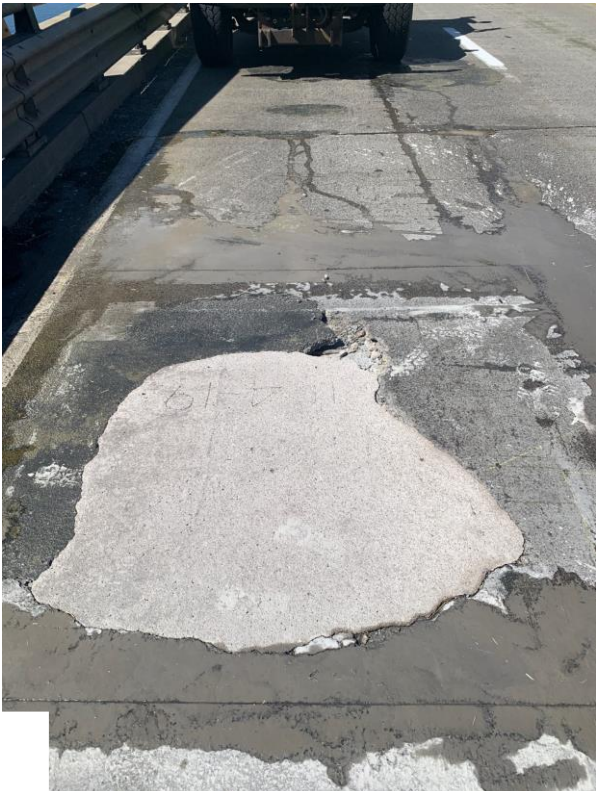
The Vantage Bridge experiences frequent blow outs creating holes in the deck requiring unplanned emergency repairs resulting in long traffic . Patches that were meant to be temporary have failed, and WSDOT is replacing the patches in this lane with patches expected to help the deck last until it is able to be funded for full deck rehabilitation. It is estimated to cost about \$40 million to rehabilitate this vital bridge deck.

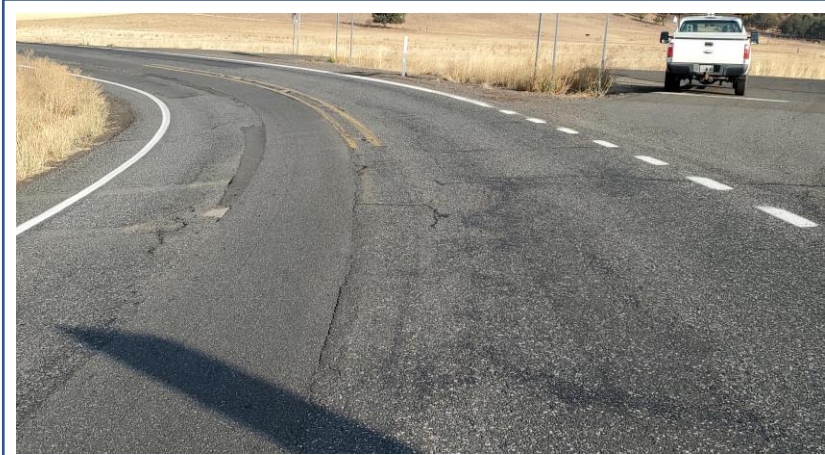
Patching and cracking on State Route 142. A chip seal surfacing with pavement repair is needed now.

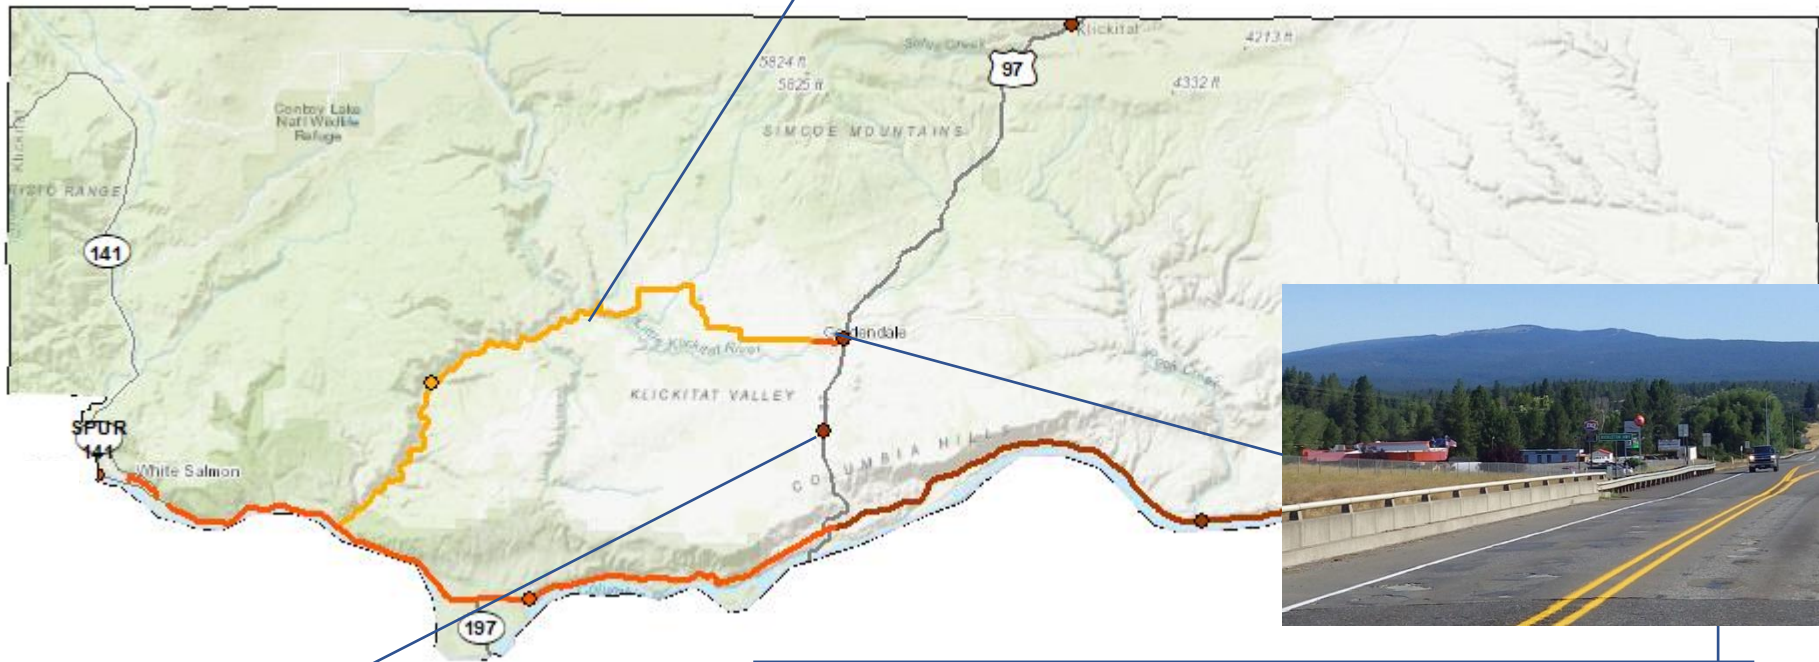
Extensive cracking and patching on the Swale Creek bridge deck and Bickleton Road bridge deck on State Route 97. Deck resurfacing is needed not only for a smooth, pothole free driving surface, but to protect the underlying bridge structure. Left unaddressed the entire deck may need to be replaced.

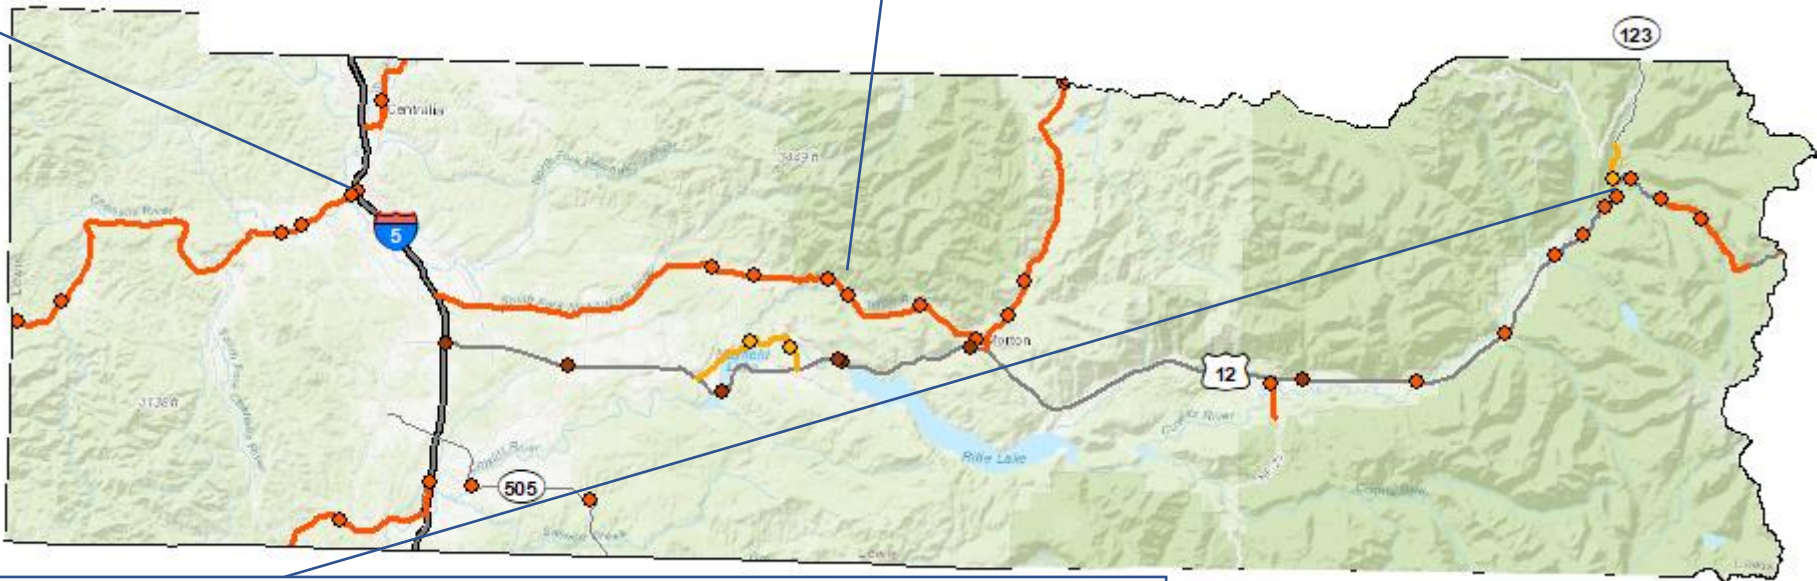
This bridge on US 12 over the Clear Fork of the Cowlitz River shows patching and potholing and needs resurfacing.

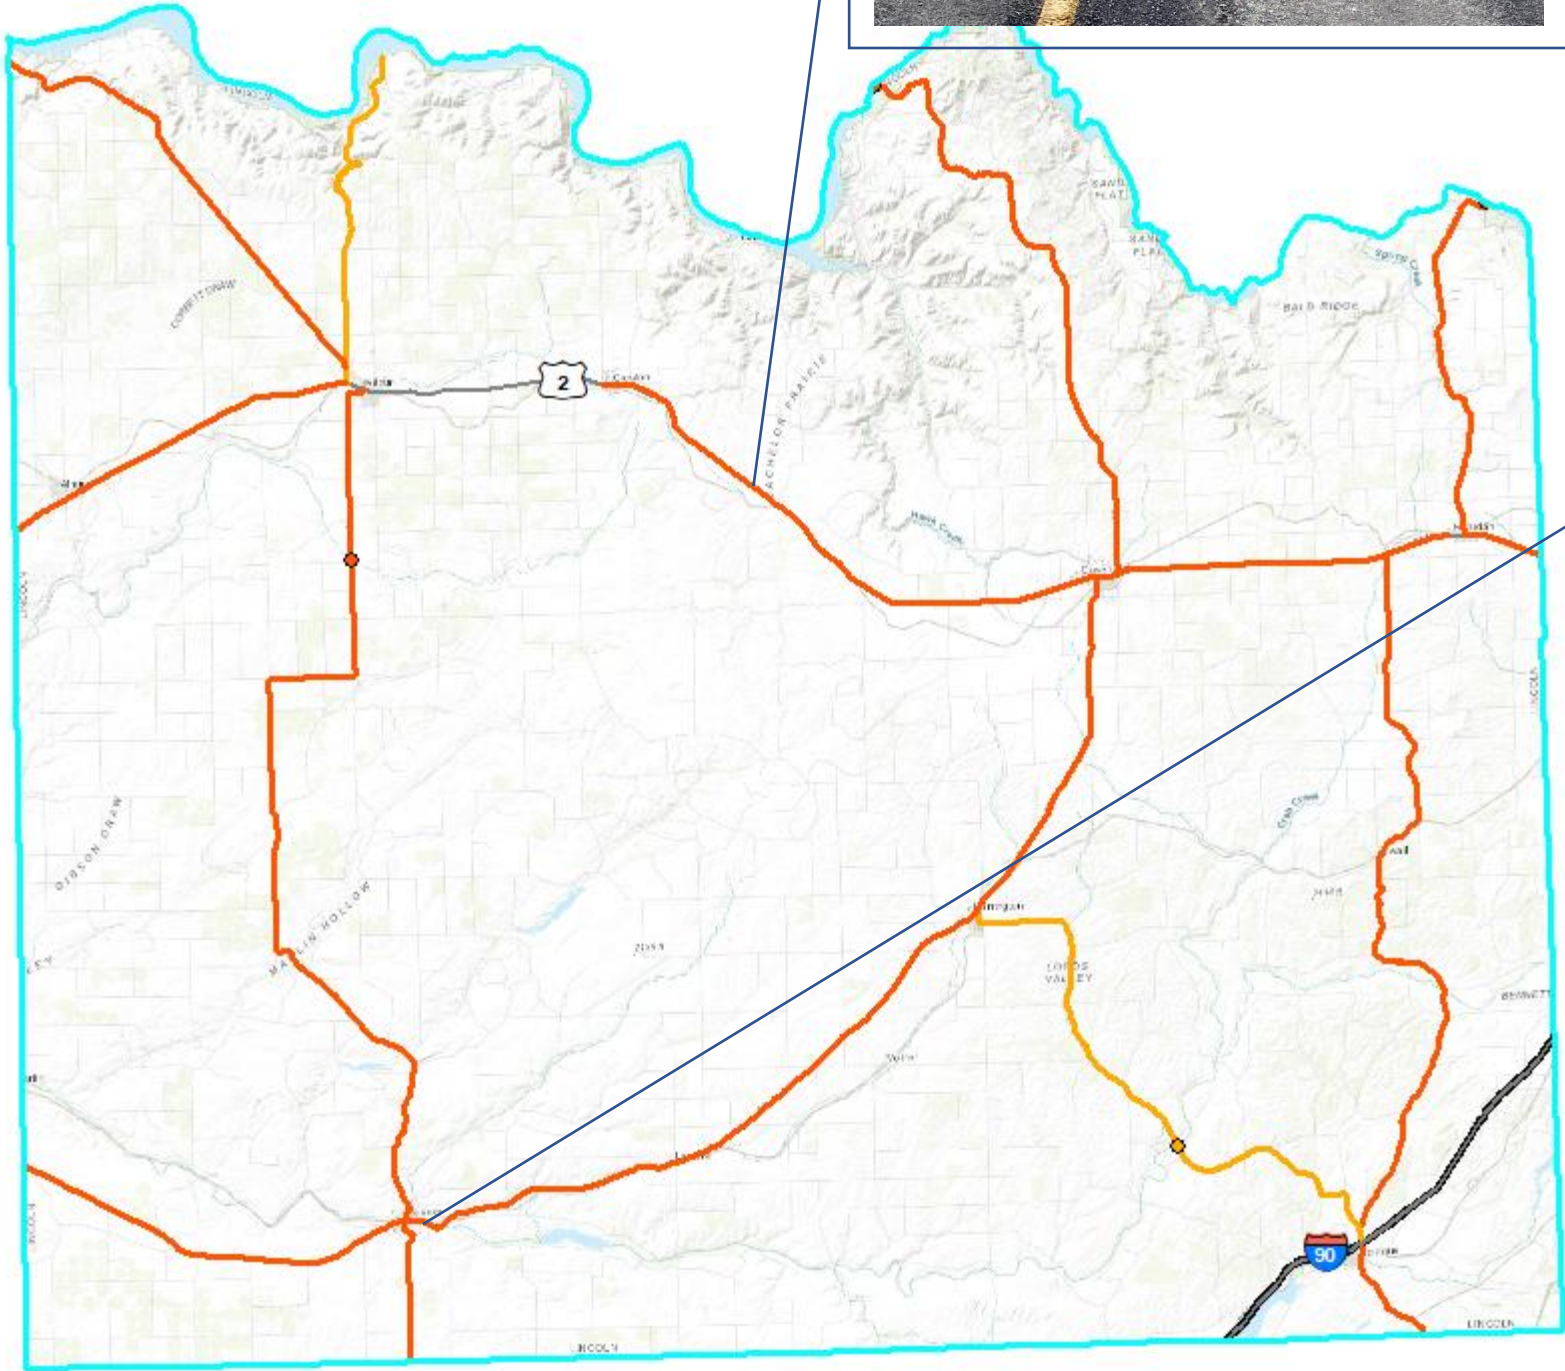
Severe cracking on State Route 28 in Odessa.

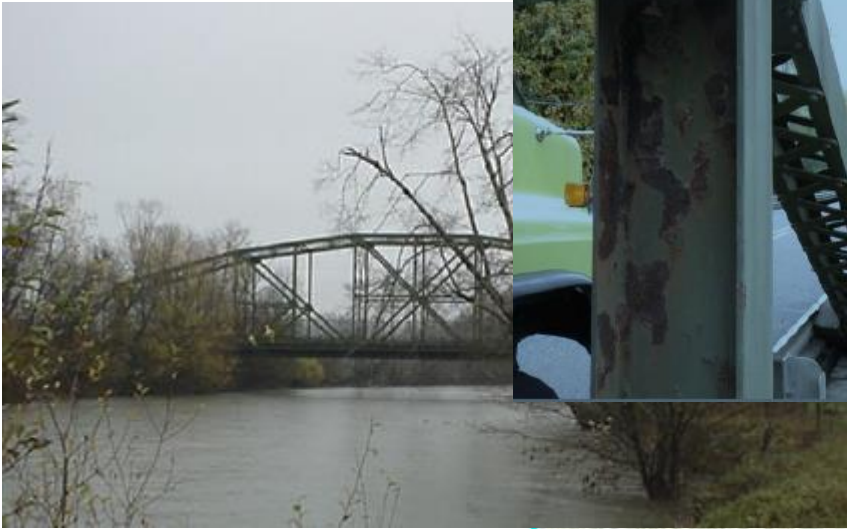
This bridge on US 101 over the Skokomish River has areas of chipped or peeled paint with some rust spots and staining. Steel members are starting to experience section loss.

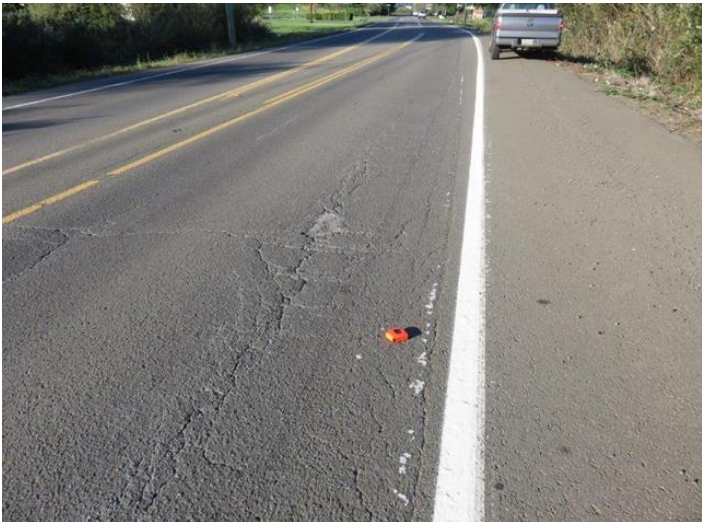
Alligator cracking on US 101 outside of Bruceport. This section needs resurfacing now, and will require costly major rehabilitation or possibly reconstruction if left unaddressed.

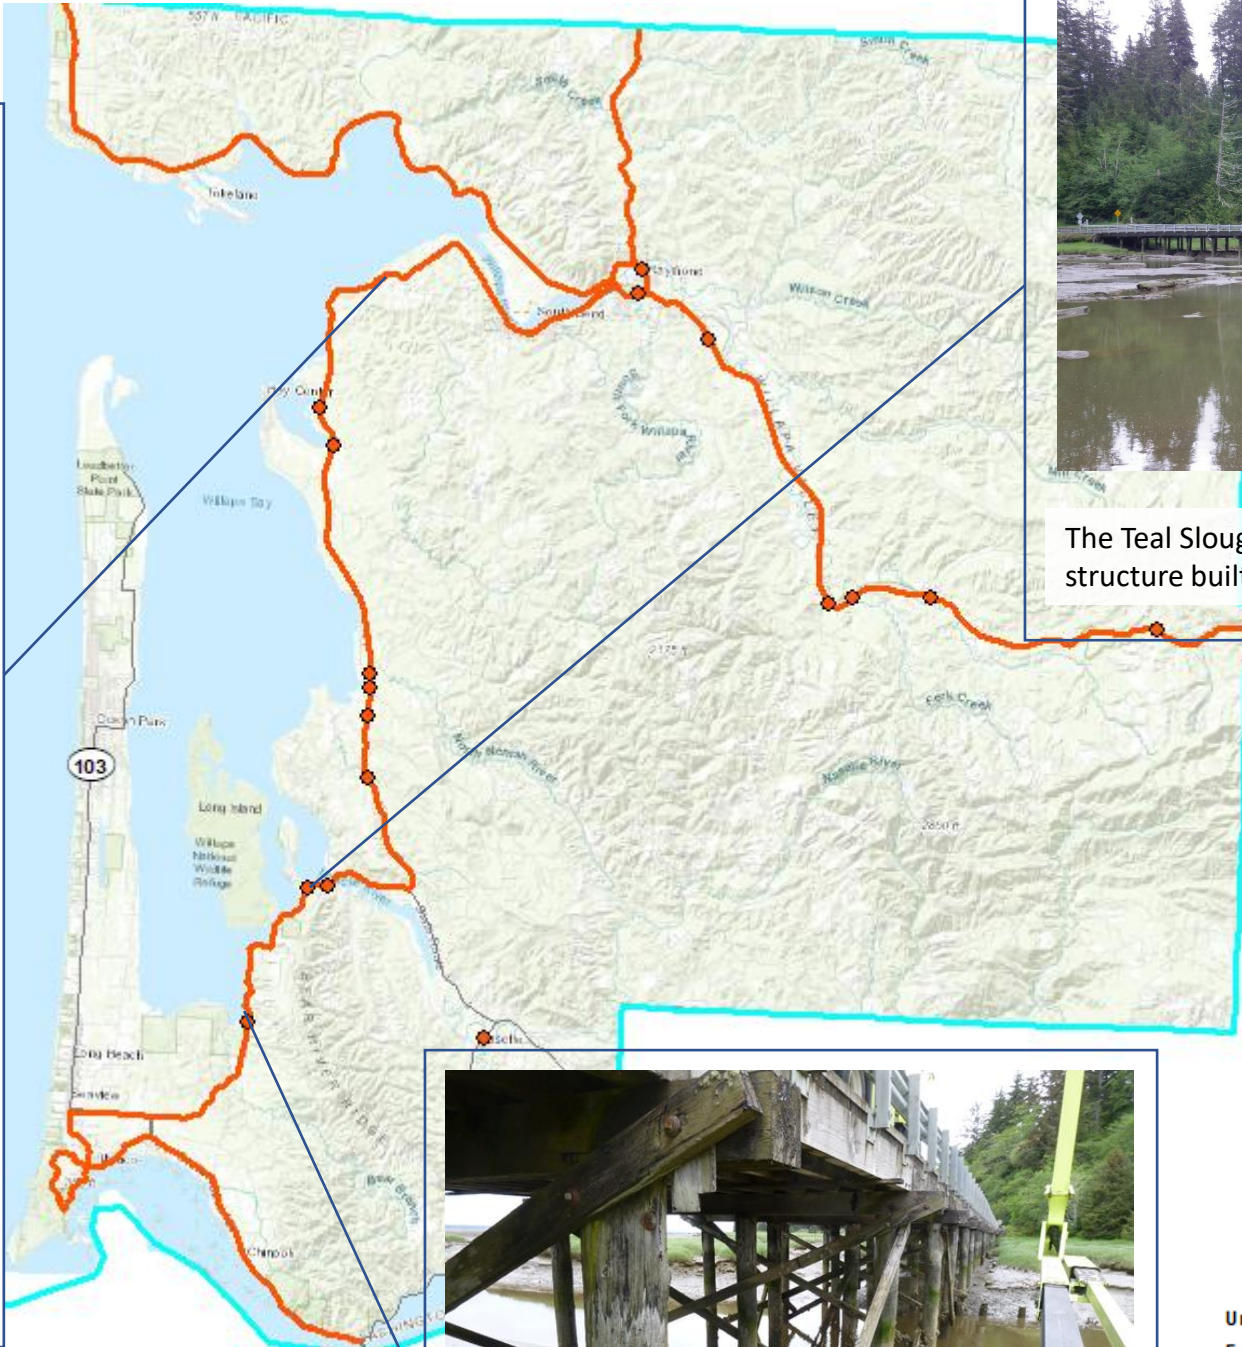
The Teal Slough bridge on US 101 is a timber structure built in 1934. It needs to be replaced.

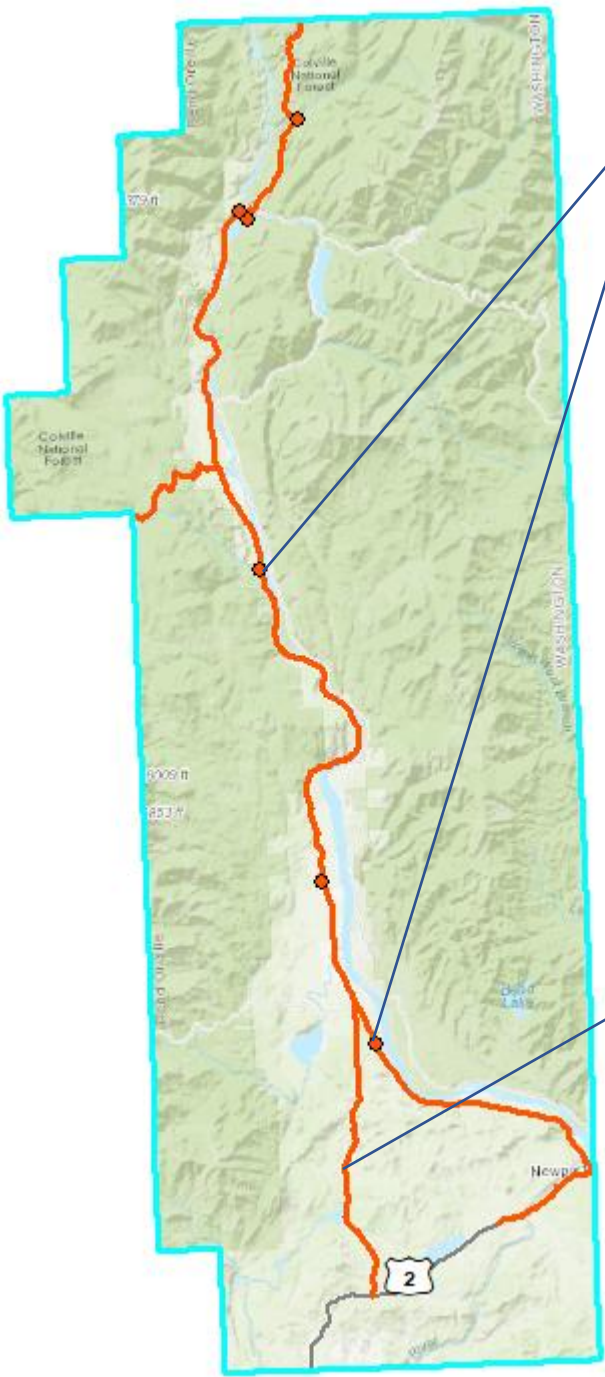
The Davis Creek and Lost Creek bridge are timber structures that were built in the mid-1930s. The timber portions are rotting, and the bridges need to be replaced.

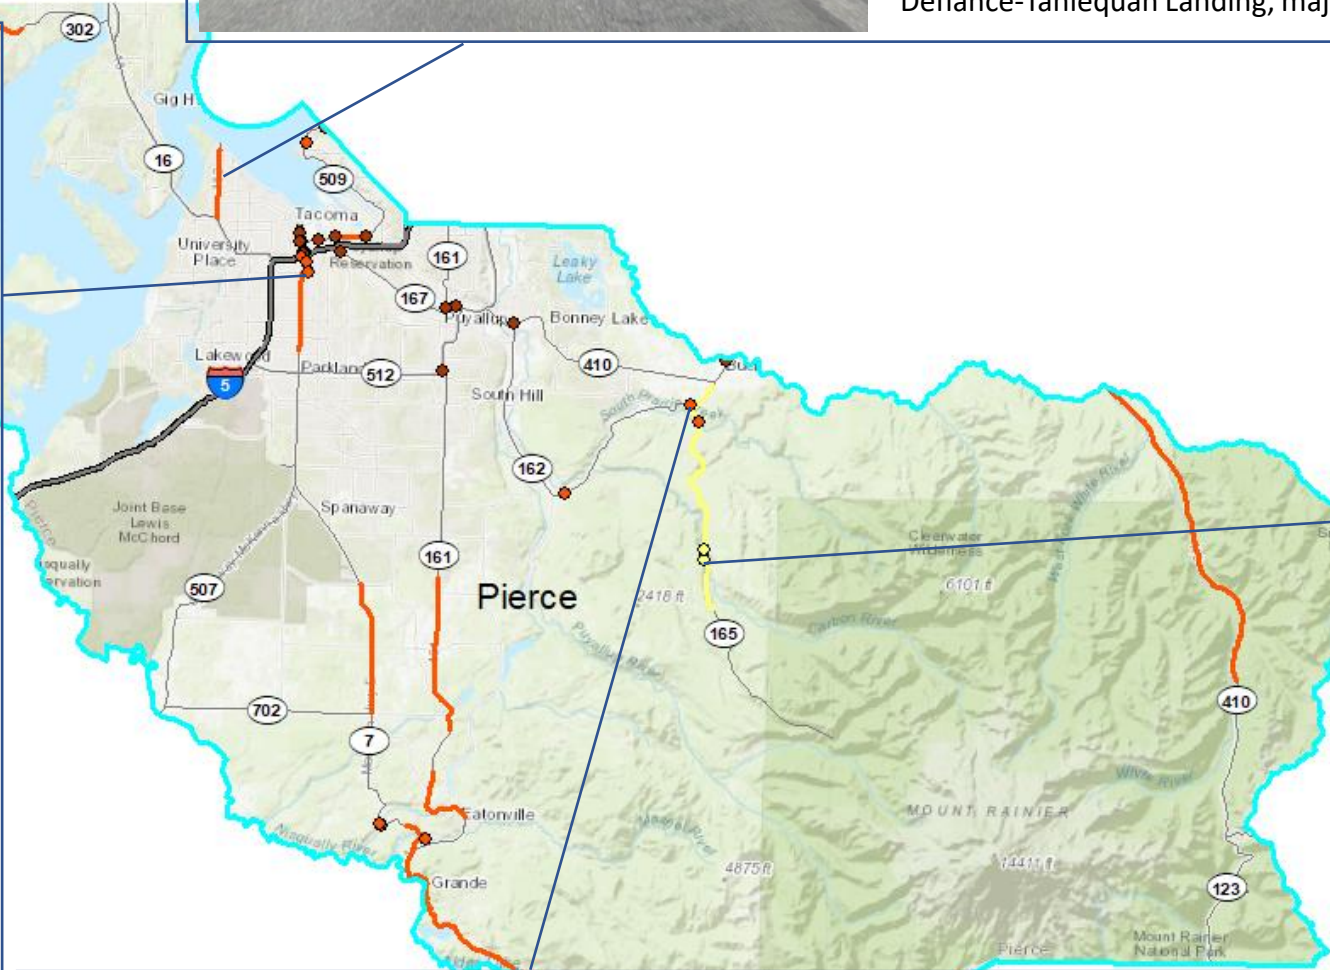
SR 165 Carbon River Bridge: Steel components need painting. Rust blooms throughout the rivets and plates, with some starting on stringers and floor beams. This sections also needs paving in the next ten years.

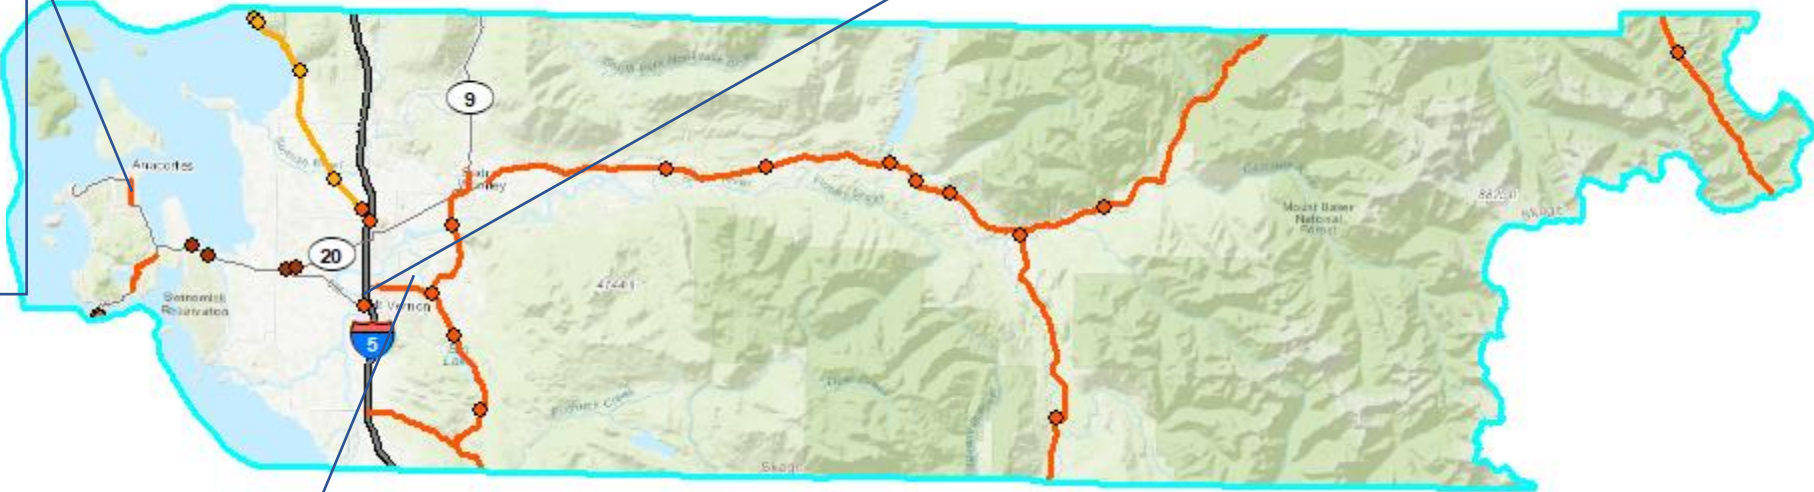
State Route 538 was last paved between 1980 and 2002. Cracking and deterioration is prevalent, with some sections delaminating and spalling.

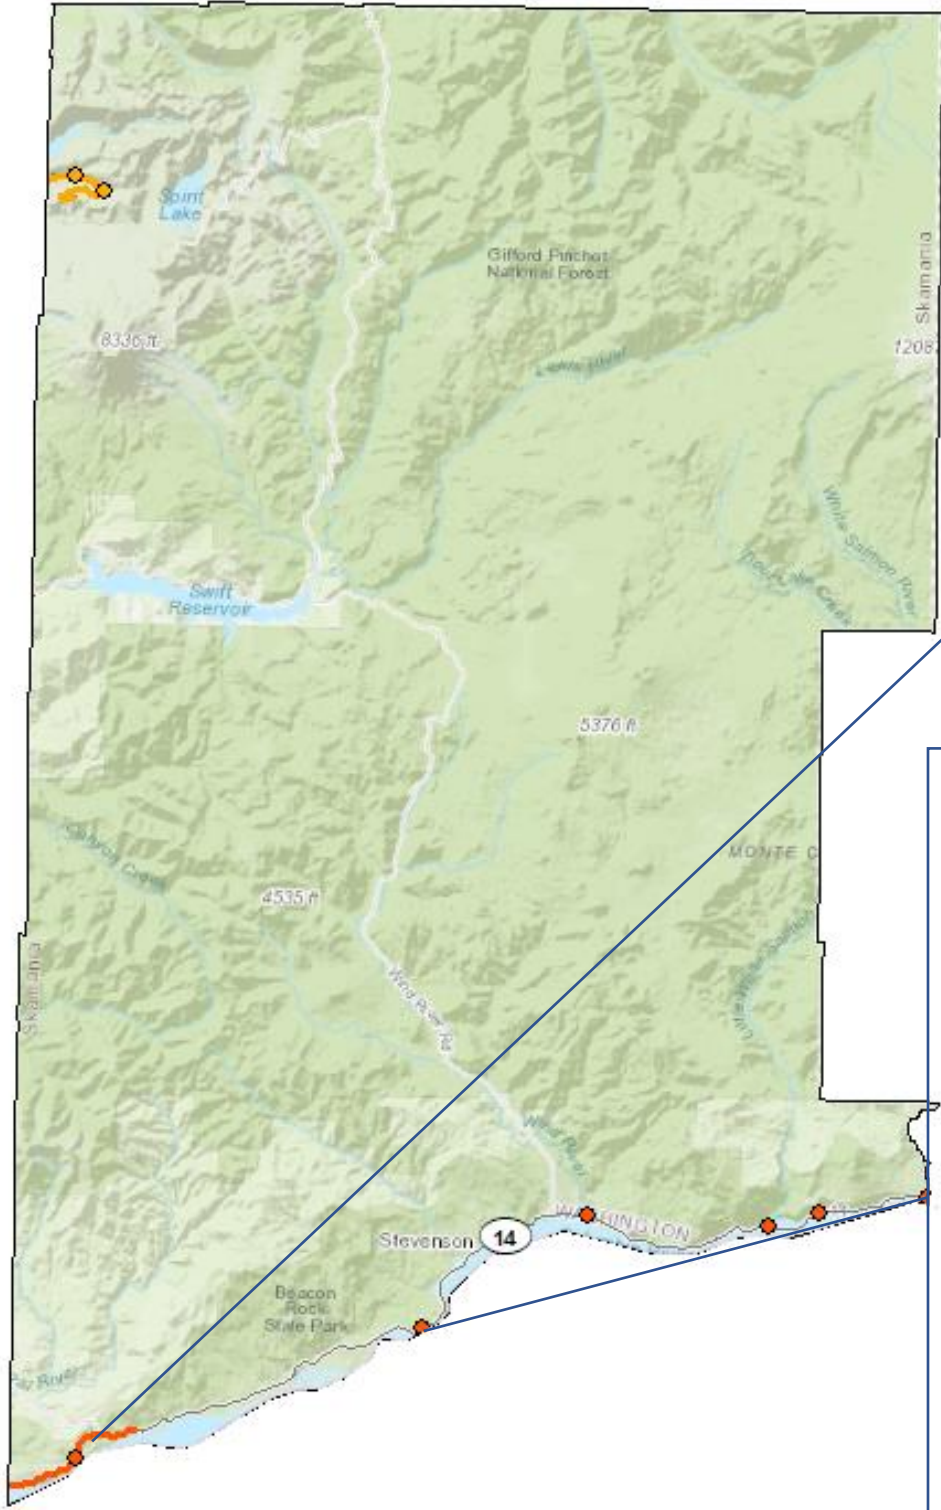
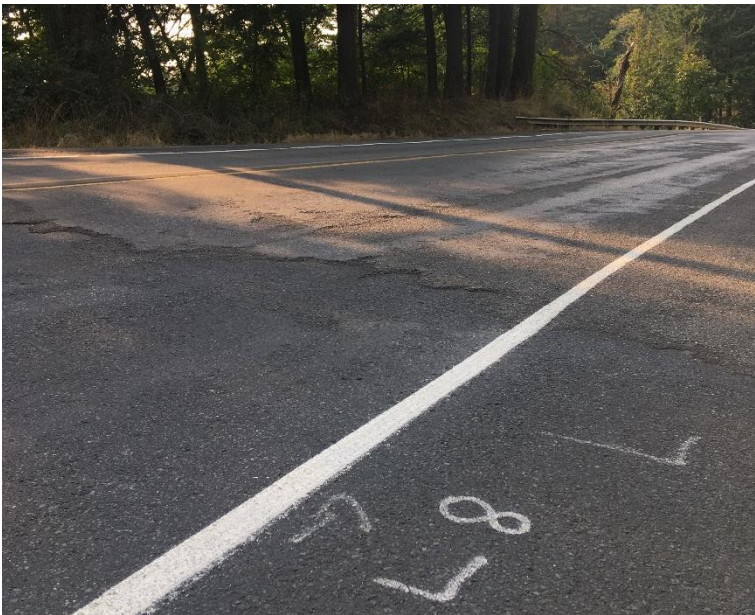
Pavement delamination on State Route 14. A resurfacing is needed now to prevent further deterioration.

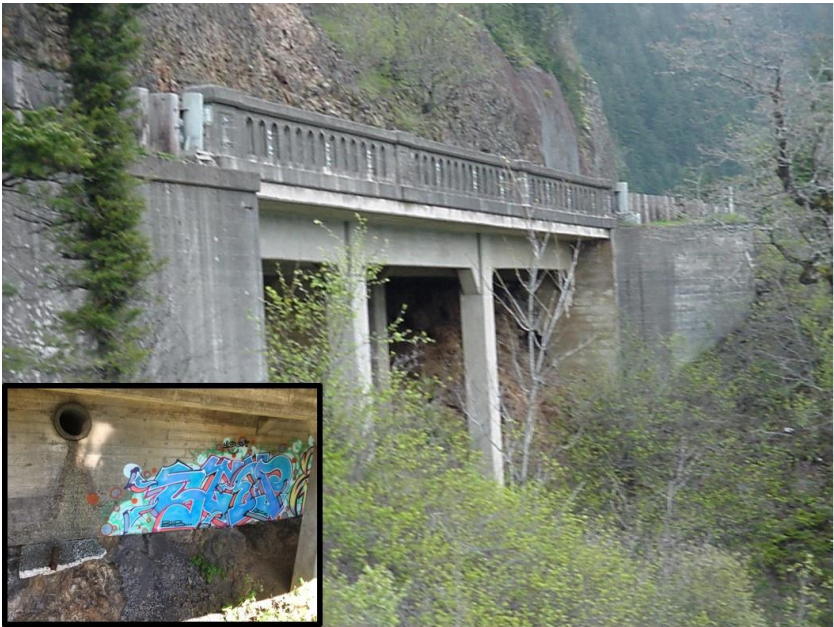
This half-bridge on State Route 14 was built in the 1930s. It has multiple exposed footings. A project to apply shotcrete to the slope and footings, along with likely drainage modifications, is unfunded

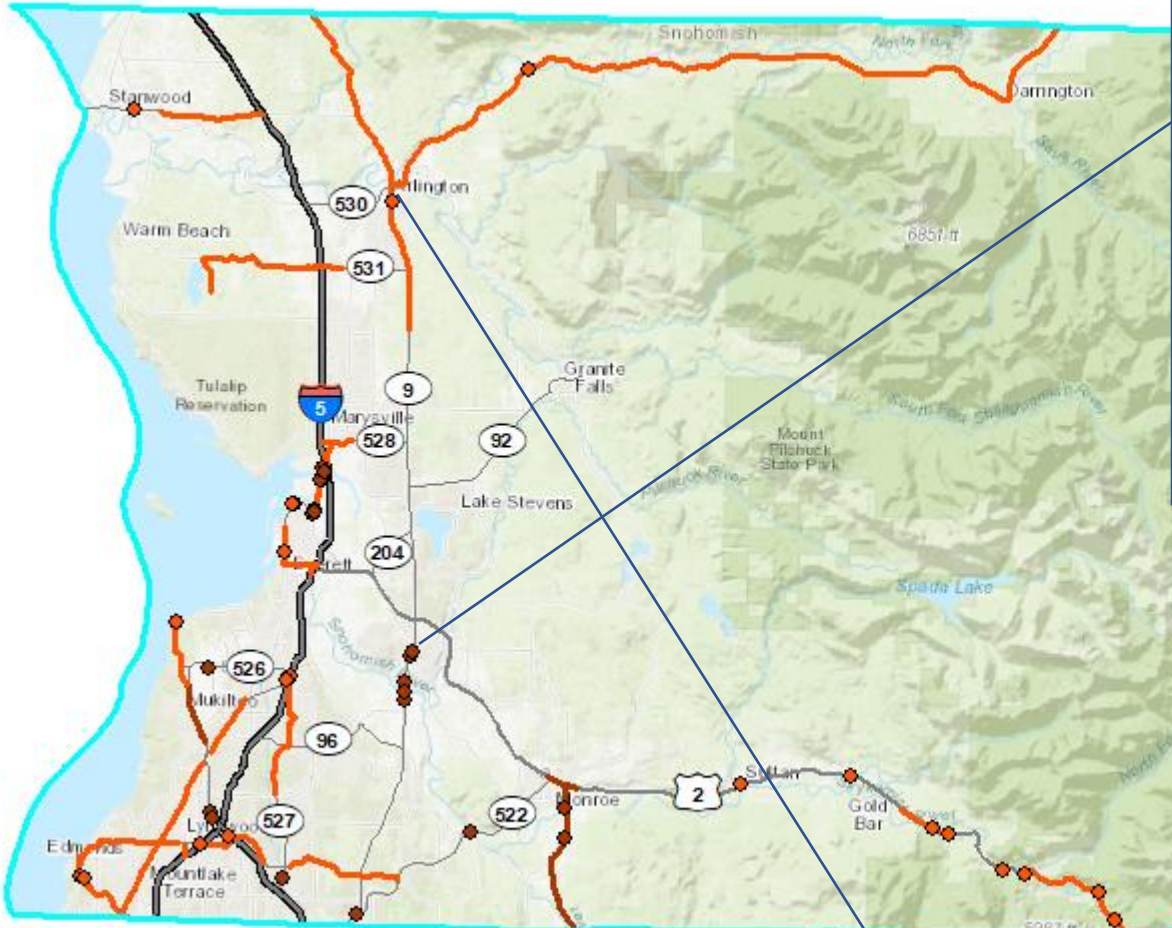
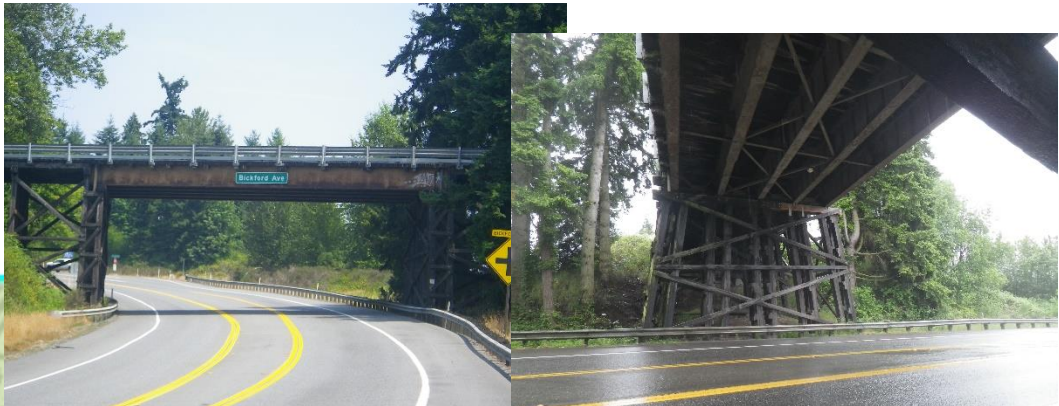
The Bickford Avenue Bridge over State Route 9 has rusting girders and rotting timber. This bridge is rated in poor condition and needs to be replaced.

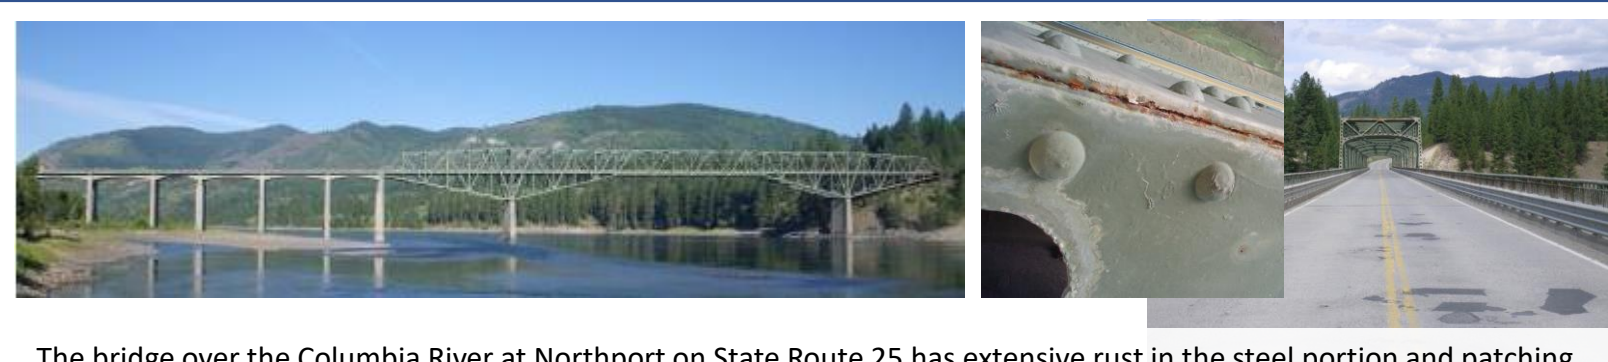
The bridge over the Columbia River at Northport on State Route 25 has extensive rust in the steel portion and patching and distress in the deck. It is in poor condition and needs steel painting and deck rehabilitation.

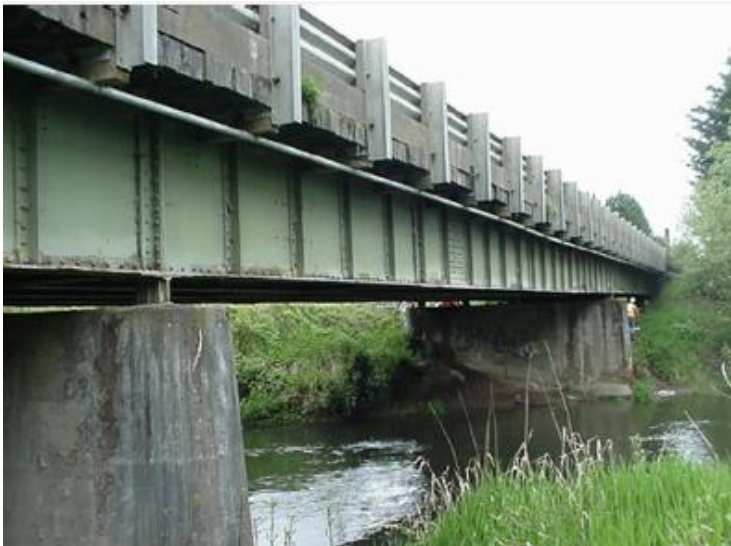
The Deschutes River bridge on State Route 507 has not had its steel members painted in 37 years. The stringers have seam rust, rust stains and peeling paint. WSDOT has performed spot painting on the bridge, but it needs full painting now.
