Unfunded Preservation Needs

Adams County

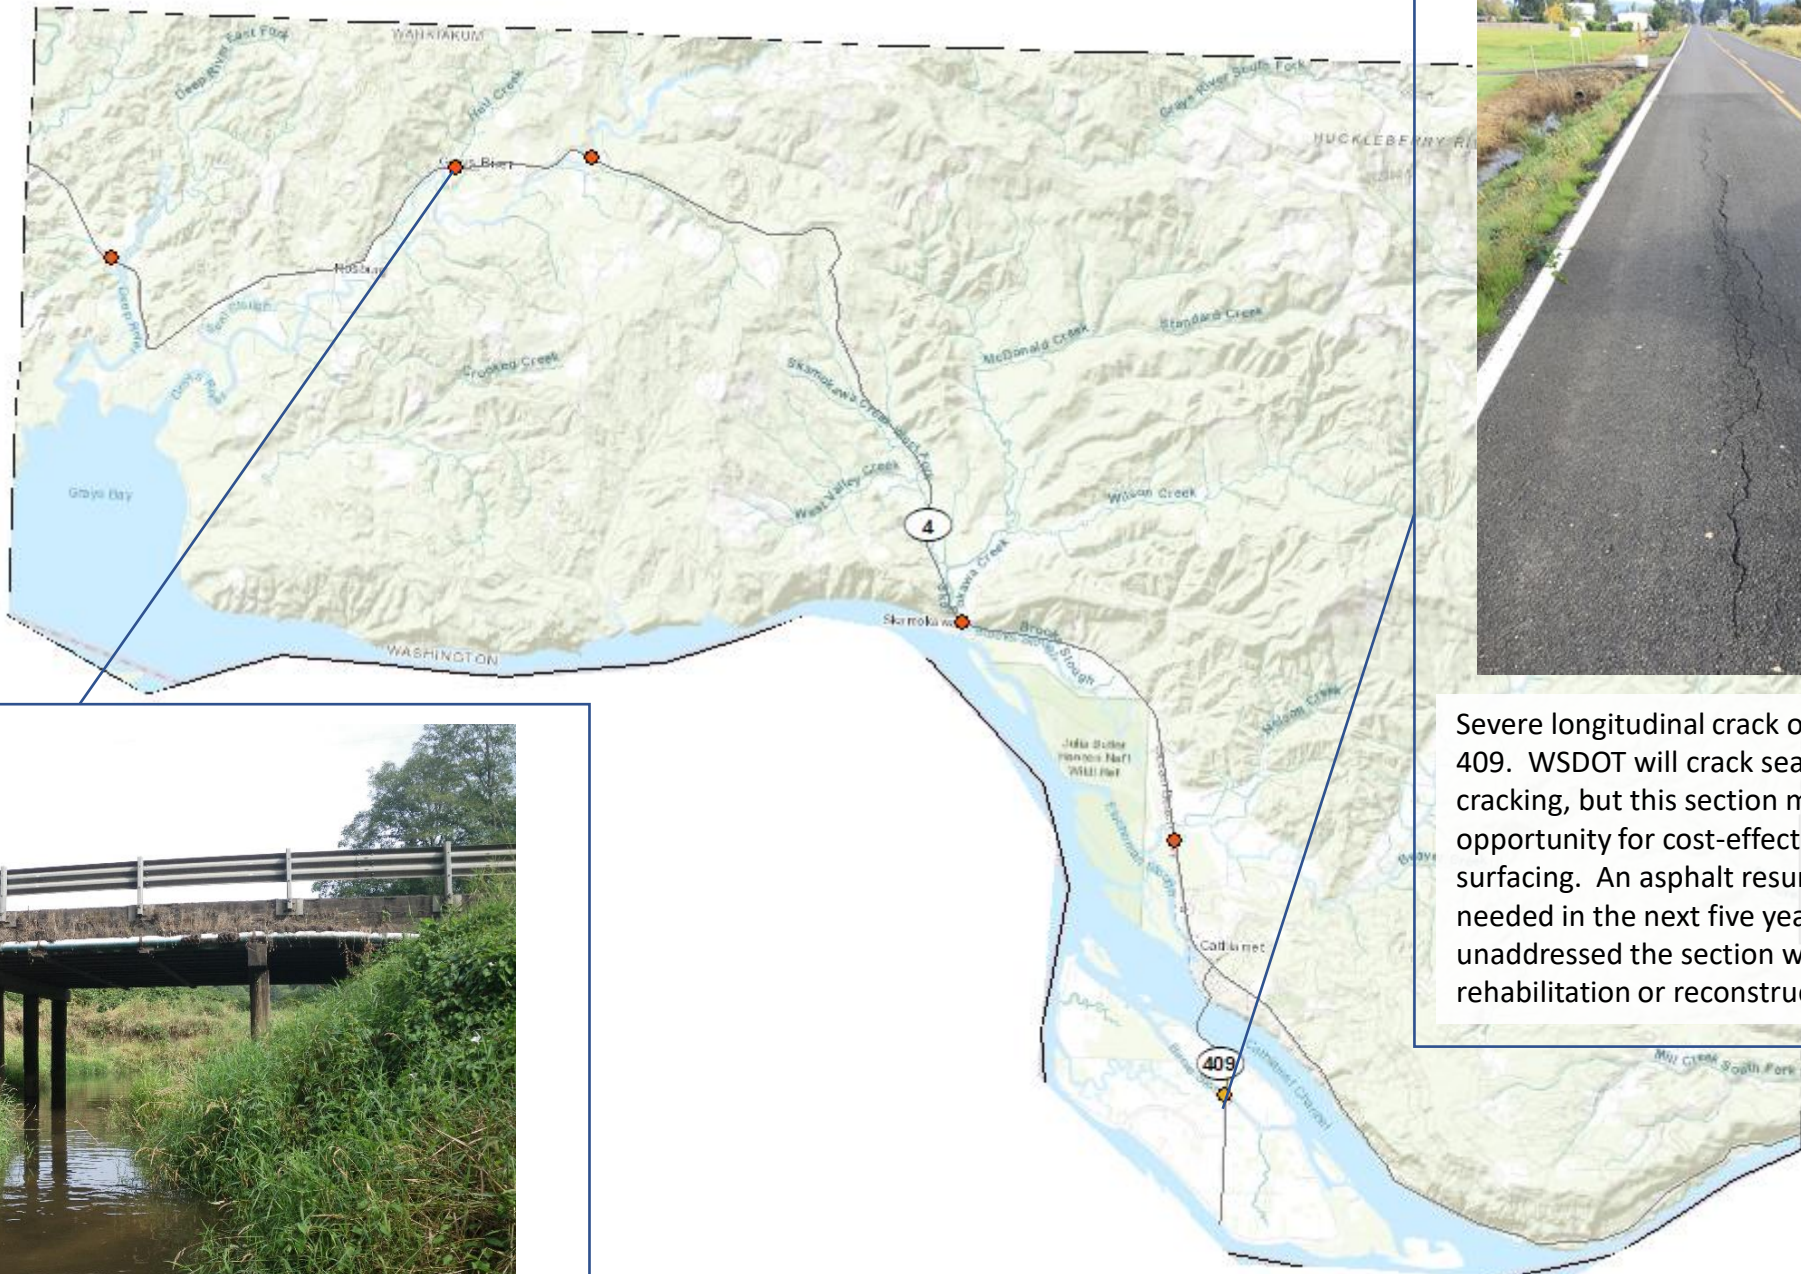
Severe longitudinal crack on State Route 409. WSDOT will crack seal this type of cracking, but this section missed the opportunity for cost-effective chip seal surfacing. An asphalt resurfacing is now needed in the next five years, and if left unaddressed the section will need major rehabilitation or reconstruction.

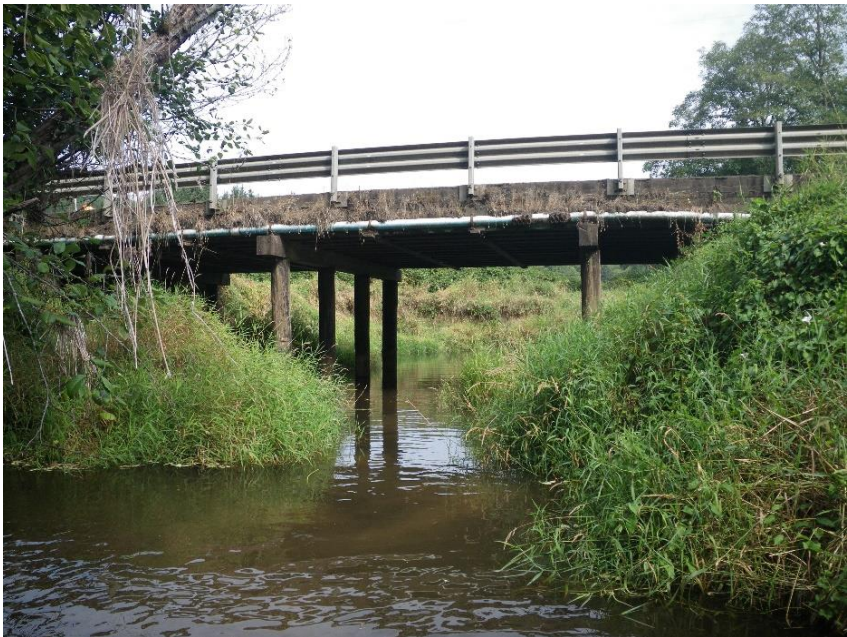
The Hull Creek bridge on State Route 4 was built in 1934. It is a timber bridge that needs to be replaced.

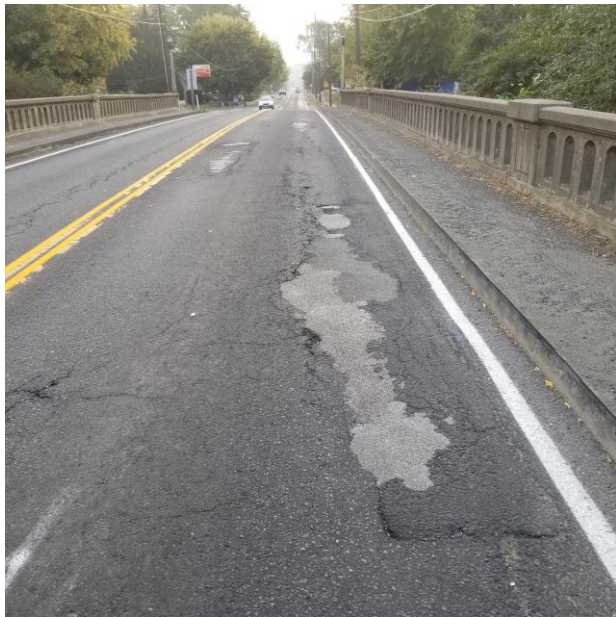
Pavement deterioration including rutting, longitudinal cracking and multiple patches on US 12 in Waitsburg.

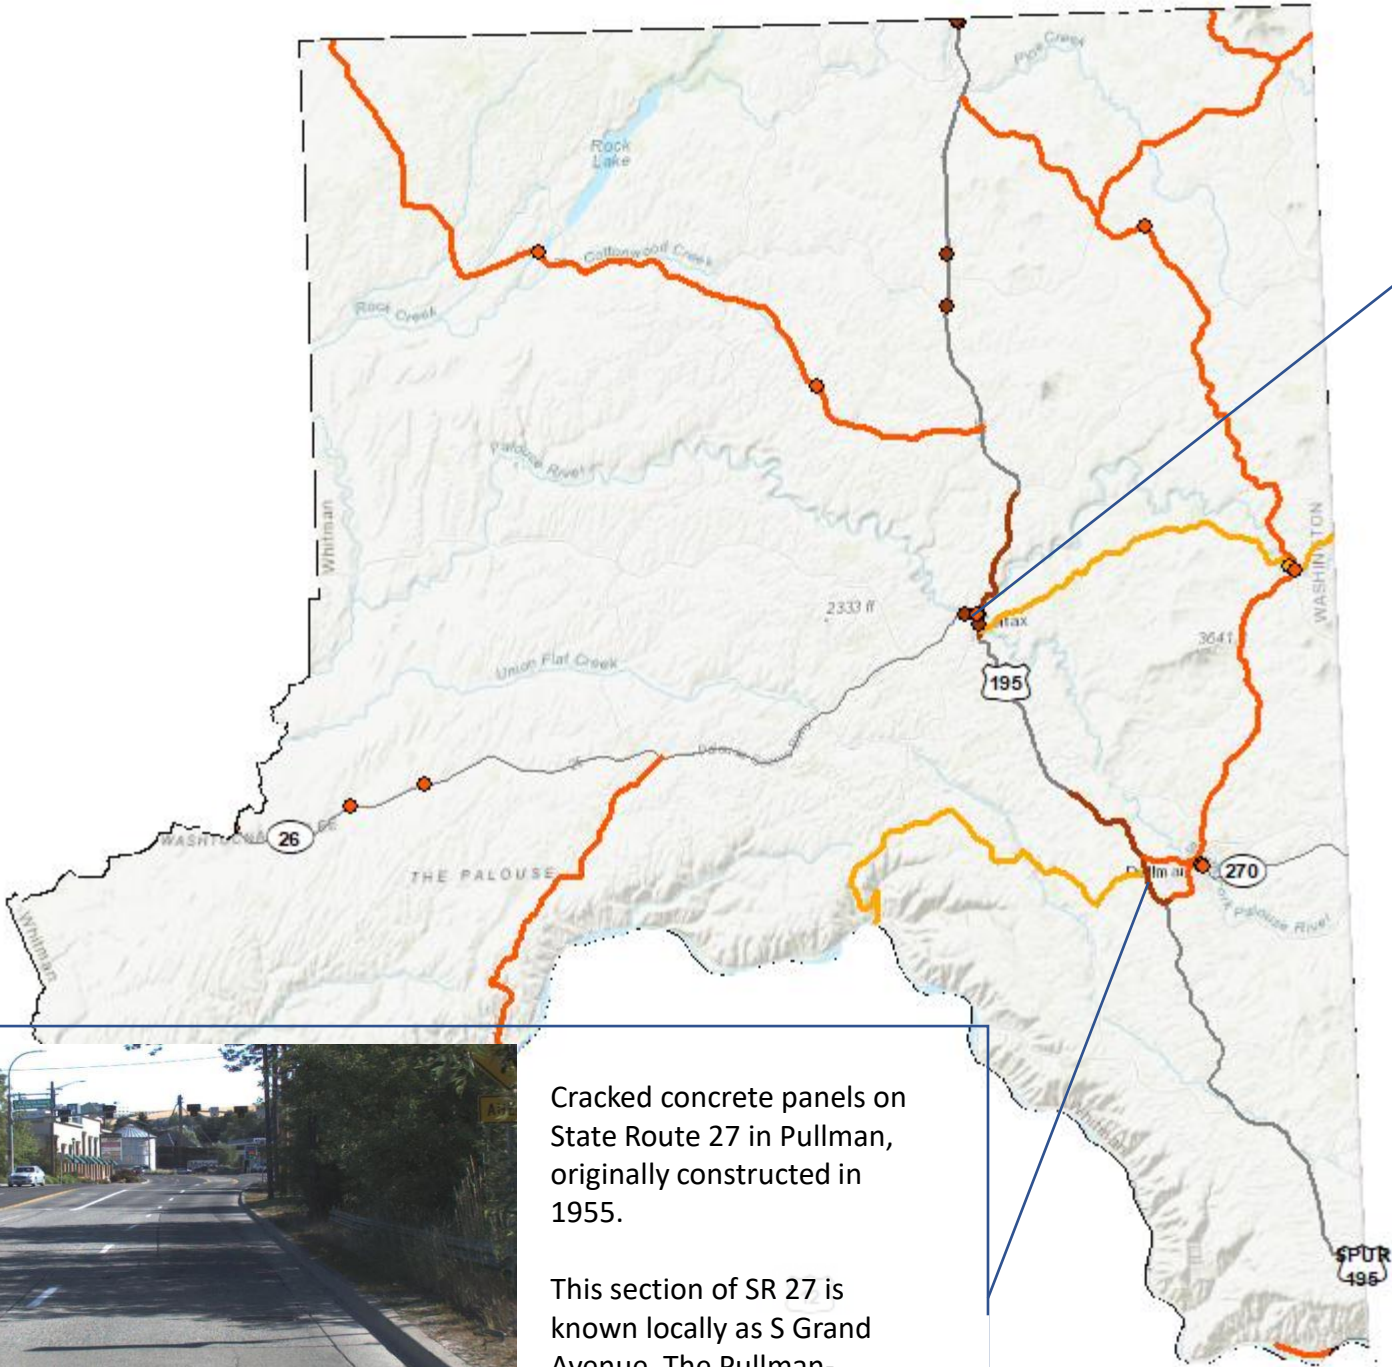
The Palouse River Bridge on US 195 in Colfax has deck deterioration and cracks and the sub-structure (shown). This bridge was built in 1931 and is due for replacement.

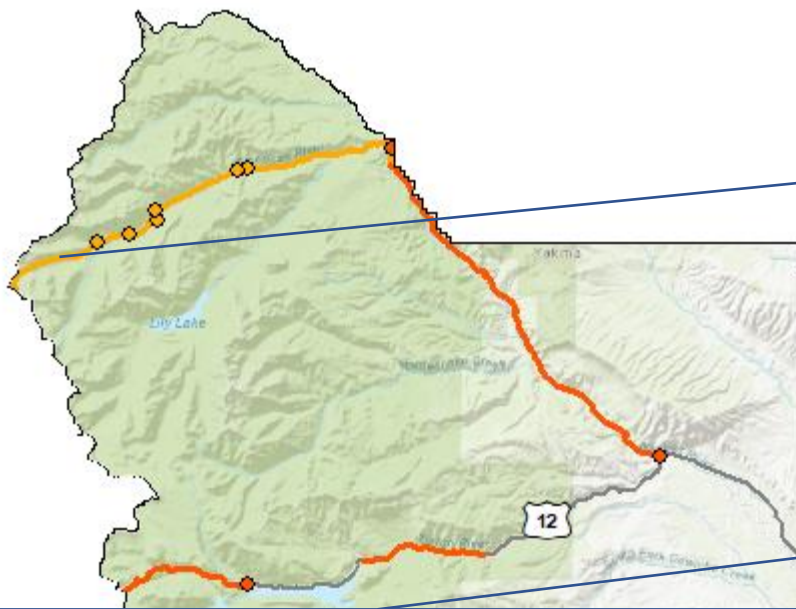
Drainage system failure has undermined gabion wall resulting in risk to highway embankment on State Route 410 in Chinook Pass. The roadway remains at risk because a long-term fix is unfunded at current Preservation amounts.

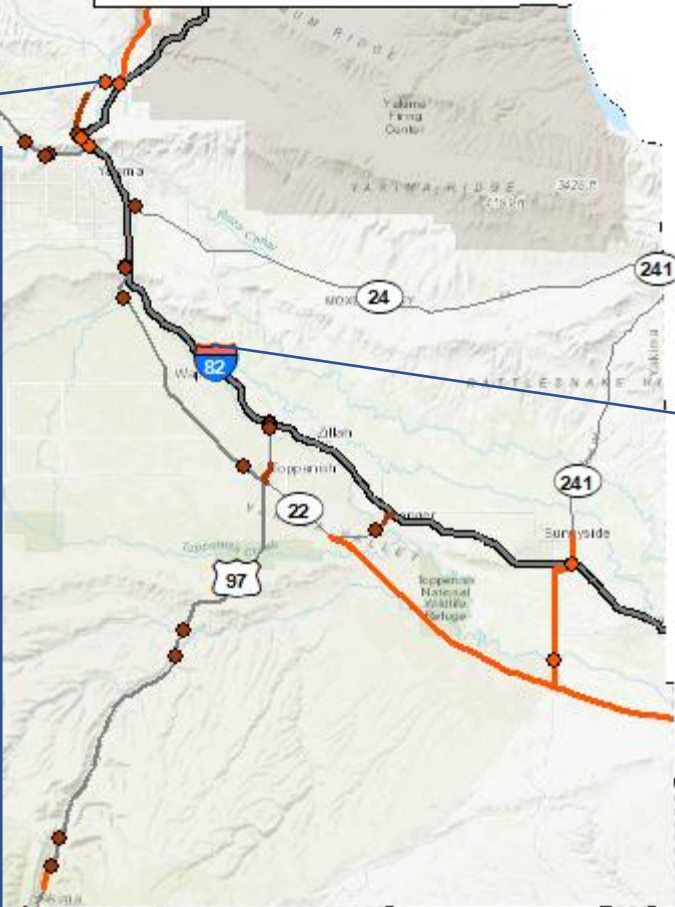
Severe pavement deterioration at the I-82 Donald Rd interchange near Wapato.
