Advanced Technology in the Decision Making Process for Major Bridge Repairs

David R. Reser, P.E. Project Manager

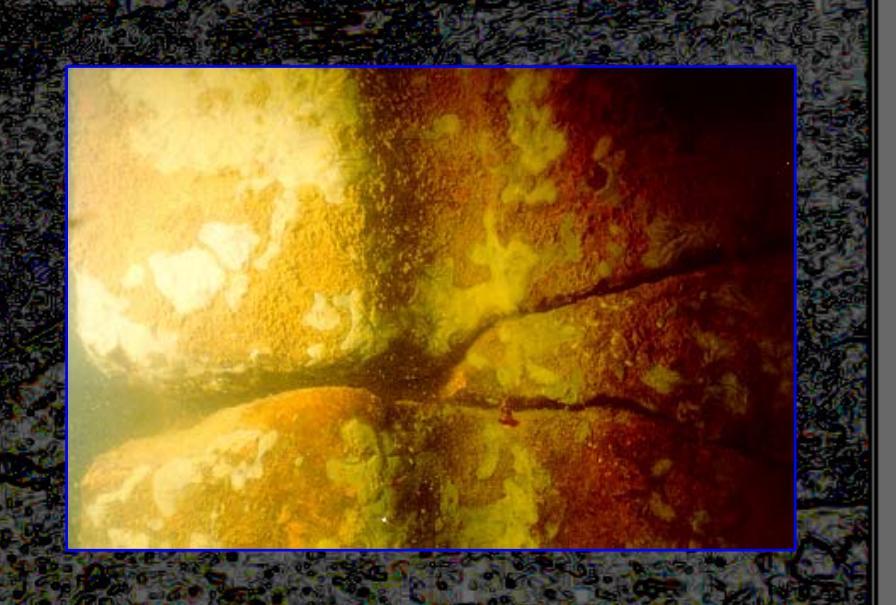
•Pier 7 seal failed after construction.

Single tremie was stationary.
Mix designs were verified.

•Contractor personnel inexperienced.

•Foundation rock highly fractured at several seal locations.

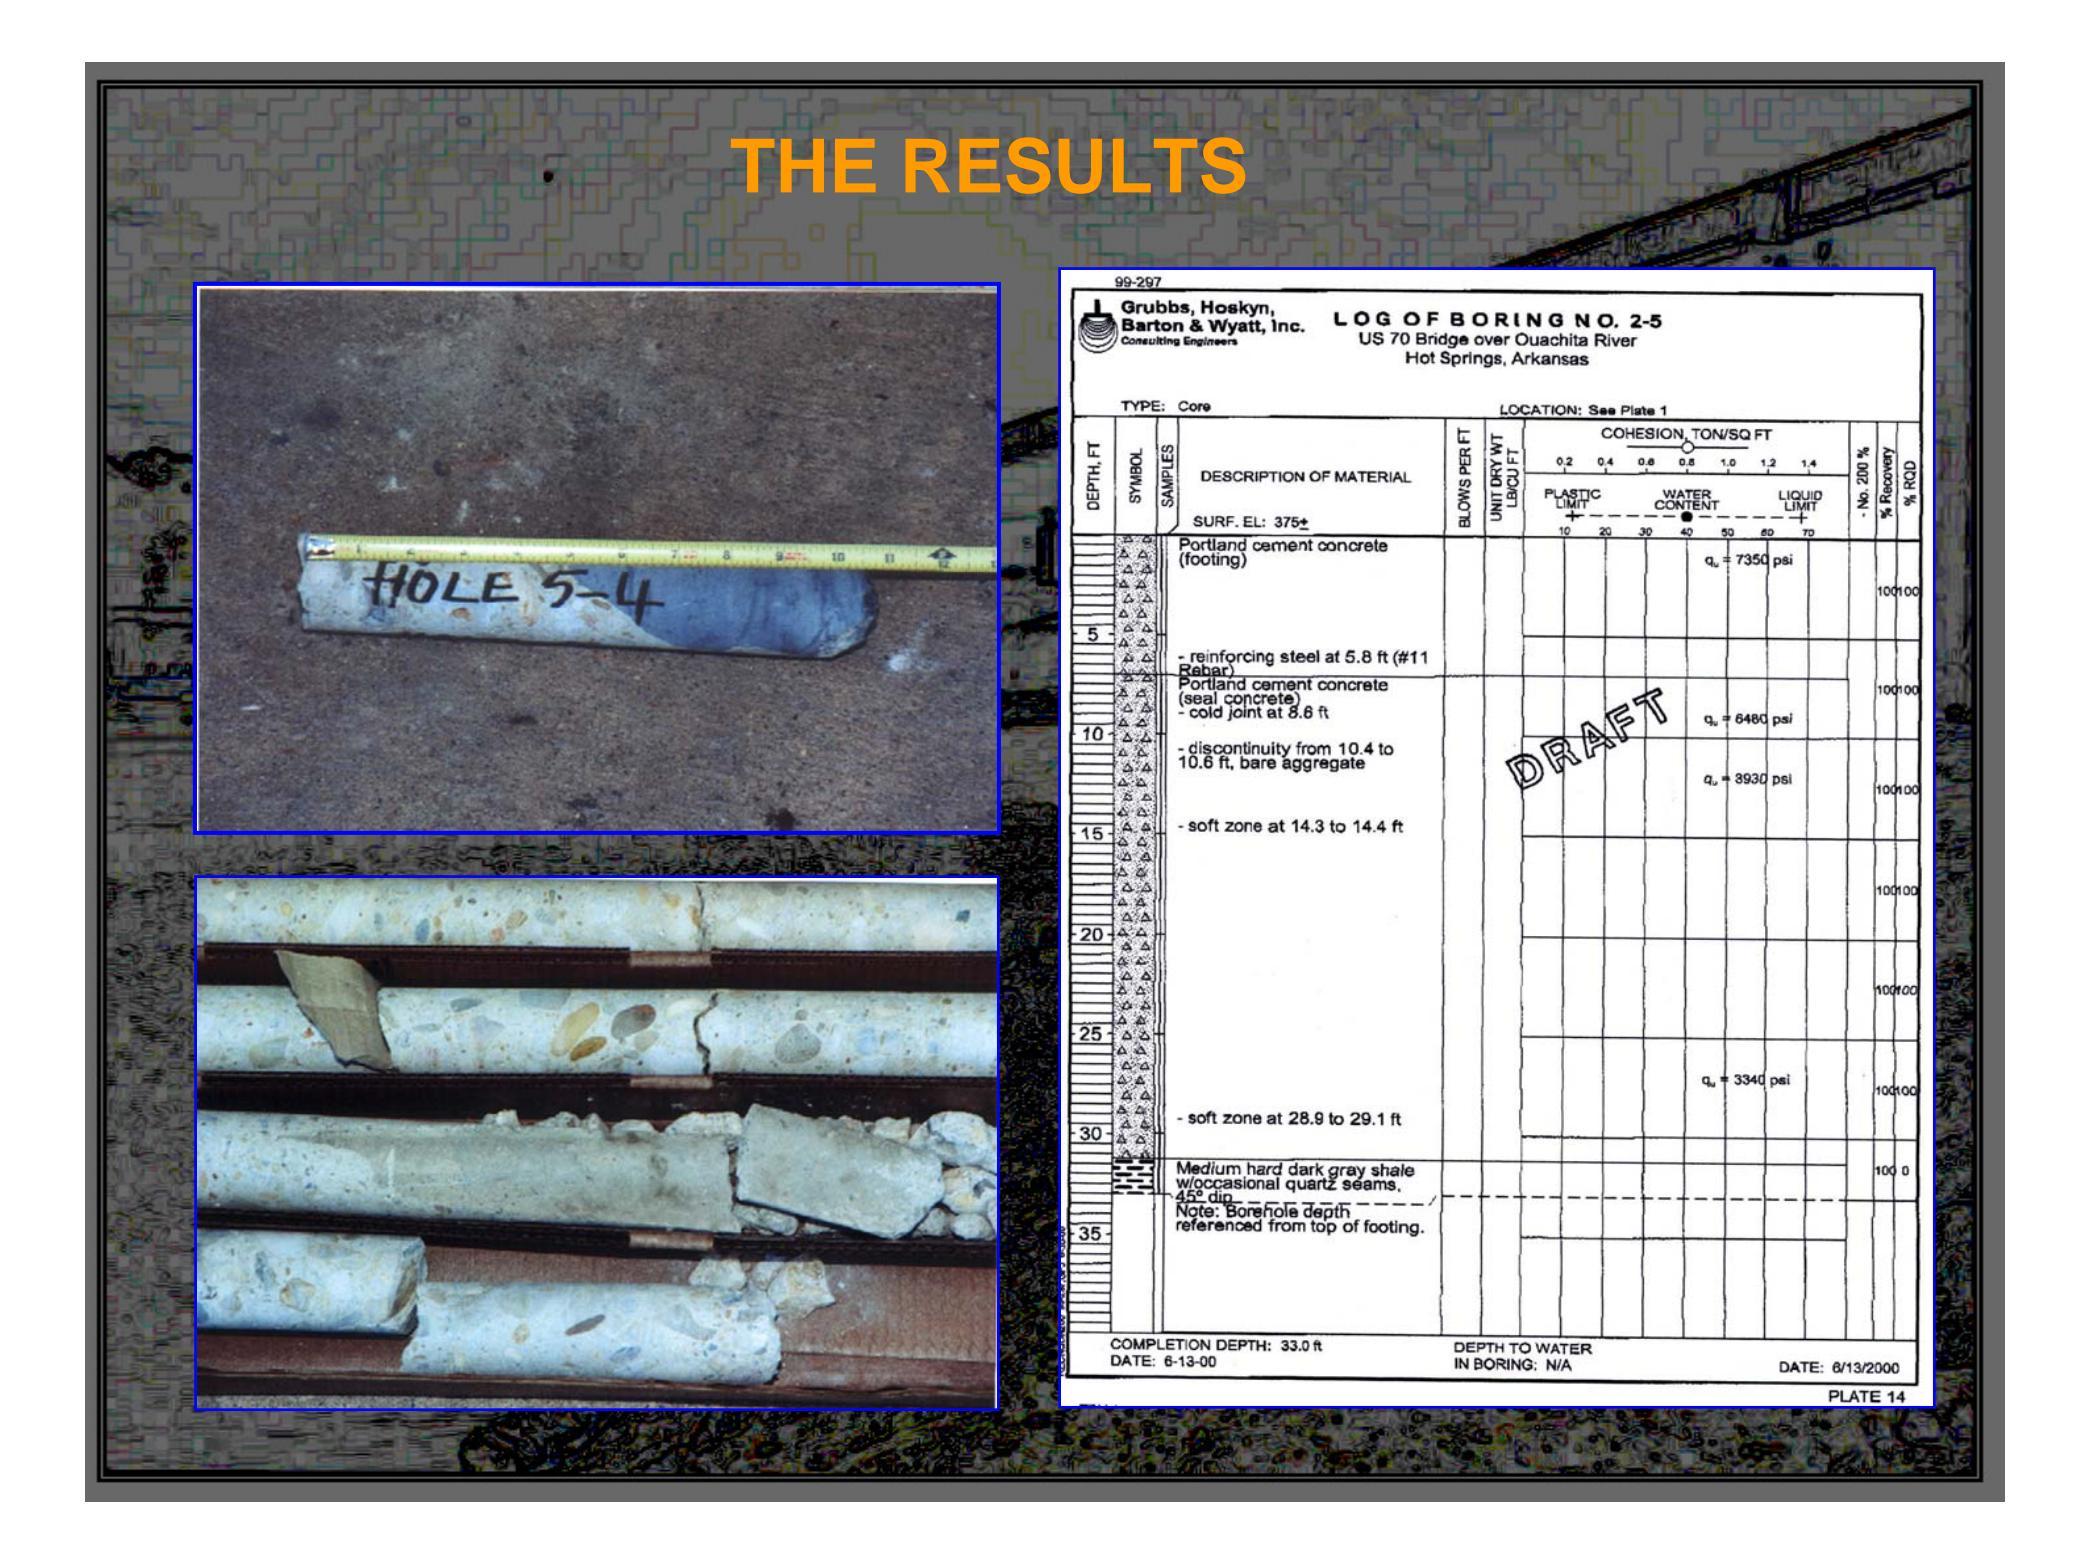
VISUAL INSPECTION RESULTS •All seals have seams of soft concrete with isolated areas of bare aggregate. Several vertical and horizontal cracks were bisected by the core barrel. The interface of the footing and seal concrete is generally good. Highly weathered and fractured foundation rock at Pier 2.
