Viaduct Structure Rehabilitation

**Bridge Deck Reconstruction, Miscellaneous
Structural and Roadway Improvements,
and Repainting of Structural Steel,
Structure No. E109.83**

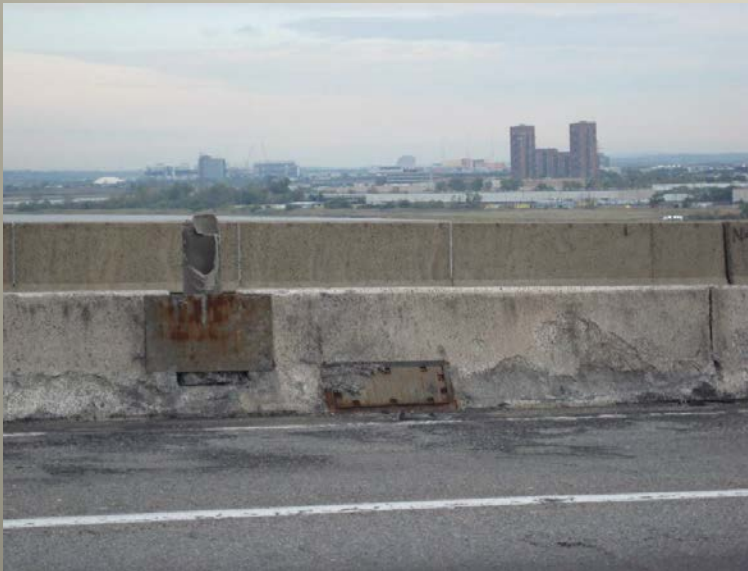
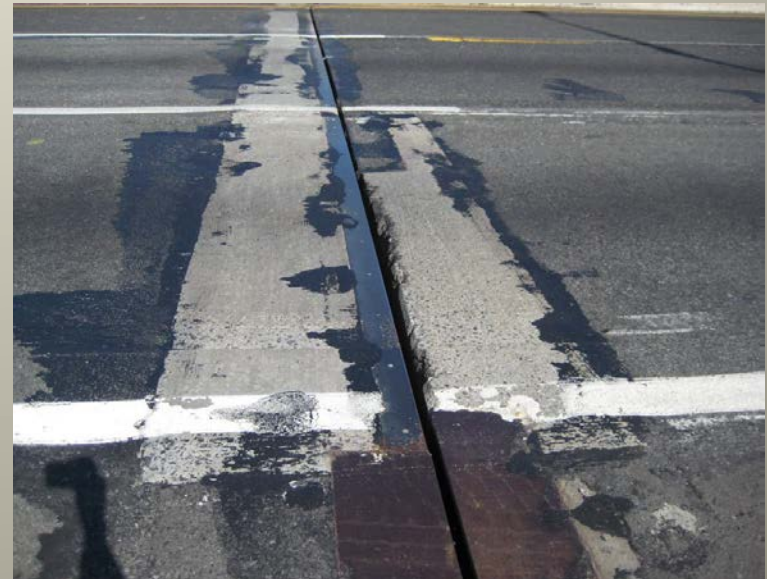
Existing Condition

- **Two Deck Sections in service since built in 1951 and widened in 1972.**
- **Non Composite with supporting stringers**
- **Obsolete finger style joints allowed water flow into structure steel**
- **60 year old portions of the deck were heavily patched and paved**

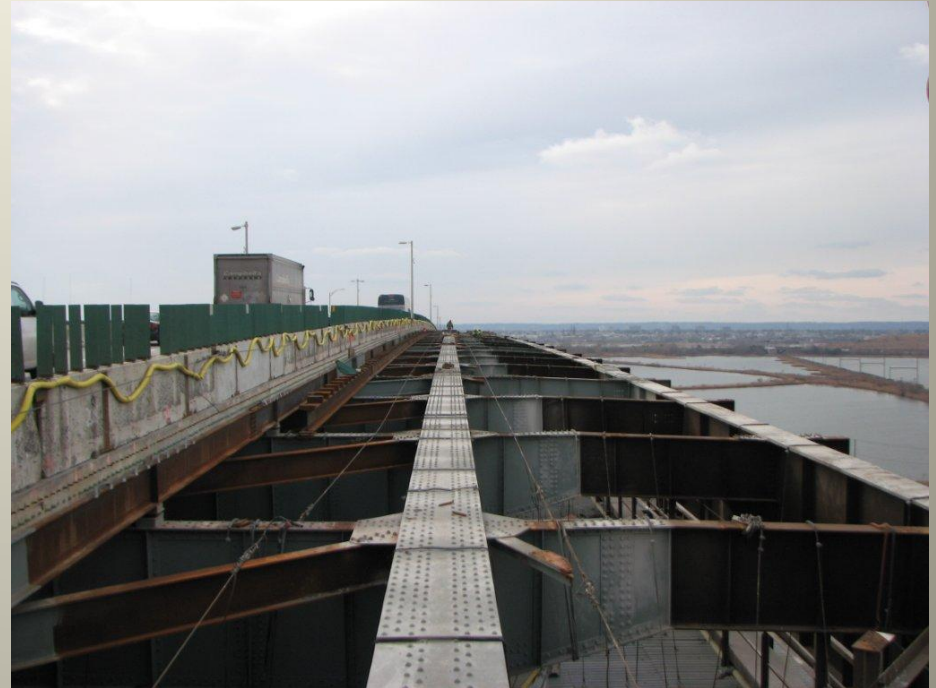
Girders and Floorbeams Stripped of Stringers

- Stringers in the River Spans Unit had section losses at the joint locations.
- The original 1951 stringers were coated with lead paint and would have been expensive to clean and repaint.
- Original grade 36 steel rated low.
- New weathering steel stringers were cost effective, stronger, never needed repainting, and did not require repairs.
 - Cost to repaint a 100' long stringer at \$12/SF and repair end deteriorations was estimated at \$18,400.
 - Cost to replace a 100' long stringer with a new stringer at \$2.50/lb. was \$17,800.

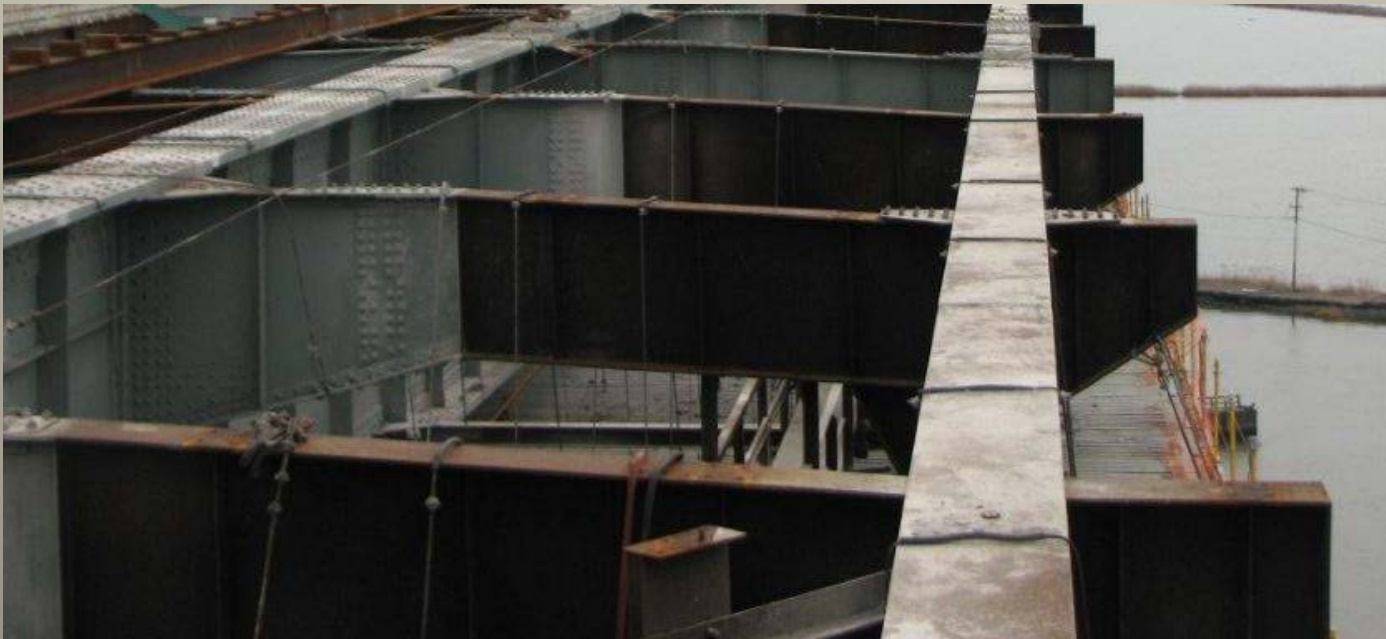
- **4 girder system with non prismatic floorbeams.**
- **Inner girders designed ASD and built-up riveted plates.**
- **Outer girders designed LFD and welded plate construction.**
- **50% stiffness difference between girders.**
