Underwater Sound Levels Associated with Pile Driving during the Anacortes Ferry Terminal Dolphin Replacement Project

April 2007

Prepared by:
Tim Sexton
Washington State Department of Transportation
Office of Air Quality and Noise
15700 Dayton Avenue North,
P.O. Box 330310
Seattle, WA 98133-9710

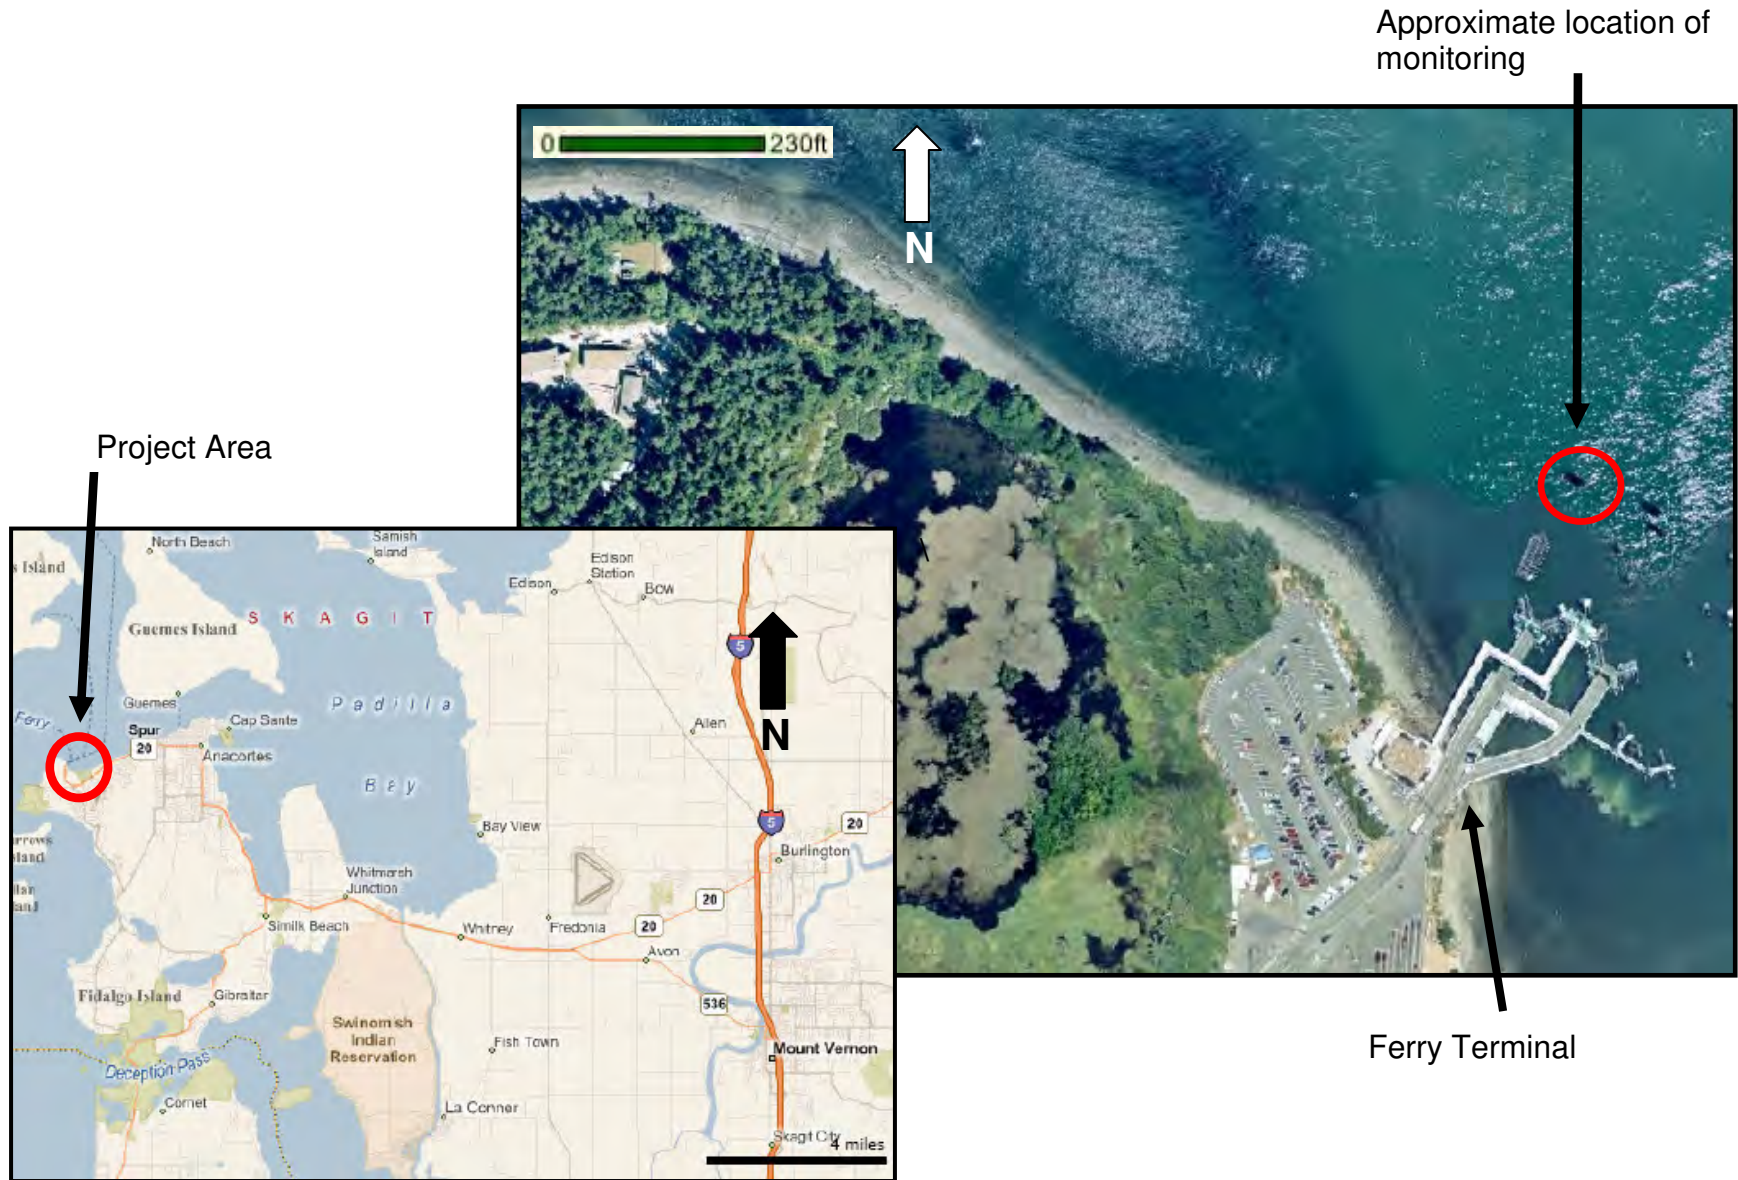
Figure 1: Location of dolphin replacement work at the Anacortes Ferry Terminal.

The eight piles were monitored at mid-water depths, dependent on location and tidal flux. A bubble curtain was tested with on/off cycles during each pile driving event. Equipment failure prevented collection of data for pile 3. Figure 1 shows the project area and Figure 2 shows the locations of monitored piles.

The project location was in the northeast section of the existing Anacortes Ferry Terminal (Figure 1). Piles were driven during slack tide when water depths were approximately 42 feet deep. There was an approximate five-foot tidal flux over a six-hour period. No substantial currents were observed in the area monitored.

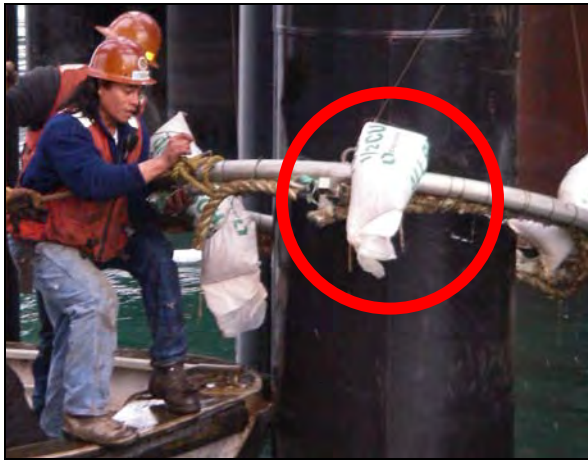
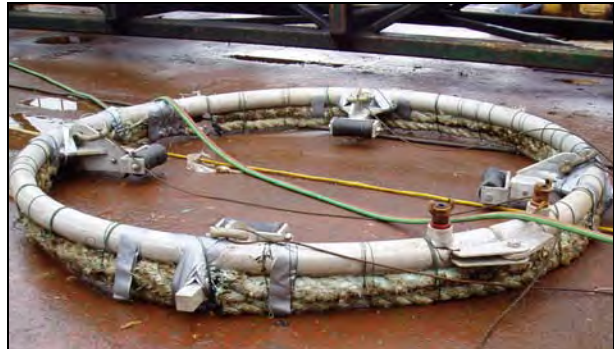
Figure 6: Photographs of the bubble curtains prior to deployment around the pile.

The red circle shows the sandbags strapped on to the metal rings for weight for bubble curtain one. Rope was strapped to the base of the bottom ring to cover the lugs and keep the ring flush with the seafloor bottom.

Bubble curtain specifications are described in Table 3 and Figure 6 shows a photograph of the bubble curtains.

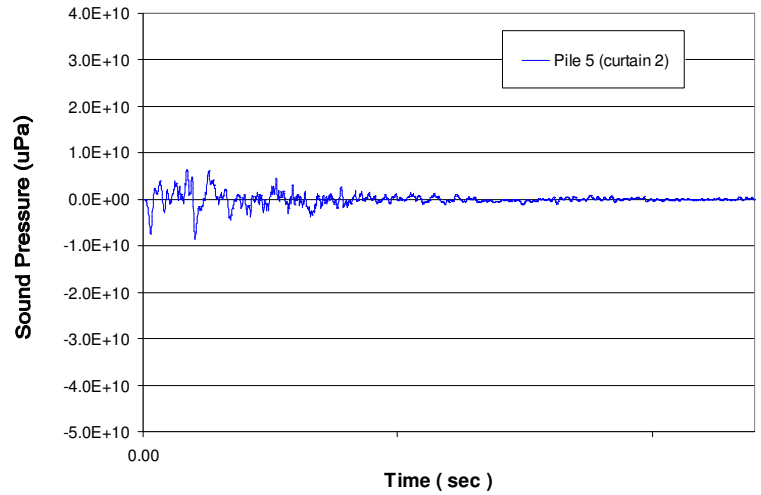
Figure 10: Waveforms and frequency spectral analysis for Pile 5 using bubble curtain one.

a. Waveform: Pile 5 no bubble curtain

b. Waveform: Pile 5 with bubble curtain

c. Waveform: Pile 5 no bubble curtain (2)

d. Waveform: Pile 5 with bubble curtain (2)
