### “Partnership for Environmental Excellence in Construction Management” Award

Project Name: North of Wenatchee Wildlife Fence Stage 2

Contractor Name: R.M.Shearer, Inc.

# North Central Region US 97 A Wildlife Fence

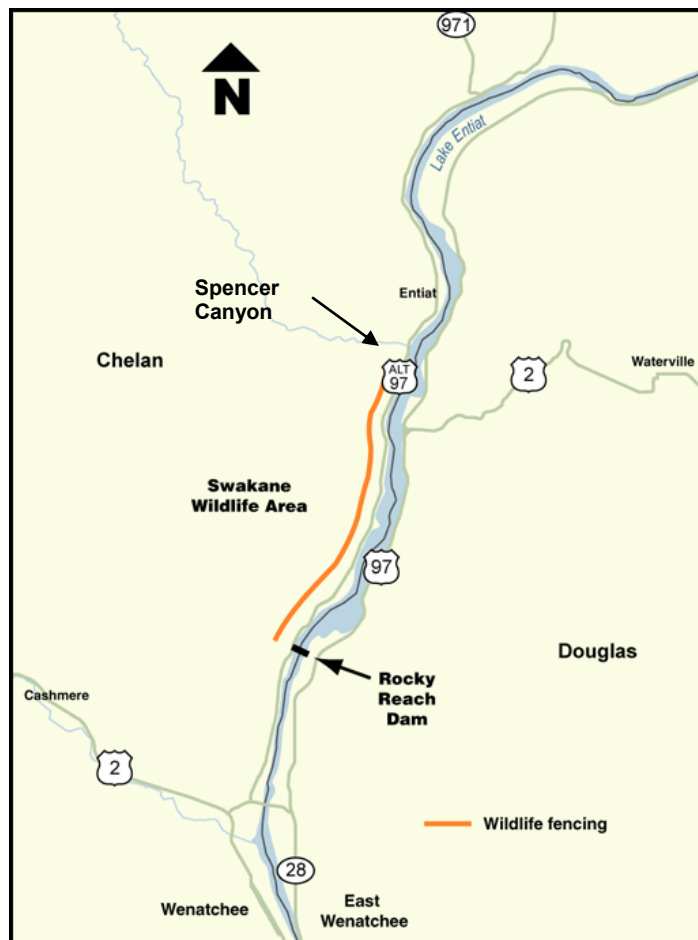
The first phase constructed the fence from MP 207.95 to MP 212.1. This phase was completed Nov. 2009.

The second phase constructed the fence from MP 206.4 to MP 207.95 and was completed Oct. 2010.

The third phase is currently under construction and completes the fence from M 203.15 to MP 206.4. The fence will be completed 2011.

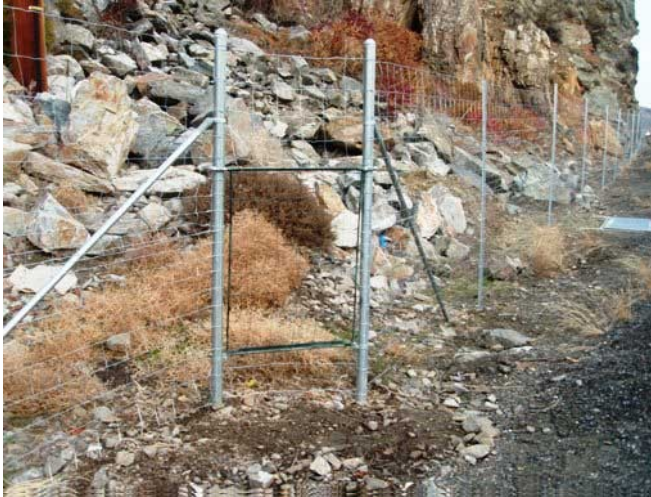
### Wildlife Fence Reduces Collisions with Deer and Sheep by 80%

The two sections of wildlife fence installed in phases one and two have drastically reduced the number of collisions with deer and sheep.

Since phase one was completed there have only been 11 vehicle/wildlife collisions (VWC) reported by maintenance within the project limits. Three of these collisions were within phase one mile post limits, two within phase two mile post limits, and the remainder in phase three mile post limits which is just now being constructed.

Prior to the fence installation this section of roadway saw an average of 40 VWC's per year. The 11 VWC's over a twenty month period equates to over an 80% reduction.
