I-90 SNOQUALMIE PASS EAST PROJECT

Phase 1C – Rock Slope Engineering Report 2008 Geotechnical Program

Volume 1 of 2

April 2009

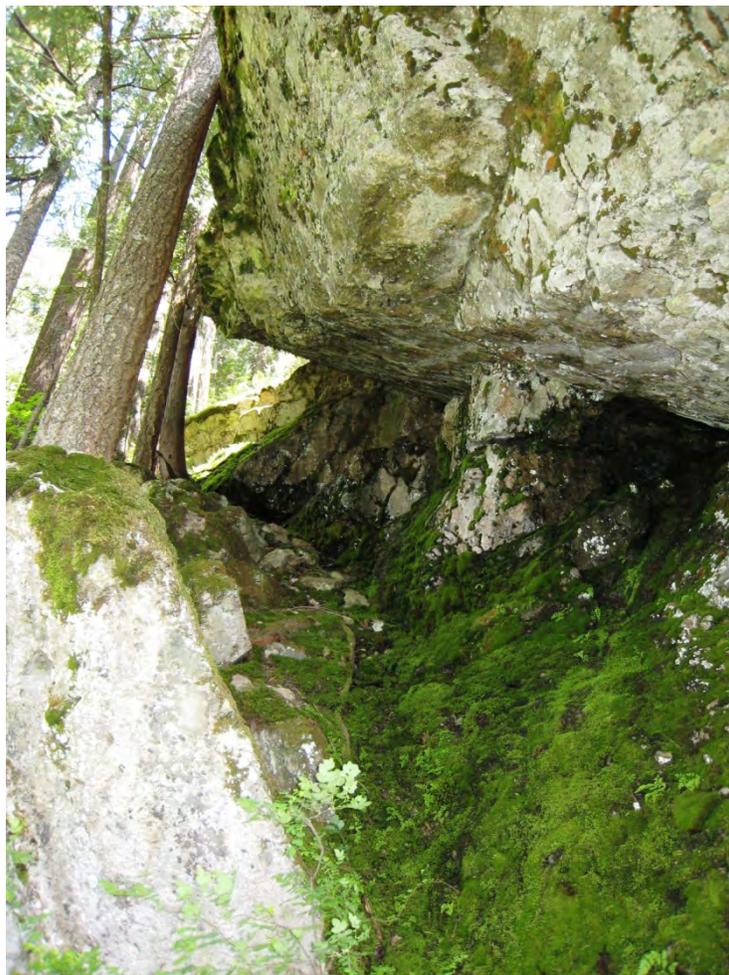
Photo looking east at the persistent discontinuity

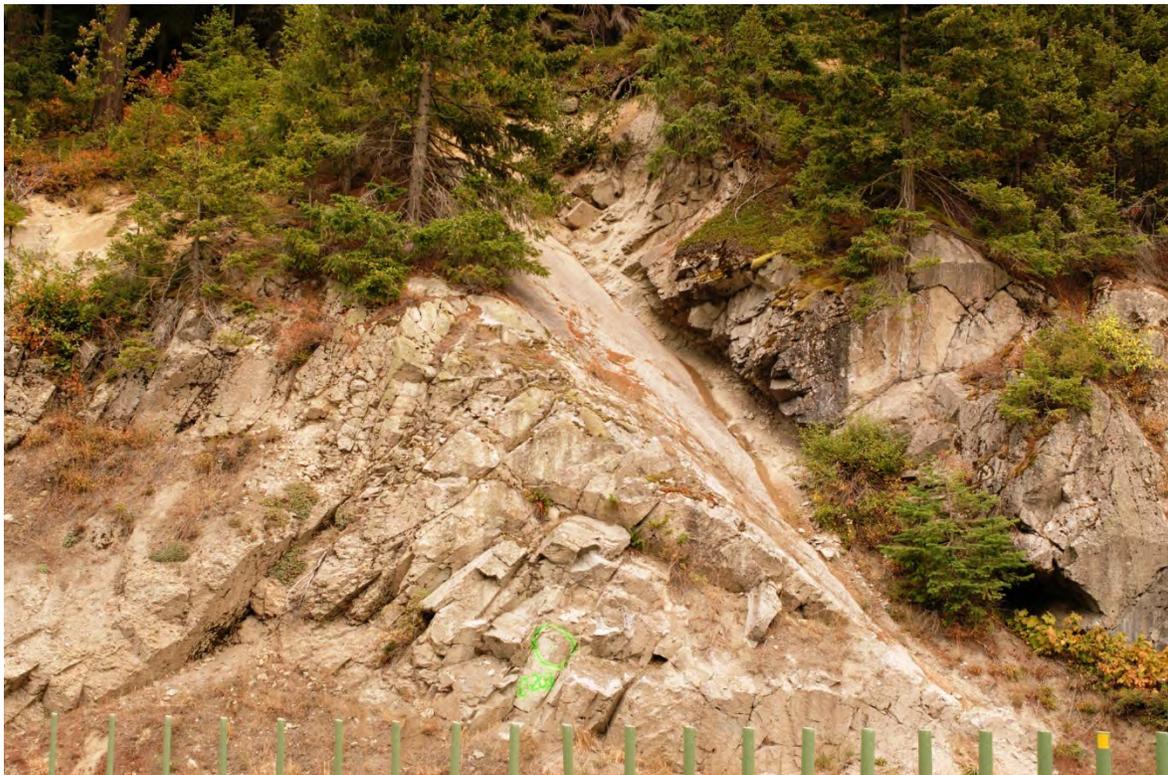
1. Rock outcrops are intermittent throughout sector.
2. At WB station 1379+50 is a bedrock outcrop with a persistent (greater than 75 feet) discontinuity dipping obliquely out of the slope (refer to photo below).
3. Approximately 300 feet of rock outcrop observed along the central portion of the sector.

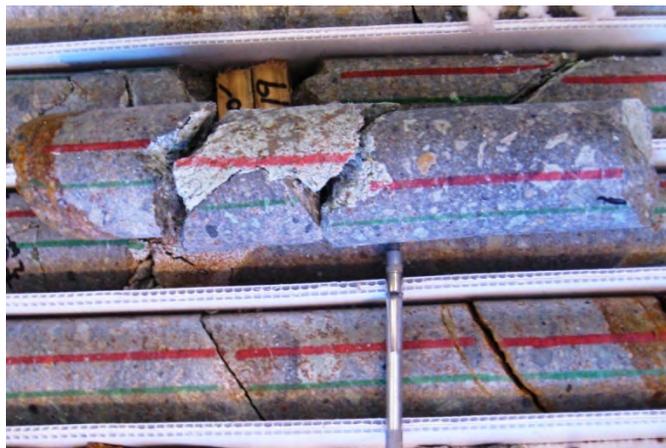
5. Domain 2 rock observed in boreholes drilled in 2007 and reviewed in 2008 showed spotty iron staining of fresh rock and swelling clays present in altered pumice fragments (refer to margin photo from RKS-19-07), damaging the existing core. This alteration occurred within one year. The presence of these clays and high susceptibility to weathering further support that Domain 2 rock will degrade in cut faces over a life-of-highway timeframe.

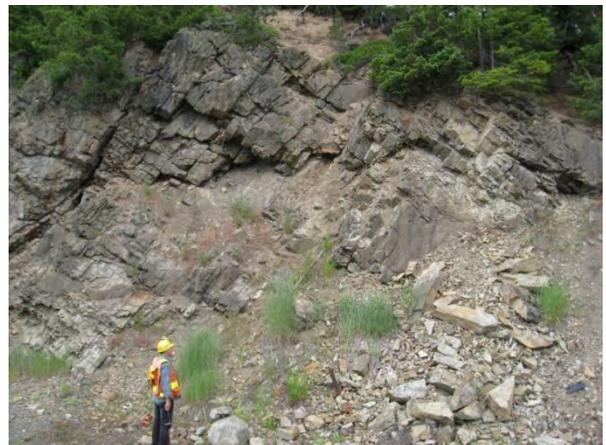
4. Existing cut slope in the silicic volcanic (approximately WB station 1474+50 to 1477+00) is slightly to moderately weathered and does not appear to perform well in outcrop with apparent preferential erosion along foliation and rock fall development block size of up to 2 feet (refer to margin photograph).

5. The silicic rocks were foliated and slightly weaker parallel to the foliation [~55/ 260].
