## Nomination Form

“Partnership for Environmental Excellence in Construction Management”  
Award

Project Name: I-405, I-5 to SR 169 Stage 2 Widening and SR515 Interchange Project

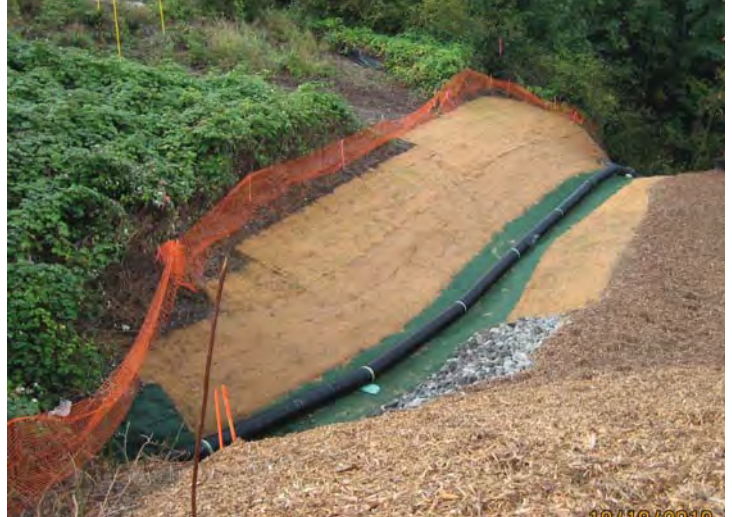
Figure 2: View of stream mitigation site.

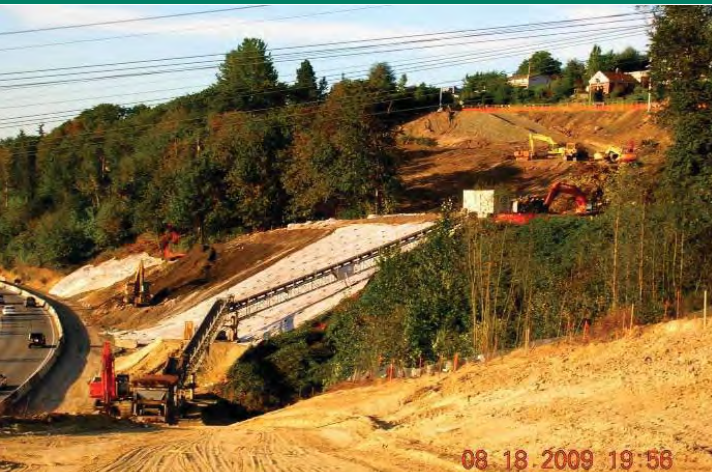
Figure 5: Conveyor system obviated 10,000 truck trips through the City of Renton.

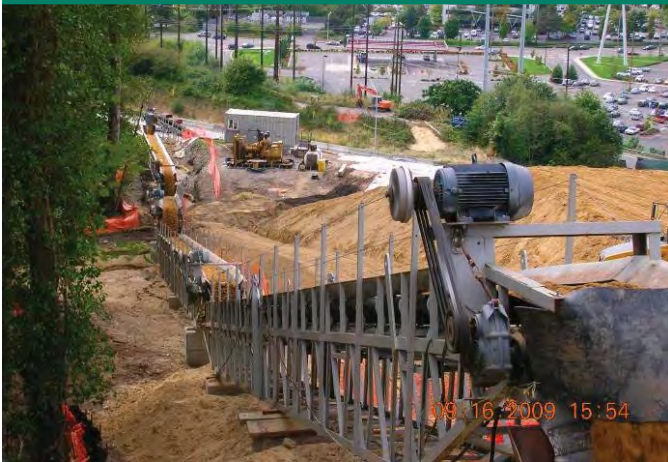
Figure 6. Conveyor kept pace with fill, keeping excess embankment onsite.

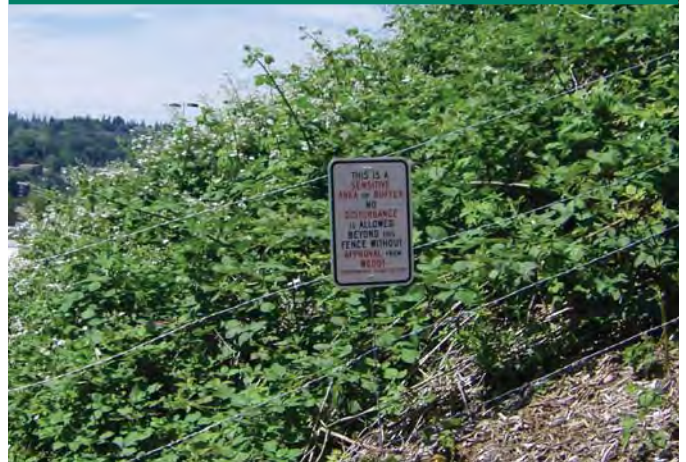
Figure 7. Sensitive environmental areas were fenced off and signed as such.

**Identifying and Protecting Sensitive Areas** – The Project implemented a TESC plan prior to beginning any work on the project and took an active role in the implementation of environmental policy (Figure 7). CDB instituted a mandatory environmental awareness program for all personnel. Over 800 people completed the environmental training. The training included orientation on environmental commitments, detailed the project environmental sensitive areas; erosion and sediment control procedures; reporting procedures; and management of contamination and unanticipated archaeological discoveries.

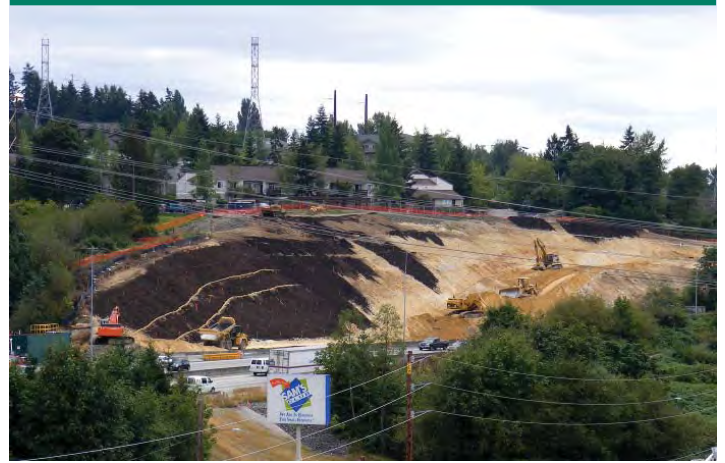
Figure 10. Permanent slope covering was installed as excavation proceeded.

**Using Methods Beyond BMPs** – The project required a large amount of ground disturbance within congested Renton. 115,000 CY of soil needed to be excavated from Rolling Hills, which drains to catch basins along the highway (Figure 10, 11, 12, 13, 14). The available right-of-way was insufficient to clean turbid runoff by standard means before reaching state-regulated waters. The team implemented the “bath tub” to prevent water contamination. The system had capacity to store about 120,000 gallons of turbid water. (Figure 19, 20, 21)

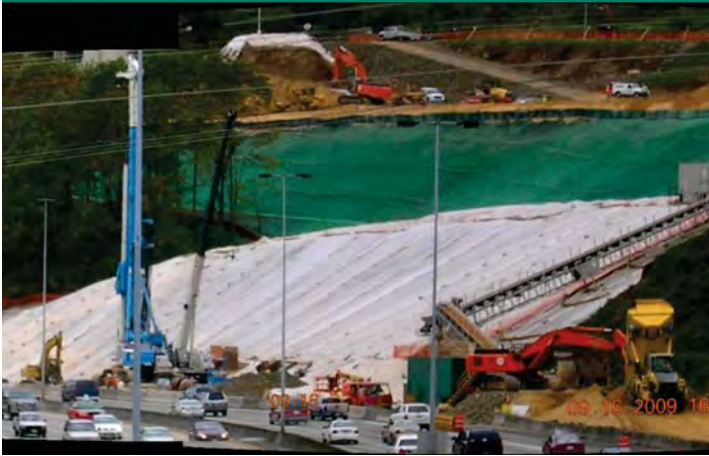
Figure 11. Permanent fill slope covering was installed as fill slope was constructed.

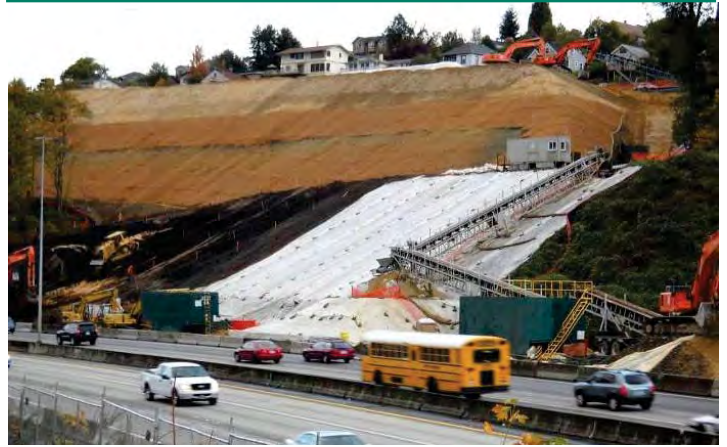
Figure 12. Permanent fill slope covering was installed as fill slope was constructed

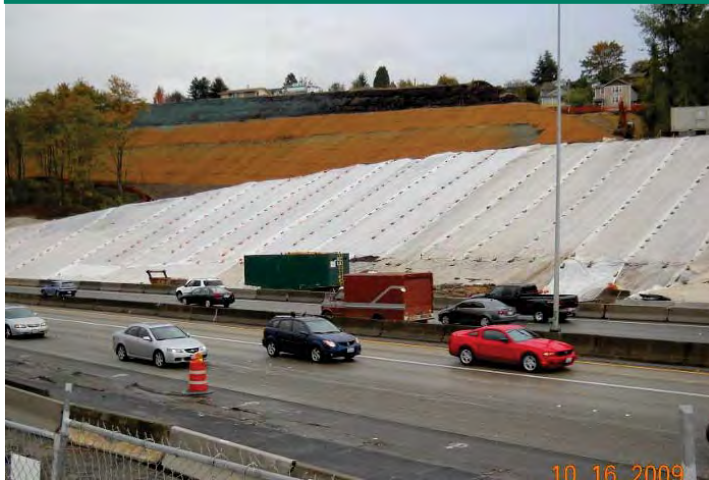
Figure 13. Permanent fill slope covering was installed as fill slope was constructed.

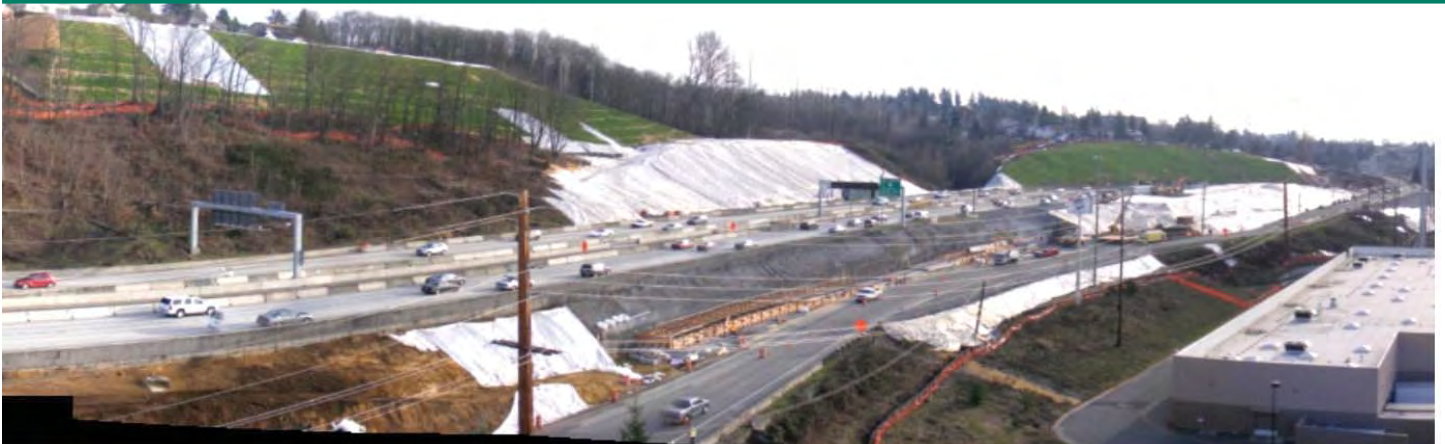
Figure 14. Cut and fill slopes were green and stable in time for the rainy season.

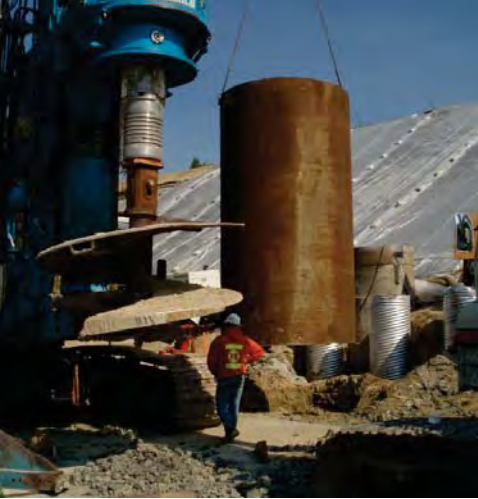
Figure 16. Diversion well casing, cut-off wall, and observation casing at abandoned mine shaft.

**Adapting to Unexpected Conditions** – While drilling shafts for the construction of a bridge a mine shaft and chamber from the historic Renton Coal Mine was discovered. CDB and WSDOT devised an adaptive plan for stabilizing a 20’ x 30’ void under the shoulder and partially under the travelled lanes, a changed condition. Through CDB and WSDOT interdiscipline collaboration, the project team located and filled the void without contaminating groundwater with sediment or high pH. (Figure 15, 16, 17, 18).

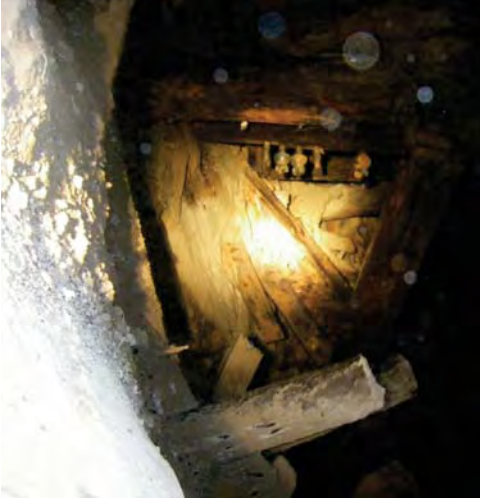
Figure 18. Diversion well casing, cut-off wall, and observation casing at abandoned mine shaft.

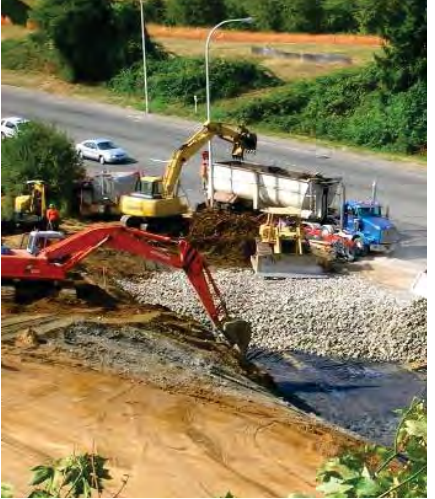
Figure 19. Lower cell placed over separation fabric. Quarry spalls filtration system.

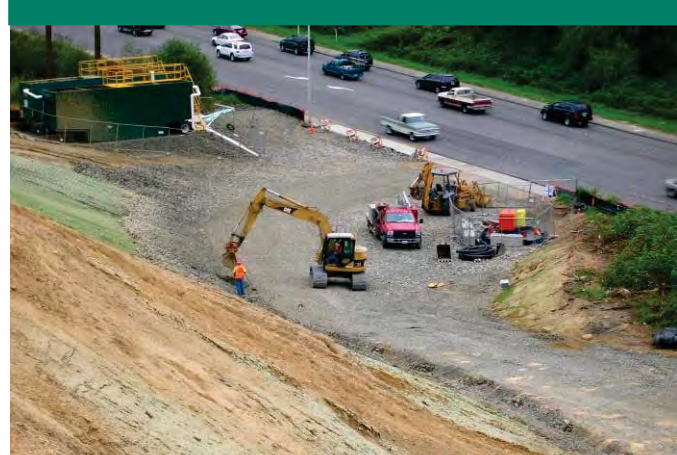
Figure 21. Quarry spalls filtration system.
