WASHINGTON STATE DEPARTMENT OF TRANSPORTATION
SUMMARY OF INVENTORY FINDINGS:

Palouse River Fecal Coliform Total Maximum Daily Load

January 5, 2015

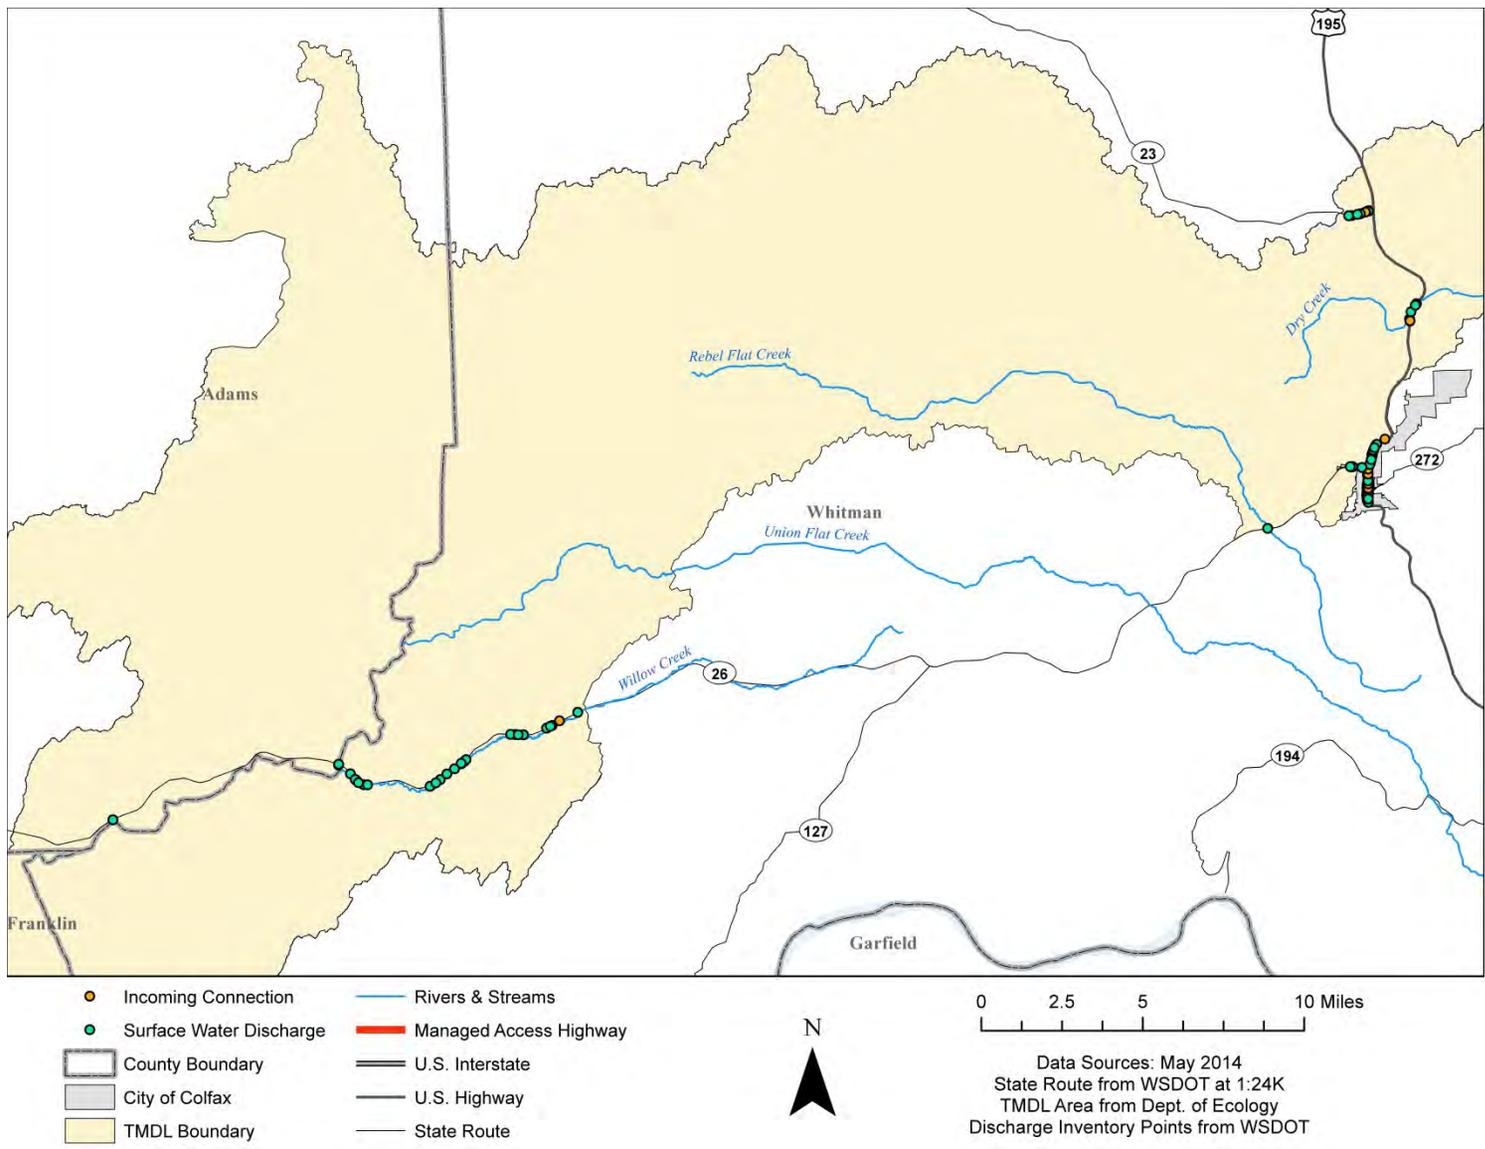
Figure 1. Map of surface water discharge points, incoming connections and managed access areas on WSDOT state routes in the Palouse River Fecal Coliform TMDL.

Figure 1 presents discharge points and incoming connections identified during field work within the TMDL boundary. Figure 2 shows the potential pollutant source locations that are further described below.

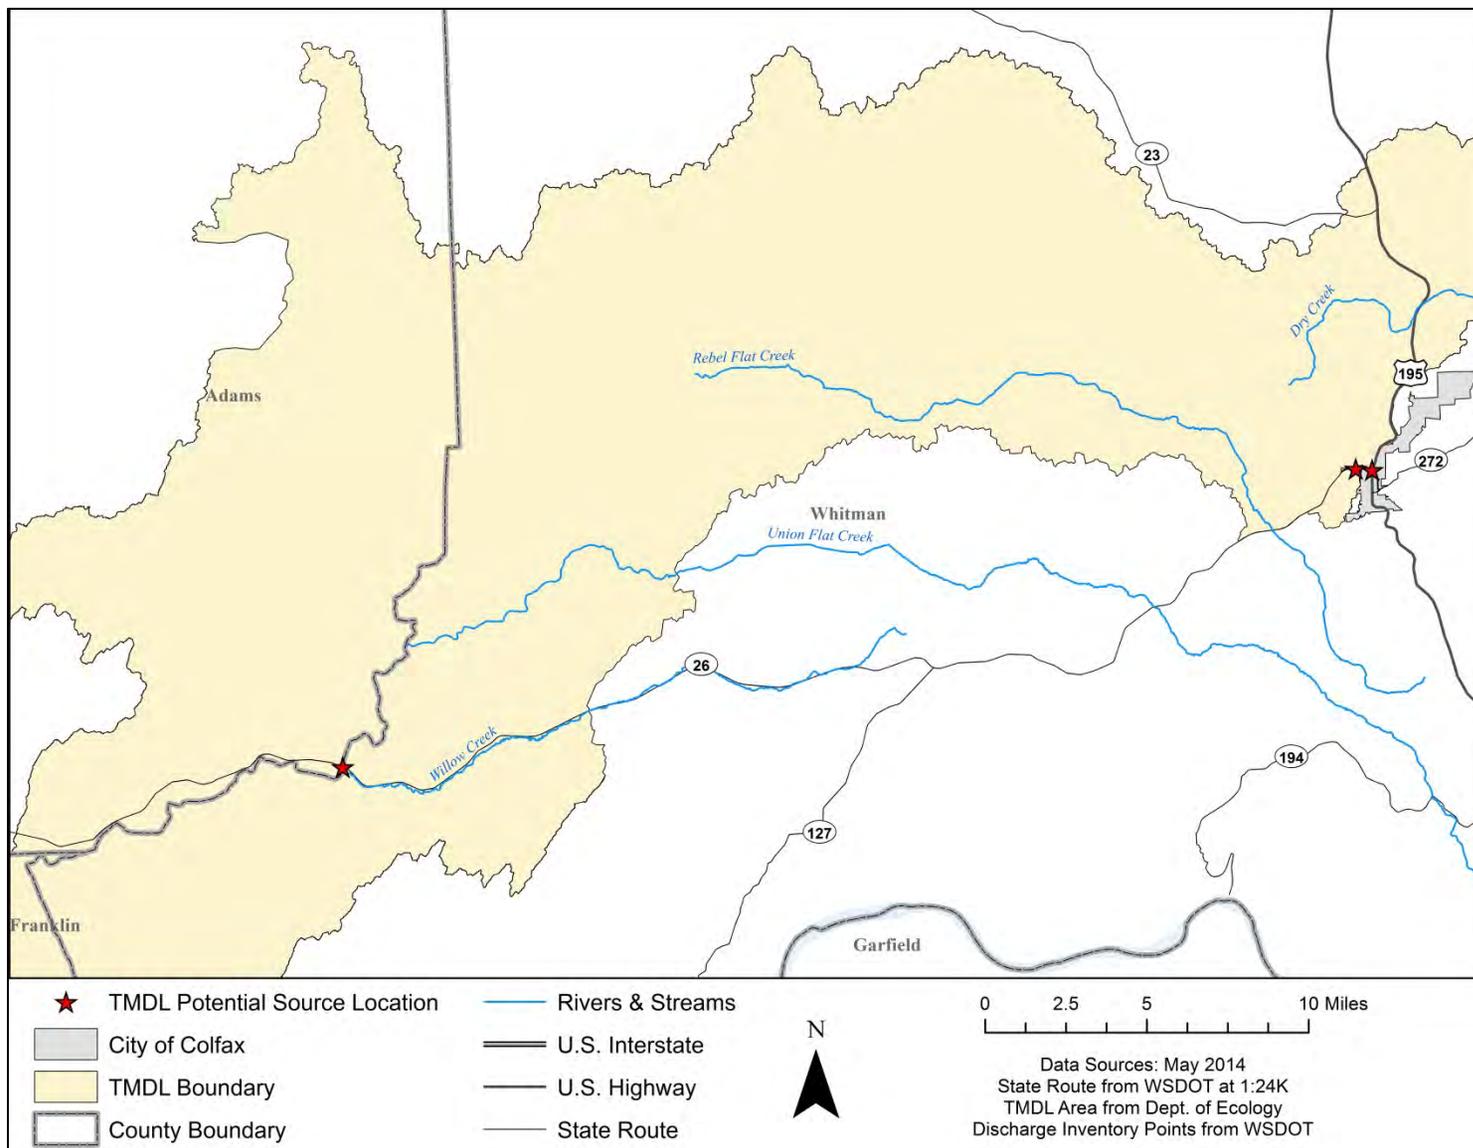
Figure 2. Map of potential pollutant sources on WSDOT state routes in the Palouse River Fecal Coliform TMDL

A total of six potential fecal coliform and sediment source locations were documented during the 2014 field season (*Figure 2*). Two categories of potential source locations were identified:

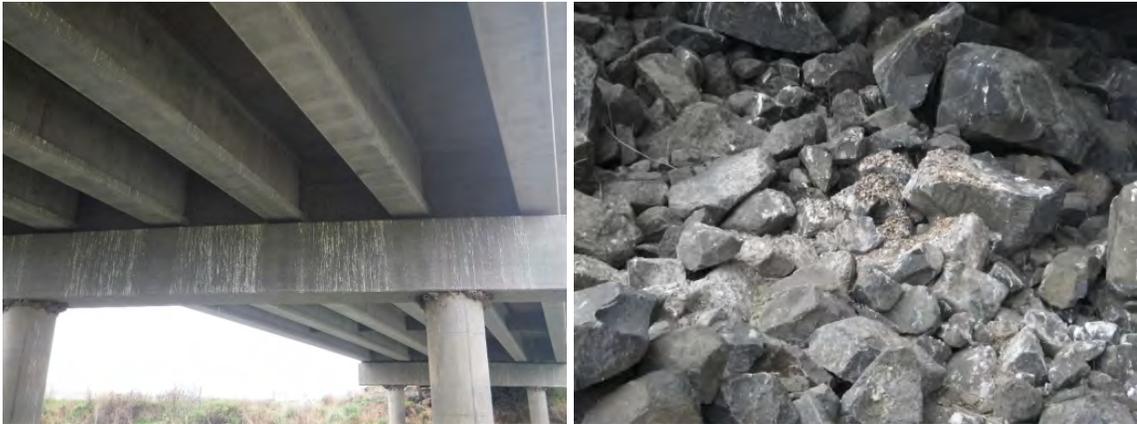
SR 26 at Milepost 96.87 (46.773603, -118.041961) – **Fecal Coliform Concern** – Field crews suspect that mud swallows (or other birds) may be nesting under the bridge. Guano was observed on the bridge structure

WSDOT staff accessed the underside of the structure on 11/10/14 and observed mud swallow nests. We believe the birds are causing a fairly minor impact. Mud swallows are protected under the Migratory Bird Act, preventing us from disturbing them during nesting. However, there may be opportunity to remove the nests in association with maintenance work during the winter months when the swallows are not present, where feasible. It is likely that the birds would return even if nests were removed.

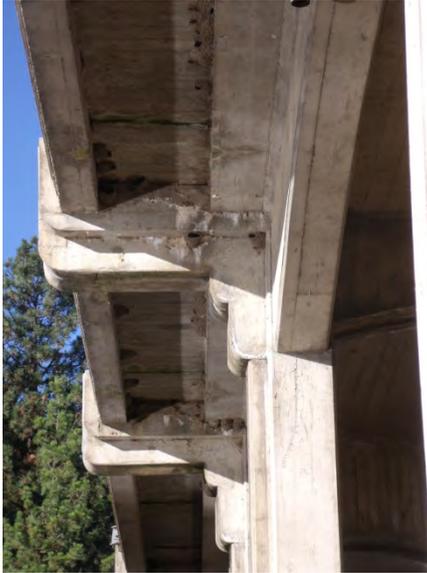
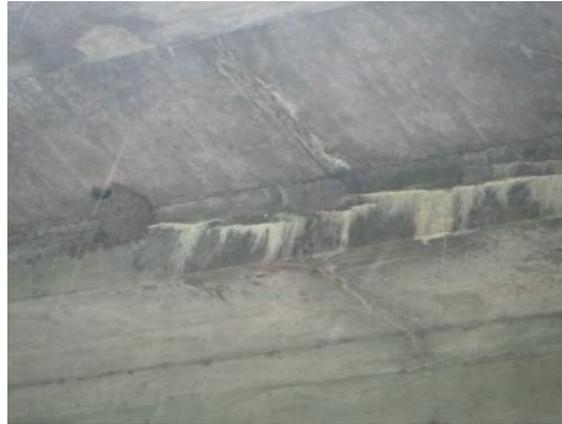
SR 26 Milepost 132.99 (46.890869, -117.374934) – **Fecal Coliform Concern** – Field crews suspect that mud swallows (or other birds) may be nesting under the bridge. Guano was observed on the bridge structure.

WSDOT staff accessed the underside of the structure on 11/10/14 and observed mud swallow nests. We believe the birds are causing a fairly minor impact. Mud swallows are protected under the Migratory Bird Act, preventing us from disturbing them during nesting. However, there may be opportunity to remove the nests in association with maintenance work during the winter months when the swallows are not present, where feasible. It is likely that the birds would return even if nests were removed.

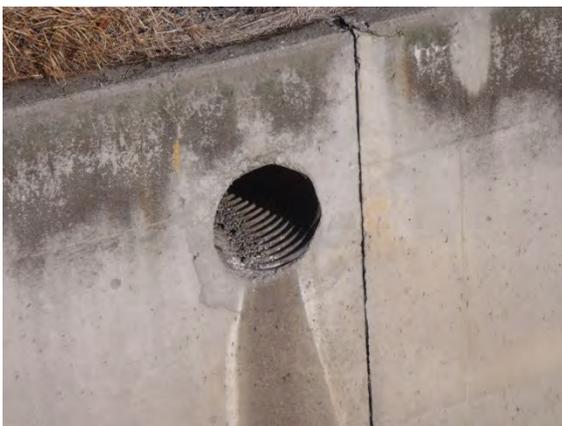
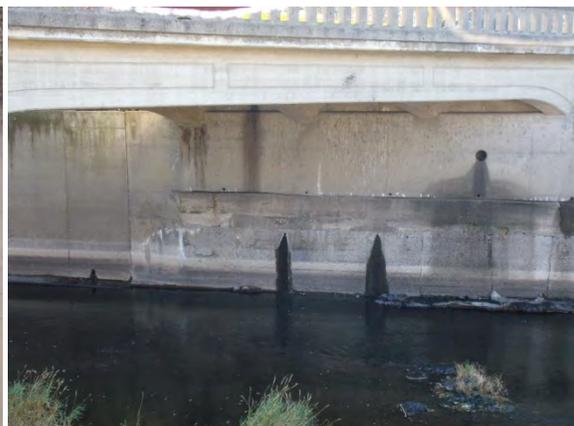
SR 195 at Milepost 38.51 (46.890046, -117.364286) – **Fecal Coliform Concern** – Field crews observed pigeons roosting in the stormwater outfall pipes located under on the north and southbound sides of SR 195 (2 bridges).

WSDOT staff accessed the underside of the structures on 11/10/14 and observed some minor bird guano in the outlet pipe on the west side of the bridge and some on a ledge on the east side. We do not think it is feasible to safely exclude birds from the pipe as netting or grates could catch debris and block water. The City of Colfax owns the pipe in question.
