**SR 500 I-205 Interchange Improvements (Burnt Bridge East)  
Mitigation Site**

**USACE NWP (14) NWS-2007-806**

**2014 MONITORING REPORT**

**Washington State  
Department of Transportation**

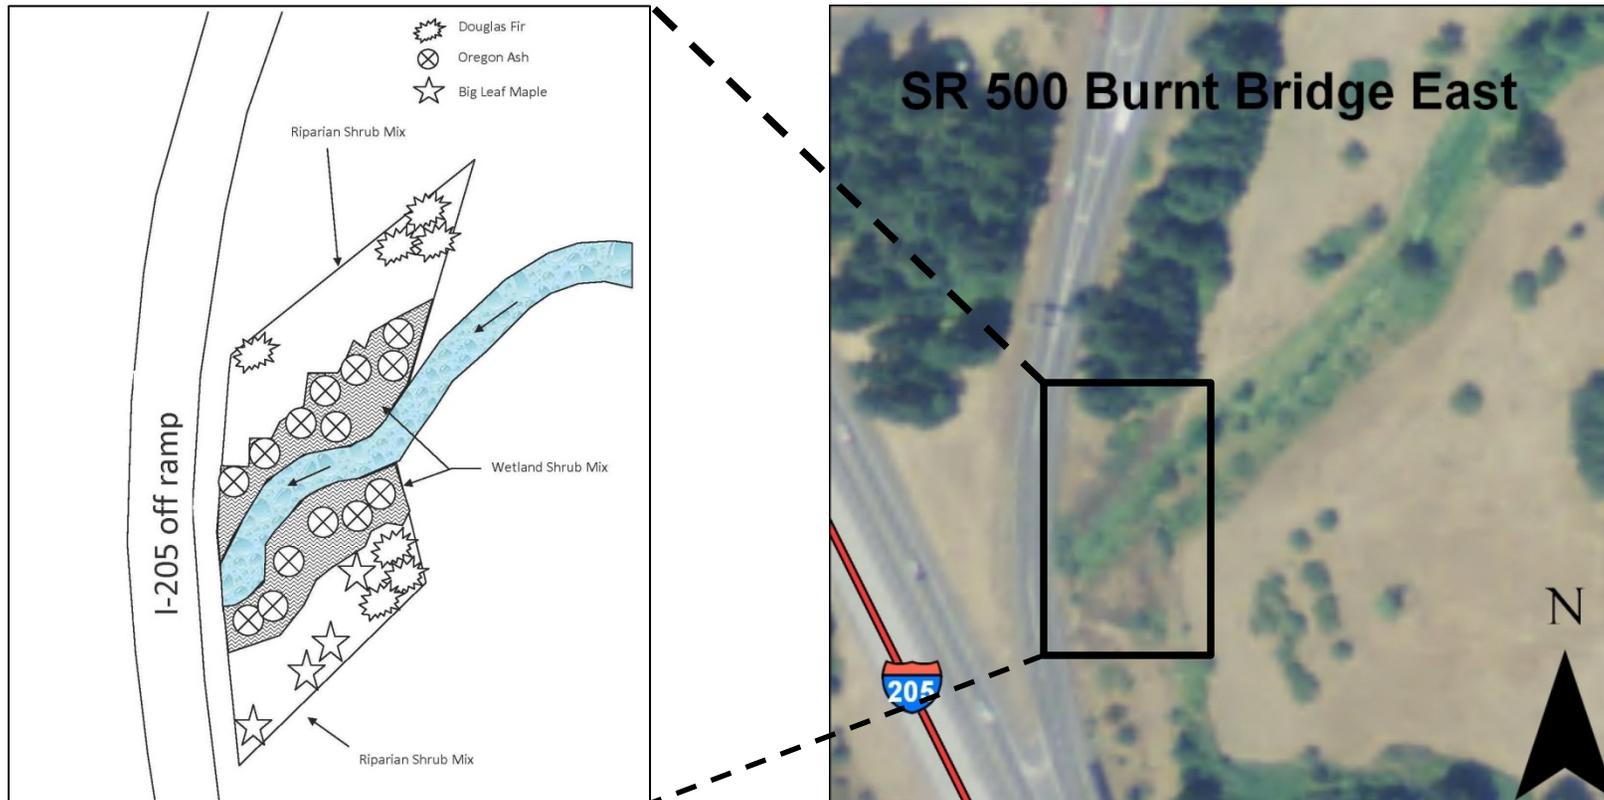
**Figure 1 Site Sketch**

This 0.25-acre mitigation site (Figure 1) comprises wetland/riparian enhancement on the Kevanna Reach section of Burnt Bridge Creek at the junction of the SR-500 eastbound off-ramp and I-205 northbound. This site was created to compensate for the loss of 0.022 acre of wetlands due to road improvements at the SR 500/I-205 interchange. The wetland/riparian enhancement is designed to provide mitigation for lost wetland functions including wildlife habitat, biological support, improved floodplain function, and nutrient and sediment removal.

The SR 500 Burnt Bridge East Mitigation Site contains two enhanced wetland benches and two riparian buffer enhancement areas flanking both sides of Burnt Bridge Creek. Appendix 2 includes site directions.

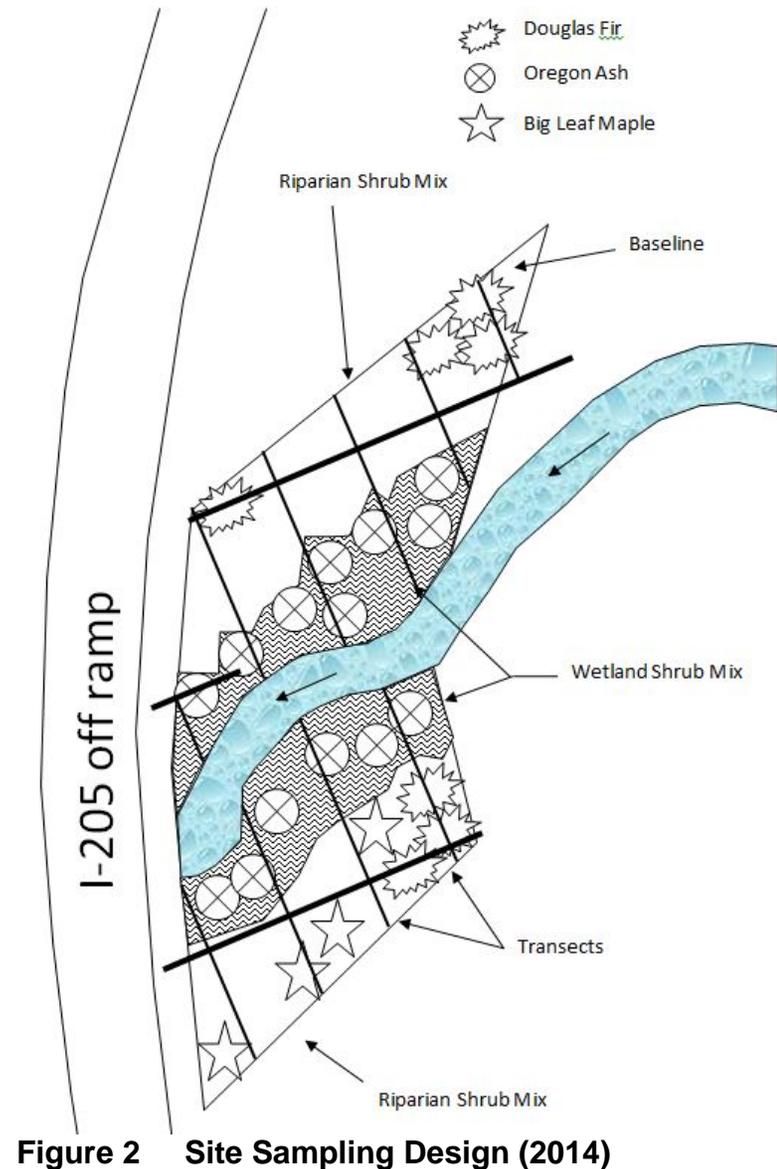
To evaluate vegetative performance standards, a 76-meter baseline was established along both sides of Burnt Bridge Creek (Figure 2). Ten sampling transects were placed perpendicular to the baseline using a systematic random sampling method. The unequal-area belt transect method was used to determine the density of native woody species (Performance Standards 2, 3, and 5). One-meter-wide sample units were positioned along the entire length of each transect. The point-line method was used to determine the cover of invasive species (Performance Standards 9 and 10). Ten five-meter-long point-line sample units (20 points each) were randomly positioned along the transects.

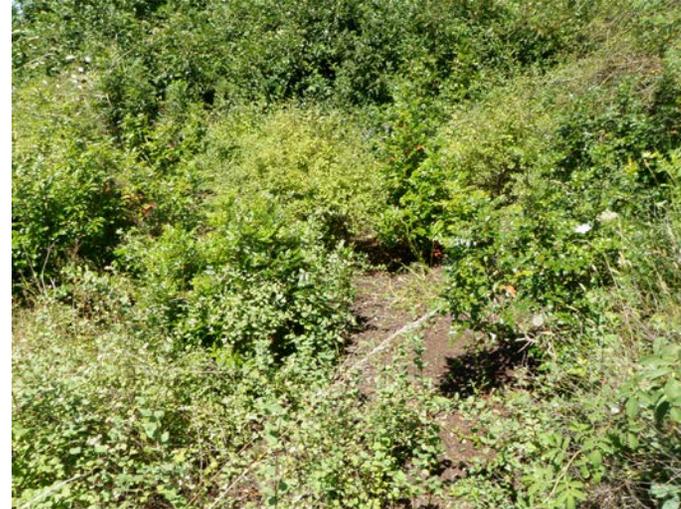
**Photo 1**  
**Woody density in the riparian buffer (July 2014)**

The density of native shrubs in the riparian buffer (Photo 1) is estimated at 6,689 shrubs per acre ( $CI_{80\%} = 5,510-7,867$ ). This easily exceeds the performance standard threshold.

The density of native trees in the riparian buffer is estimated at 112 trees per acre ( $CI_{80\%} = 18-206$ ). This is well short of meeting the performance standard, however, it is not entirely clear that this performance standard was written with this zone in mind, and the overall native woody density (including shrubs) is quite high (see results for Performance Standard 3 below).

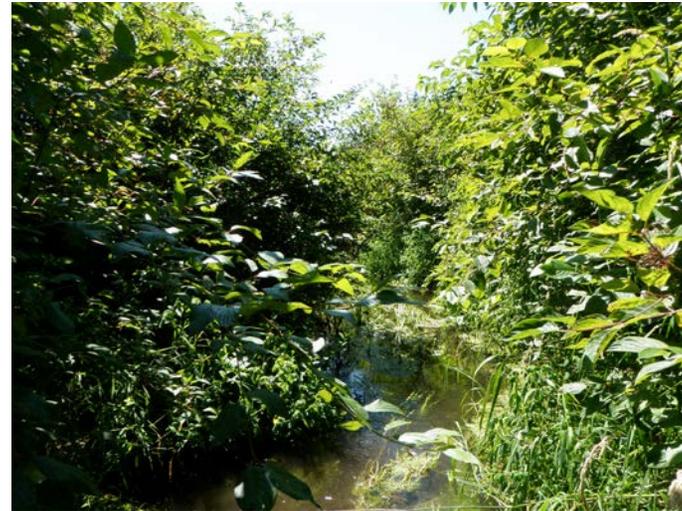
**Photo 2**  
**Woody density in the scrub-shrub wetland (July 2014)**

The density of native shrubs in the scrub-shrub wetland is estimated at 4,153 shrubs/acre ( $CI_{80\%} = 3,773-4,534$ ) (Photo 2). This is likely meeting (or at least very close to meeting) the performance standard. There are also Oregon ash (*Fraxinus latifolia*) planted in this zone. Including this tree species, the native woody density is estimated at 4,579 plants/acre ( $CI_{80\%} = 4,160-4,999$ ). Regardless, the density in this zone is clearly adequate, as the native woody cover is visually estimated at 99 percent.

Two native shrub species are present in the scrub-shrub wetland. These species are redosier dogwood (*Cornus alba*) and twinberry honeysuckle (*Lonicera involucrata*). One native tree species, Oregon ash (*Fraxinus latifolia*), was also present in this zone. Based on visual estimates, no single species is exceeding 60 percent cover in this zone. Redosier dogwood, however, is likely close to this threshold.

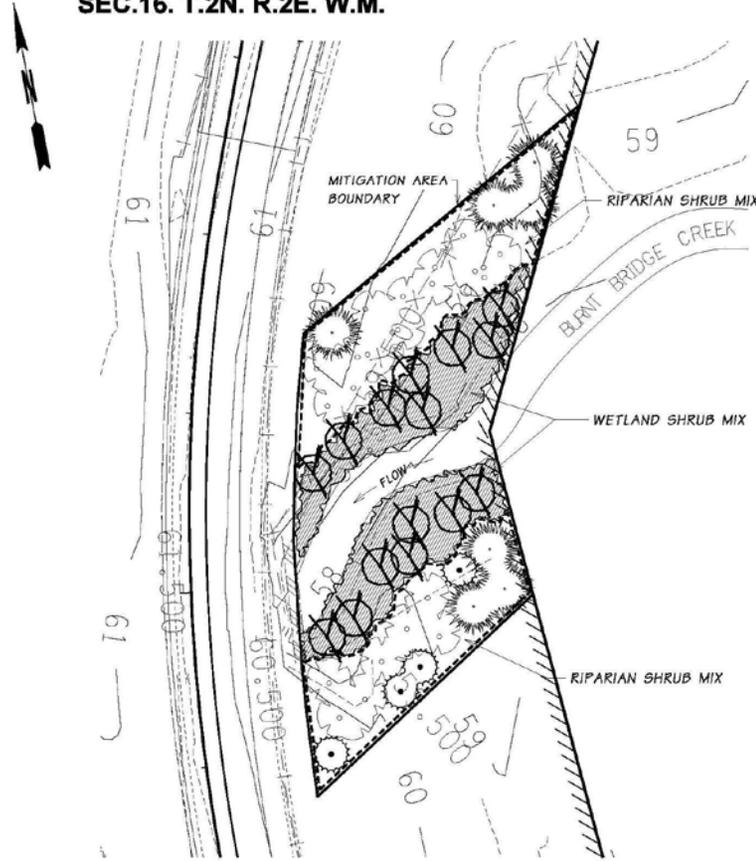
# Appendix 1 – Planting Plan

WETLAND MITIGATION AREA

Appendix 1 shows the planting plan (WSDOT 2010).

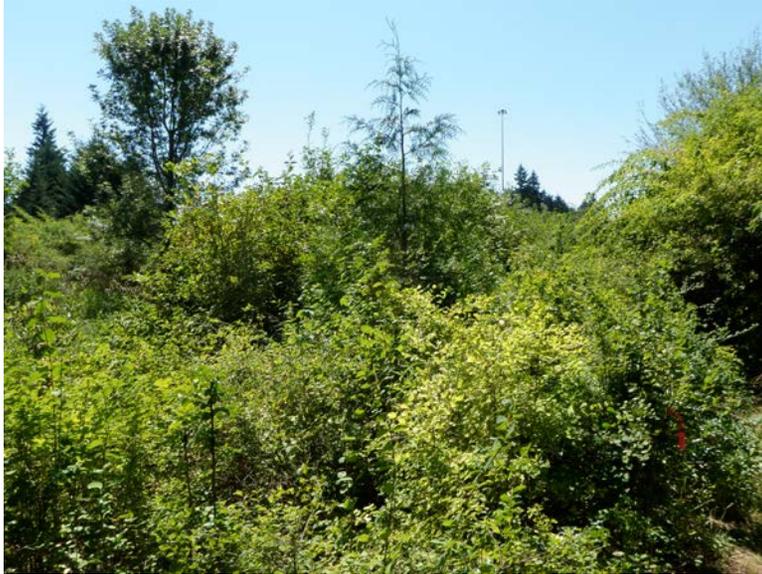
**Photo Point 1**

The photographs below were taken from permanent photo-points on July 28, 2014 and document current site development.

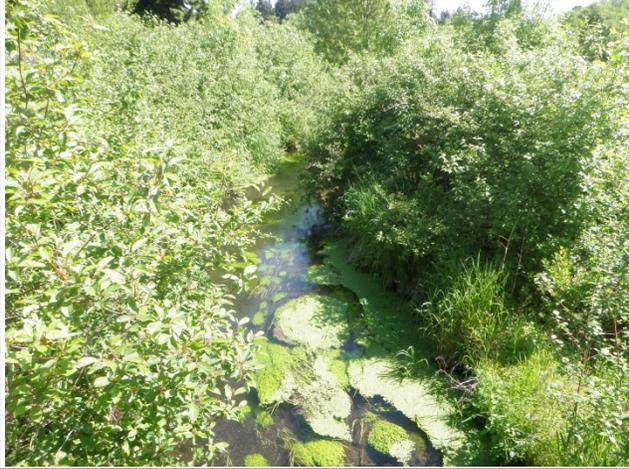
Figure 1. Vicinity Map

General Information for the SR 500 Burnt Bridge East mitigation site		
<b>Location:</b>	DCL 56, T2N, R2E. Clark County. (Vicinity map, Figure 1)

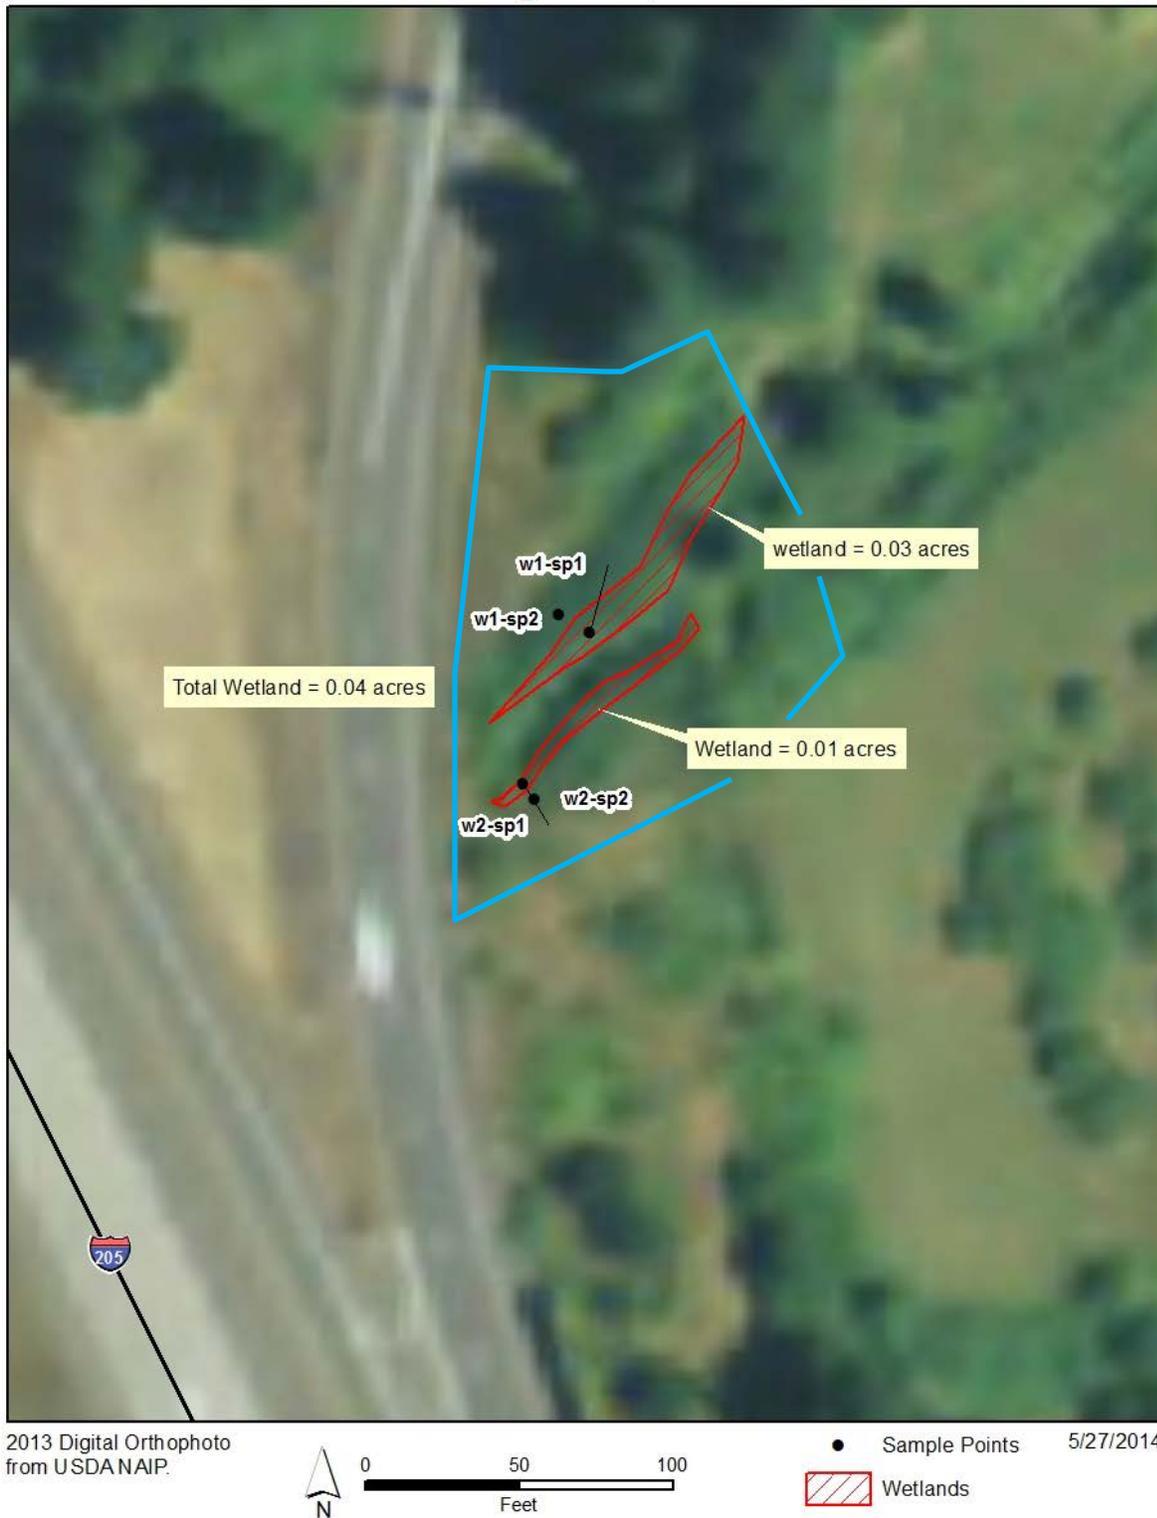
A Global Positioning System (GPS) Trimble GeoXT mapping grade unit was used to record the wetland boundaries and sampling point locations (Figure 2). Wetland boundary points were recorded at regular intervals and at any change in direction along the boundary.

Wetlands described in this report were assessed only within the wetland mitigation site boundary (Figure 2).

**Figure 2. Study area in blue, wetland boundary in red, and sampling point locations in black.**

The delineation determined 0.04 acre of wetland were present within the SR 500 Burnt Bridge East mitigation site. Delineation data were collected at four sampling points and recorded on wetland determination data forms (Appendix A). Paired wetland and upland sample points were used to define the wetland edge. Data recorded on wetland determination data forms characterize typical wetland and upland conditions observed on site. Vegetation, soils, and hydrology were examined in many additional sampling locations to determine the wetland boundary.

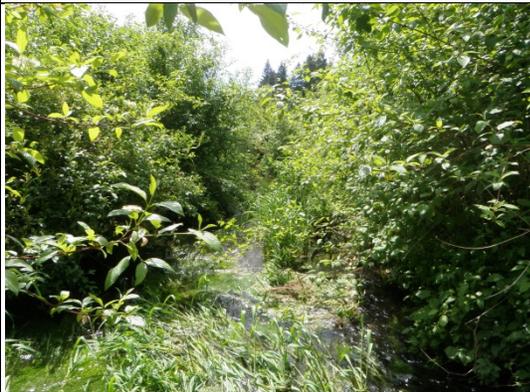
SR 500 Burnt Bridge East Mitigation Site – Wetland Delineation Summary		
<b>Total Delineated Wetland Area</b>	0.04 acre

<b>Wetland Determination Data Form(s)</b>	Appendix A; Sampling Point W1-SP1 and W2-SP1
	<b>Upland Determination Data Form(s)</b>	Appendix A; Sampling Point W1-SP2 and W2-SP2
	<b>Delineator(s)</b>	Doug Littauer Sean Patrick
	<b>Delineation Date</b>	May 14, 2014
<b>Vegetation</b>	Trees – none Shrubs – redosier dogwood ( <i>Cornus alba</i> ), sweetbriar rose ( <i>Rosa eglanteria</i> ), twinberry honeysuckle ( <i>Lonicera involucrata</i> ), Oregon ash ( <i>Fraxinus latifolia</i> ) Herbs – jewelweed ( <i>Impatiens capensis</i> ), reed canarygrass ( <i>Phalaris arundinacea</i> ), fringed willowherb ( <i>Epilobium ciliatum</i> )	
<b>Soils</b>	Soils examined to a depth of 18 inches exhibited hydric characteristics. Matrix colors of 10YR 2/1 with redoximorphic concentrations observed in the second layer starting between 6 to 8 inches below the surface. Indicator Redox Dark Surface (F6) met.

<b>Hydrology</b>	Flows associated with Burnt Bridge Creek appear to be the main source of hydrology, providing both seasonal flood water as sheet flow, and sub-surface hyporheic flows. Drift deposits and oxidized rhizospheres were observed. Direct observation of water was not present during the time of the investigation in mid-May. Water was flowing in Burnt Bridge Creek.	
<b>Rationale for Delineation</b>	Positive indicators of all three wetland criteria are present. Placement of boundary determined mostly by presence/absence of hydric soil indicators. Topography was also informative in the wetland boundary placement.

Wetland polygons, sampling point locations, and wetland names shown in Figure 2.
