I-5 Blakeslee to Grand Mound (TDA 11) Mitigation Site

USACE IP NWS-2008-744-SOD

2015 MONITORING REPORT

Issued March 2016

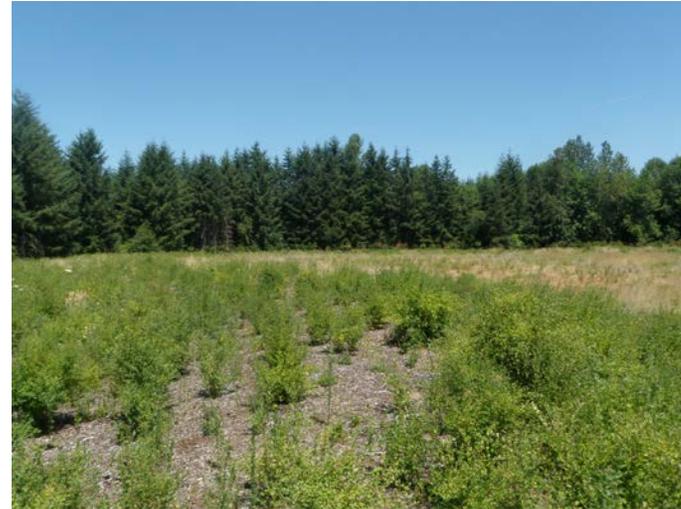
Density of tree species in the forested zones is estimated to be 1,227 plants/acre (CI_{80%} = 905-1,548) (Photo 1). Density of shrub species in the forested zones is estimated to be 5,032 plants/acre (CI_{80%} = 4,683-5,380). A total of eight tree species and 15 species of shrubs are present within the forested planting areas. Snowberry is estimated to provide 60% of the total cover across both forested zones.

Photo 1
Woody density in the oak and riparian forested upland (July 2015)

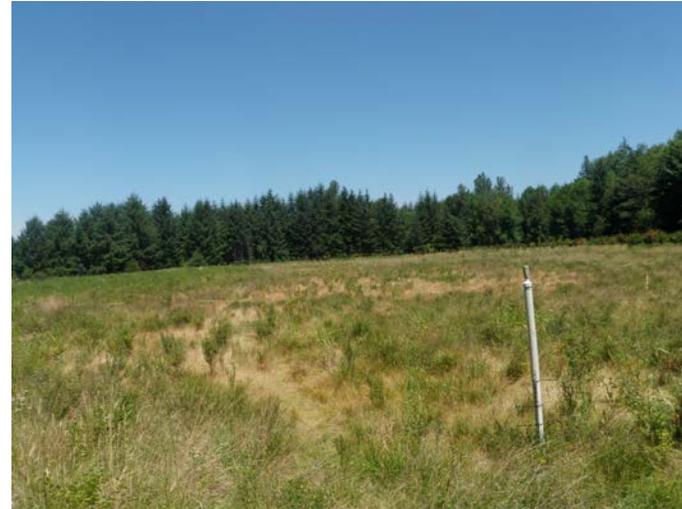
The density of shrubs in the scrub/shrub zone is estimated at 2,108 plants/acre (CI_{80%} = 1,905-2,312). There are eight species of native shrubs within the scrub/shrub planting zone. No single species provides more than 60% total aerial cover, however hardhack (*Spiraea douglasii*) is fast approaching this threshold (Photo 2).

Photo 2
Shrub density in scrub/shrub wetland (July 2015)

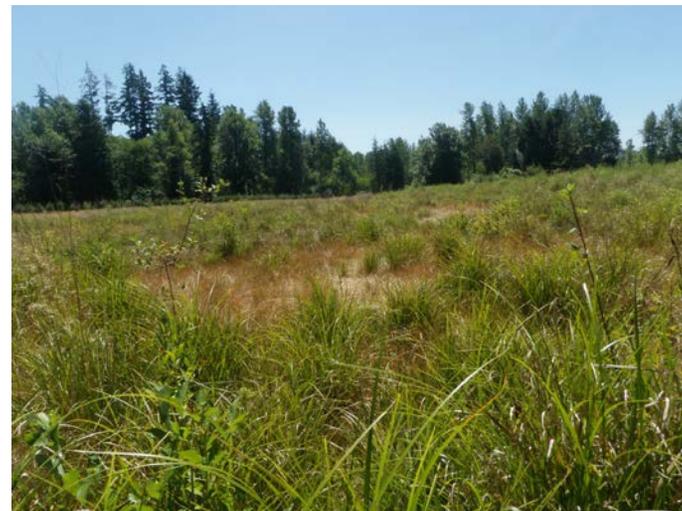
The cover of native facultative or wetter species within the emergent zone is estimated at 95%. This consists of an approximately two meter of band of tufted hairgrass (*Deschampsia caespitosa*) and slough sedge (*Carex obnupta*) around the outside edge and predominantly common spikerush (*Eleocharis palustris*) within the center of the zone. This area is planted with scattered native woody species as well.

Photo 3
Emergent cover in scrub/shrub wetland (July 2015)
