**SR 503 Lewisville Park Vicinity Climbing Lane (Climbing
Lane) Mitigation Site**

USACE NWP (14) NWS-2008-704

2014 MONITORING REPORT

**Washington State
Department of Transportation**

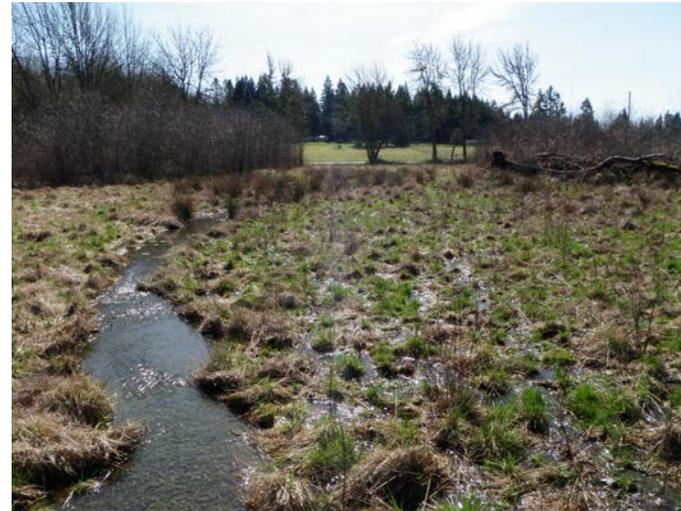
Photo 1
Inundation in the wetland (March 2014)

Saturation or inundation was present in three of the four wells on the first two hydrology visits in the spring 2014 (Appendix 3, Table 1) (Photo 1). Well 2 is located on a high area in between two emergent areas and did not meet the standard. On the third visit, saturation was present within 12 inches of the soil surface in two of the four wells.

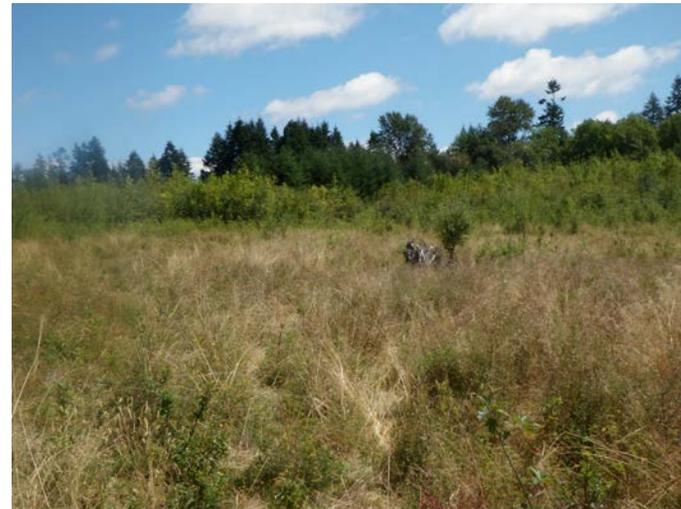
Photo 2
Density in the forested and scrub-shrub wetland (August 2014)

1,567 trees/acre ($CI_{80\%} = 1,234-1,899$) were found in the forested and scrub-shrub areas combined (Photo 2). This value exceeds the performance standard target.

3,502 shrubs/acre ($CI_{80\%} = 3,278-3,725$) were found in the combined forested and scrub-shrub wetland (Photo 2). This value is below the performance standard target.

See Performance Standard 3 above (Photo 2).

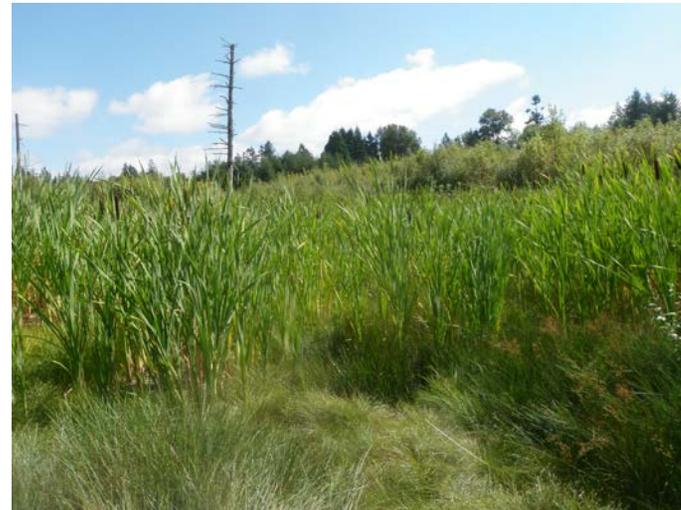
Photo 3 Cover in the emergent wetland (August 2014)

Cover is 98 percent ($CI_{80\%} = 96-99\%$) in the emergent wetland (Photo 3). This value exceeds the performance standard target.
