**SR 502 NE 15th Ave to NE 102nd Ave
(Mill Creek North) Mitigation Site**

USACE NWS 2009-1093

2014 MONITORING REPORT

Issued March 2015

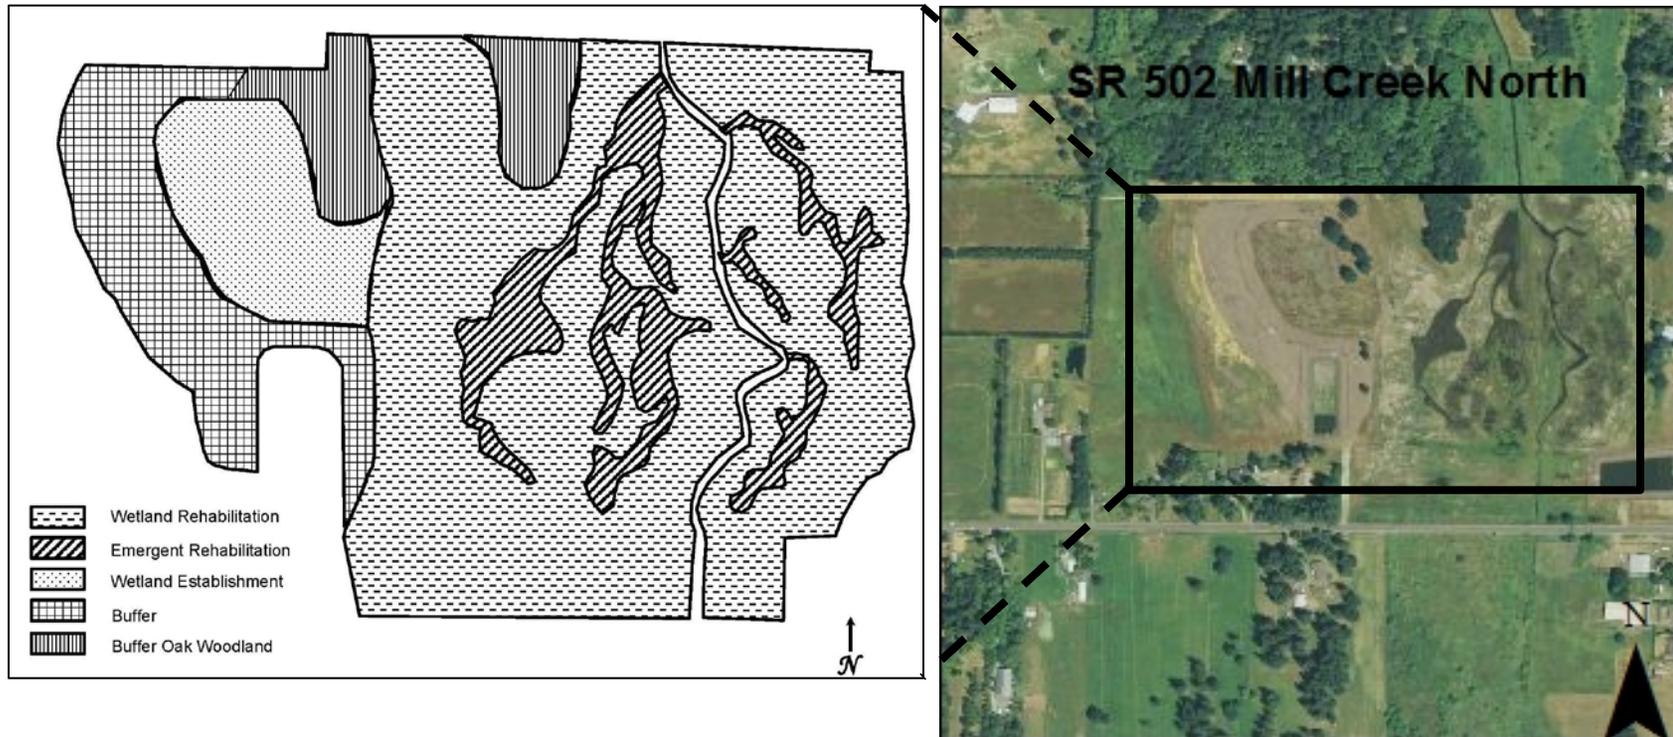
Figure 1 Site Sketch

This 64.64-acre mitigation site (Figure 1) is a combination of wetland establishment and wetland rehabilitation. This site was created to partially compensate for the loss of 11.12 acres of wetlands due to road improvements along SR 502. The newly established ponded depressions, channel realignment and surrounding scrub-shrub and forested areas are designed to provide mitigation for lost wetland functions including wildlife habitat, nutrient and sediment removal, and flood flow attenuation.

The SR 502 Mill Creek North Mitigation Site contains two stands of Oregon White Oak with an enhanced understory. Emergent and scrub-shrub areas flank the channel of Mill Creek. Appendix 2 includes site directions.

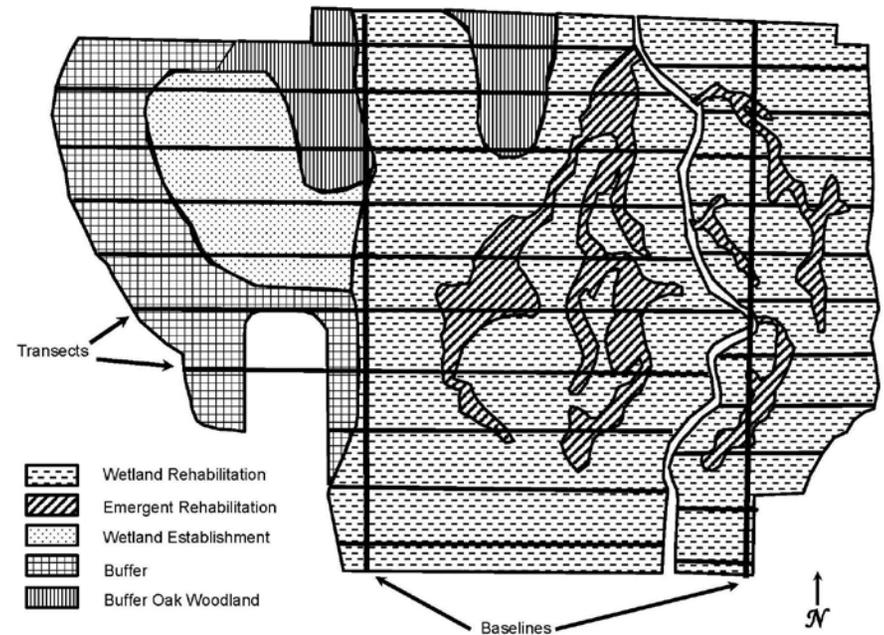
Figure 2 Site Sampling Design (2014)

To evaluate standards for vegetative cover, a segmented baseline was established parallel to the site boundary with one on either side of Mill Creek (Figure 2). Twenty-seven sampling transects were randomly placed perpendicular to the baseline. The unequal belt transect method was used to estimate woody survival (Performance Standard 2), and the point intercept method was used to estimate reed canarygrass cover (Performance Standard 5). A total of eighty-five twenty-meter sample units with a resolution of forty points were used to estimate reed canarygrass cover. The presence or absence of Class A Noxious Weeds and the cover of blackberries and Class B Noxious Weeds was evaluated qualitatively with visual estimates (Performance Standards 3 and 4).

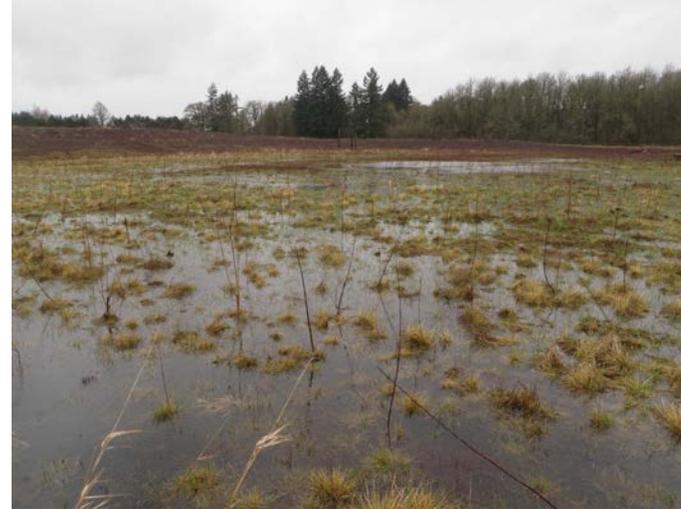
Photo 1
Inundation within the wetland establishment (March 2014)

Flood attenuation, sediment and toxicant retention, and nutrient removal and transformation were other functions intended for this site. Grading and plant establishment activities have likely enhanced the performance of these functions. The newly established depression wetland is being subjected to longer term seasonal inundation promoting nutrient and sediment removal (Photo 1).

On all three hydrology visits each of the three ground monitoring wells was either saturated to the surface or had water within the top twelve inches of the soil surface. A majority of the site was either inundated or saturated to the surface on each of the three hydrology visits (Photo 1). See Appendix 3 Table 2 for complete results.

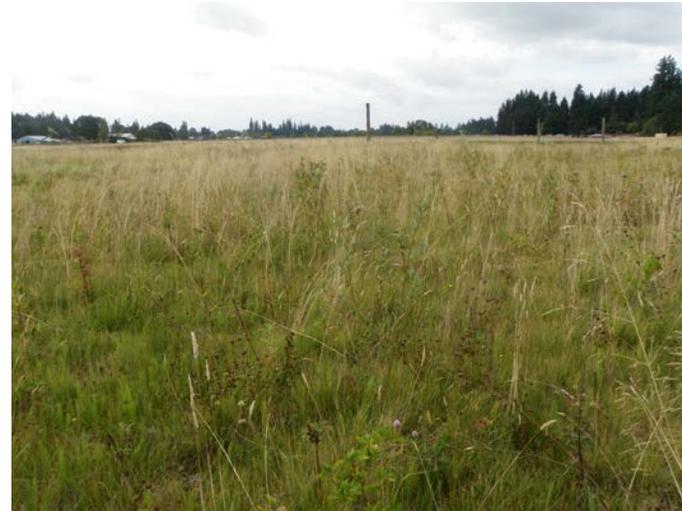
Photo 2
Woody survival in the rehabilitated wetland (August 2014)

Survival of planted woody species across the site is estimated at 88 percent ($CI_{80\%} = 86-90\%$) (Photos 2 and 3). This fails to meet the performance standard, but is within the confidence interval. There was significant die-off in between the two Oregon white oak preserves and in the southeast corner of the site that experienced an extended period of inundation.

The region has plans to replant and continue weed control as needed.

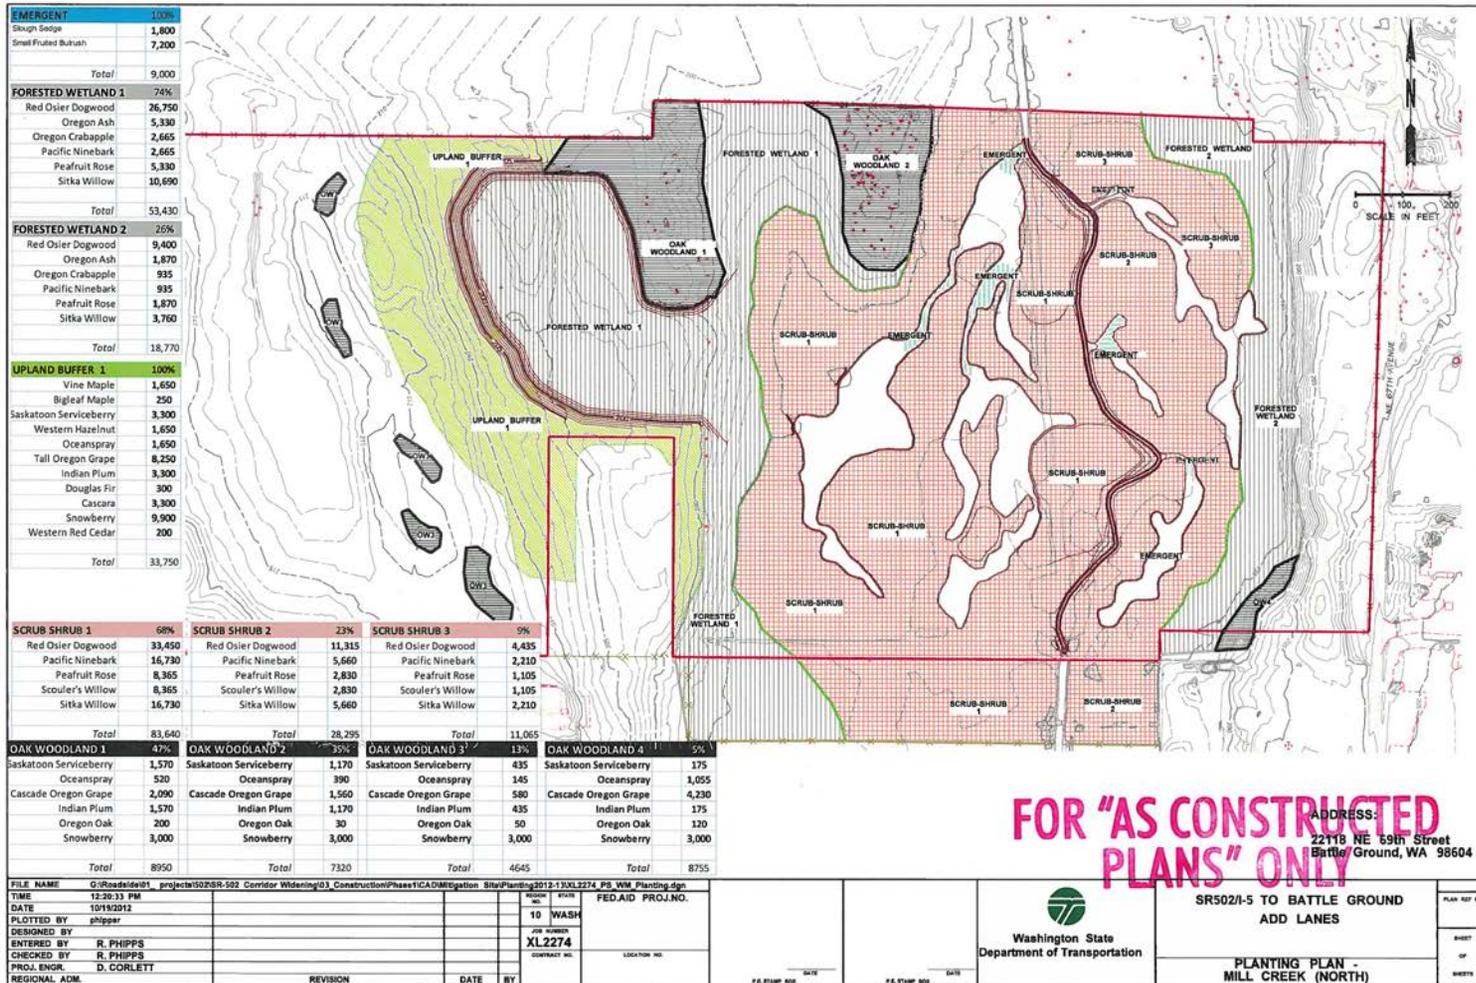
Appendix 1 – Planting Plan

Appendix 1 shows the planting plan (WSDOT 2012).
