**I-82 Valley Mall Boulevard Interchange Improvement
Mitigation Site
(Valley Mall Mitigation Site)**

USACE NWP (23) NWS-2009-121

2014 MONITORING REPORT

**Washington State
Department of Transportation**

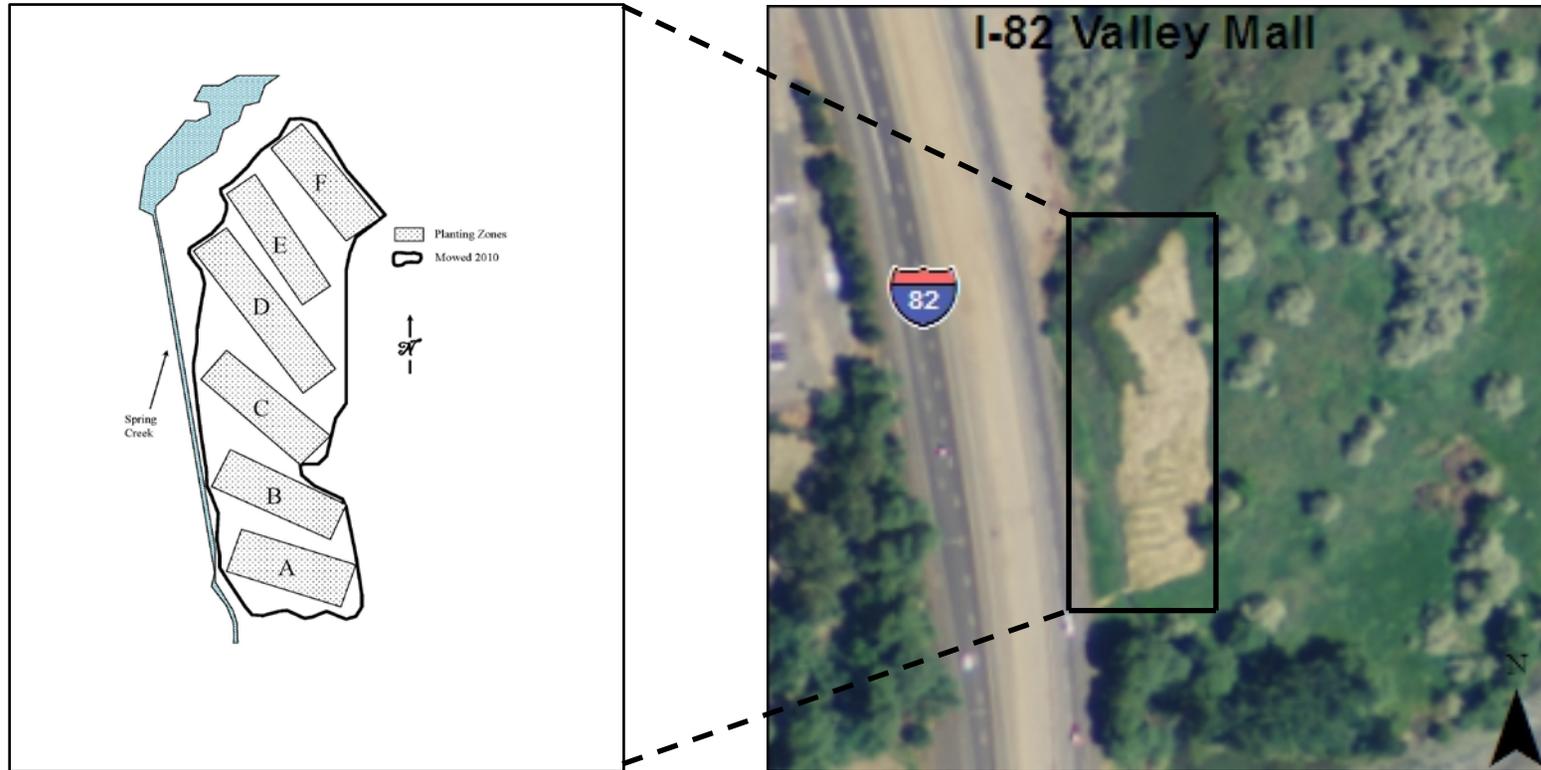
Figure 1 Site Sketch

The I-82 Valley Mall Mitigation Site contains six rectangular planting areas on the left bank of Spring Creek. They are planted with sandbar willow (*Salix exigua*). Appendix 2 includes site directions.

This 0.36 acre riparian enhancement area (Figure 1) is part of a larger parcel owned by WSDOT. This site was created to compensate for the loss of 0.04 acre of wetlands and 0.79 acre of wetland buffer due to interchange improvements along I-82 and Valley Mall Boulevard. The six seasonally inundated planting zones are designed in a ribbed configuration that is intended to deflect floodwater from the I-82 embankment. The long-term goal is for willow to outcompete and replace reed canarygrass.

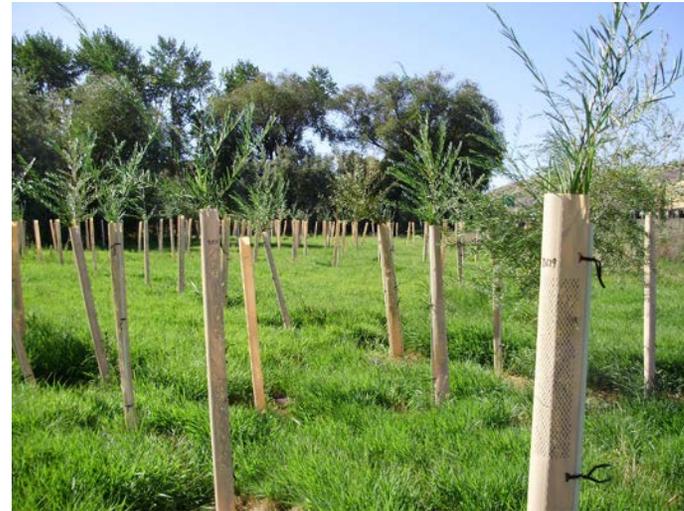
A total of 192 live stakes (including volunteers within the plots) were observed compared to the 233 stakes that were planted, resulting in 82 percent native woody plant survival (Photo 1). This value exceeds the performance standard target.

Photo 1
Native, woody plant survival (September 2014)

Vegetation management will include mowing of reed canarygrass and control of yellow-flag iris and thistles. Dead willow stakes may also be replaced, depending on how many have died and how quickly canopy coverage increases.

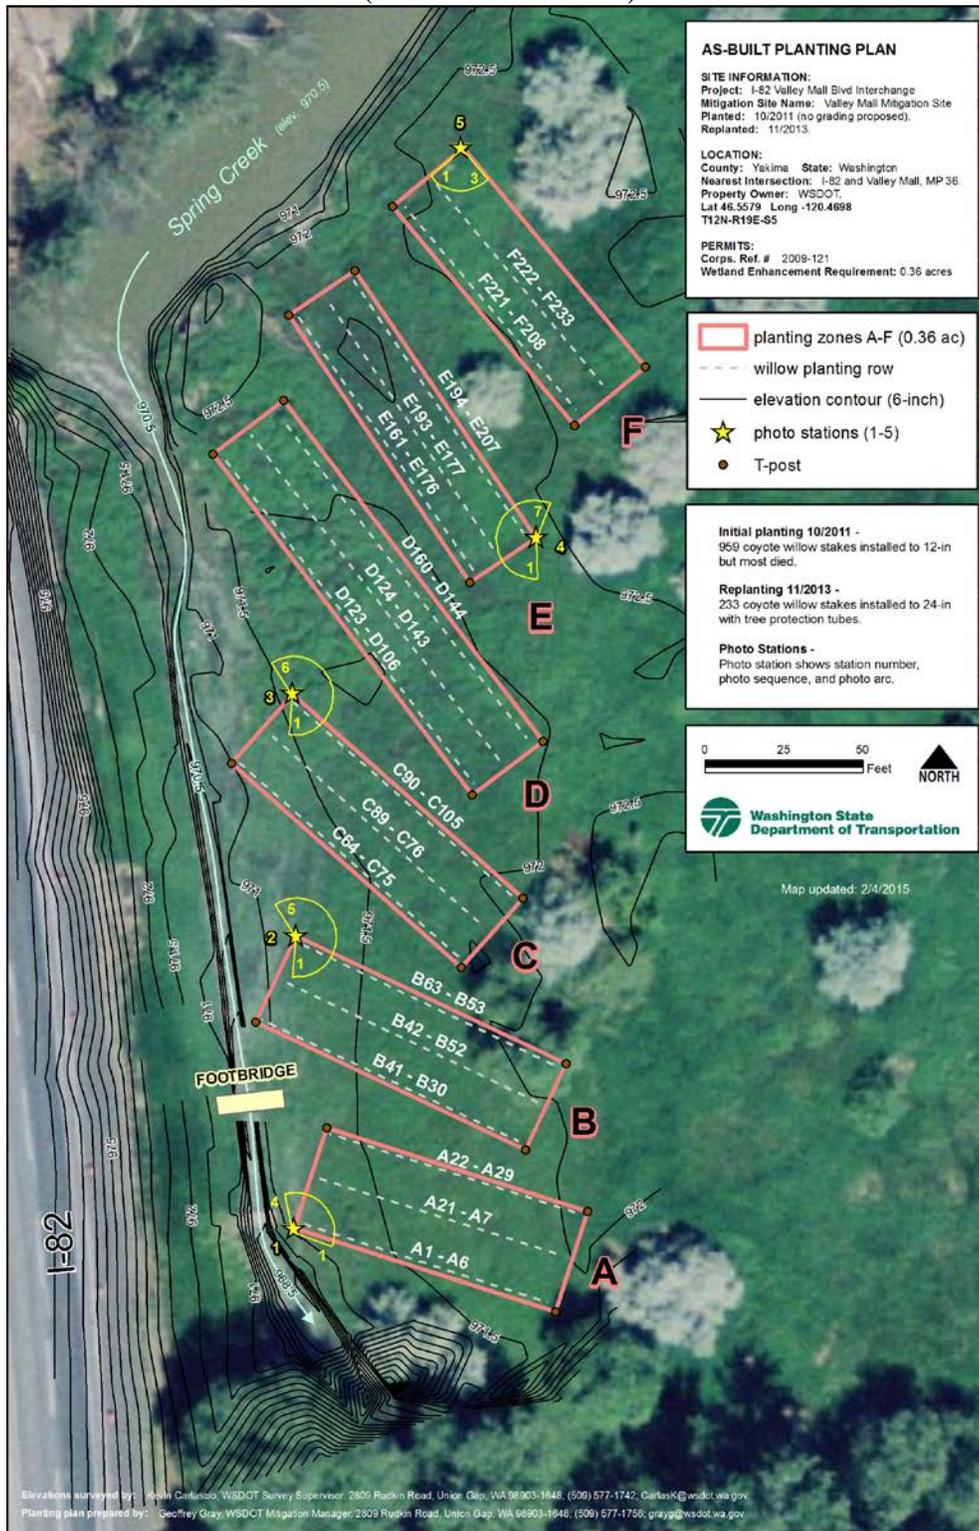
Appendix 1 – As-Built Planting Plan with Photo Point Locations

Appendix 1 shows the as-built planting plan (WSDOT 2014)

To evaluate standards for vegetative survival, a total count of live stems was completed by South Central Region Staff to compare to original planting numbers from the 2013 as-built (Performance Standard 1) (Appendix 1). Wetland monitoring staff also looked for county-listed Class A noxious weeds and other invasive plant species across the site (Performance Standard 2).
